Comstock Mine Environmental Monitoring Report Third Quarterly 2002

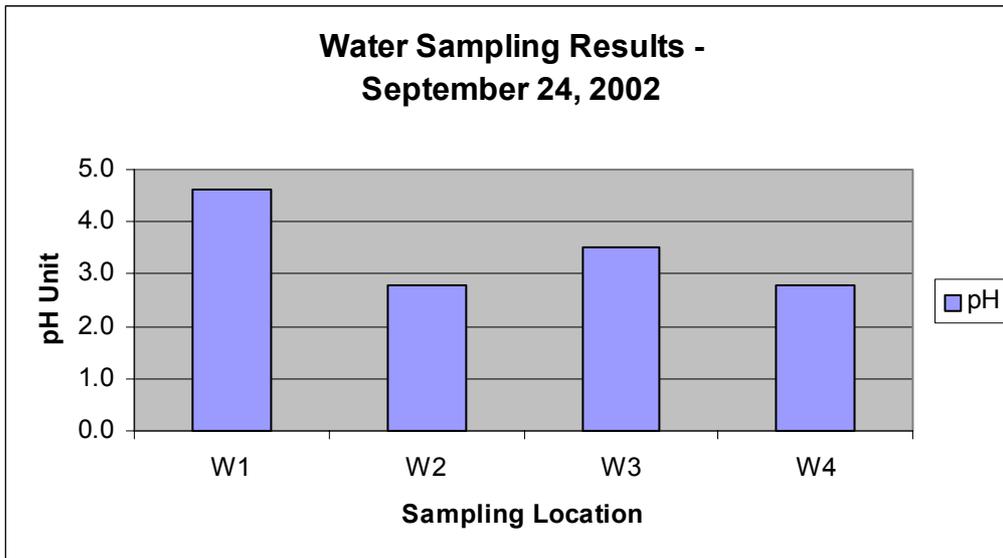
Figure 1. Water sampling results for pH on 24/09/02.

The pH at this location has risen to 2.6. As with W1, this location has proven a significant decrease in almost all parameter concentrations. The inactivity on site and seasonal rainfall has likely contributed to these results.

The pH at this location has increased and the heavy metals have decreased, some fairly significantly. The only poor result during this sampling activity was the TSS measurement increase. The dam in this area is filling quickly with run-off silt and sediment and will need to be emptied as soon as possible. Safe vehicle access to this area will be the first of many activities in this area in the near future.

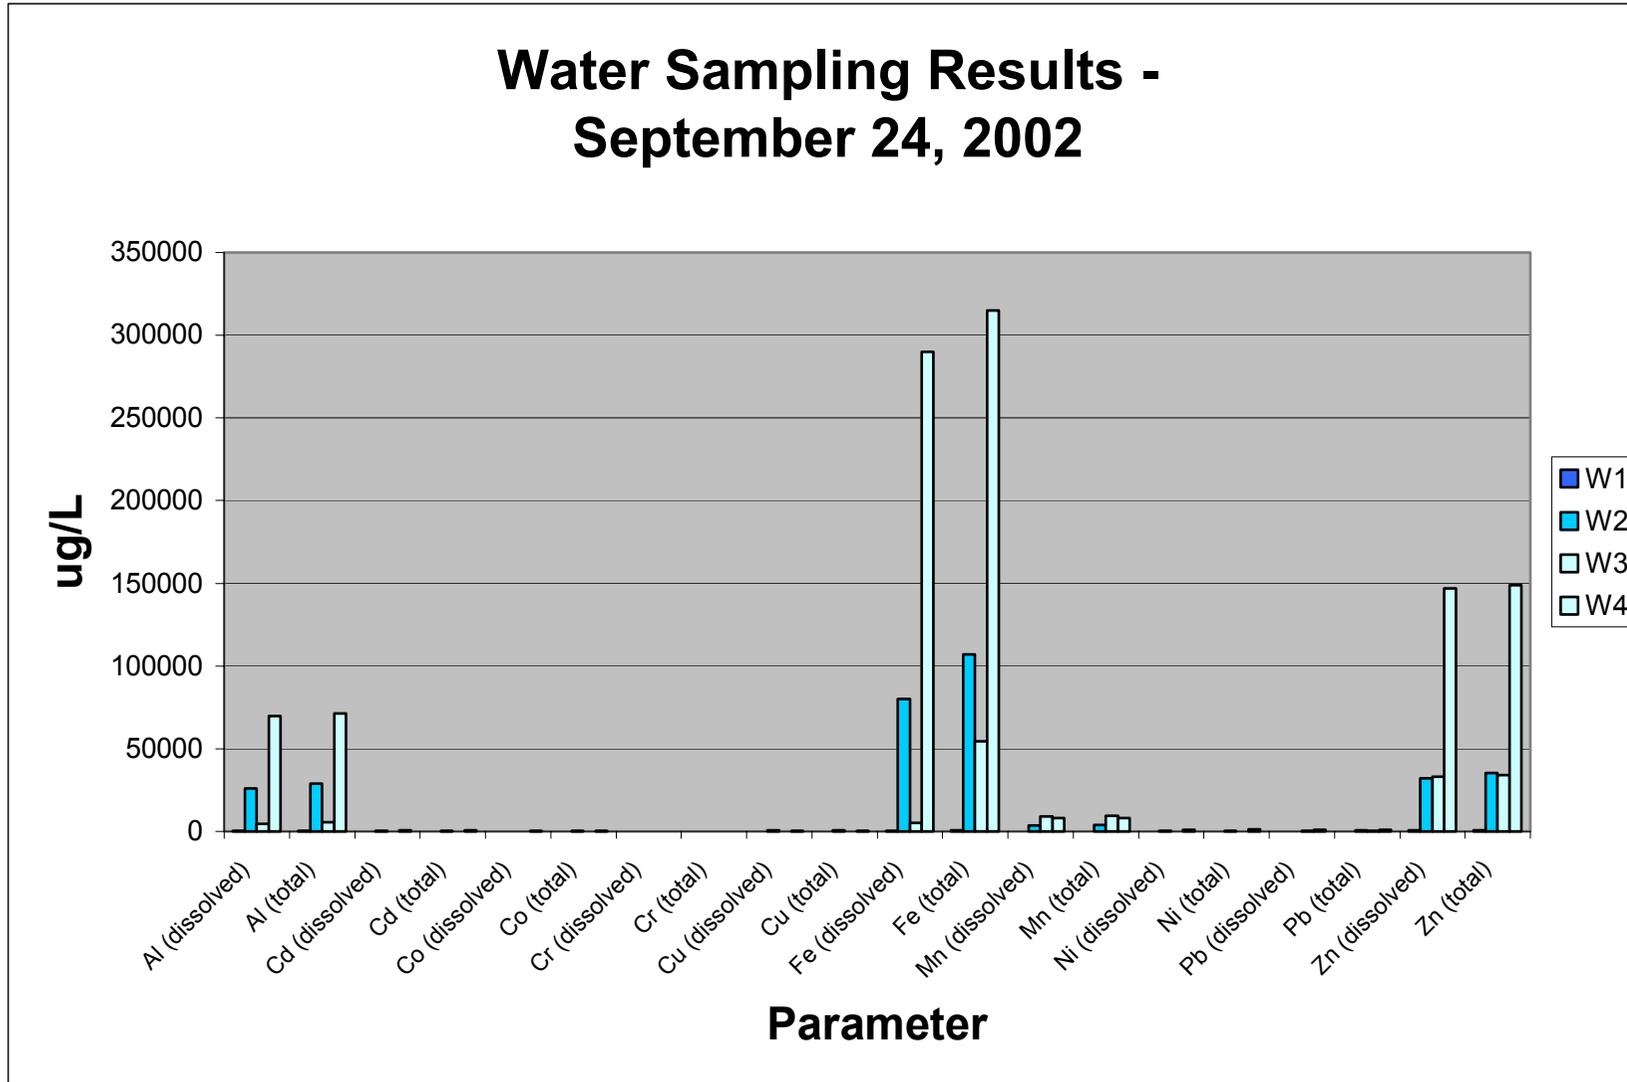
Figure 3. Water sampling results for metals on 24/09/02.

All parameters, with exception to manganese, have decreased significantly. This would be expected due to the quality of the upstream locations, W1 and W2, which feed into the adit system.
