Comstock Mine Environmental Monitoring Report Fourth Quarterly 2002

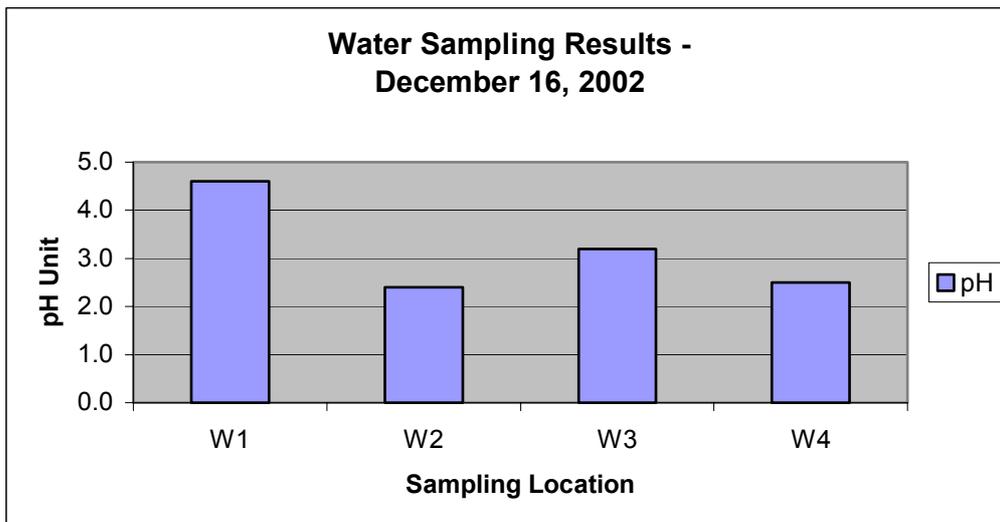
Figure 1. Water sampling results for pH on 16/12/02.

Compared to the previous sampling event, about half of the metals concentrations have increased slightly. The pH has remained steady at 4.6, which is fairly average for this sampling location.

The pH at this location has fallen to 2.4. Most metals concentrations have risen compared to the last sampling event, but would still be considered low when compared to the last two years of results. TSS has decreased substantially as well.

Besides the pH dropping 0.3 units from the last sampling event, the majority of metals concentrations have dropped significantly. This is likely due to the lack of mining activity 'upstream' of this location.

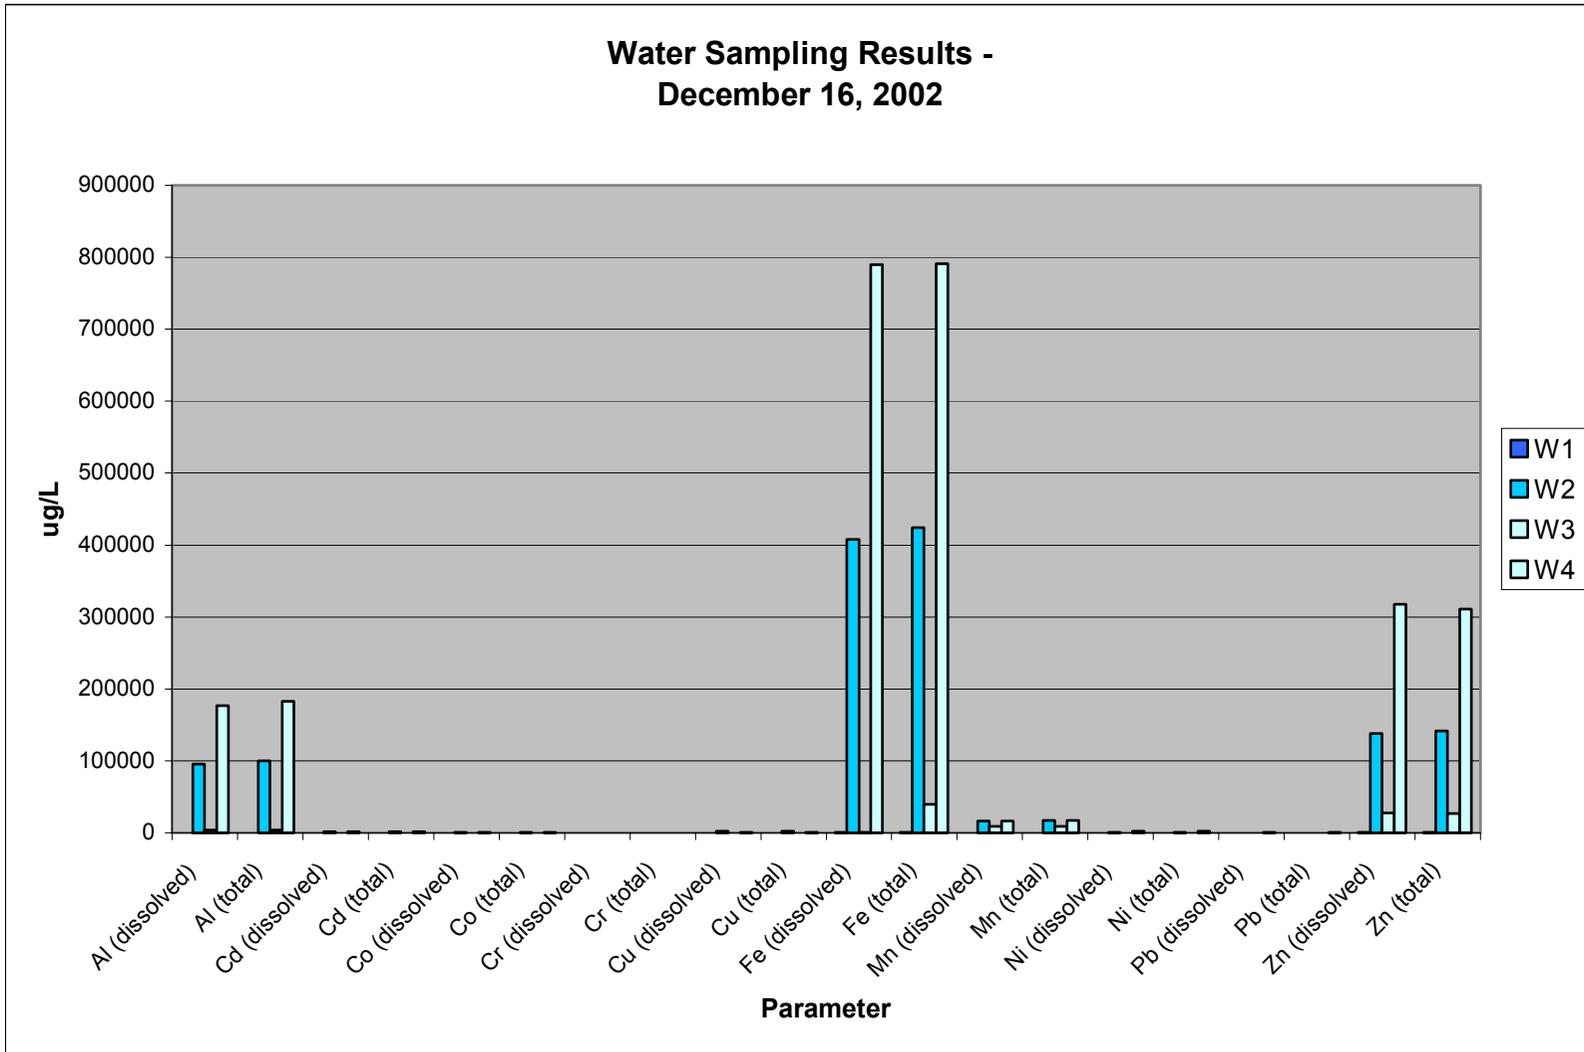
Figure 3. Water sampling results for metals on 16/12/02.

The concentration of metals at this location has increased since the last sampling event, likely due to the lack of maintenance in this area. In response to this issue, heavy equipment has been ordered onto the sight by the third week of February 2003, which will provide access to this site and clean the accumulated solids. A limestone addition is also planned given the appropriate conditions (safety).

W4 has been flagged as a problem area. It will be modified within 2-3 weeks, as the water quality results in the 1st Quarter Annual Report 2003 should reflect. Erosional issues are continuously being monitored and acted upon as required.
