Comstock Mine Environmental Monitoring Report First Quarterly 2003

COMSTOCK MINE

Environmental Monitoring Report

Oceania Tasmania Pty Ltd

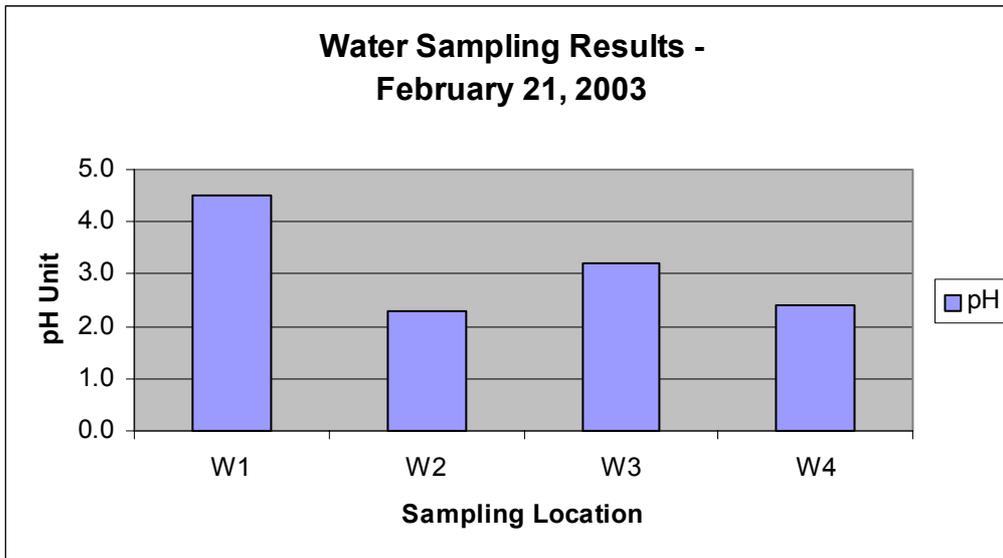
Figure 1. Water sampling results for pH on 21/02/03.

Samples were taken on February 21, 2003 and analysed at 'Allison Laboratories' on March 6, 2003 for all of the required parameters (Figures 1, 2 and 3). Laboratory results are located in Appendix A.

In general, the metals content recorded at this site have increased compared to previous sampling activities. This increase could be correlated with three (3) issues present at the time of sampling: 1) rehabilitation work was proceeding on the Central Waste Rock Dump, 2) a lack of rain was recorded, and 3) sediment traps were emptied two days previous (stirring up the retained water).

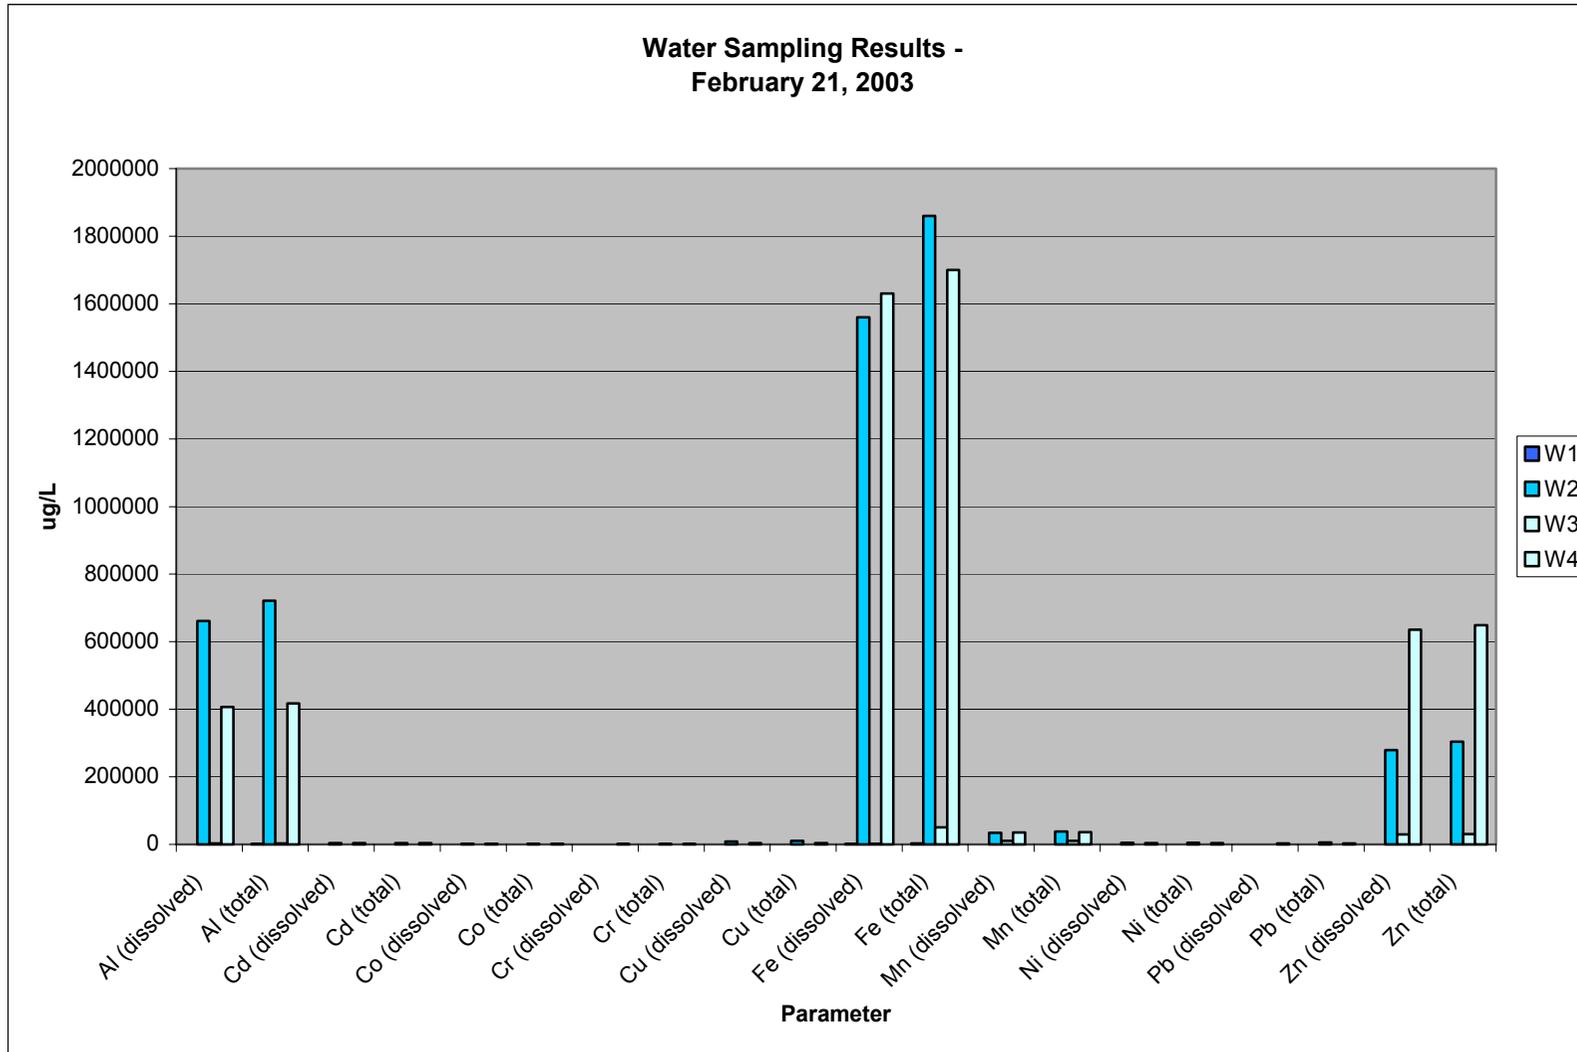
Figure 3. Water sampling results for metals on 21/02/03.

As described in the previous Quarter Annual Report, there was a lack of safe vehicle access to this retention dam for sediment extraction and limestone addition. The sampling results for this quarter indicate higher concentrations of metals at this location due to the upstream activities (development of an access road, wall and toe stabilisation, waste rock compaction, etc.).

As of today, the W4 sampling location has been moved to the bottom-centre of the Swansea Tramway Waste Rock Dump (STWRD), where a new retention dam has been constructed with improvements to the STWRD's drainage and retention dam access.

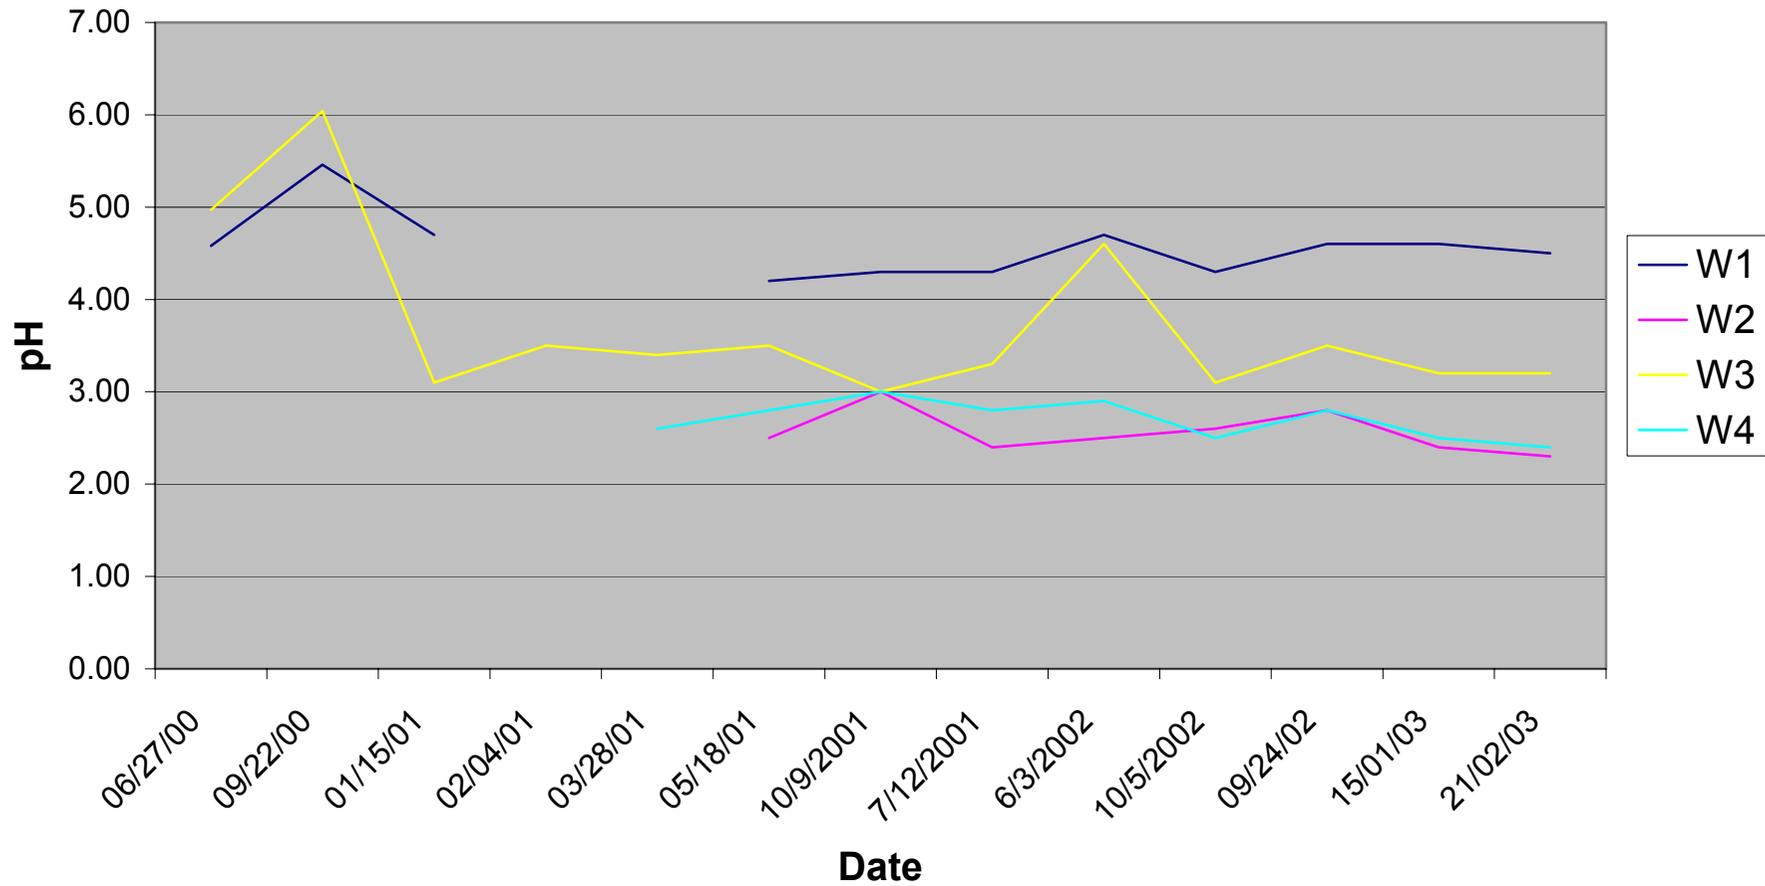
Laboratory pH Analysis - Graphed
