Grieves Siding – An Environmental Management Plan

Introduction

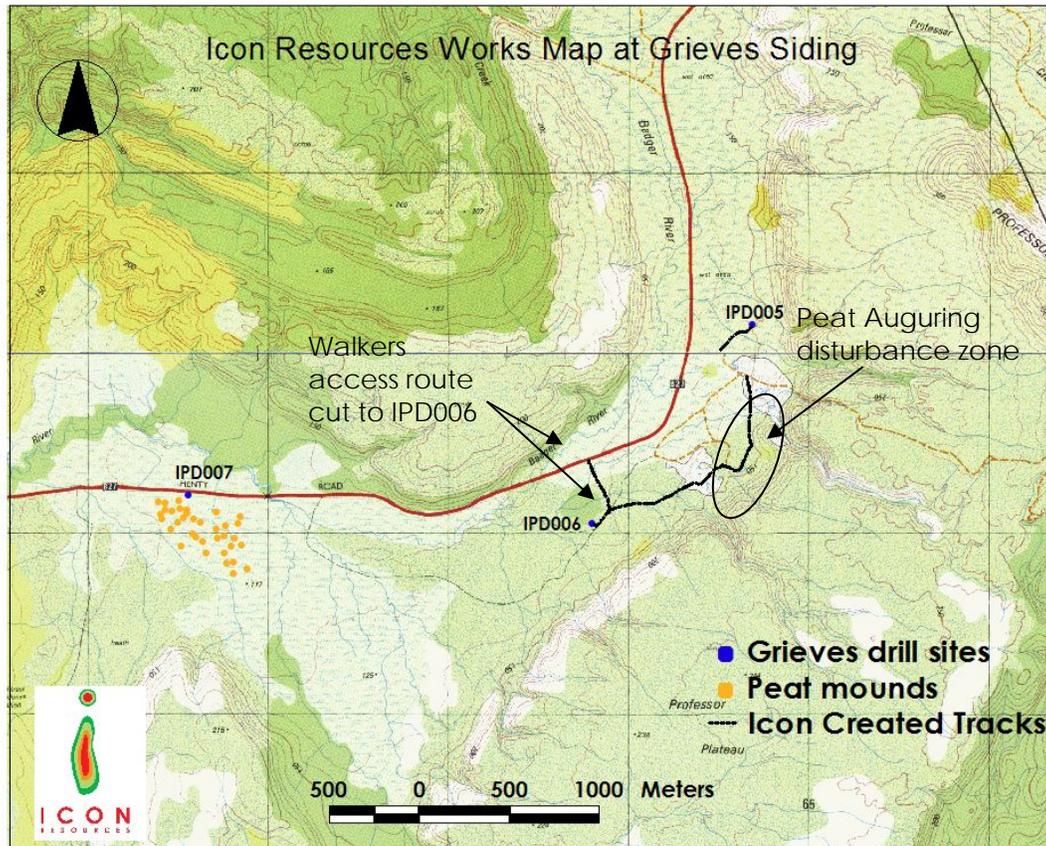
Map 1. Map of the Grieves site showing peat mounds, drill collars, peat auguring area and tracks.

Works so far carried out by Icon Resources that have physically impacted on the environment include: Diamond drilling, mobilization and de-mobilization of the drill rig, auguring "peat" and to a minor extent geophysical IP surveys (Map 1).

7. **Peat Mounds:** Recently discovered peat mounds thought to be artifacts of past glaciation were discovered near the proposed IPD007 drill site (Map 1).

The peat auguring sites were restricted to a relatively confined area towards the base of the eastern escarpment just south of IPD005 (see Map 1). The auguring was carried out using an auguring blade attached to an 8 tonne excavator.

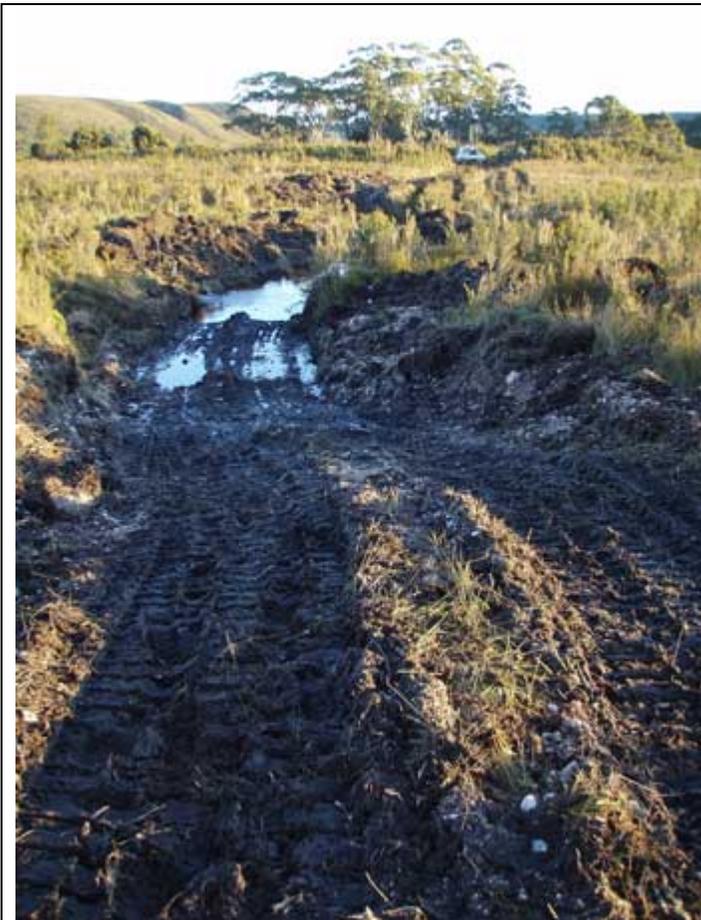
4. **Compaction of soil and vegetation.** Mobilisation and demobilization of the drill rig and Bombardier over boggy ground caused significant compaction within the Buttongrass environment (Plate 1). The heathland vegetation has largely died off in those areas compacted by machinery.

Plate 1. Access route to IPD005 used by the Drill Rig and "Bombadier" prior to rehabilitation.

All tracks created were temporary and where possible minimization of vehicle use employed. A bombardier was hired to carry fuel, core and supplies into and out from site. The Drill crew walked to and from the rig each day, their vehicle was left parked on established roads. A walking access route to IPD006 was cut by Ian Rogers (Plate 1.). This route also has rehabilitation photo monitoring sites at the access and egress points.

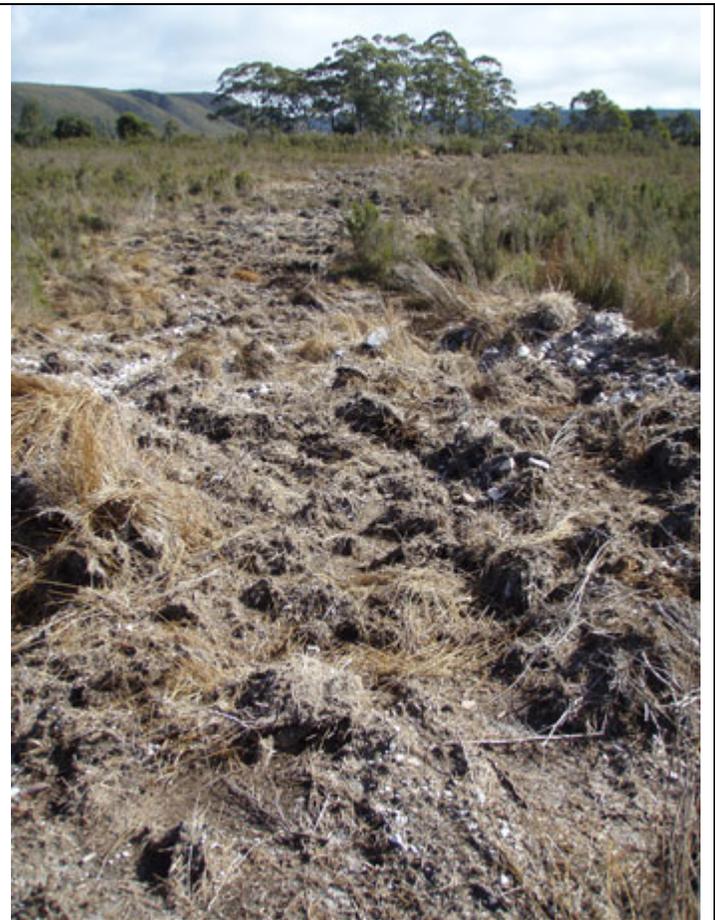
Once rehabilitated the seed-bank should largely be in tact and over time the area should recover (Plate 2).

Plate 2. Access route to IPD005 used by the Drill Rig and "Bombadier" after rehabilitation.

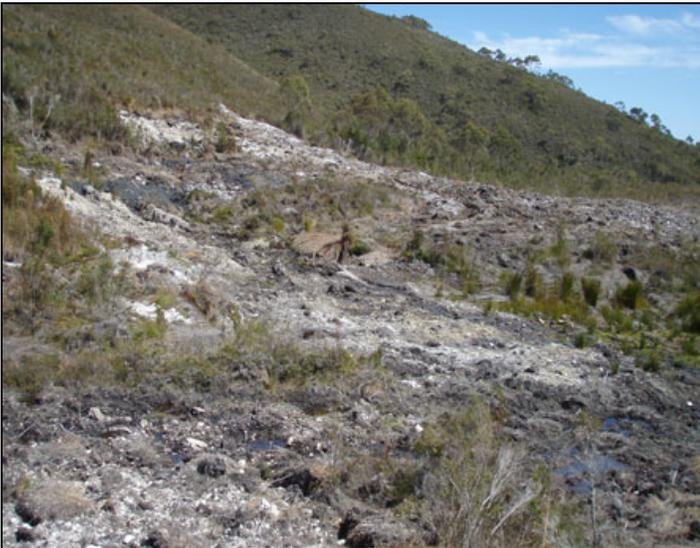
1. **Visual impacts:** The auguring sites are clearly visible from the Henty Road and appropriate considerations must be given to minimizing the visual impact of the operation as soon as possible.

Plate 3. The auguring area pictured is the largest and most visible disturbance from the Henty Road.

It is proposed that jute matting and slash are to be put down over the disturbed areas. This will help to stabilize the ground, hold the seed-bank in place and reduce evaporation enhancing the chances of survival for germinating seeds.*

The timing of rehabilitation is planned for late summer 2008 but is dependent on a planned burn to be carried out by Parks and Wildlife in the area. As per Plates 3-5 jute will be laid onto the ground with native seed bearing slash spread across it taken from the immediate area. Access to affected areas with equipment, jute etc will be via quad bike.

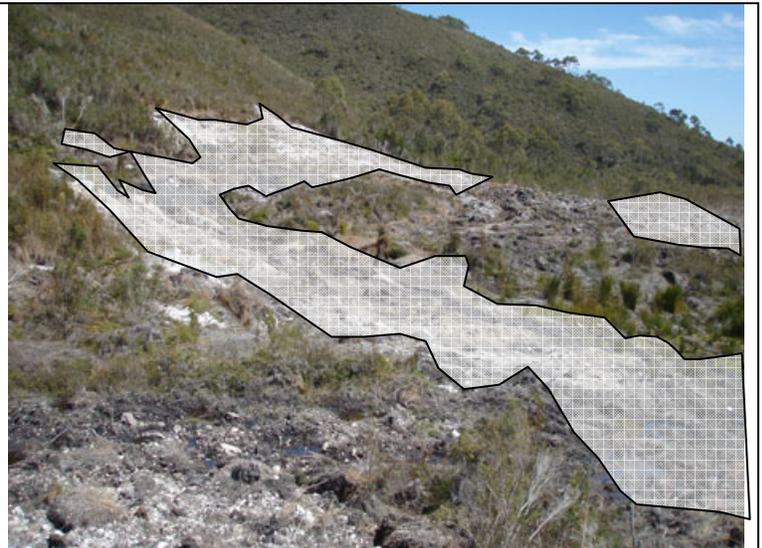
Plate 4. The shaded area is proposed to be covered in jute and slash. The remainder to be covered in slash only.

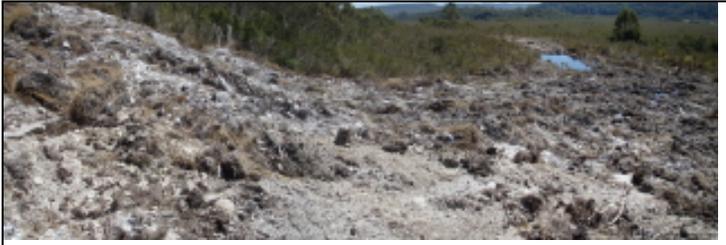
Plate 5. The above auguring site viewed looking west
