## Tamar Valley Power Station

## GEOLOGICAL AND GEOTECHNICAL INVESTIGATIONS – PRELIMINARY BRIEFING REPORT

- 1.0
- 1 February 2007

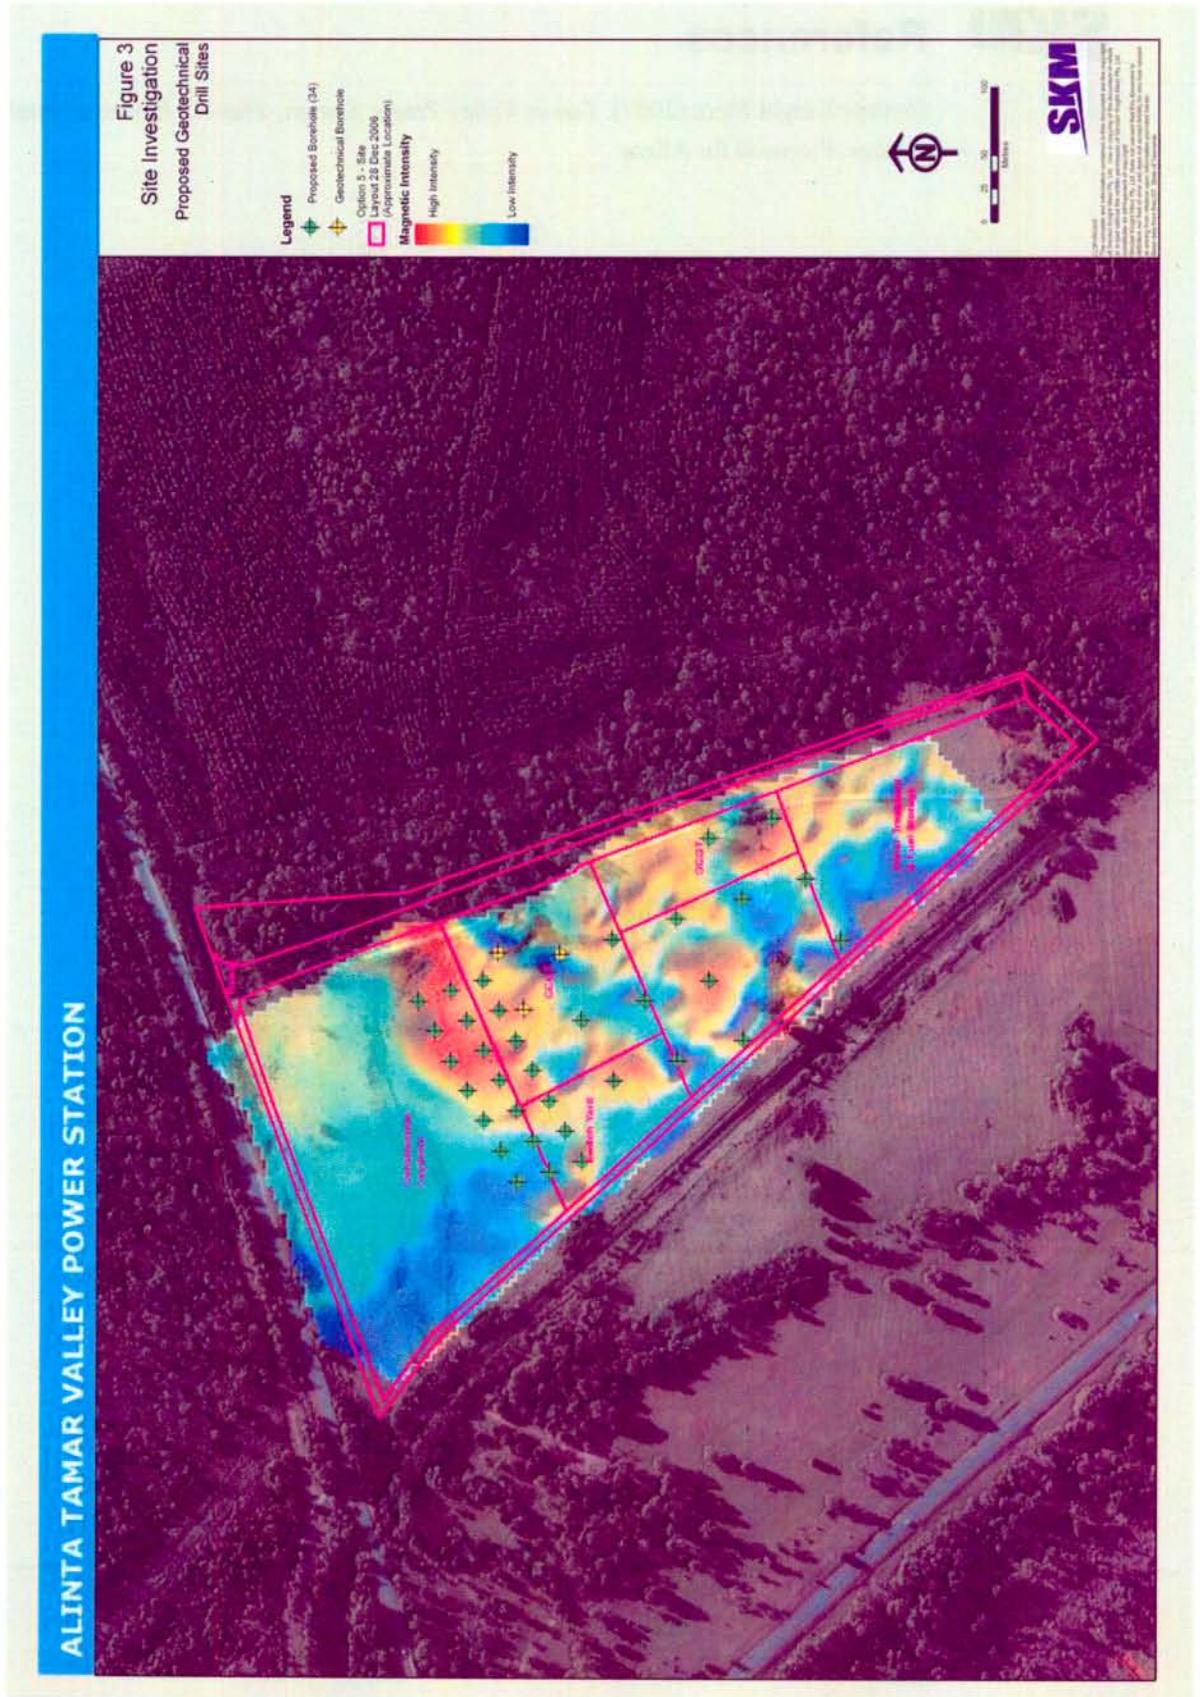
Based on and work completed to date, **Figure 3** indicates proposed further geotechnical borehole locations that would provide information to site high load infrastructure required for the power station. The proposed boreholes on the highly magnetic northern feature would provide information on the three dimensional distribution of the depth to and thickness of fresh rock which would be critical for design of foundations and excavations in this area. The majority of these boreholes would be drilled to confirm the depth to fresh rock and selected boreholes would be drilled to the base of fresh rock (to verify bearing capacity). Boreholes to the south of this area would be drilled to identify other potential locations for additional infrastructure. This work would also aid in verifying the current Site Factor of 1.25 as defined in Table 2.4(a) AS1170.4 of Minimum design loads on structures. Additional test pits would also be performed to determine near surface excavatability and recover samples for assessment of pavement design parameters.

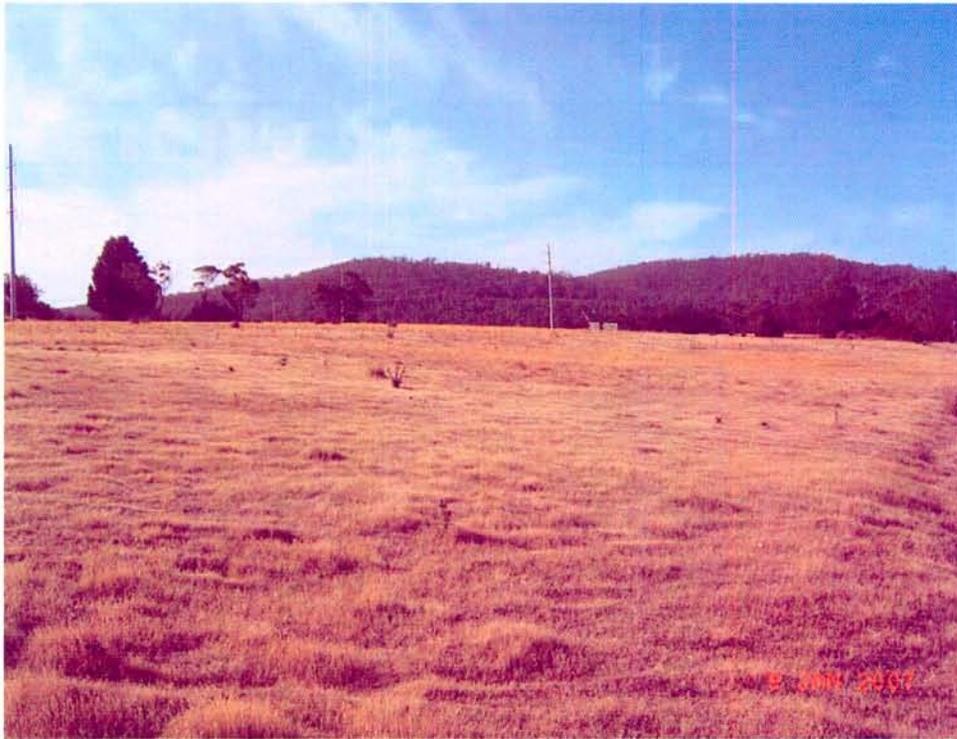
**Magnetic Survey  
of  
Proposed Power Station Site,  
Georgetown, Tasmania**

A Geometrics 856 memory magnetometer was used for the magnetic survey and UTM coordinates of ends of lines surveyed using a Magellan Meridian GPS receiver. The magnetometer has an accuracy of around 0.1 nT in quiet magnetic conditions and the GPS receiver is accurate to better than 5 m depending upon satellite configurations and signal.

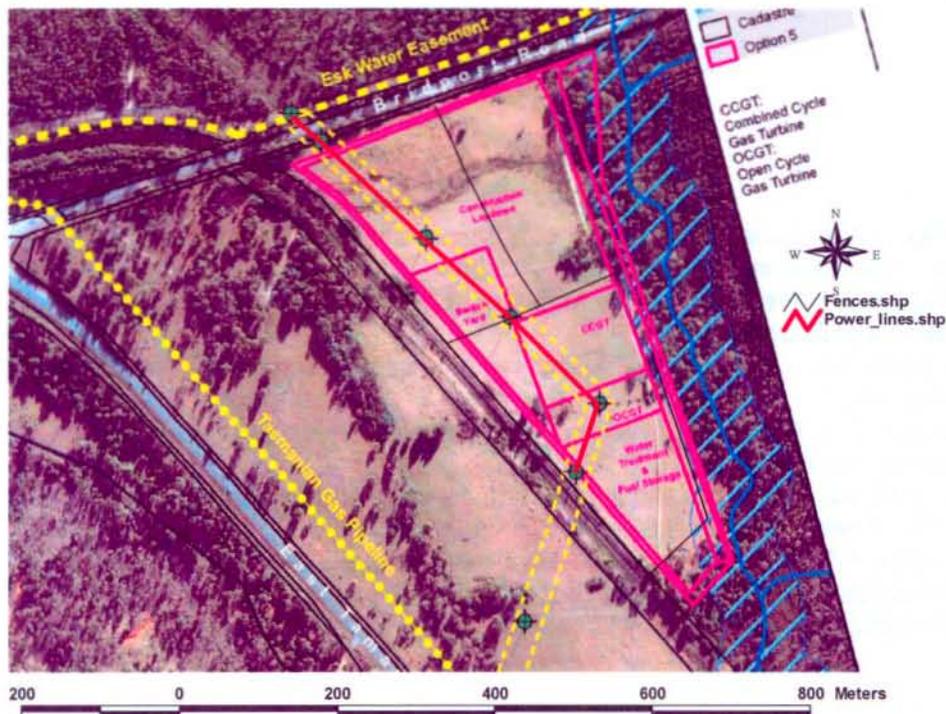
- Figure 1-1 Aerial photo of site with transmission line marked in red and proposed works in pink.

Figure 1.1 shows the layout of the site. Note the major powerline which runs through the site. There is another smaller powerline along the northern boundary and a small disused powerline extending south from that powerline for around 200 m along the NW to SE trending fence.

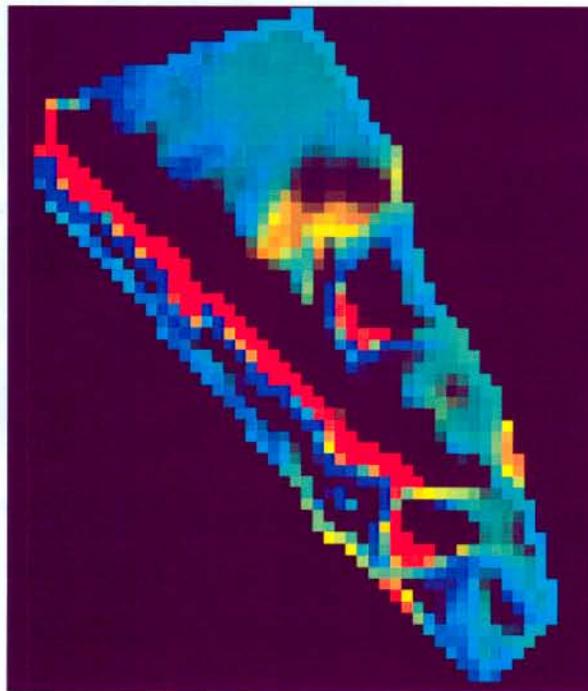
■ Figure 2-1 Preliminary total magnetic intensity (TMI) images with effects of powerline.

The effects of the power line were obvious in the initial images (Figure 2.1) and readings along the powerline easement removed from the data and new images created.

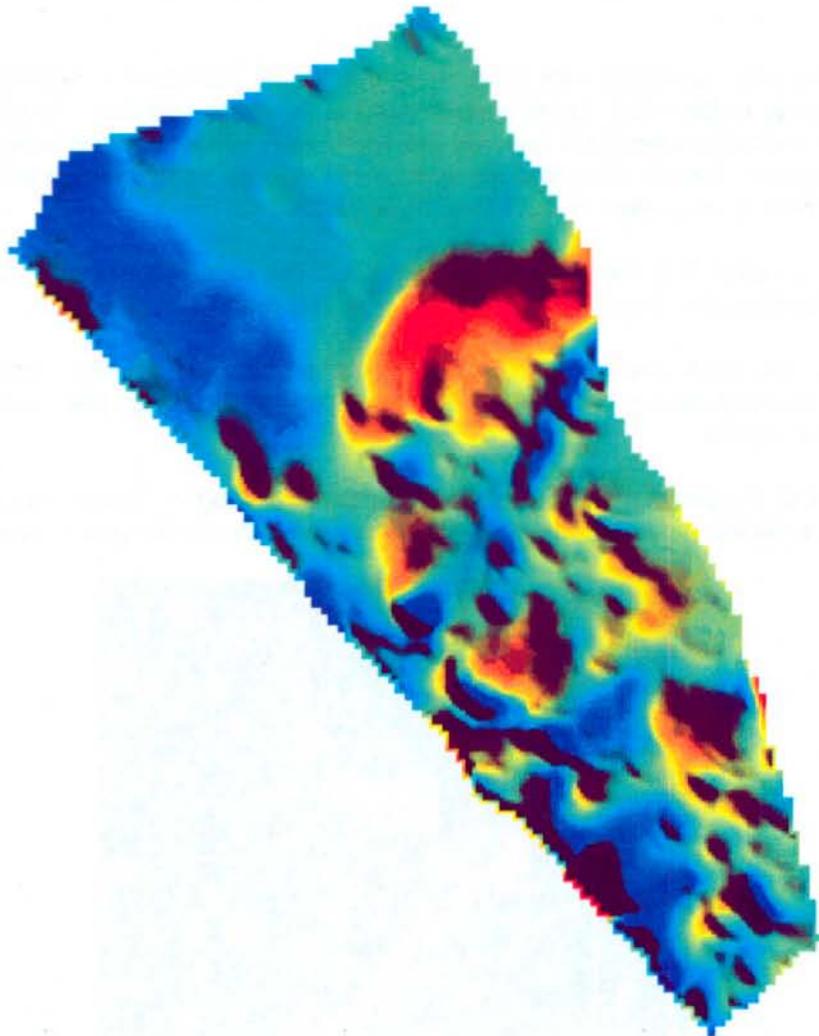
■ Figure 3-1. TMI image of area with most of powerline effects removed.

Figure 3.1 shows a TMI image with most of the effects of powerline removed and Figure 3.2 a first vertical derivative (1VD) image. The 1VD is usually used in magnetic interpretation to sharpen edges but in this case has not improved the data resolution.

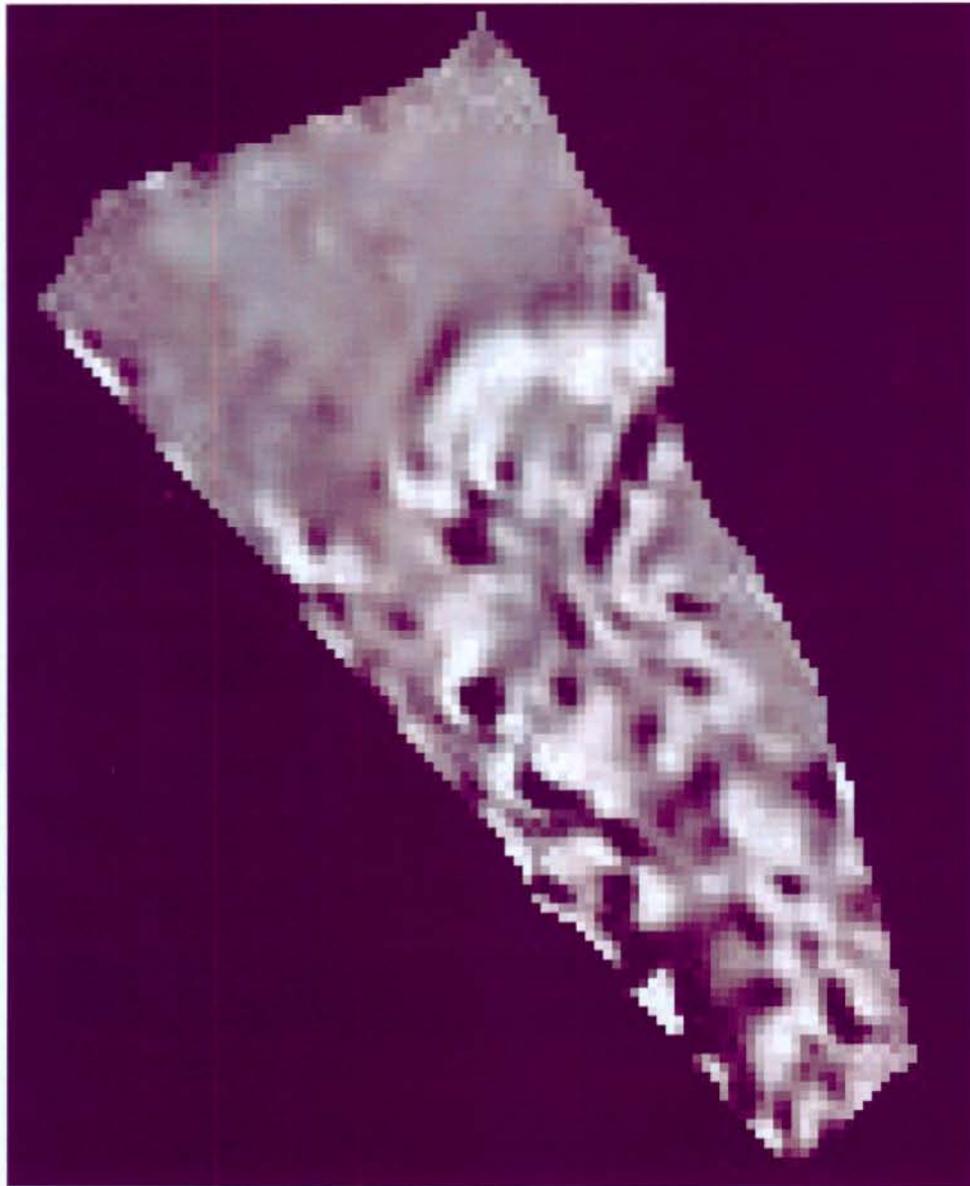
- Figure 3-2. First vertical derivative of magnetic field with powerline effects removed.

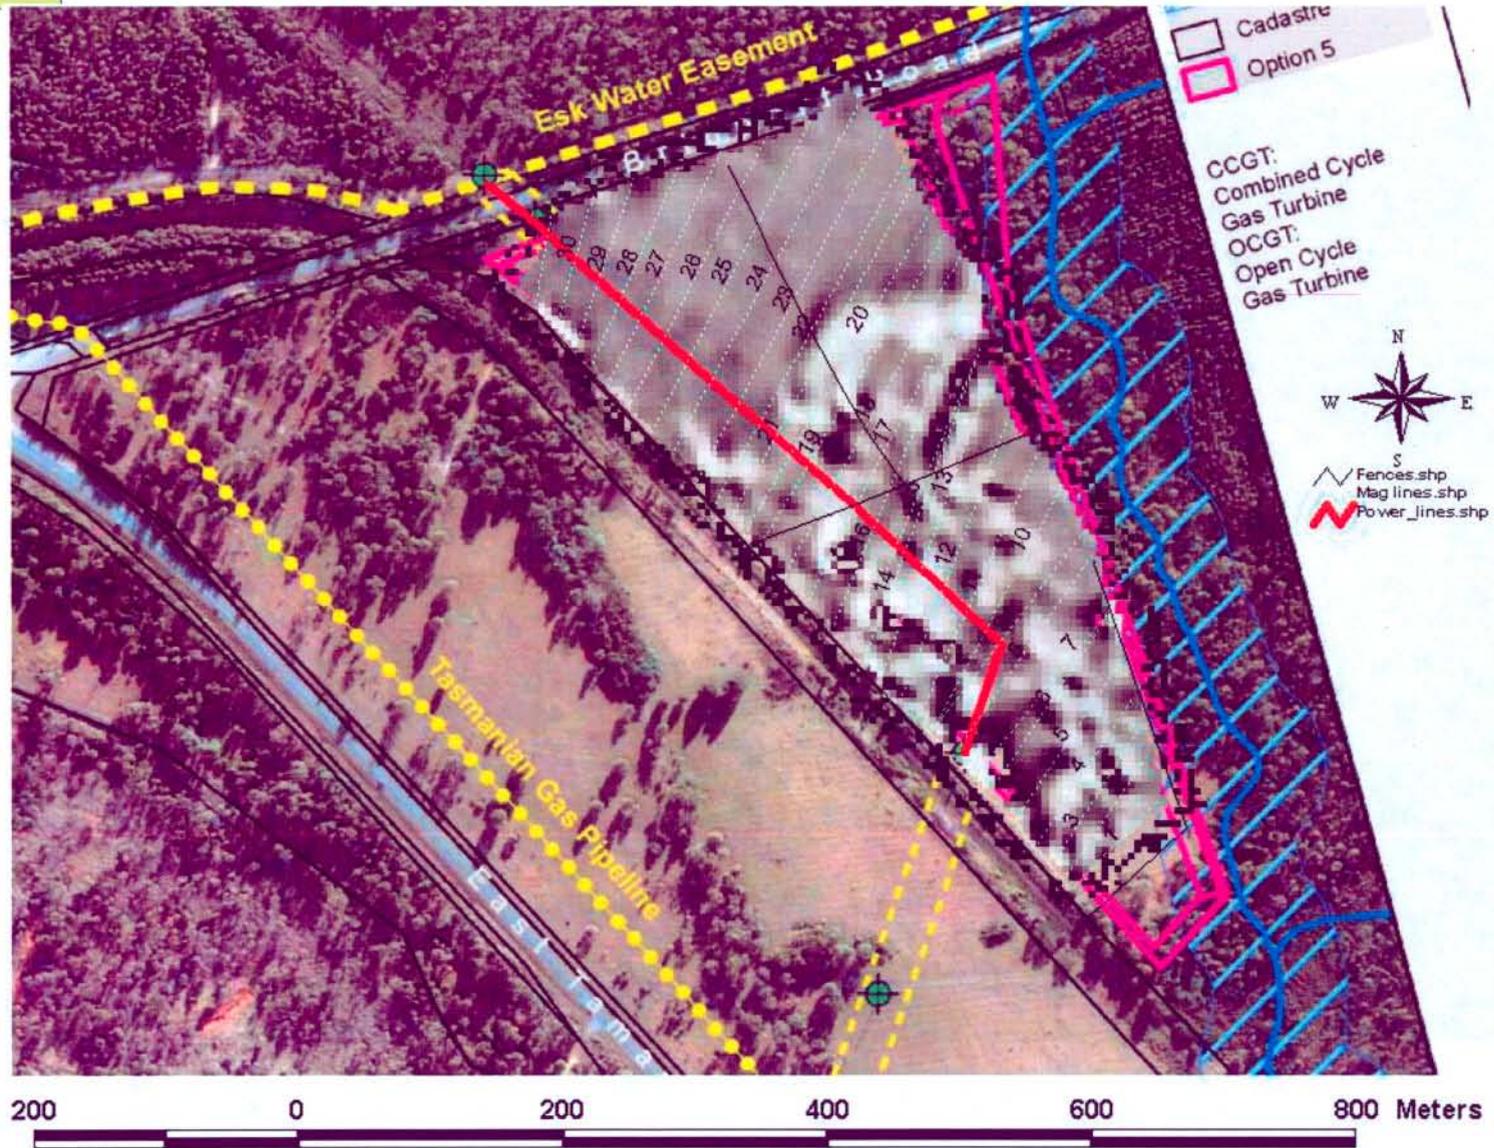
■ Figure 3-3. First vertical derivative image overlaid on aerial photo of site. Power transmission line is marked in red.

Figure 3.3 shows the 1VD image overlaid on an aerial photo of the site.

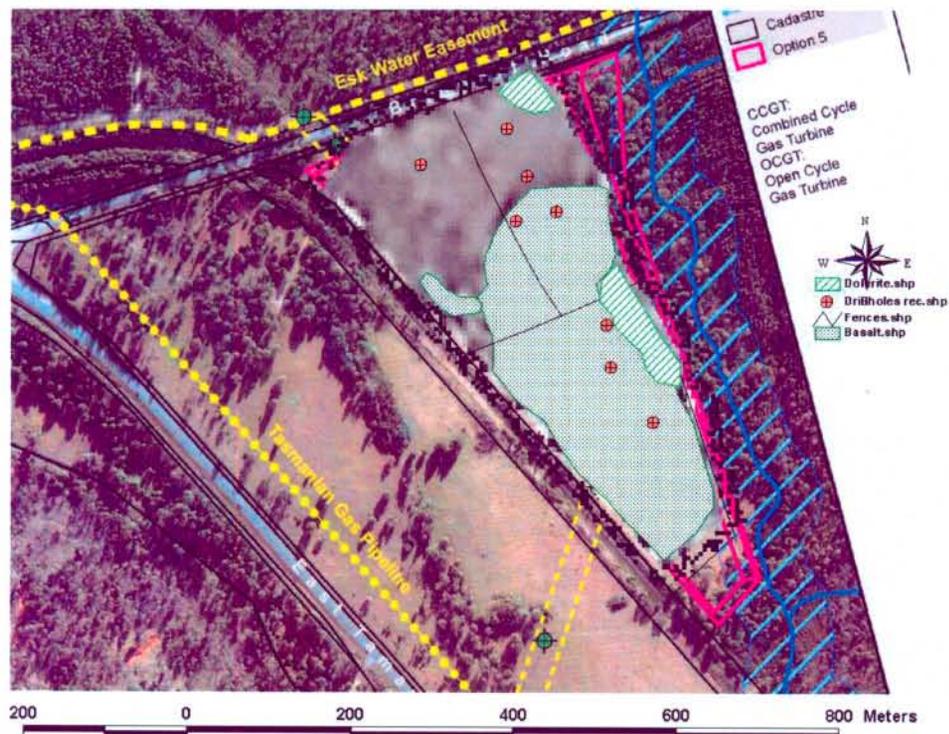
■ Figure 4-1 Site with first vertical derivative image overlaid with area interpreted as underlain by basalt flows shown as stippled and possible area of dolerite hatched.

Figure 4.1 shows interpretation of magnetic data. The 'jumbled' magnetic pattern is consistent with basalt flows seen elsewhere in Eastern Australia. Overlapping individual flows create this kind of pattern. As the magnetic field from each flow is detected laterally as well as vertically above the flow, it is not possible from the magnetic data to determine whether the basalt is continuous across the site or discrete flows.

The northern third of the area has much lower magnetic changes and appears consistent with non-magnetic sediments. Drilling in east of area intersected dolerite. Dolerite may have a similar magnetic intensity to basalt but more likely to have a more uniform signature rather than many discrete flows. Areas of possible dolerite have been interpreted in east and north of the area.
