SHREE MINERALS LIMITED

EL 32/2005 Catamaran

NOTES ON FIELD TRIP TO SAMPLE THE OUTCROPPING CATAMARAN COAL SEAM

January 2008

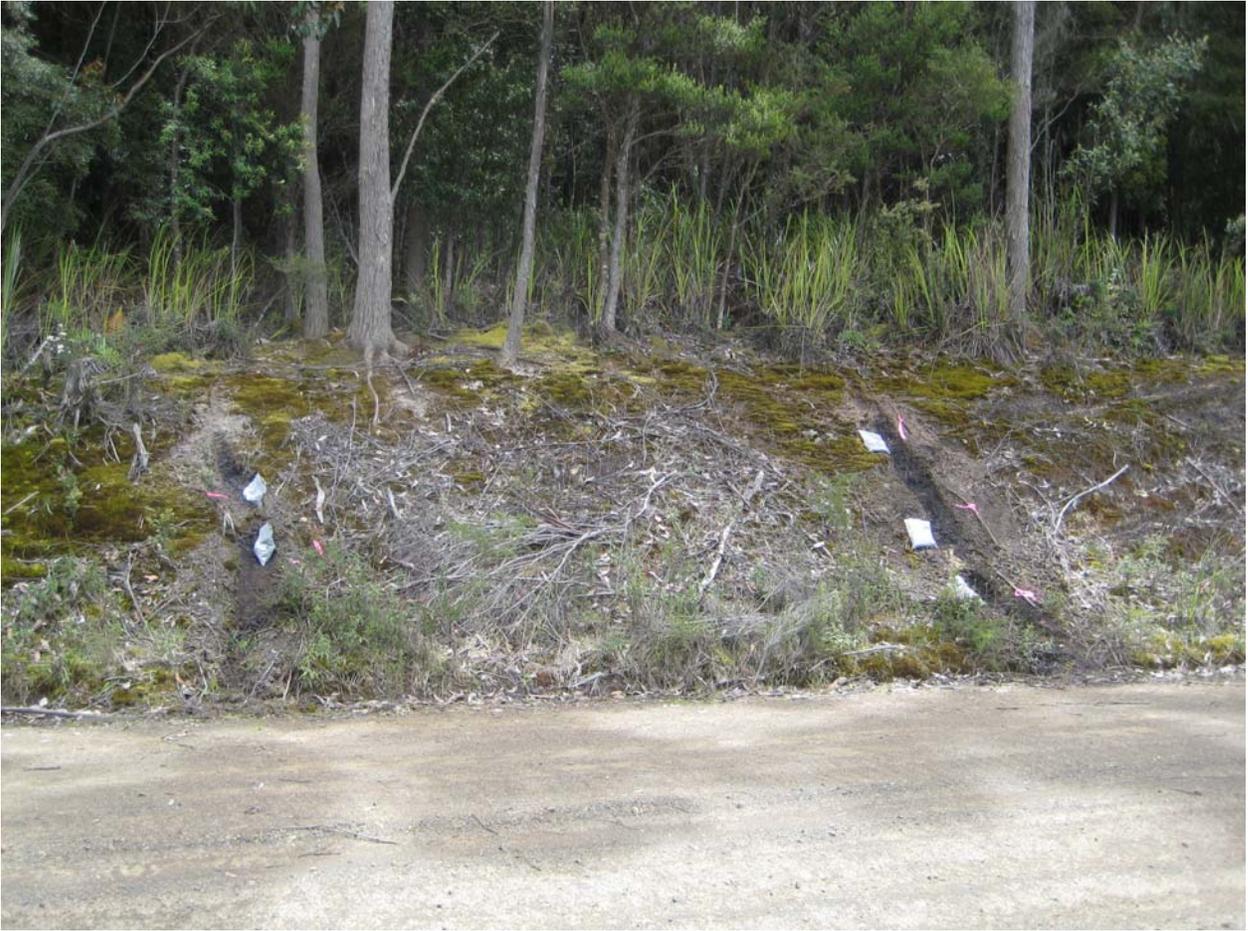
Channel 3 Coal samples CC2 &3

The best individual result was coal sample CC03 ie Sample number 3 from Channel number 3 (as illustrated in the first photo below. It is taken halfway up the embankment and is a 1m (approx) thick black coal seam. The sample is from the lower part of his seam. It is the best result in that it is from a black coal outcrop and has the highest calorific value at 3653 kcal/kg. This seam is correlates (approx) to samples CC06 which is about 10m further east and then 10m further east again CC07 and appear to be the same horizon.

Channel 4 Coal samples CC 4 5 6

Channel Sample Site 6 Coal sample CC10

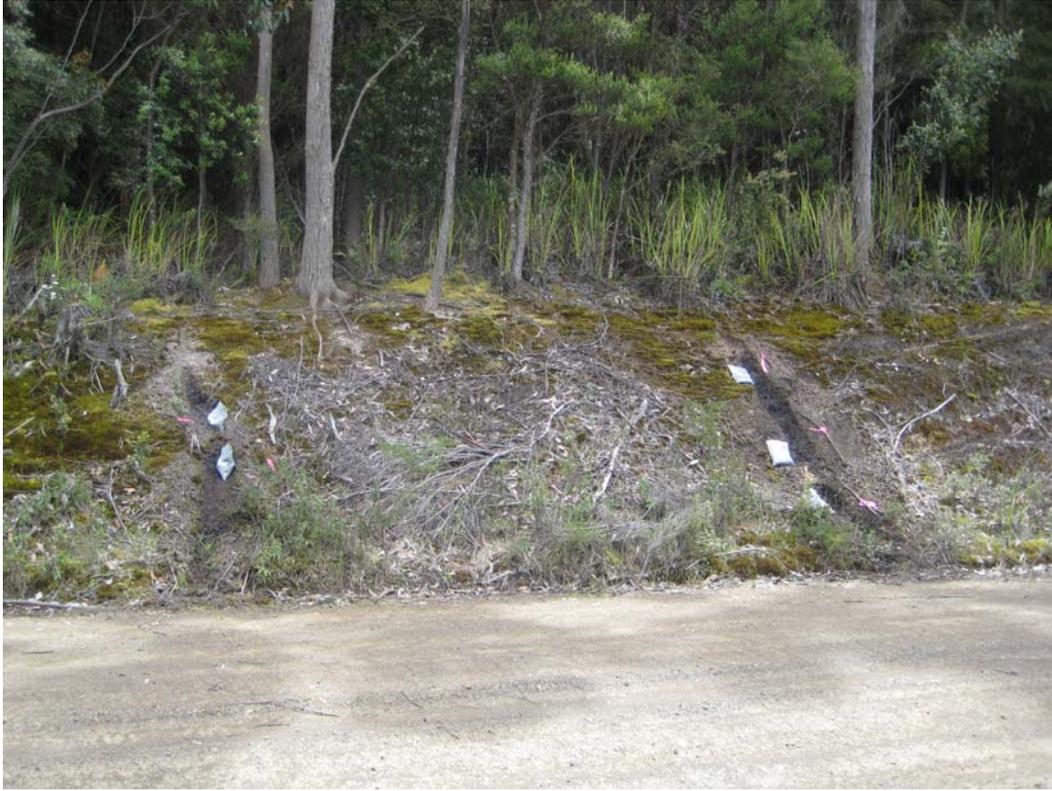
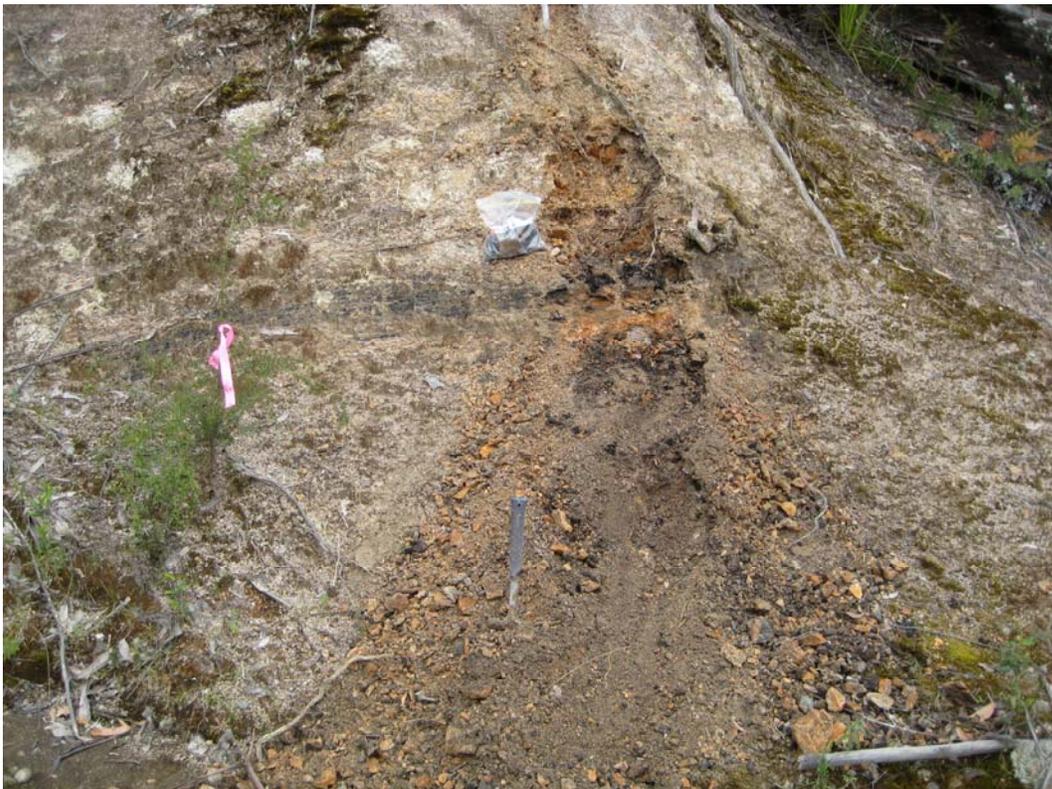
CATAMARAN : South Cape Road Coal Samples

Grab and Channel Coal Seam Outcrop Samples on right (north) side of the Forestry road less than 1km past the gate
 Sampled and photographed by Wes Harder on Monday 17th November 2008 10am -1pm
