HEEMSKIRK TIN PROJECT

REVIEW OF FIRST 12 MONTHS WATER SAMPLING

Stellar Resources

May 2013

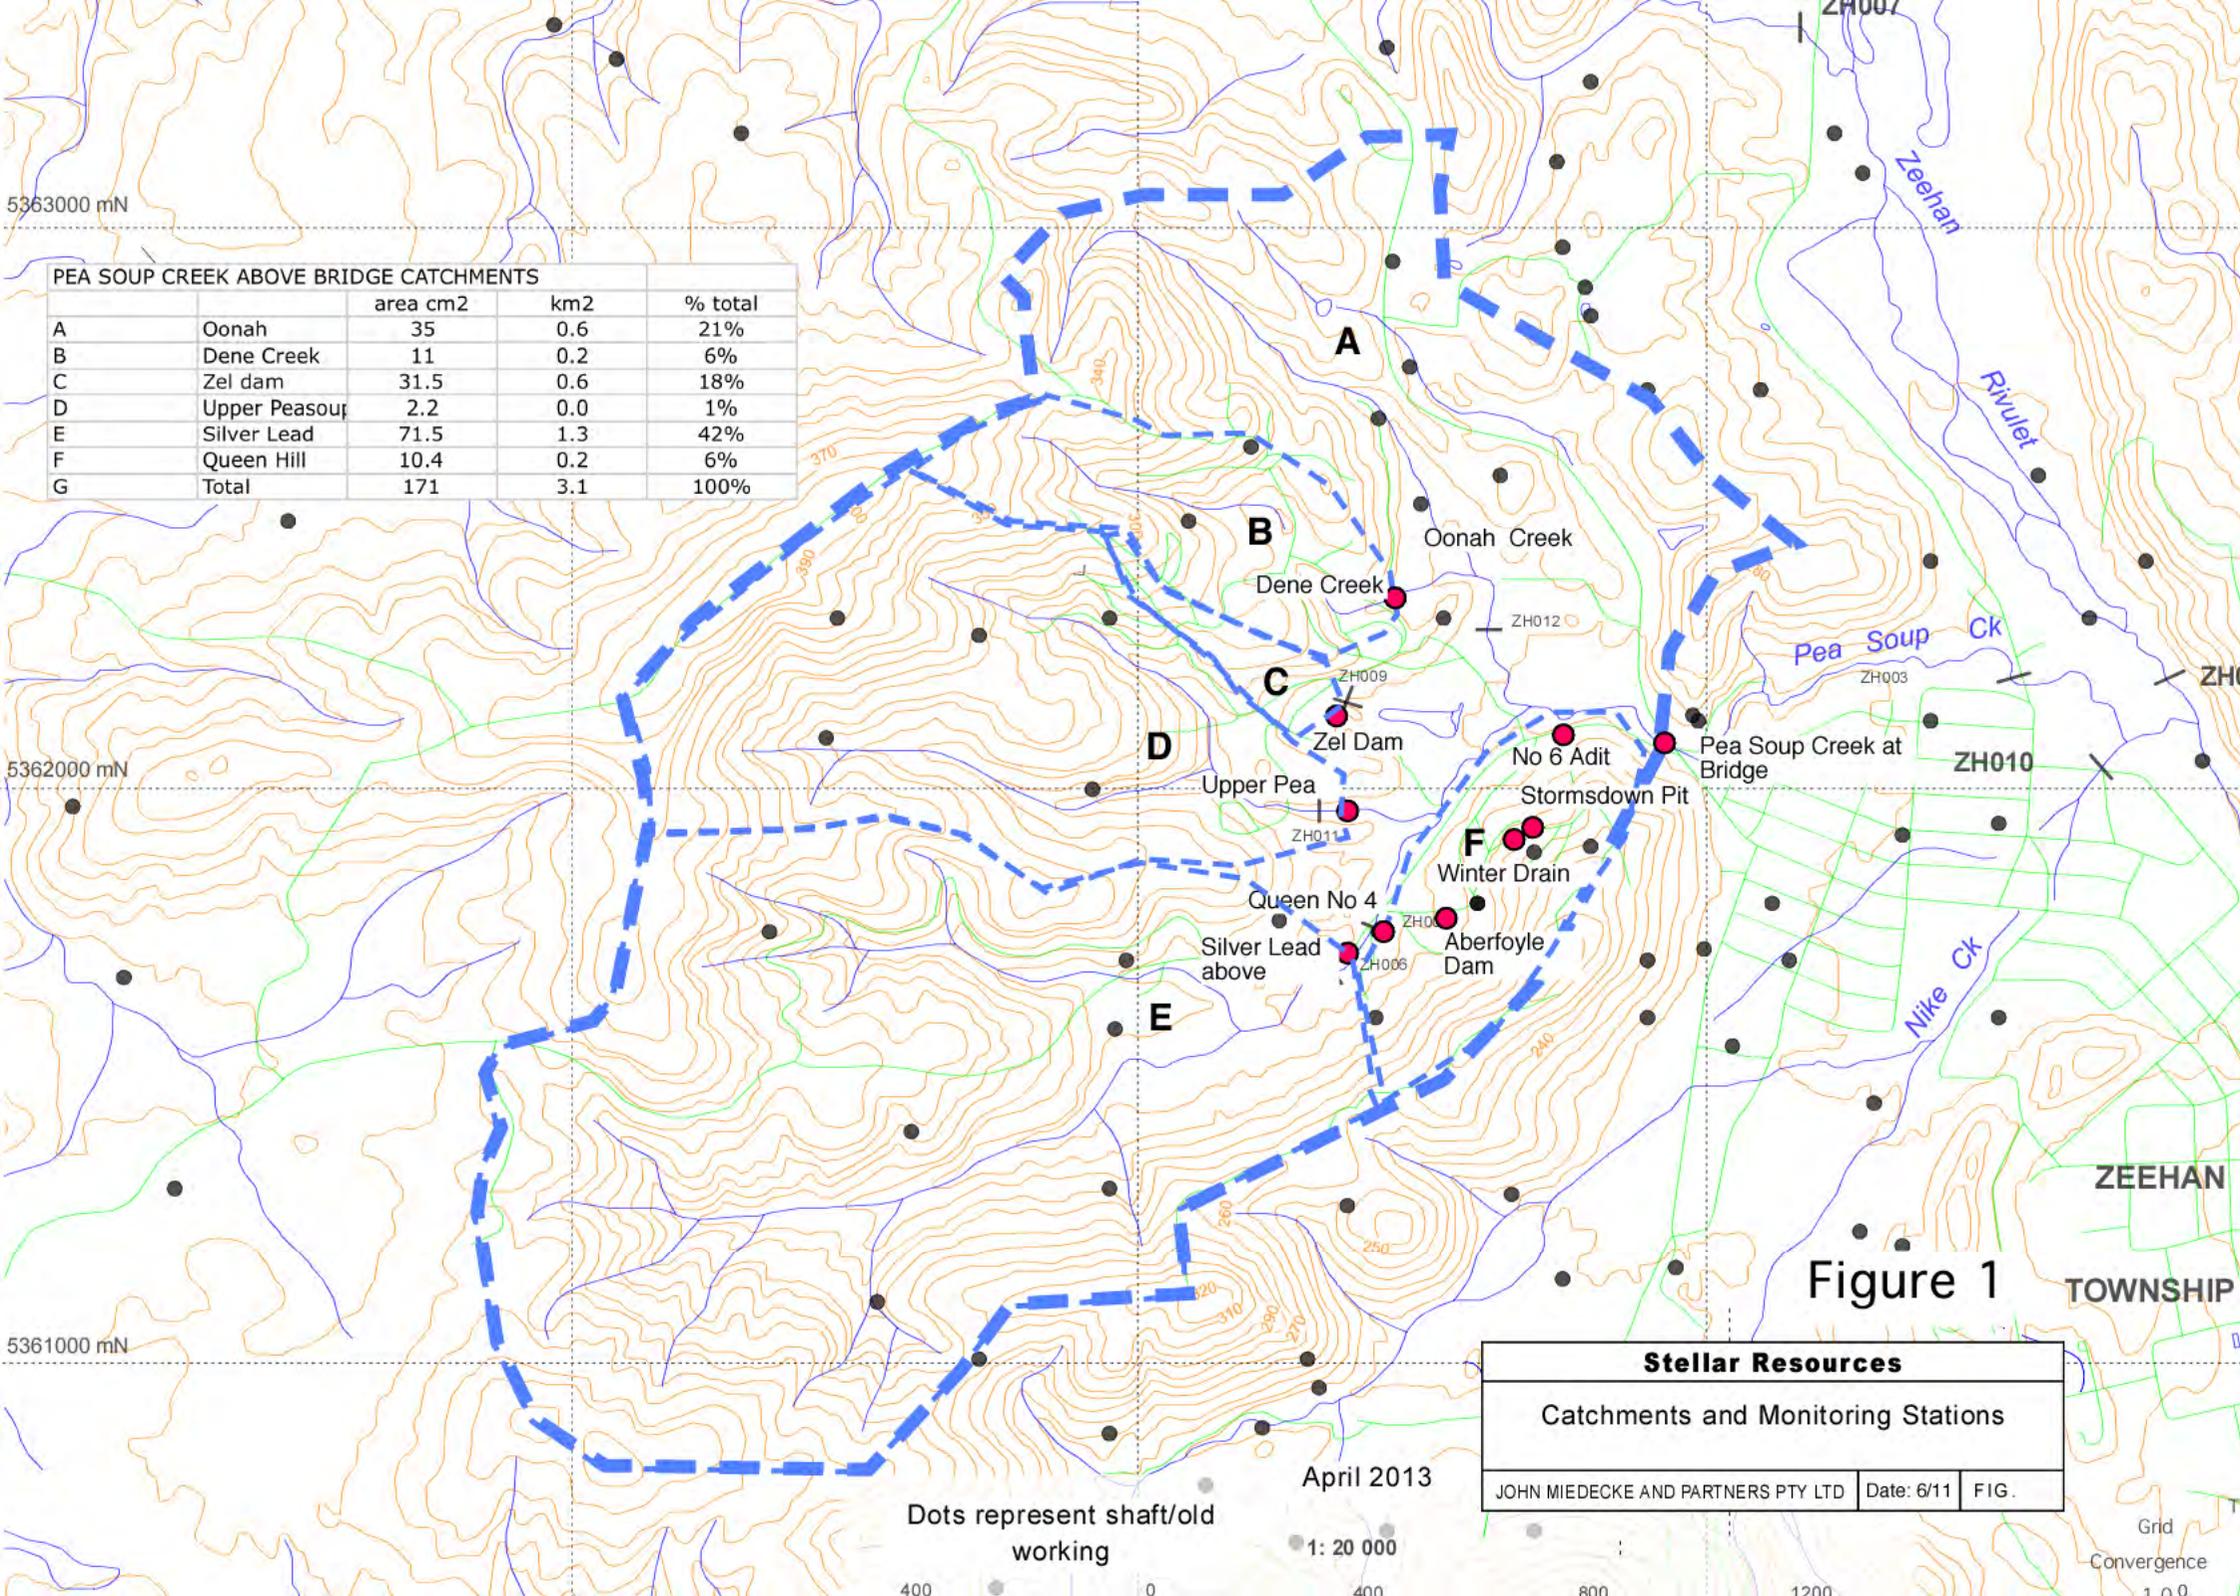
Figure 1 ZEEHAN TOWNSHIP

The map of monitoring sites is shown in **Figure 1** and includes catchment boundaries and monitoring sites. Site details are shown in Appendix A. As noted above more general historic water sampling covers the catchments draining to the Little Henty River (Earth Systems, 1999).

PEA SOUP CREEK ABOVE BRIDGE CATCHMENTS

area cm2	km2	% total
A	Oonah	35	0.6	21%
B	Dene Creek	11	0.2	6%
C	Zel dam	31.5	0.6	18%
D	Upper Peasoup	2.2	0.0	1%
E	Silver Lead	71.5	1.3	42%
F	Queen Hill	10.4	0.2	6%
G	Total	171	3.1	100%

Stellar Resources
 Catchments and Monitoring Stations

The Queen Hill catchment is a small portion of the larger catchment monitored by the downstream sample site ‘Pea Soup Creek at Corinna rd Bridge’. The larger catchment includes other sources of ARD including the Montana workings, Oonah workings, tailings and other waste within the wetland in the lower lying catchment. The figure also shows documented locations of old workings (Source ; Earth Systems , MRT). The wetland is also the former site of a breached tailings dam (Ray Hazeldene *pers comm*).

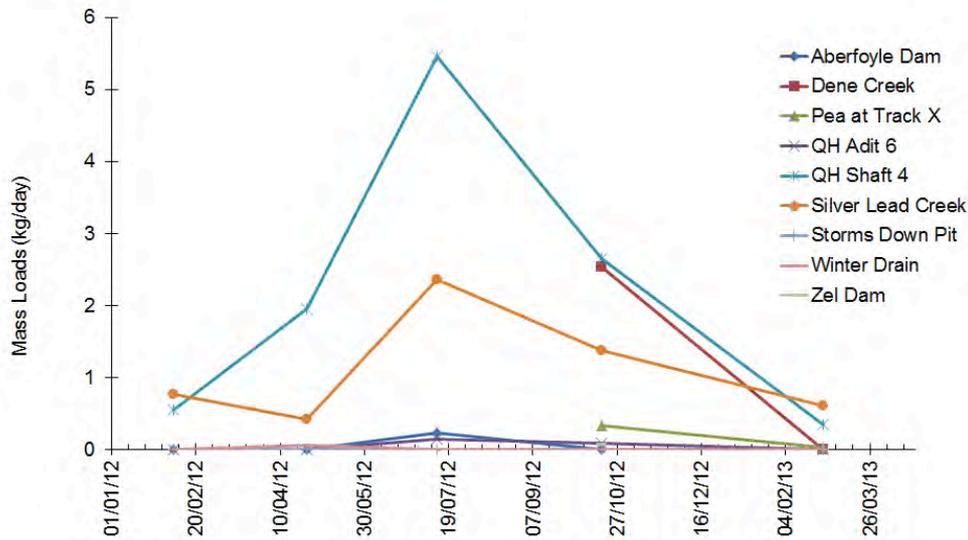
In **Figure 2** the mass load of zinc for the different sample sites within the Pea Soup catchment above the Corinna Road Bridge is presented. **Figure 3** presents the same data with the total mass load from the catchment. By comparing the graphs it can be seen that the majority of the zinc load has not been quantified. Queen Hill Shaft no. 4 and Dene Creek are the largest zinc sources monitored.

Figure 2 - Total zinc load over time for the individual sources within the Pea Soup Catchment.

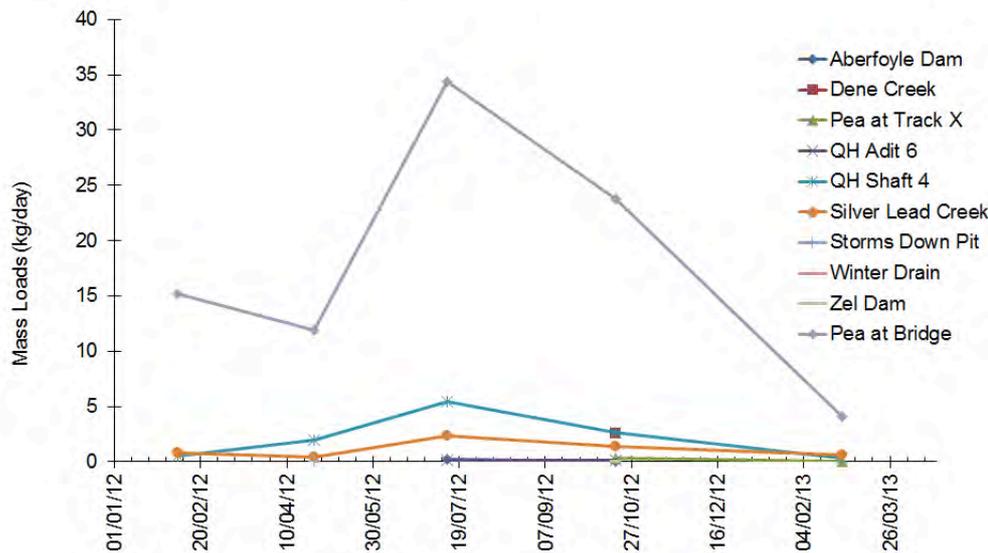
Figure 3 - Total zinc load over time for the Pea Soup Catchment and the individual sources

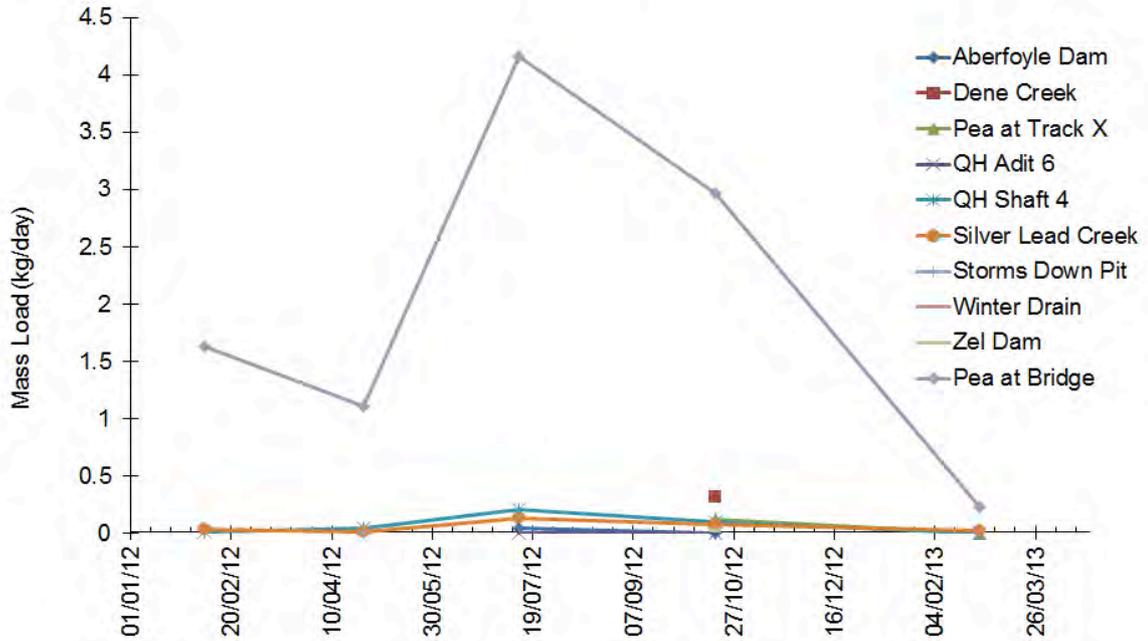
The majority of the lead load within the catchment has not been identified. In **Figure 4** the lead load from other sources are relatively small compared to the total load measured at the Pea Soup at Corinna Rd Bridge sample site. This may suggest that the lead is coming from a diffuse source such as tailings within the wetlands. Lead may be present within the ARD producing material but may not be released as it forms insoluble lead sulphate.

Figure 4 - Total lead load over time for the Pea Soup Catchment and the individual sources

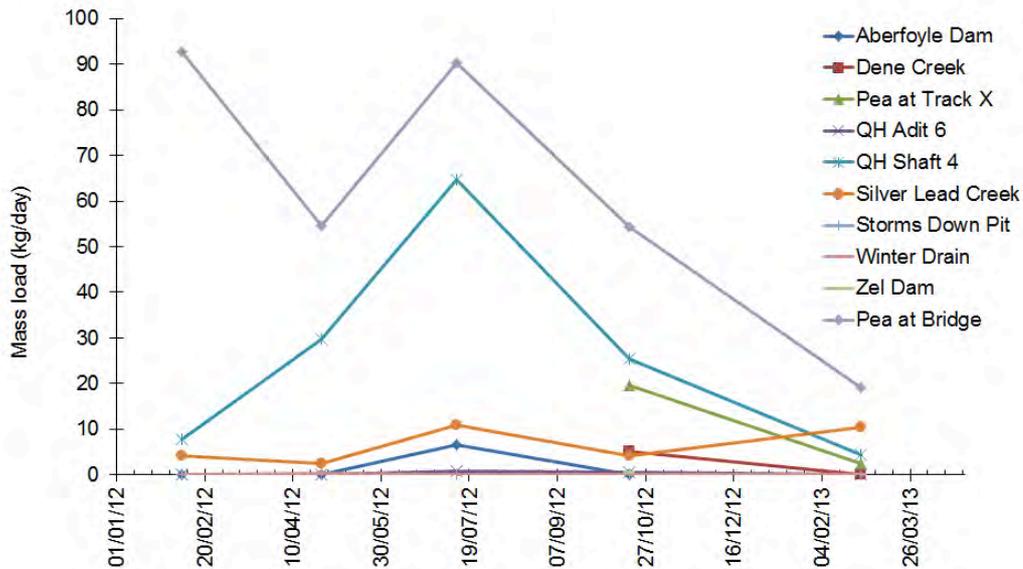
Figure 5 shows the iron load data. Iron may be getting removed by the wetlands located above the Corinna Rd Bridge and the areas of iron deposition within the catchments such as within the Zel Dam and downstream of the dam. Given the iron removal processes within the catchment it is likely the majority of the iron load has not been identified.

Figure 5 - Total iron load over time for the Pea Soup Catchment and the individual sources

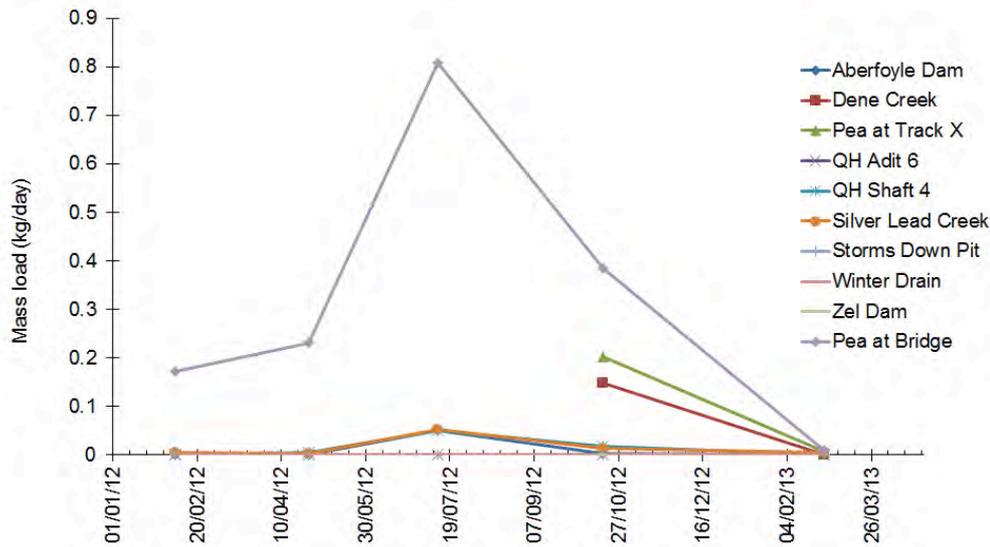
Figure 6 shows the copper load data. The copper load from the Queen Hill sources are a relatively small in comparison to the catchment mass load. The western sources such as the upper Pea Soup Creek (Pea at Track X) and Dene Creek which drains the Oonah working are larger copper contributors. As these Western catchment sources have only been sampled a couple of time, further sampling is required to validate this conclusion.

Figure 6 - Total copper load over time for the Pea Soup Catchment and the individual sources

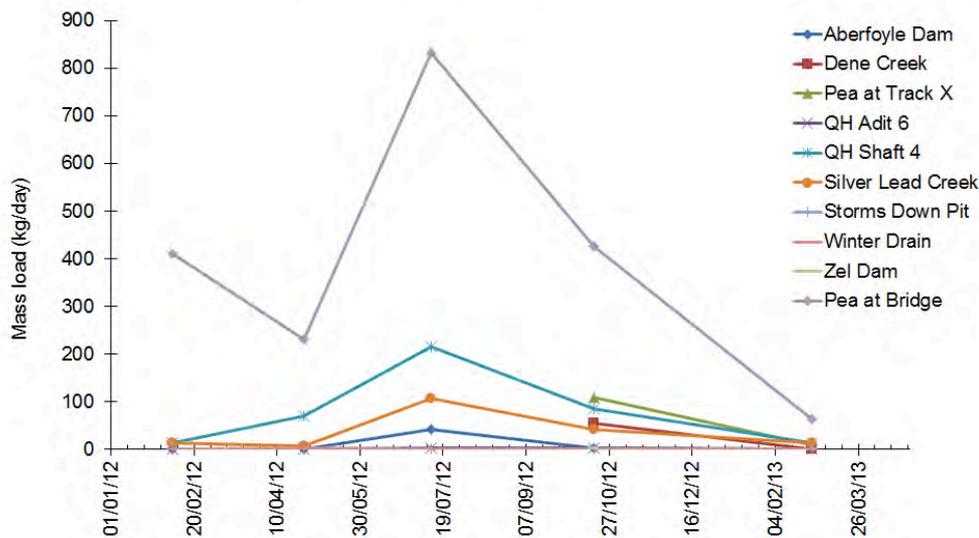
The acidity loads are presented in **Figure 7**. The major contributor from the Queen Hill Shaft No. 4 sample site averages 80 kg/day CaCO₃ equivalent. This would cost in the order of \$50 to \$100 per day to neutralised. Much greater loads would have to be neutralised in the event of drawing down the water table beneath Queen Hill and in the event of an open pit or acid forming rock being left exposed to oxygen. The control of acid generation will be an important requirement of future operations undertaken at Queen Hill.

Figure 7 - Total acidity (CaCO₃ eq) load over time for the Pea Soup Catchment and the individual sources

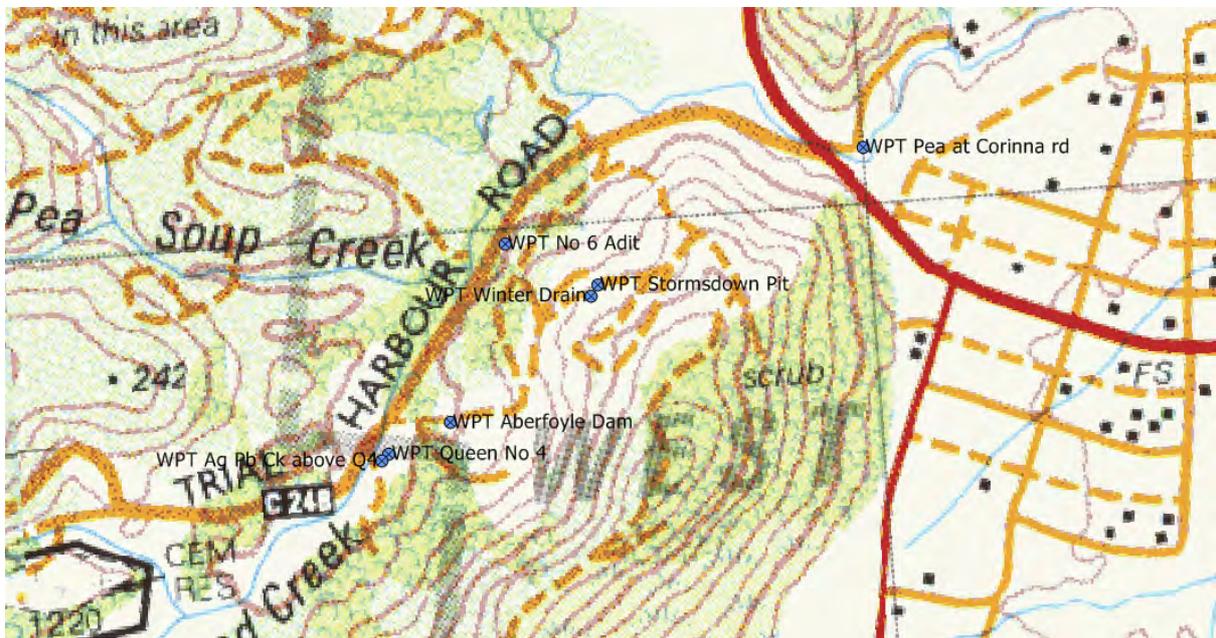
The Queen Hill lease is being monitored to ascertain the pre existing water quality prior to further mining activity. The initial sample locations for the lease are presented in the figure below.

- Pea Soup Creek at Corinna Rd
- No 6 Adit above Trial Harbour Rd
- Queen No 4
- Silver Lead Creek above Queen No 4
- Aberfoyle Dam overflow
- Storms Down Pit
- Winter Drain

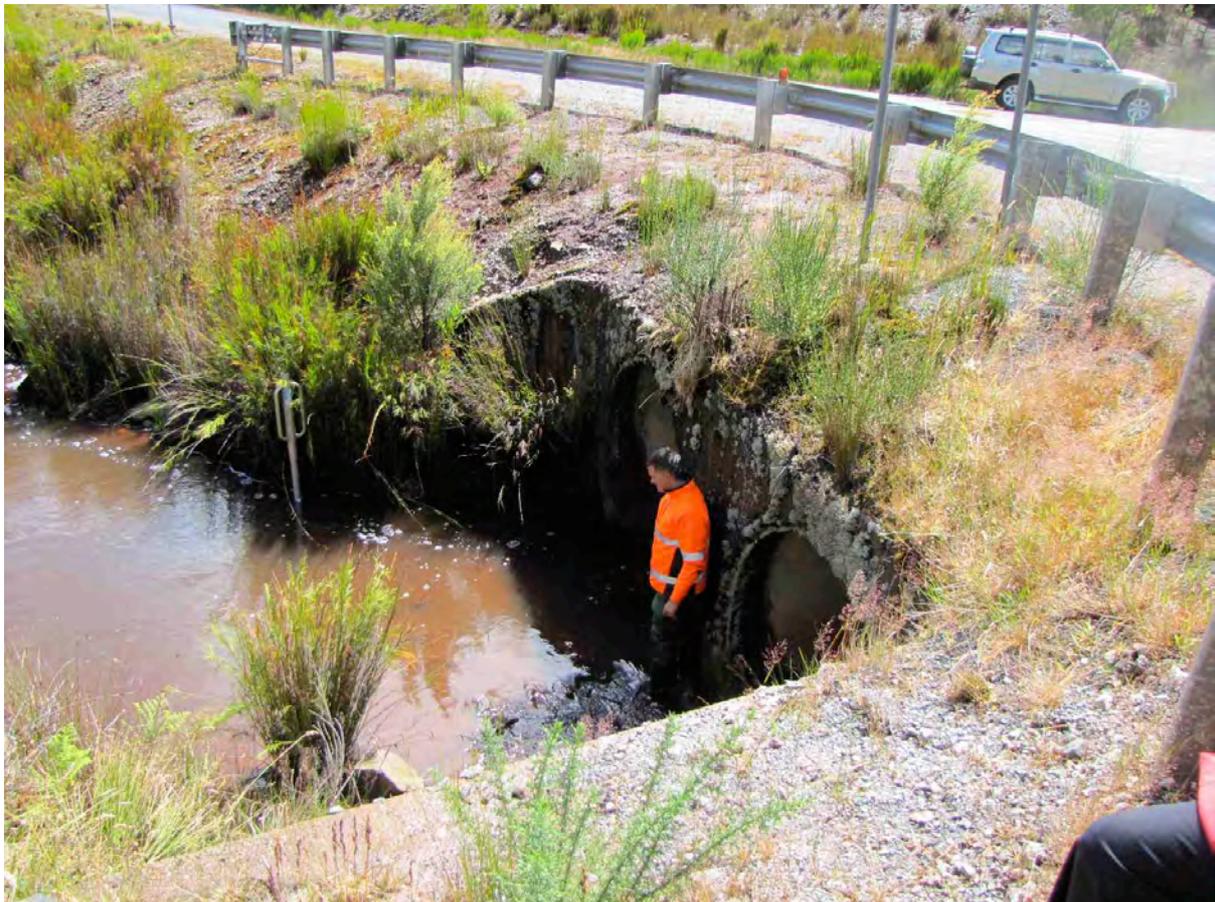
Pea Soup Creek at Corinna Rd

The gauge site is situated immediately upstream of the Bridge prior to water flowing into the culverts. The gauge board is situated precisely halfway between the 2 culverts with 0 level being at the well-defined corner between the vertical face of the bridge and the horizontal platform upstream of the bridge (See photo below taken before gauge boards were fitted, but Danny is standing in front.

The sample site for this site is situated after the bend of the river approximately 40 m downstream of the bridge over the Corinna Road. This sample site is situated well downstream of the bridge to avoid localised effects of road drainage considered likely at the bridge. Downstream the road drainage is likely to be mixed into Pea Soup Creek.

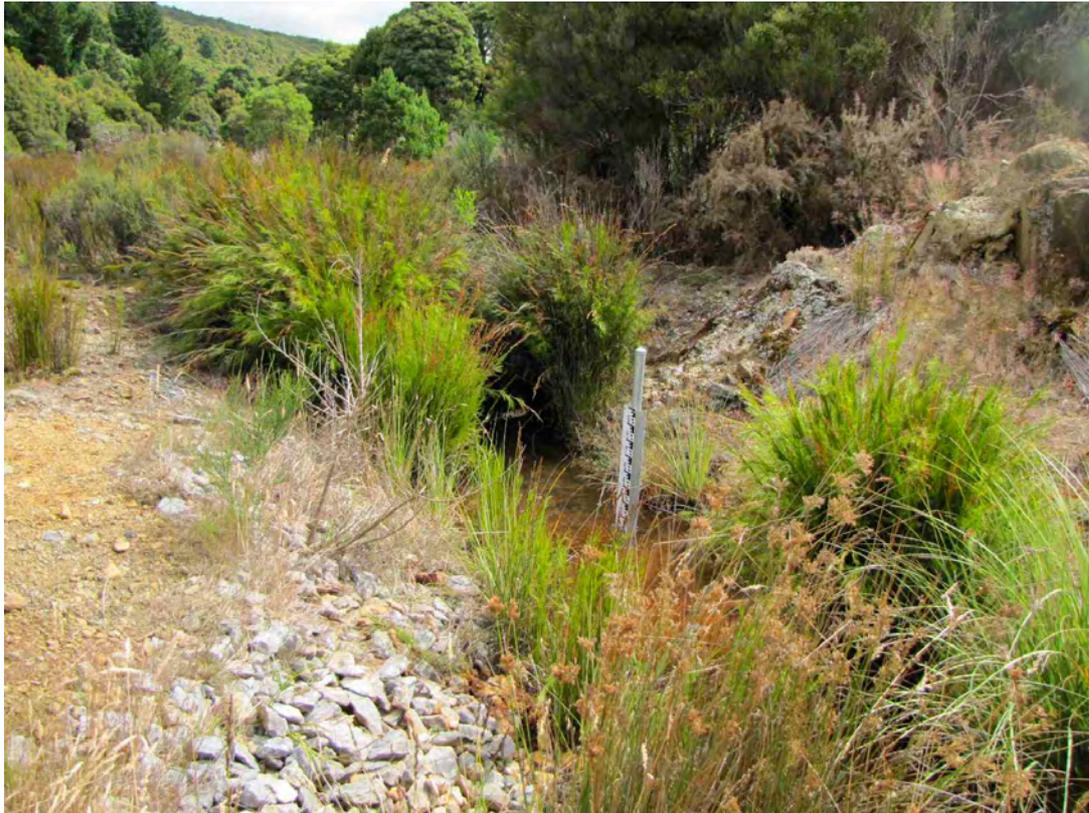
Silver Lead Creek above Queen No 4

The Silver Lead Creek is sampled upstream from the Queen No4 ponds where the gauge board is situated (see photo below). Care should be taken not to disturb the Creek bed near Queen No 4 as the control for flow measurement is made from poorly consolidated material.

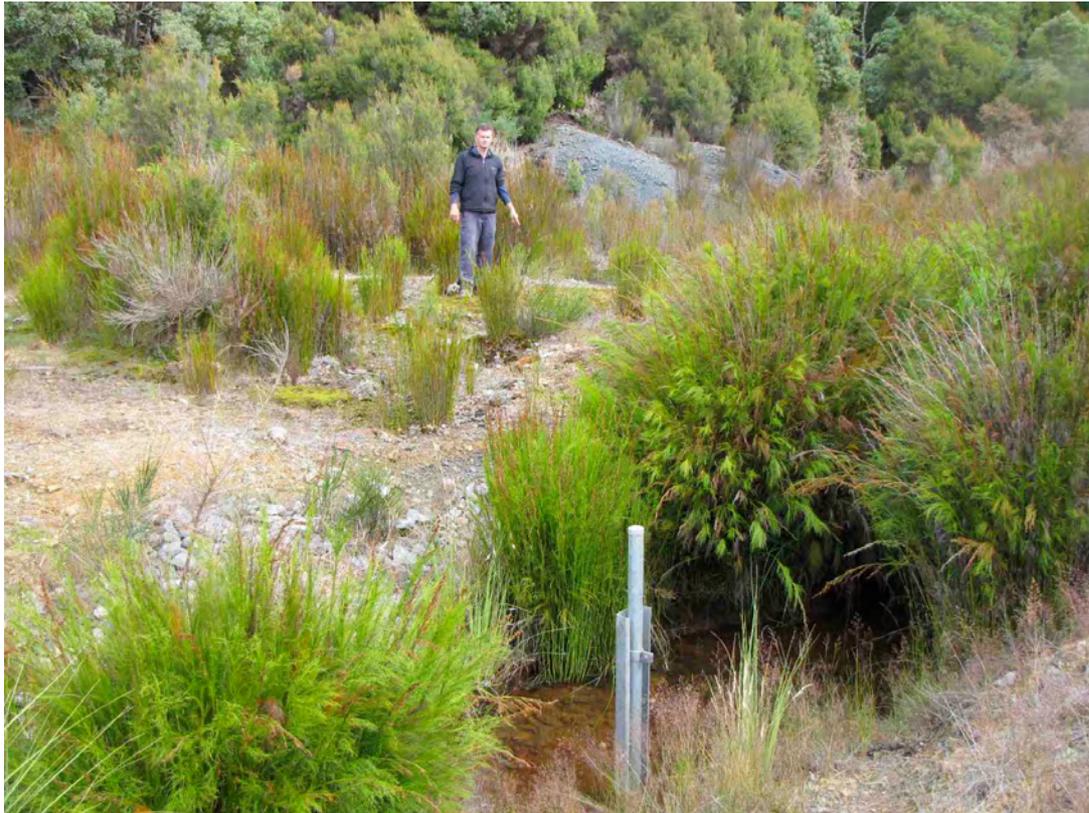
Flow measurement is obtained by taking the water level from the gauge board. Gaugings are also taken from this location with care not to disturb the control which is made from loose rock and sediment. The 0 point for the gauge board is taken from the control being pointed at in the picture below. The control is made from a rio metal painted with fluoro paint. The 0 point for the gauge board is 1.443m below the top of the control.

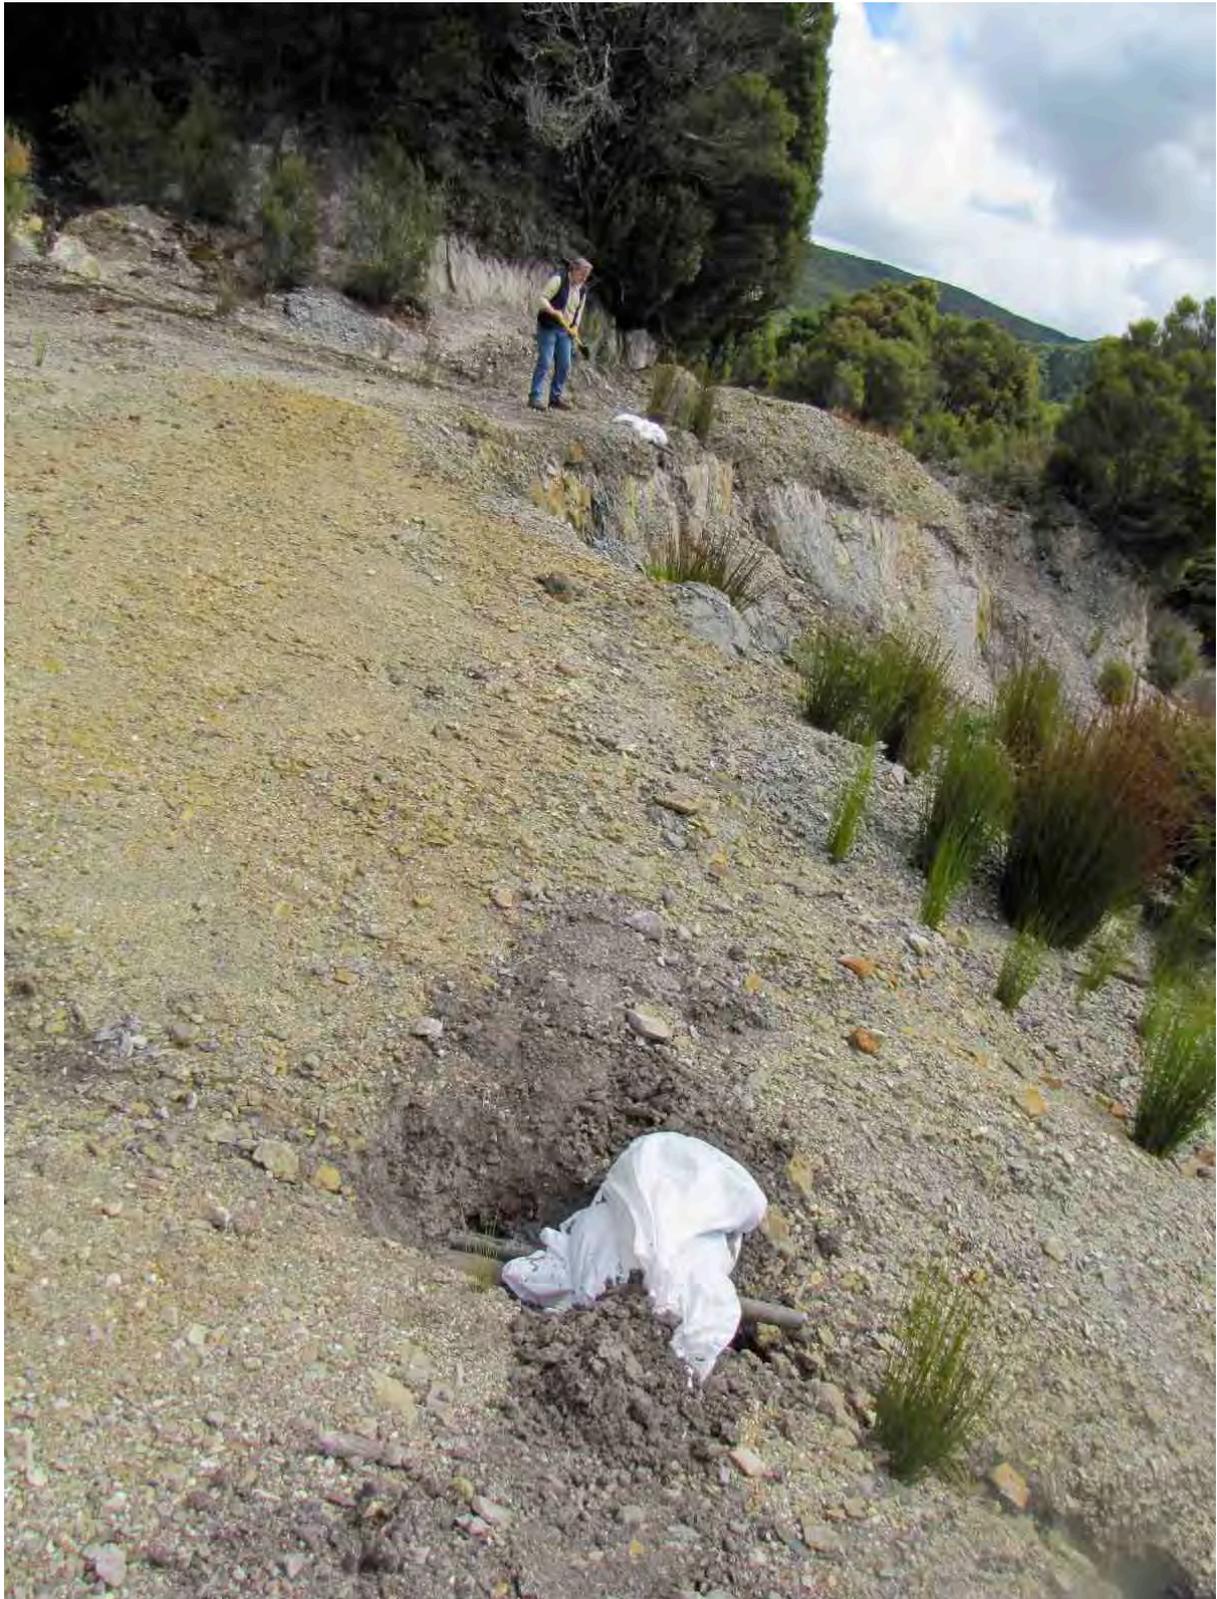
Storms Down Pit

Storm Down Pit is drained by a small drain that runs across a unsealed road. The drain only flows intermittently during the drier months. The water then flows through pipes that are used for sampling and flow measurement. The pipes are secured by sandbags as seen in the photo below

and will need to be maintained as required. The water samples are taken prior to any disturbance of the pipes, sandbags or the water as it drains over the road.

Flow measurement is taken by timing a bucket to fill to a known volume from the pipes.
