# **Annual Report for the Period**

**April 2014 to March 2015**

**EL15/2009**

**Hawkes Creek North**

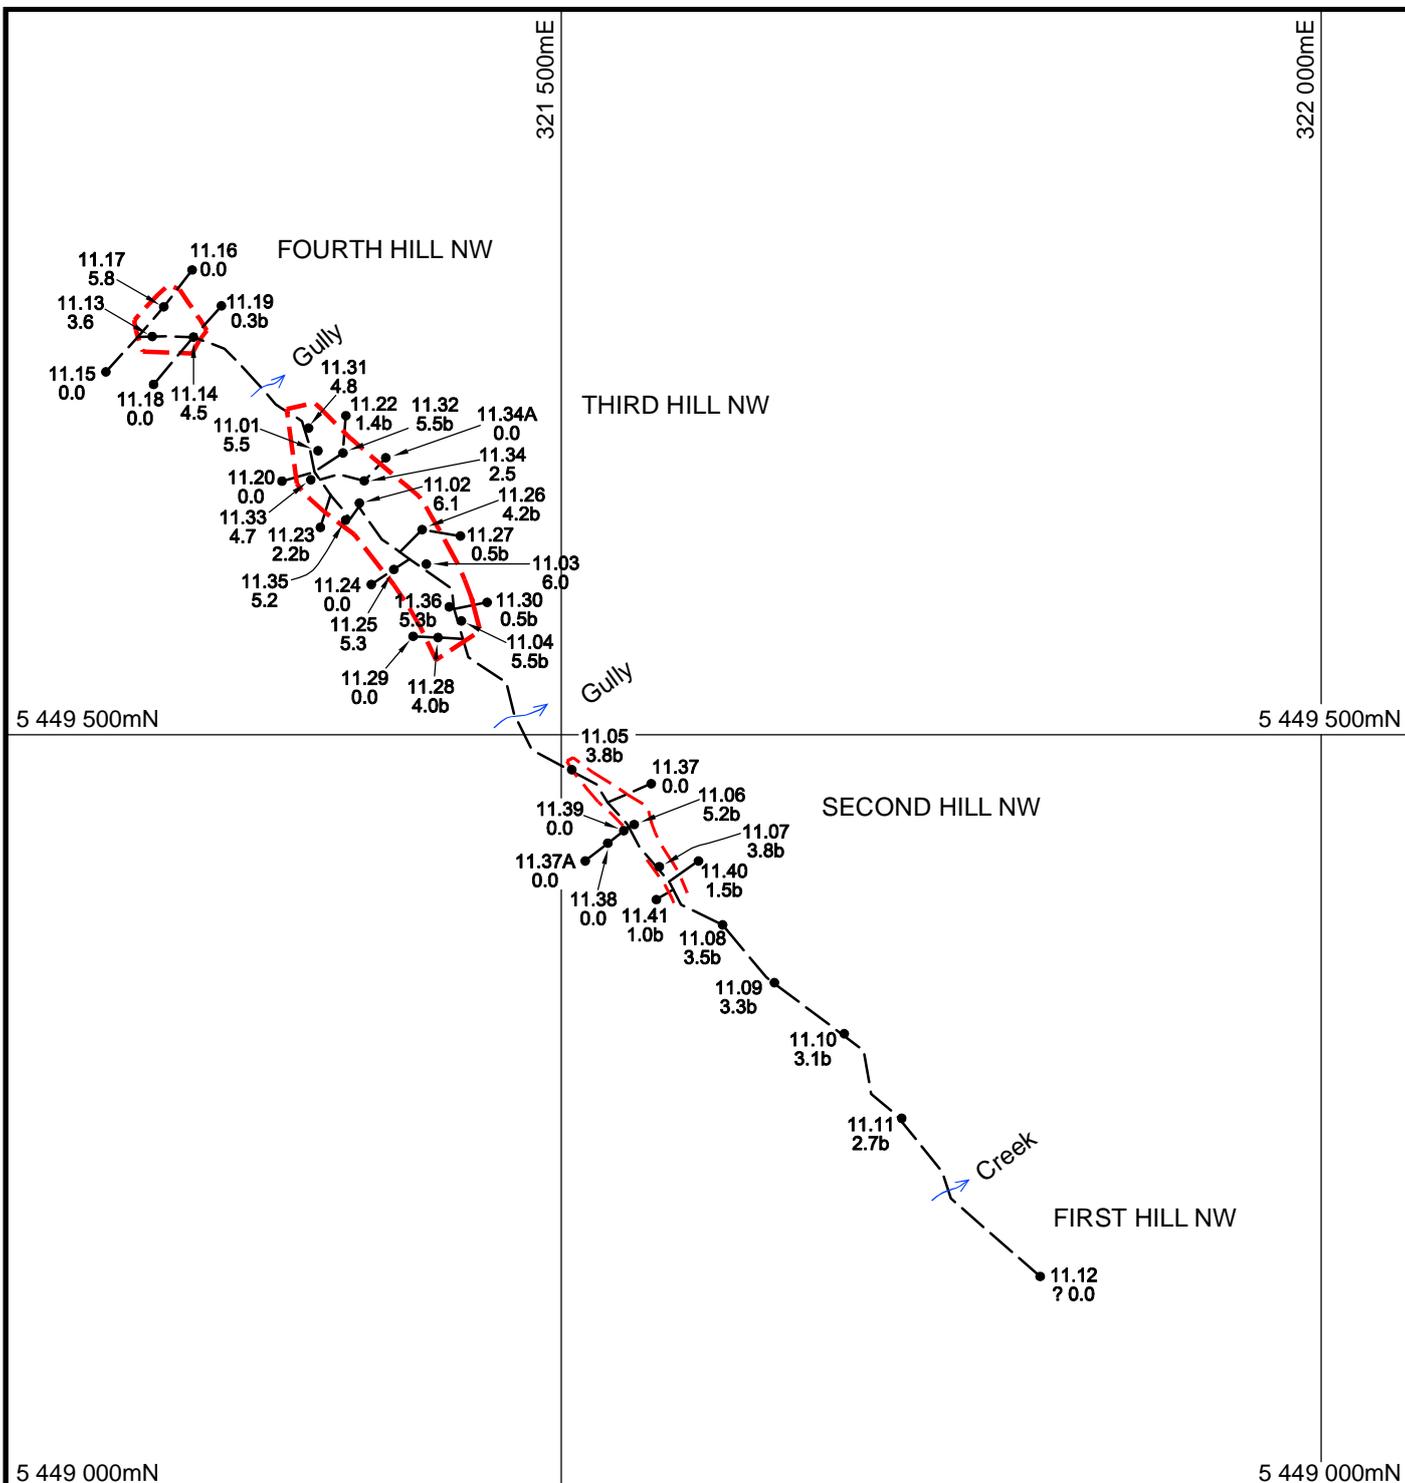
- Rough Track
- 11.33 4.7 Test pit with the number (11.33) and thickness (4.7m) of pale silica flour and lump silica.
- - - Interpolated 3m thickness line or isopach.
- b Indicates that the bottom of the pale silica was reached.

Previous work on the licence comprises two test pitting programs, one in 2010 and the next in 2011. The locations of these test pits are shown in Figure 2. For the 2010 campaign a 7.5t Takeuchi excavator was used, but was less than ideal due to the tightly packed and rocky nature of the silica in many pits. In the second round of exploration some 42 additional test pits were dug in November-December 2011 with a 12 tonne Caterpillar excavator, a substantially larger and more capable machine than the Takeuchi. Pits were dug along the crest of the ridge and on short side lines. Pale coloured silica flour is present on all of the four hills, but on the Third and Fourth Hills Northwest the occurrence is up to 50 m wide whereas on Second Hill Northwest the occurrence may be only 15 m wide. The occurrence on the First Hill Northwest is small though it is of easy access.

On Third and Fourth Hills Northwest a 3m thickness line or isopach was interpolated from the test pit data. The combined area enclosed by the 3m isopach at Third and Fourth Hills NW is substantial and 16 test pits with an average thickness of silica flour of 4.9 m fall inside the isopach. Assuming an overall average thickness of 4m of silica flour within the 3m isopach allows the following speculative resource estimate to be made 64,400 tonnes. However it was observed that the proportion of lump and waste within the resource was unknown, so the current round of bulk sampling was recommended to assess the yield of commercial silica flour.

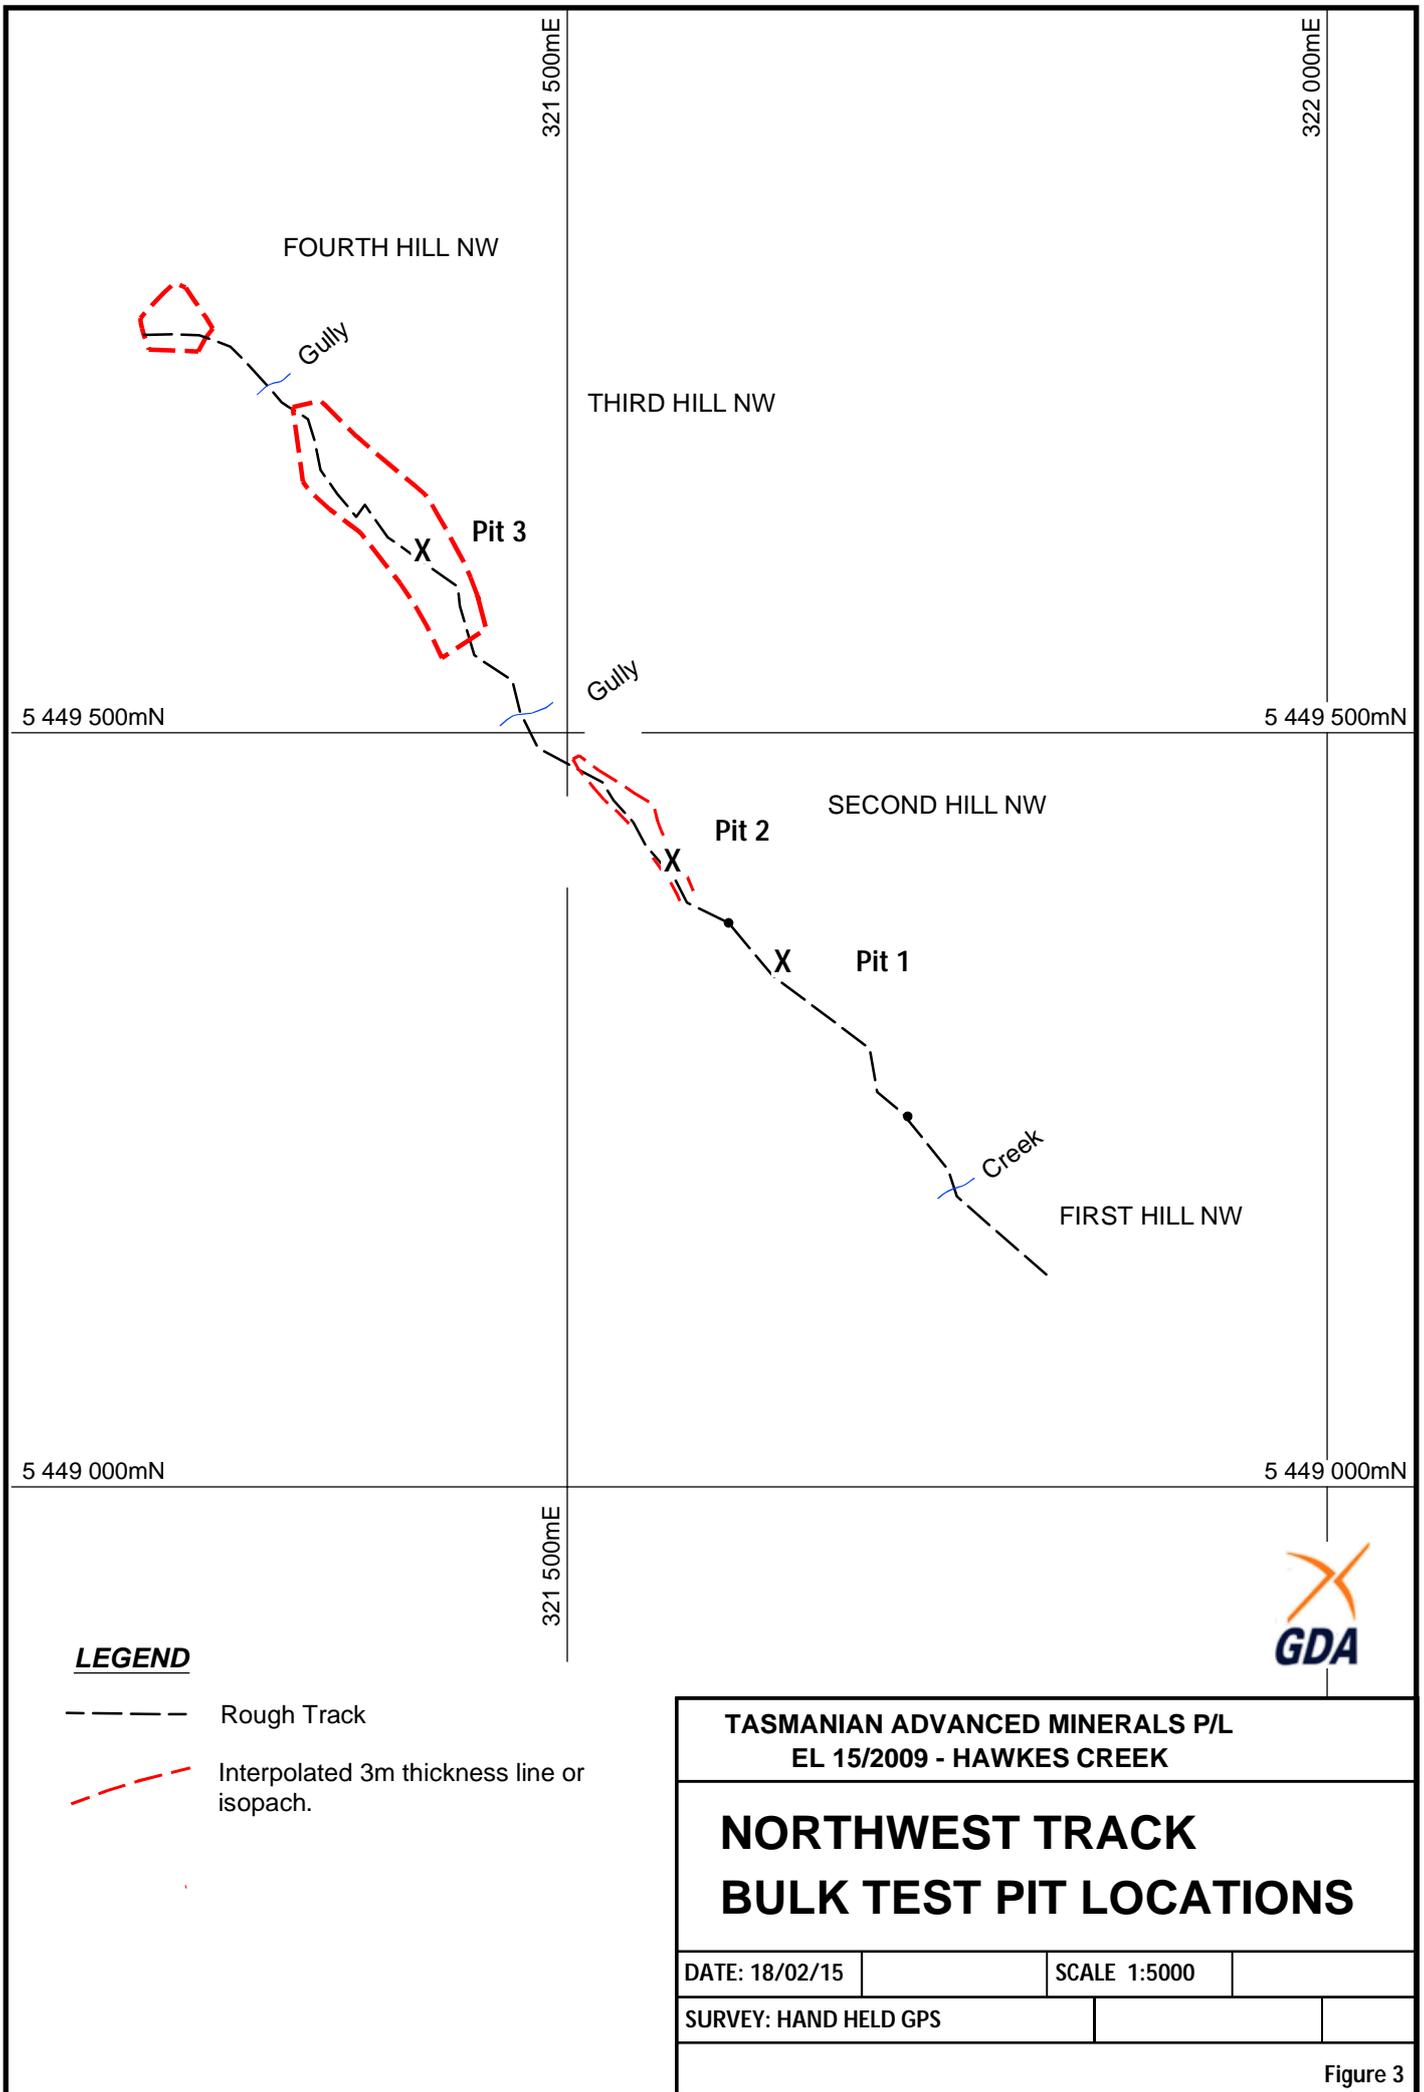
<b>TASMANIAN ADVANCED MINERALS P/L</b> <b>EL 15/2009 - HAWKES CREEK</b>			
<b>NORTHWEST TRACK</b> <b>BULK TEST PIT LOCATIONS</b>			
DATE: 18/02/15		SCALE 1:5000	
SURVEY: HAND HELD GPS			
Figure 3

- Rough Track
- - - Interpolated 3m thickness line or isopach.

The objective of the exploration was to extract several samples of approximately 300 tonnes each to investigate processing characteristics. Bulk test pit locations are shown in Figure 2. Physical and chemical characteristics can impact on suitability for processing. Important physical characteristics include particle size and shape, and the hardness of lump material. Some critical chemical impurities are iron and chromium, the latter present as chromite.

The pits were excavated with an animal-safe construction, with at least one sloping side and drainage to the side of the ridge. The location of the test pits are shown in Figure 2. The pits and tracks were rehabilitated by replacing top soil and vegetative matter after completion of the extraction.

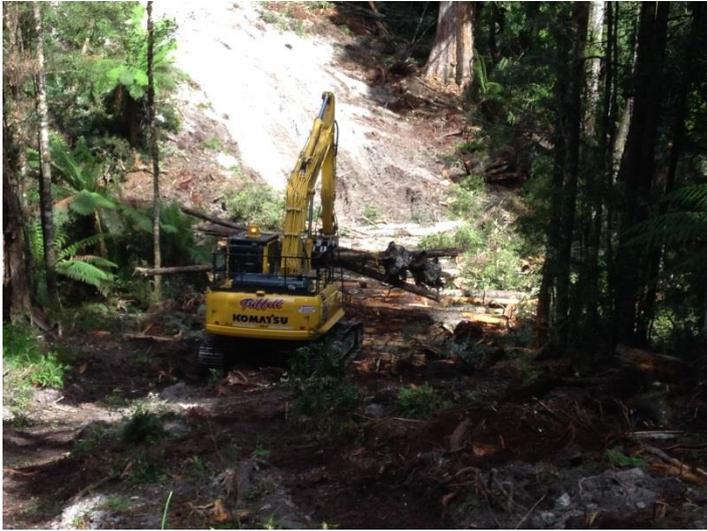
Construction of gully crossing

Access is gained via the Northwest Track from the northern border of TAM's Hawkes Creek mine 27M/2009. In preparation for the sample extraction the track was cleared of fallen trees, and flow-through log bridges and silt-traps were either constructed or repaired in the gullies between the hills. A new stockpile pad was constructed on 27/M2009 for screening and storage of the samples.

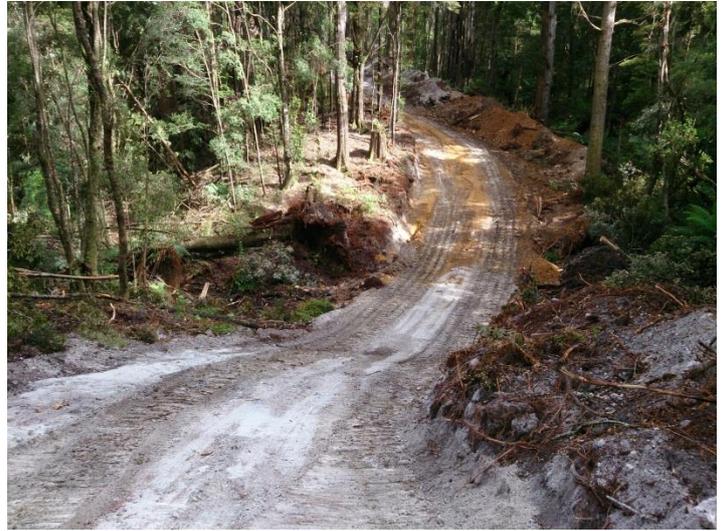
Gully Crossing to 2<sup>nd</sup> Hill

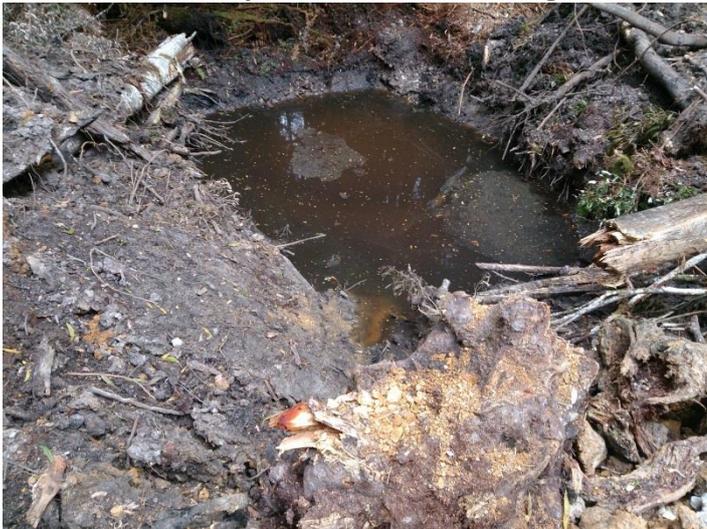
Silt trap at near creek crossing

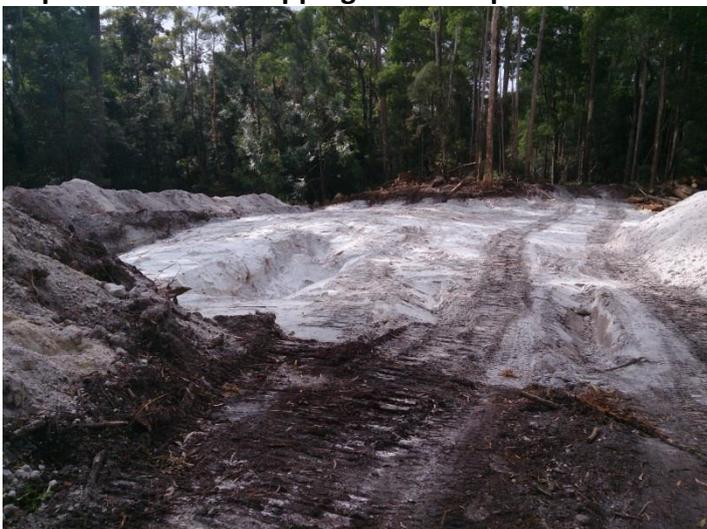
Topsoil removal: strippings downslope for silt control

Clearing, stripping and mining of the test pits was undertaken with a 22t Komatsu excavator, one of the excavators TAM uses for its commercial mining operations. Trees were cleared then topsoil was stripped prior to surface sampling. This initial sampling is to gauge whether or not stripping has been sufficient prior to mining as high impurity levels are found near the overburden contact. In Pits 1 and 3 initial surface results indicated the need for further stripping. A summary of the daily work log is given in Appendix 1, and photographs of activity are shown in Appendix 2.

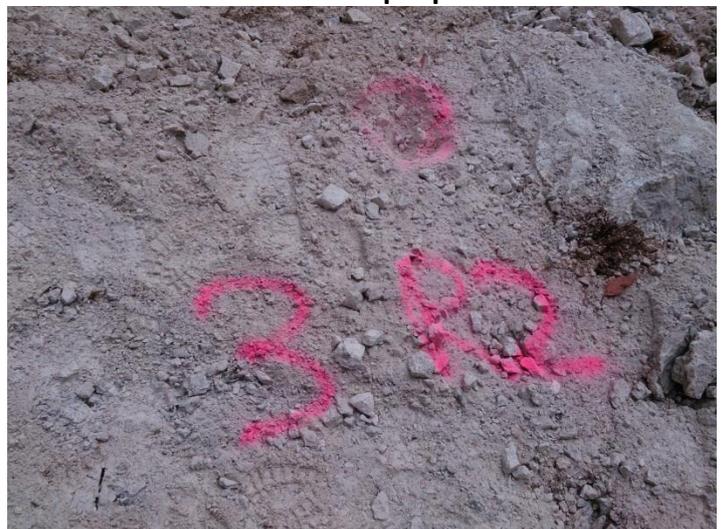
Surface sample point

After stripping the topsoil from the test pits the upper layer of silica, generally 0.5m in depth was stripped, as is common practice is TAM's other mining operation locations. Then the upper surfaces were sampled on a grid basis, and checked for impurities. If the impurity levels are too high further stripping is undertaken. Two of the most important contaminants in silica for use in LCD and OLED glass are iron and chromium.

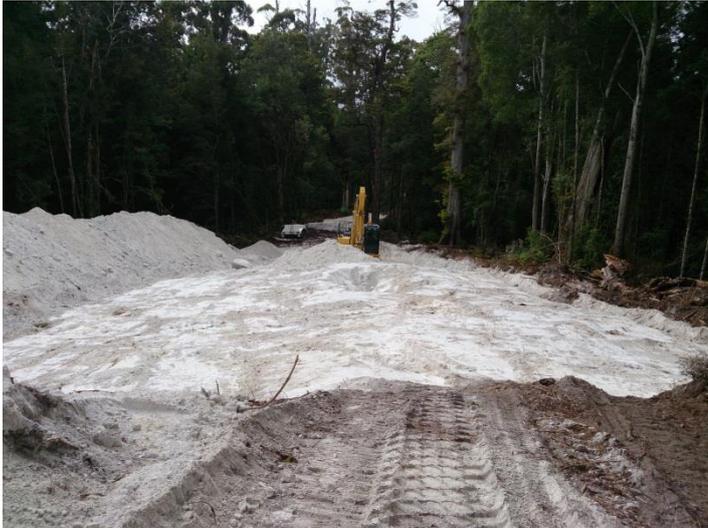
**Extracting the bulk sample**

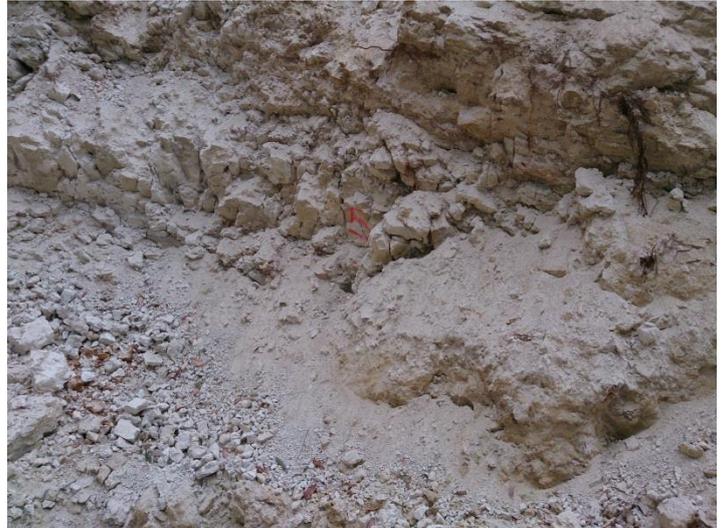
**Pit 3: High lump content**

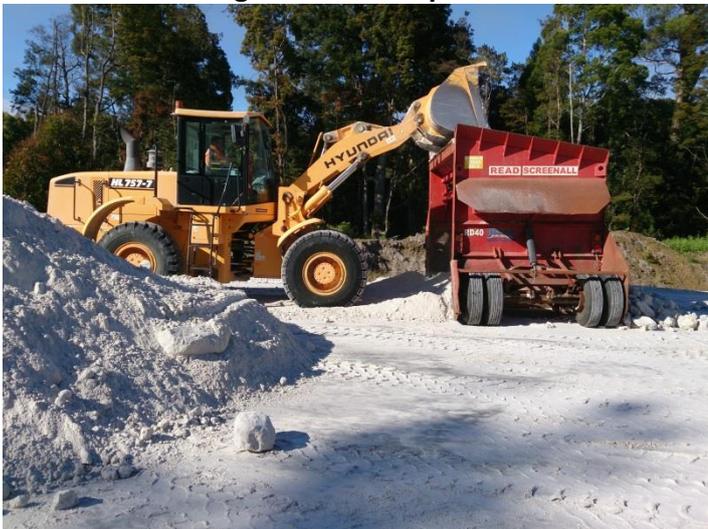
**Screening the bulk sample at 50mm**

After extraction the silica was trucked to the stockpile pad on 27M/2009 where it was screened over a Reid Screen with 50mm mesh aperture. As the screened stockpile was being added to, samples were taken approximately every 60 tonnes from around the perimeter of the added portion of the pile in order to obtain details of the impurity profile average and range.

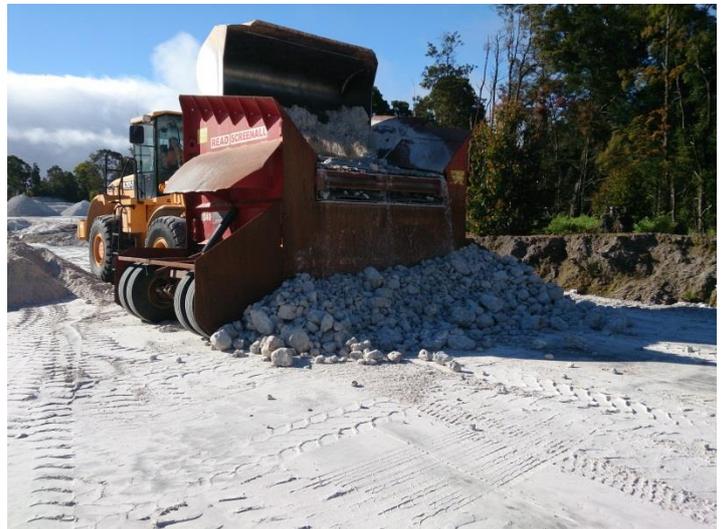
**Oversize will be broken down and re-screened**

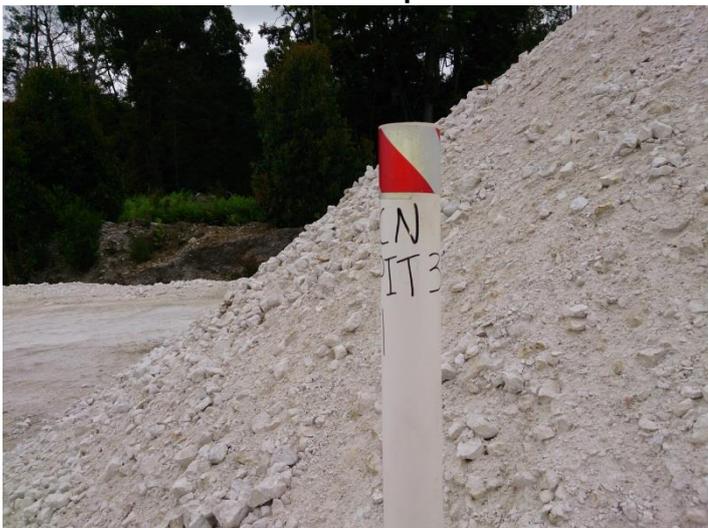
**Pit 3 Stockpile**

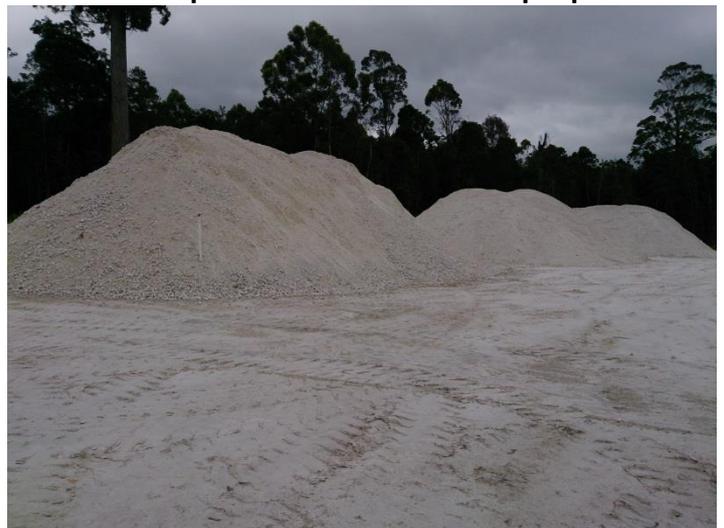
**Stockpiles from each bulk sample pit**

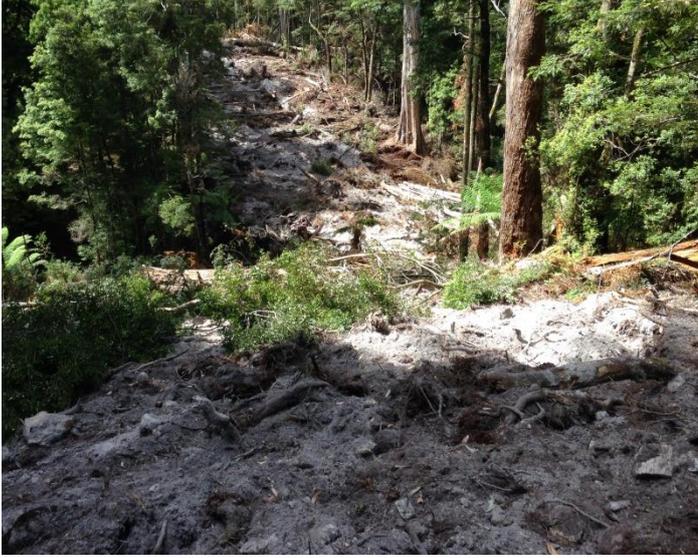
**Track Rehabilitation**

The pits were excavated in an animal-safe construction with at least one sloping side and drainage to the side of the ridge. The pits and tracks were rehabilitated by replacing top soil and vegetative matter after completion of the extraction.

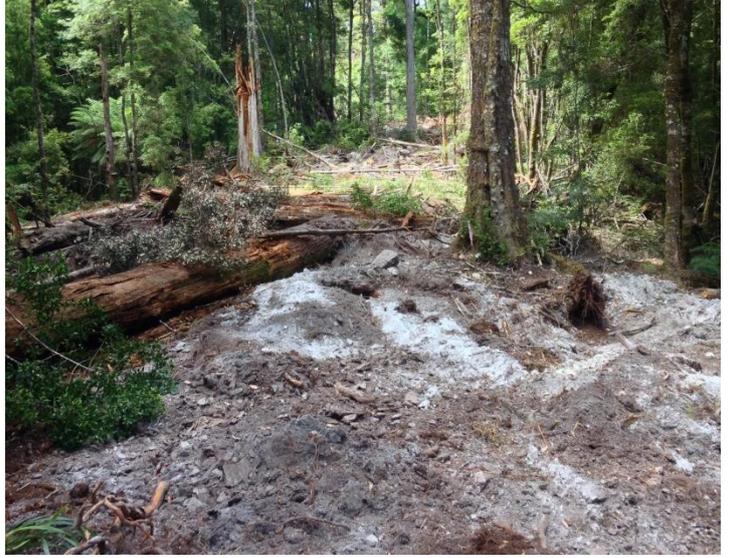
**Test Pit Rehabilitation**
