MIDDLETON CREEK

SITE INVESTIGATION

MIDDLETON CREEK SITE INVESTIGATION

PART TWO SOUTHERN SECTION

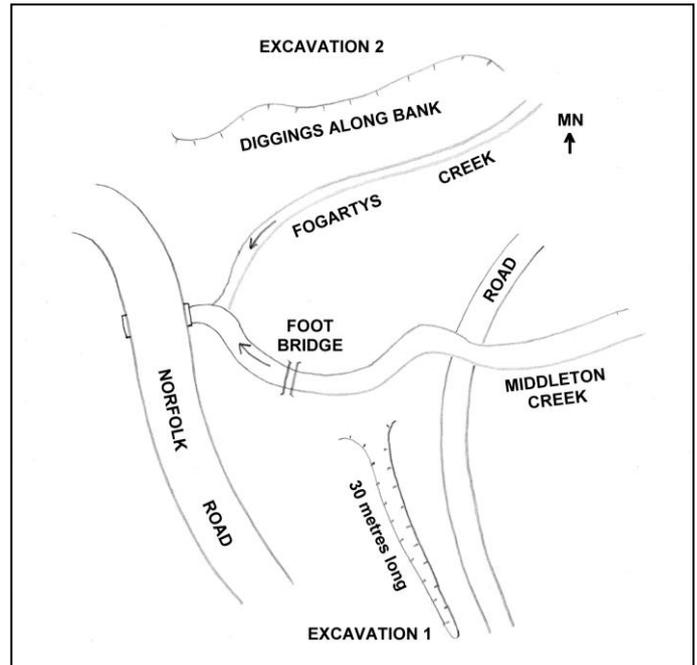
EXCAVATION 1.

Excavation 1 is a 30 x 4 metre trench on the West side of a mining / forestry track.

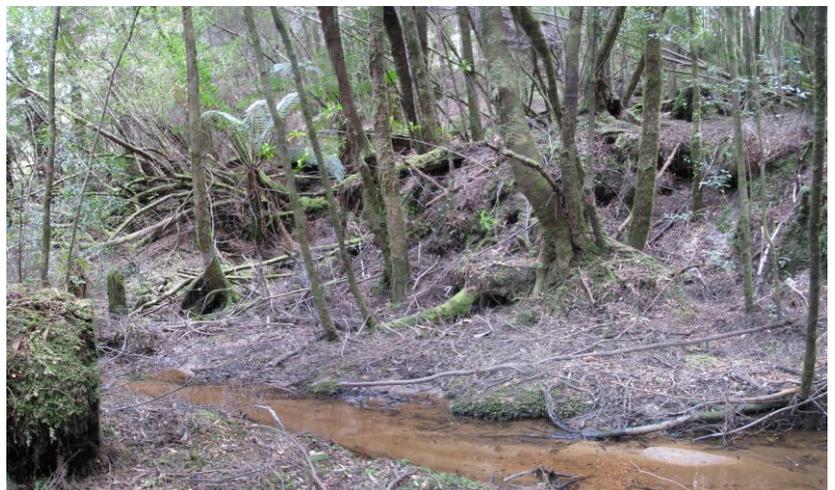
EXCAVATION 2

Excavation 2 is a length of diggings in the North bank of Middleton Creek between the Norfolk Road and Fogartys Creek.

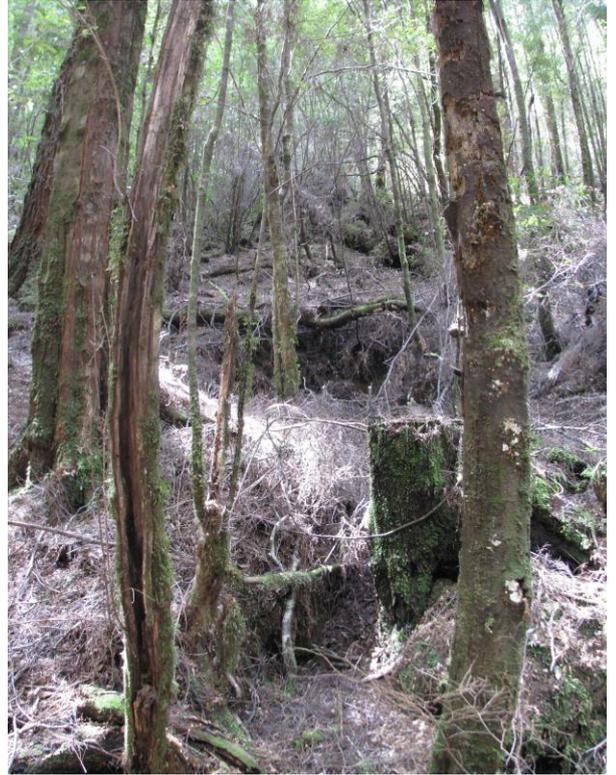
EXCAVATION 3

Diggings 60 metres up Fogartys Creek,
3 metres in diameter.

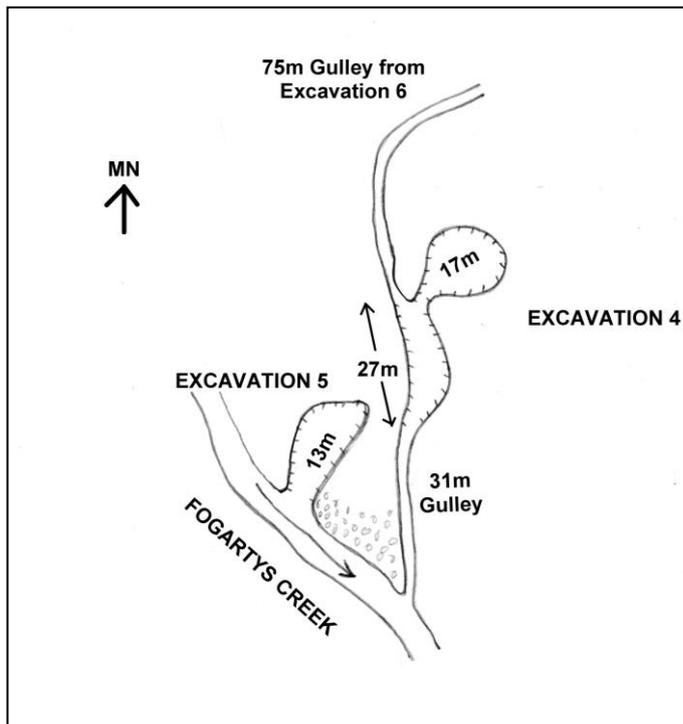
EXCAVATION 5

Workings 100 metres up Fogartys Creek on the
north bank and side gully.

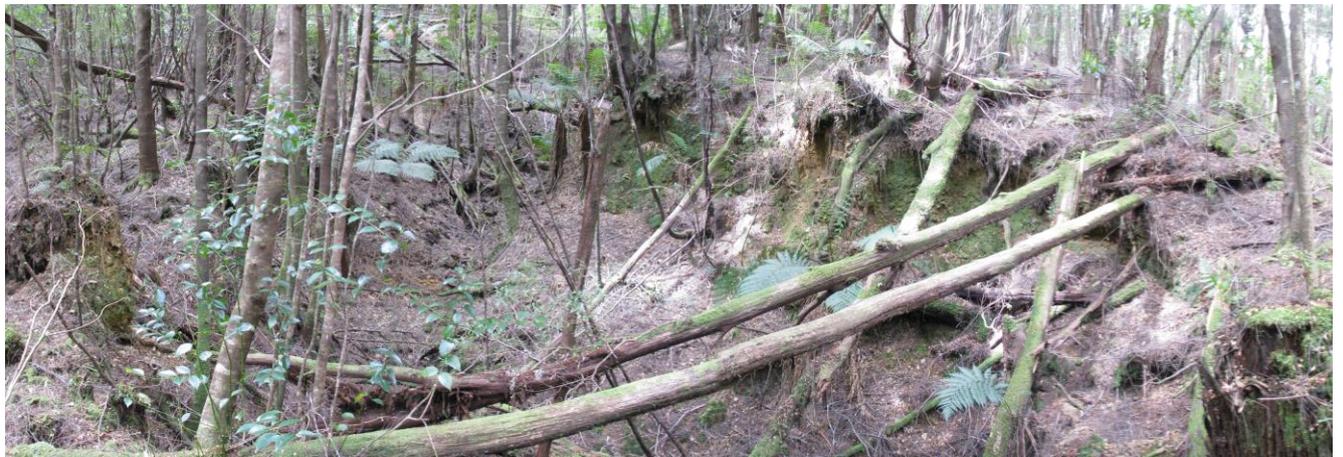
FACE OF ADIT (ARCH).

Major workings on the hillside up the minor gulley above Excavation 5. Behind the face of an adit the ground has been opened up into an open cut quarry, leaving an Arch feature.

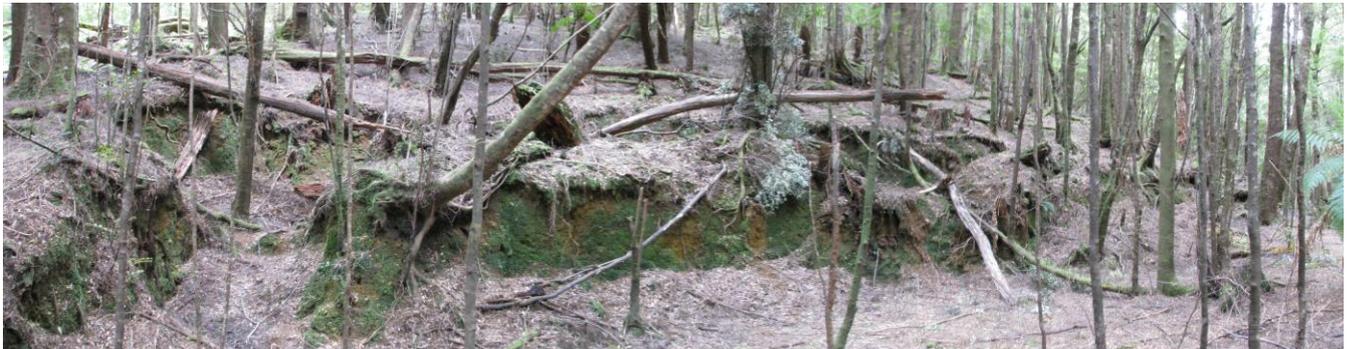
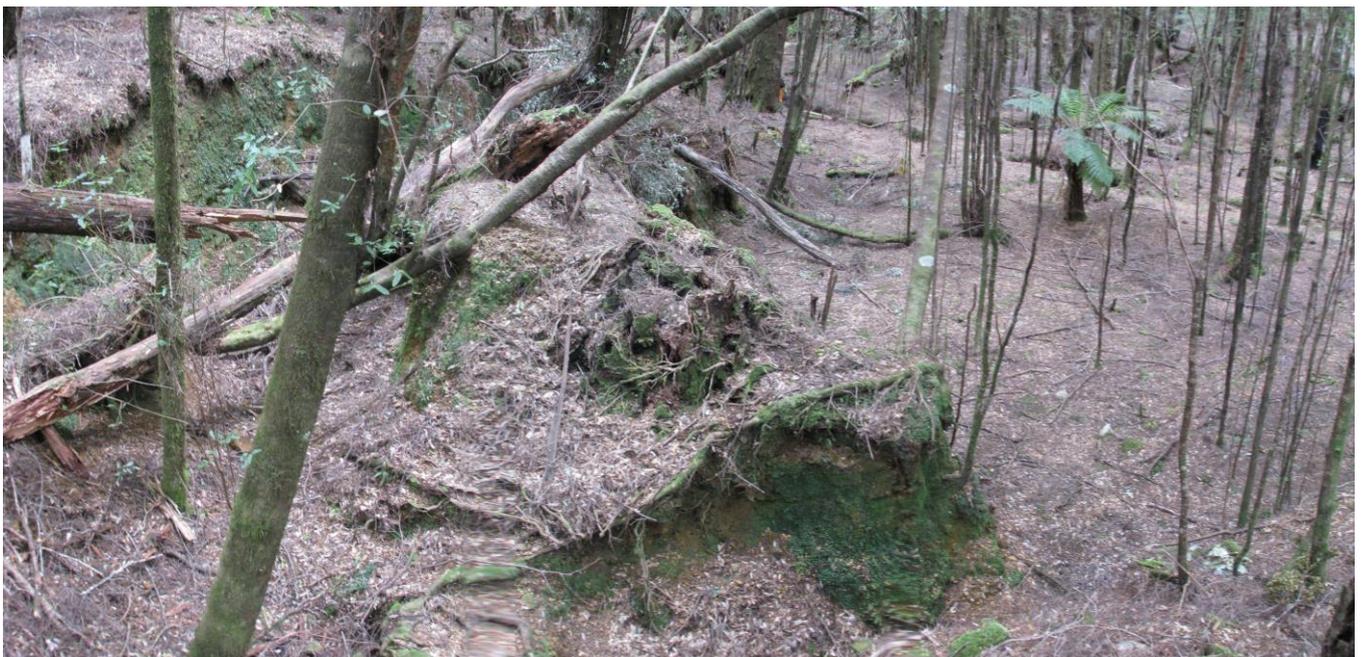
EXCAVATION 7.

Hydraulic workings on North East corner of Fogartys Creek / Middleton Creek junction.

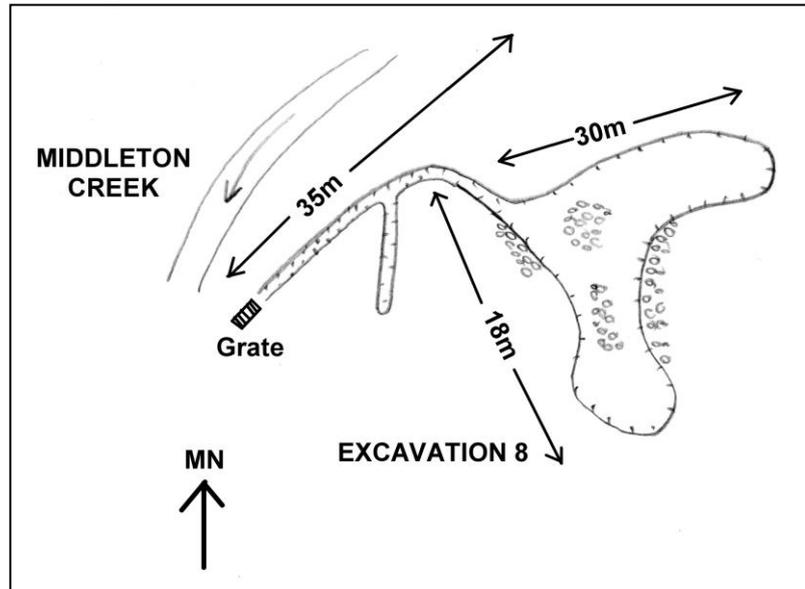
**LOWER TRENCH.**

Trenching and hydraulic slucing on East bank of Middleton Creek.

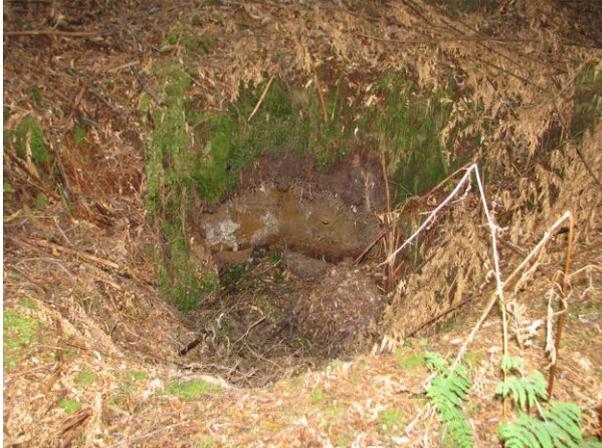
HOLE.

Large area of surface alluvial workings on East side of Middleton Creek with a narrow by pass trench. No water was observed flowing through the workings.

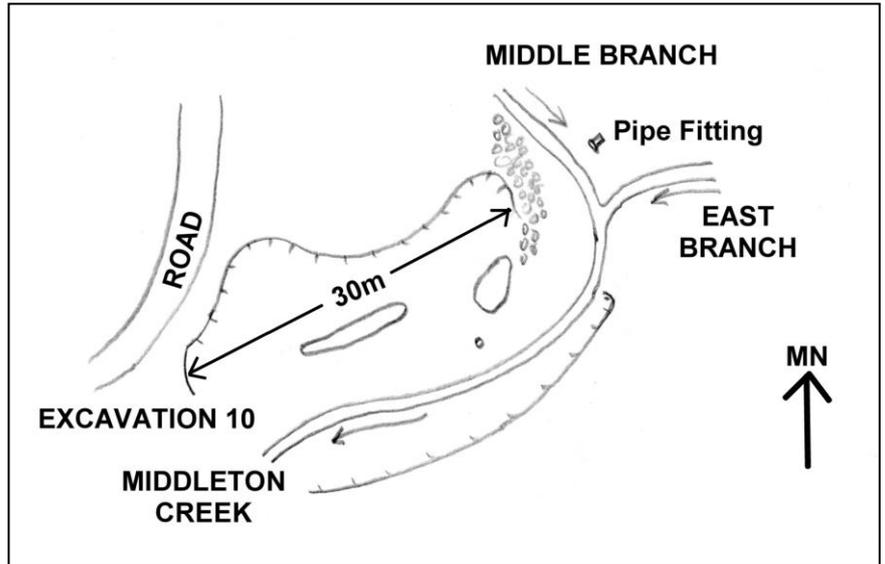
LOOKING NORTH ACROSS THE FLAT.

Large area of alluvial excavation on flat at junction of East and Middle Branches of Middleton Creek.

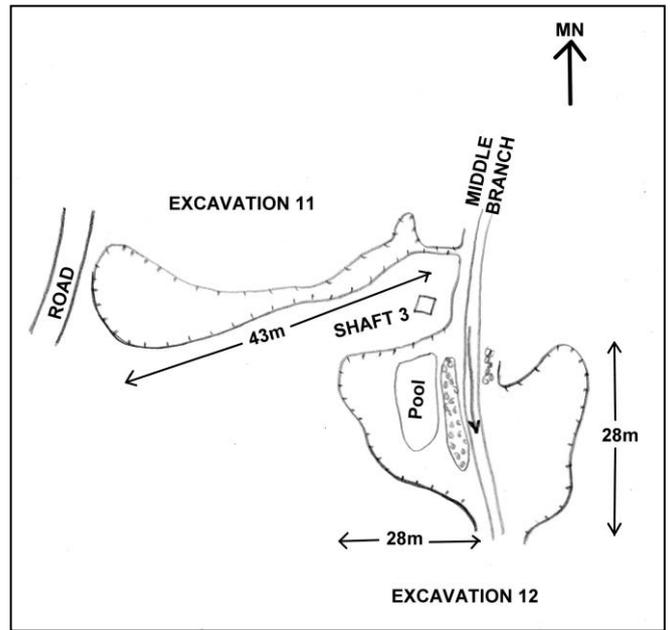
EXCAVATION 11.

Excavation 11 is Hydraulic workings in, or forming, a deep narrow gully on the West side of the Middle Branch. The western end has formed into a damp compound with no surface water inflow.

Between the two excavations on the West side of the creek is a flooded shaft which may be one of two shafts mentioned in *The Report on the Corinna Goldfield, Mine Offices, Launceston, 9 April 1894.*

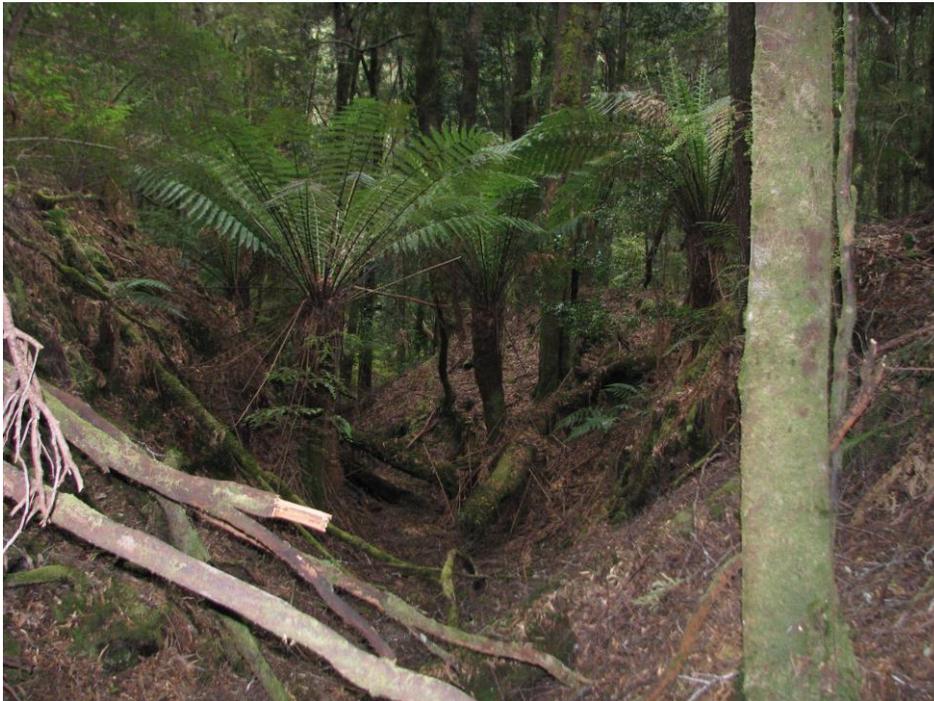
**EXCAVATION 13
QUARRY.**

Excavation 13 is a quarry on the North side of Middle Branch just up from the junction of East Branch. It has a narrow trench to the north east into a swampy pit which has a creek entering on its top end. This could be the remains of the "Gold Gurgler". See reference 5.

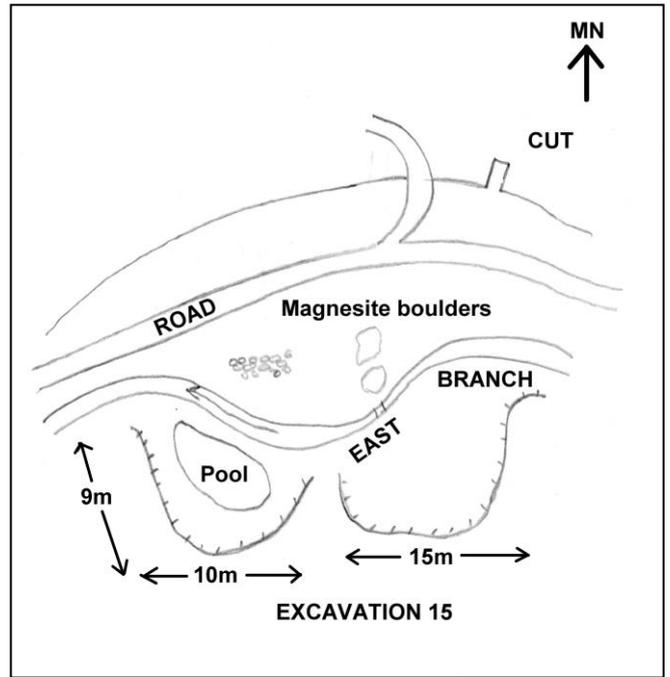
EAST BRANCH CREEK.

Excavation 15 is workings on East Branch just up from the Middle Branch junction. Two quarries are on the south side of the creek. Mullock and Magnesite boulders litter the valley floor, with a magnesite reef crossing the East Branch. A modern excavator cut is on the northern side.

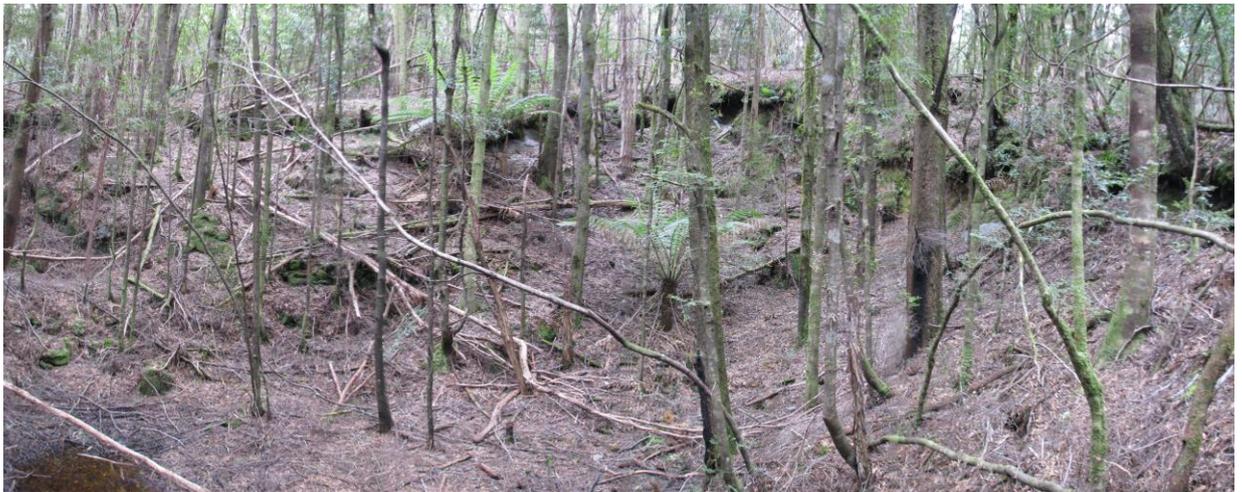
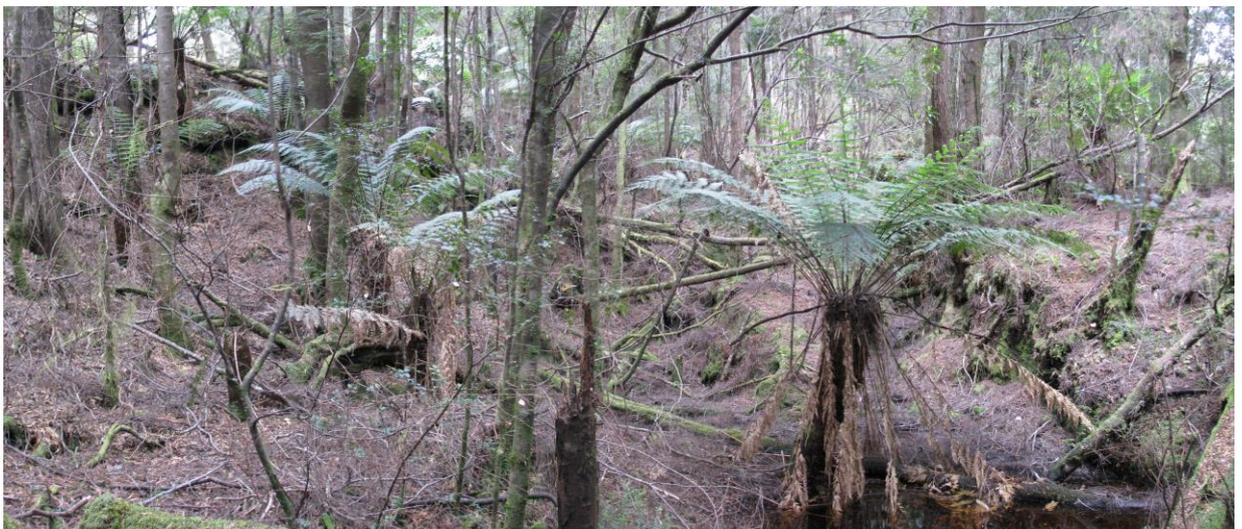
EXCAVATION 17.

Excavations 16 and 17 are two significant quarries over 100 metres to the east of Middleton Creek above excavation 8. A small creek flows through the southern quarry and is dammed by a road below the workings.

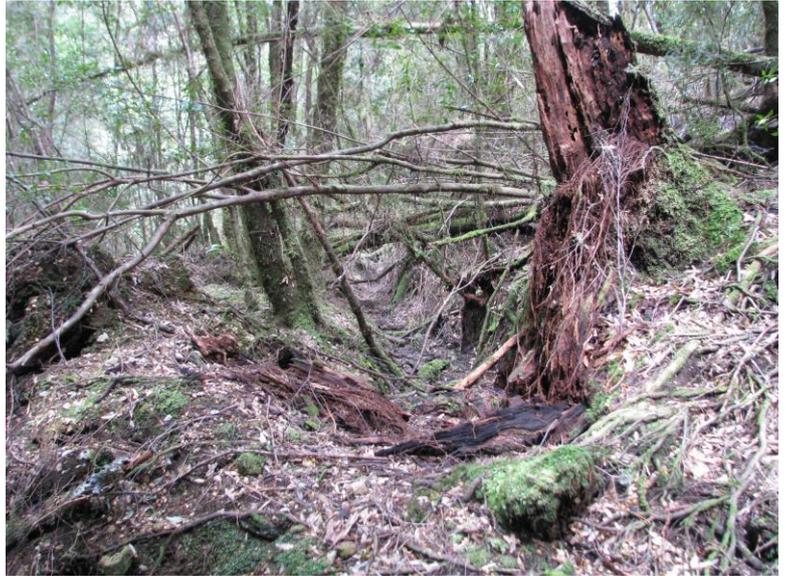
WATER RACE 1.

**RACE 1 ON SOUTH SIDE
OF FOGARTYS CREEK.**

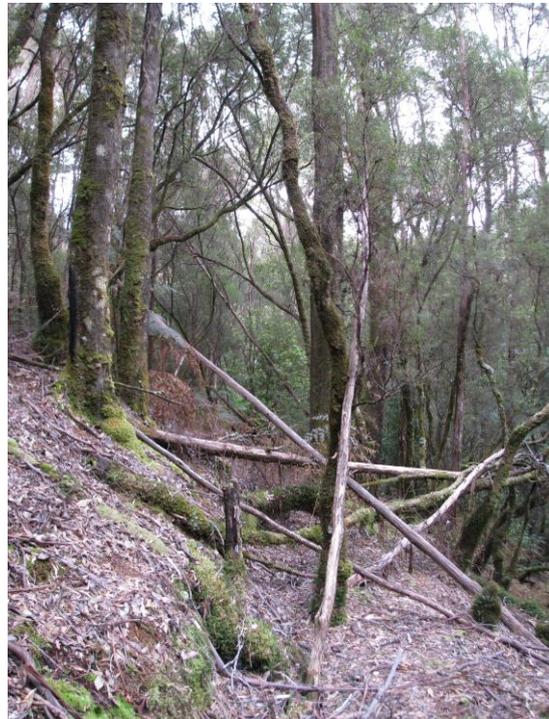
WATER RACE 2.

**RACE 2 FROM EAST BRANCH
RUNNING DOWN THE EAST
SIDE OF MIDDLETON CREEK
VALLEY.**

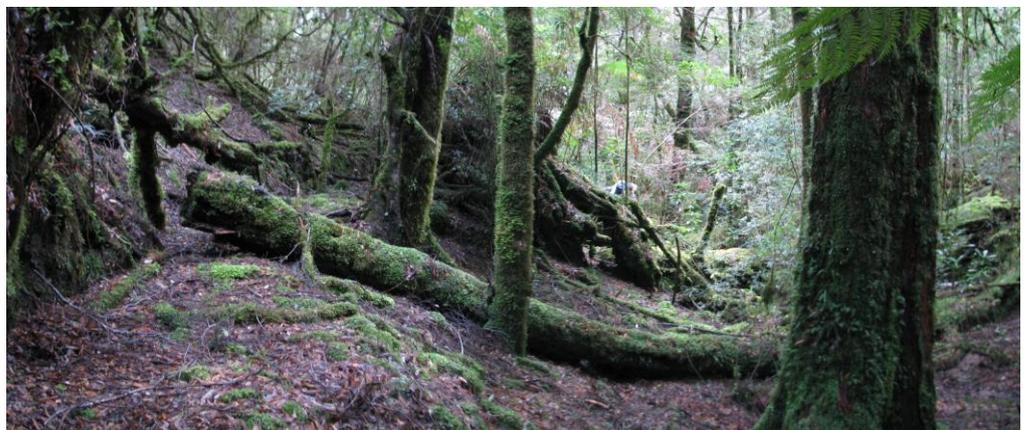
WATER RACE 3.

**RACE 3 FROM
MIDDLE
BRANCH DOWN
TOWARDS
EXCAVATION 10.**

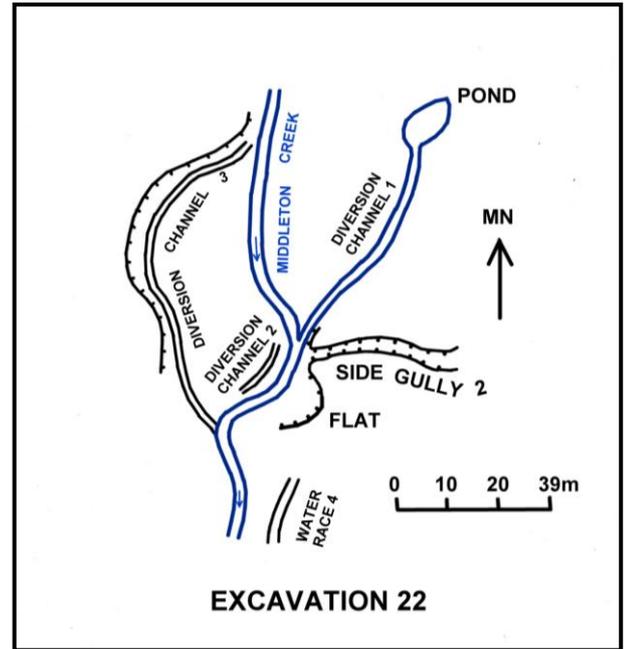
Excavation 22 is 200 meters down from the bridge mainly on the western side of Middleton Creek, with a minor flat and worked gully on the eastern side. Three diversion channels exist at this location, one emanating from a small pond. There are remains of a water race beyond this excavation, possibly fed originally from the side gully.

**EXCAVATION 22 LOOKING
ACROSS MIDDLETON CREEK.**

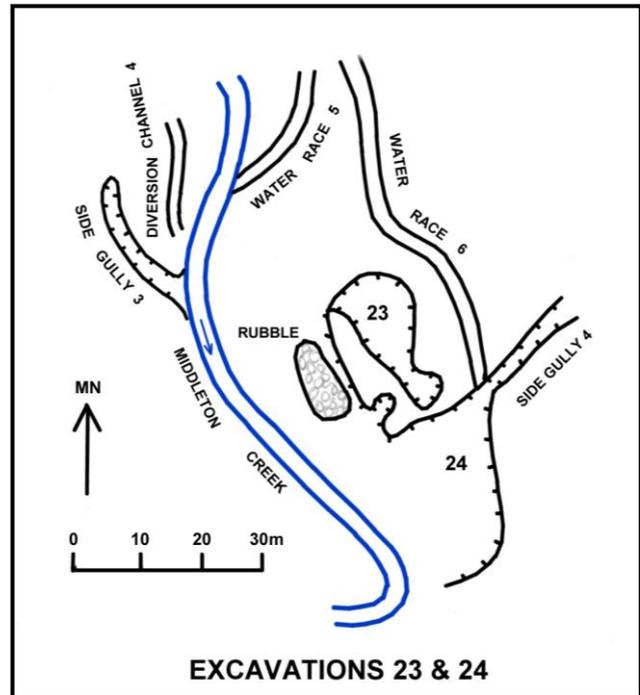
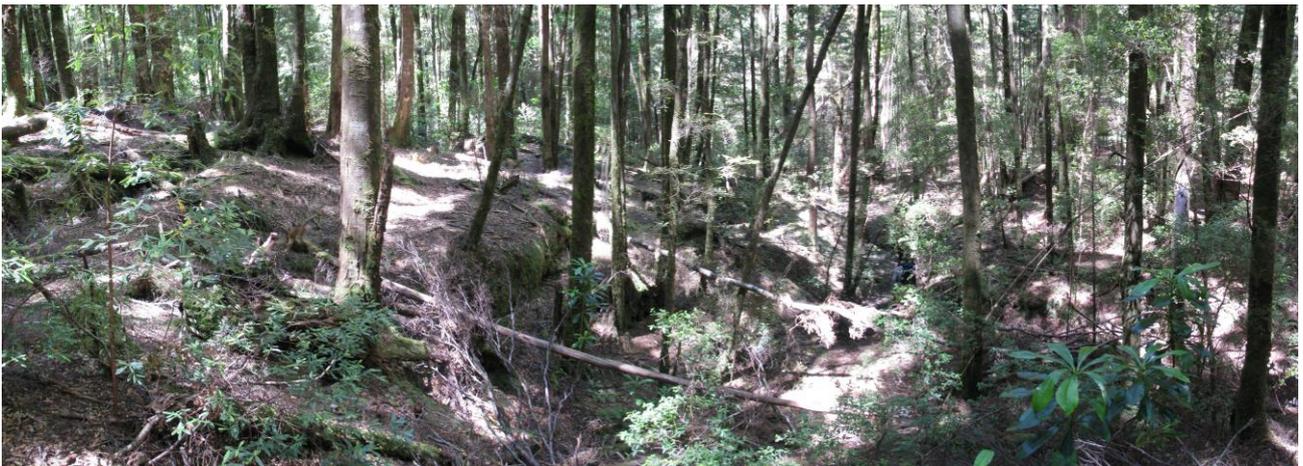
These excavations are 400 meters below the bridge, mainly on the east side, with some working in a steep gully on the west side. One water race enters Middleton Creek just upstream, while a second passes above Excavation 23, and may have ended at Excavation 24, or been obliterated by work at this site. Another diversion channel exists on the west side.

**EXCAVATION 23 from WATER RACE 6.
(Race visible on left side of picture.)**

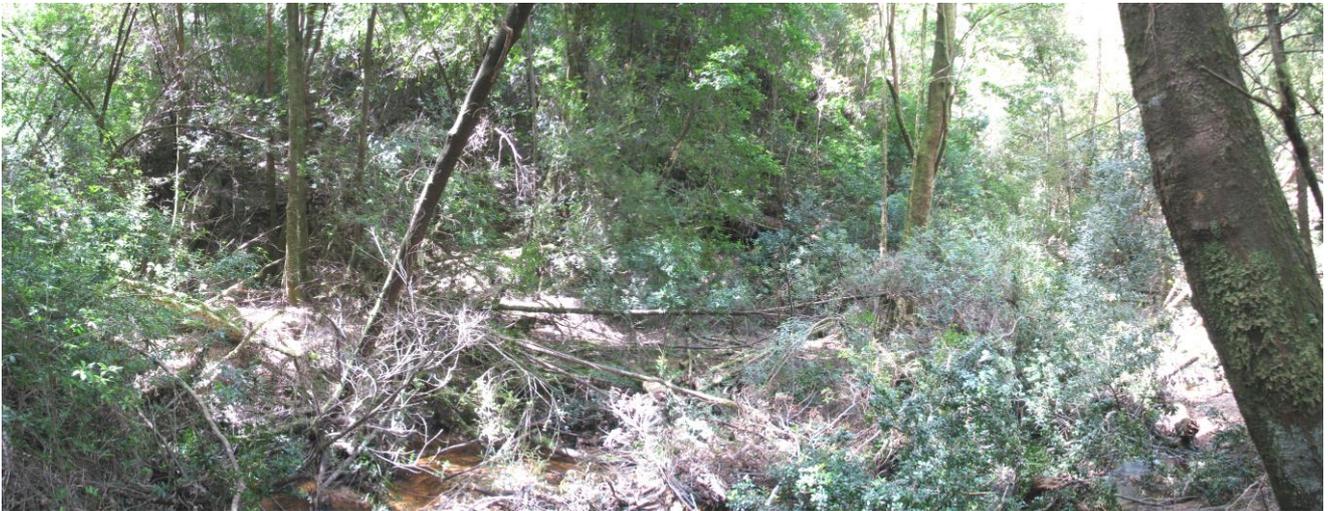
This excavation just past Excavation 25 is the last observed before Middleton Creek flows North West through the Elizabeth Ridge. The valley here widens out and becomes swampy as two side creeks join Middleton Creek. A long Diversion Channel passes this excavation.

EXCAVATION 26, COVERED BY SCRUB.

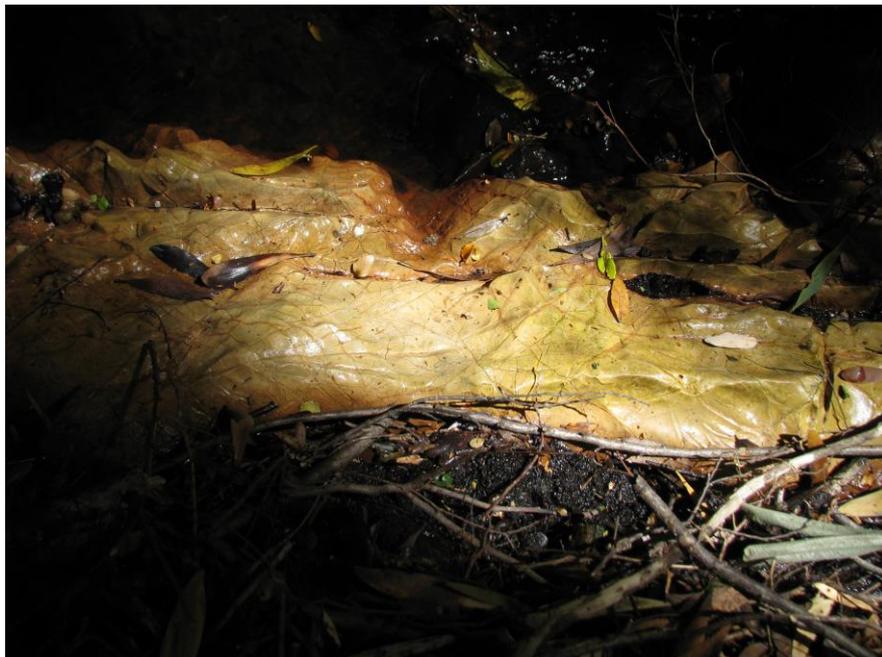
DOLOMITE REEF CROSSING SOUTH EAST SIDE CREEK.

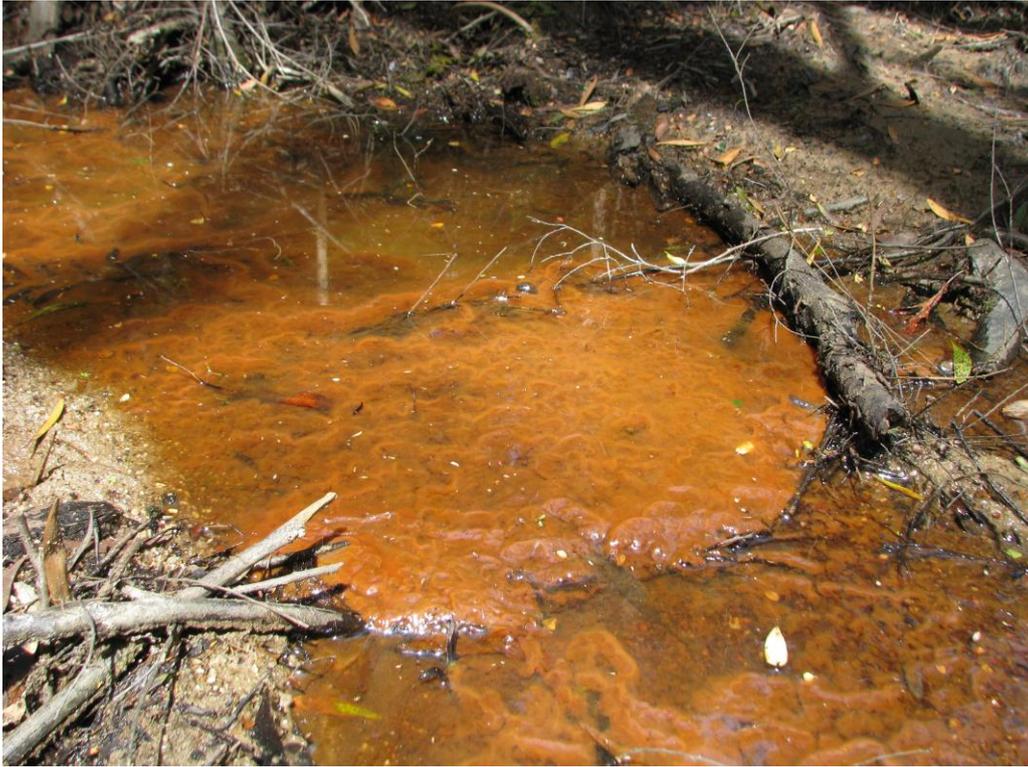
SOUTHERN SIDE CREEK.

SEDIMENTATION IN SOUTHERN SIDE CREEK AT JUNCTION WITH MIDDLETON CREEK.

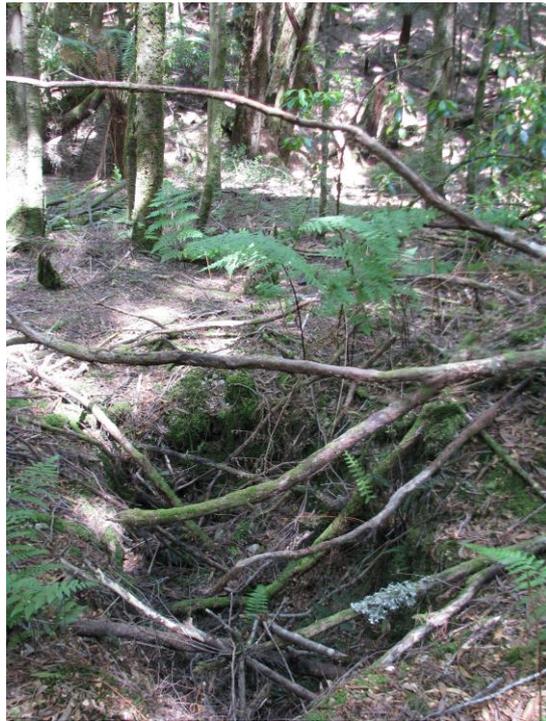
HOLE 6

A LARGER PIT ON THE EASTERN FLAT FORMED BY EXCAVATION 21.

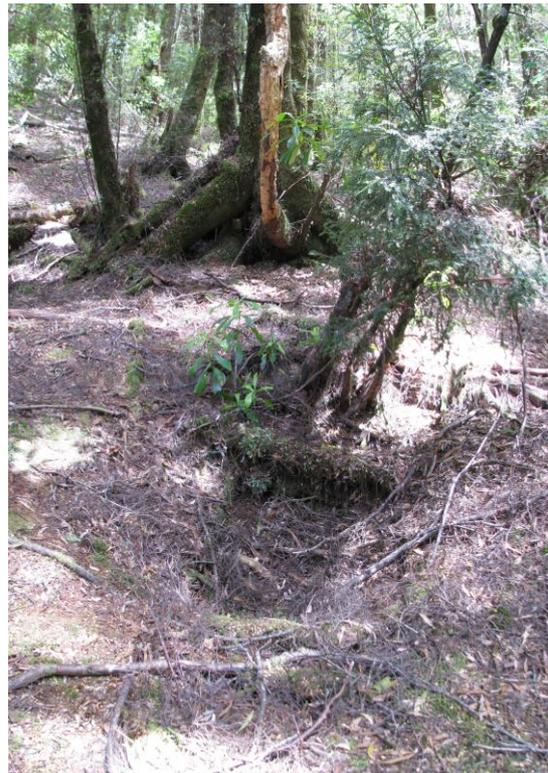
SHAFT 4

A HOLE WITH A TIMBER FRAME THAT APPEARS TO BE A FILLED IN SHAFT OR WELL BEHIND THE CHIMNEY BASE AT THE MILL SITE.

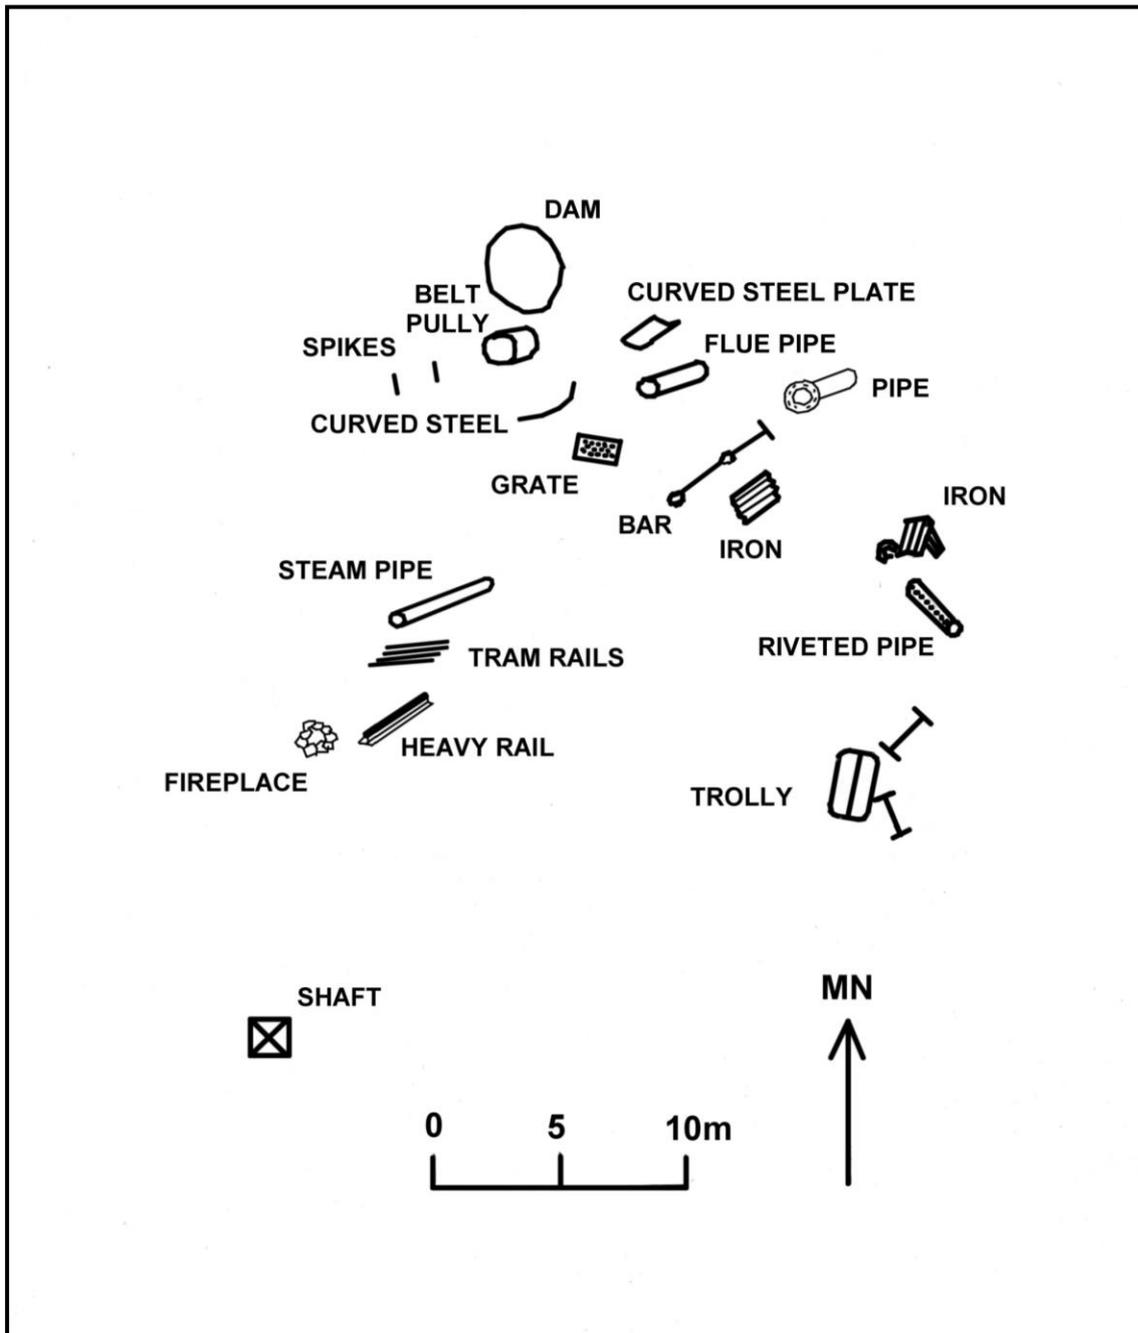
MILL SITE

Near the bottom of the Southern Section gold leases there exists evidence of what Parry Kostoglou called “*an ore milling site with adjacent timber tramway*”. The following artifacts were located, but the building foundation reported upon was not obvious. South of the mill site a formation which could be a tramway was seen, but it was only evident for about 50 meters before entering a boggy area covered with horizontal scrub. One section of heavy rail iron was seen which would match the trolley wheels, with a bundle of light tram rail iron beside it.
