MINERAL HOLDINGS AUSTRALIA PTY LTD

RETENTION LICENCE RL1/2005 HOGARTH CREEK, NW TASMANIA

ANNUAL REPORT ON EXPLORATION TO JUNE 2016

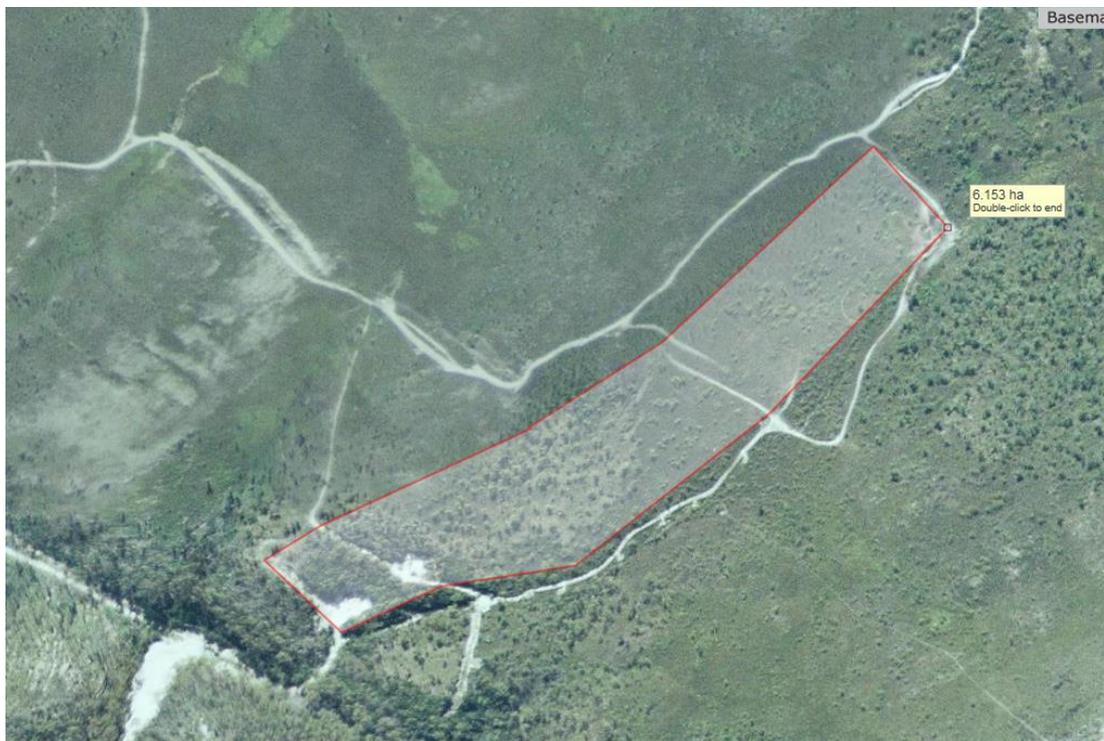
Figure 4.1.1: Resource Area 1

The sand resource exists as a thick 'layer' draped over the south-east slope of a prominent NE-SW trending ridge. A thin veneer of A-horizon soil covers the resource. The soil horizon, which supports heathland and button grass regrowth, is typically less than 0.5 metres in thickness. *Banksia serrata* trees are the only threatened faunal species but only one tree occurs within the resource area.

The grain size of the raw sand typically ranges from 1.0 mm (medium silt) down to less than 53 microns. The pay fractions, -20 to +40 mesh (-850 microns to +425 microns) and -40 to +70 mesh (-425 to +212 microns), make up 26.2% and 47.3 % respectively of the sand. The oversize fraction (+20 or +850 microns) makes up only 0.4% of the sand, while the fines (less than or minus 70 mesh or 212 microns down to -53 microns) make up an additional 25.1% of the sand. Once markets are established even the 21.8% of the sand sitting below 70 mesh to 140 mesh may be saleable to some frac sand users. Only 1.3% of the sand is fine enough to be sold as silica flour but such small quantities would hardly be economic.

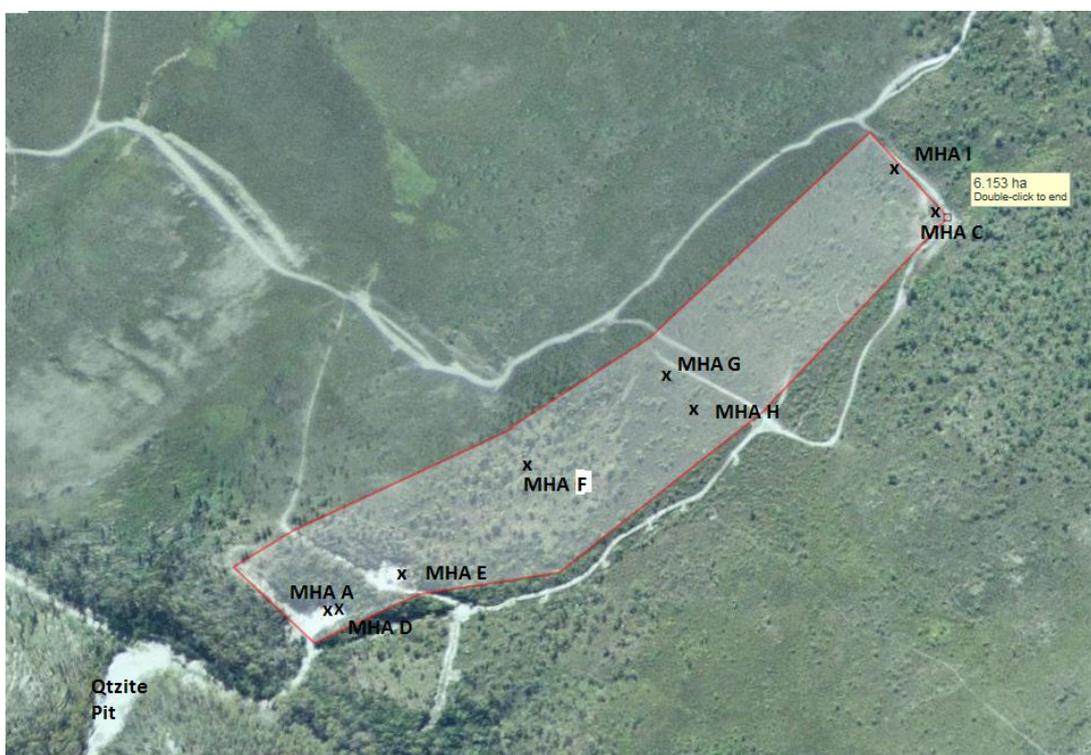
Figure 4.1.2: Resource Area 1 showing Stim-Lab Sample Sites

Eight samples were submitted to Stim-Lab for testing from Resource Area 1. Stim-Lab's testing indicates passes for roundness, sphericity and bulk density. Stress tests are in the range of 3,000 to 5,000 psi which is sufficient for the Queensland coal gas industry.

Sample site	Coordinates		Notes
	Easting	Northing	
MHA A&D	372 647E	5 462 701N	Bottom of pit face
MHA E	372 711E	5 462 744N	2m from top of face
MHA F	372 800E	5 462 816N	1.5m depth
MHA G	372 907E	5 462 904N	1m depth
MHA H	372 934E	5 462 872N	1m depth
MHA I	373 095E	5 463 078N	1.5m depth
MHA C	373 126E	5 463 048N	1m depth

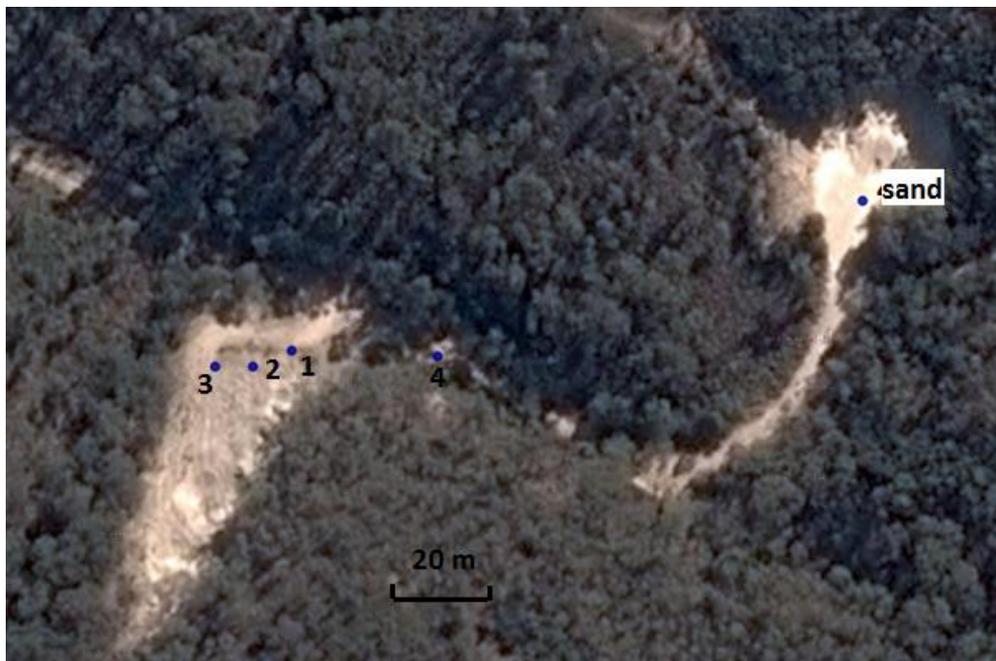
Figure 4.3.1: Location of Simcoa’s Quartzite Sample Sites

Two samples were collected from dump material from the old crusher site. An additional four samples (Nos. 1 to 4 - as shown in Figure 4.3.1) were taken from the quartzite outcrop and a sixth sample was collected from the frac sand pit.

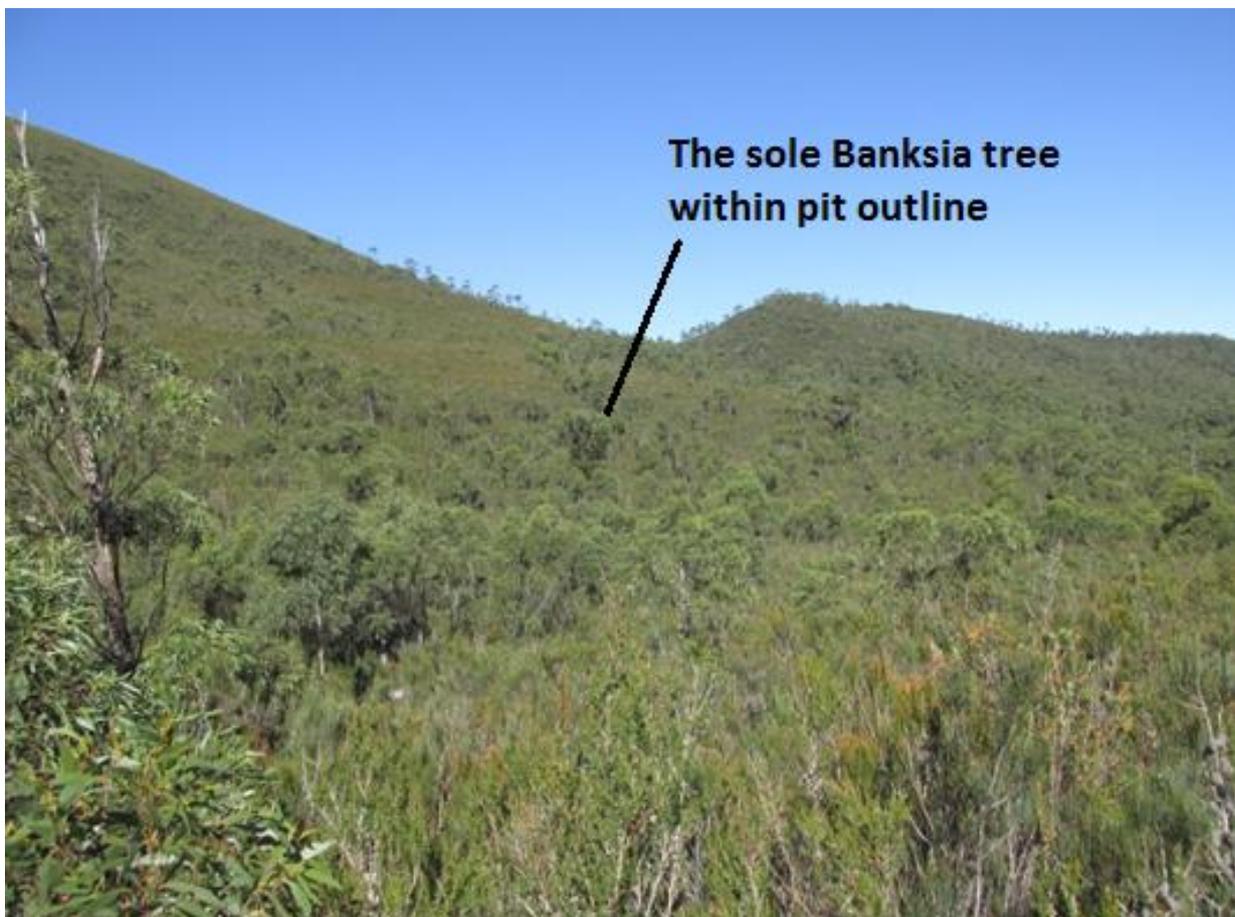
Figure E.2: Looking North-east between Sections 3 & 4

The one lone banksia tree in the centre of Figure E.2 is the one and only banksia within the pit area. The rest of the vegetation is button grass moorland and *Leptospermum* scrub.

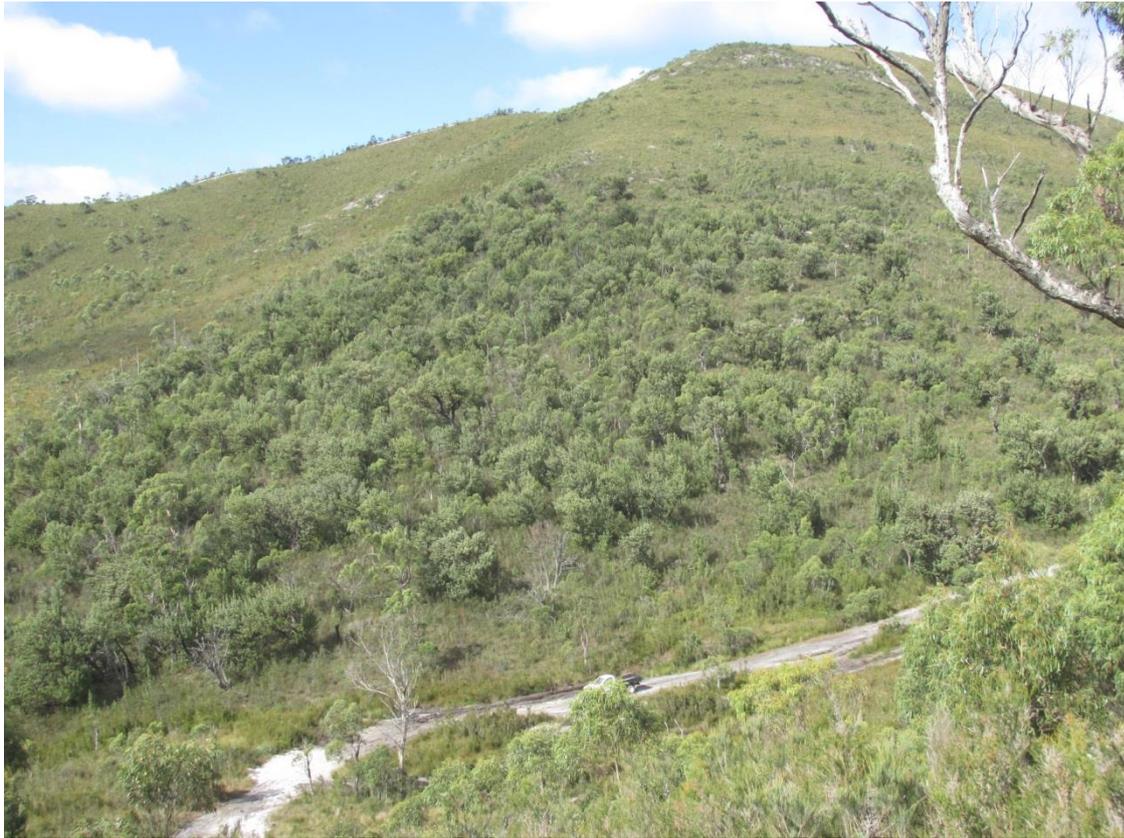
Figure E.3: Large Area of *Banksia serrata* Woodland South of Section 5

Figure E.3 shows the banksia trees south-east of Section 5, outside the boundary of the proposed pit. Almost half the trees in this area are banksia with button grass moorland on the highest peaks.
