# **NARACOOPA MINERAL SANDS PTY LTD**

**EL 25/2007 DRILLING PROGRAM 2018-19  
ENVIRONMENTAL MITIGATION MEASURES  
26 MARCH 2018**

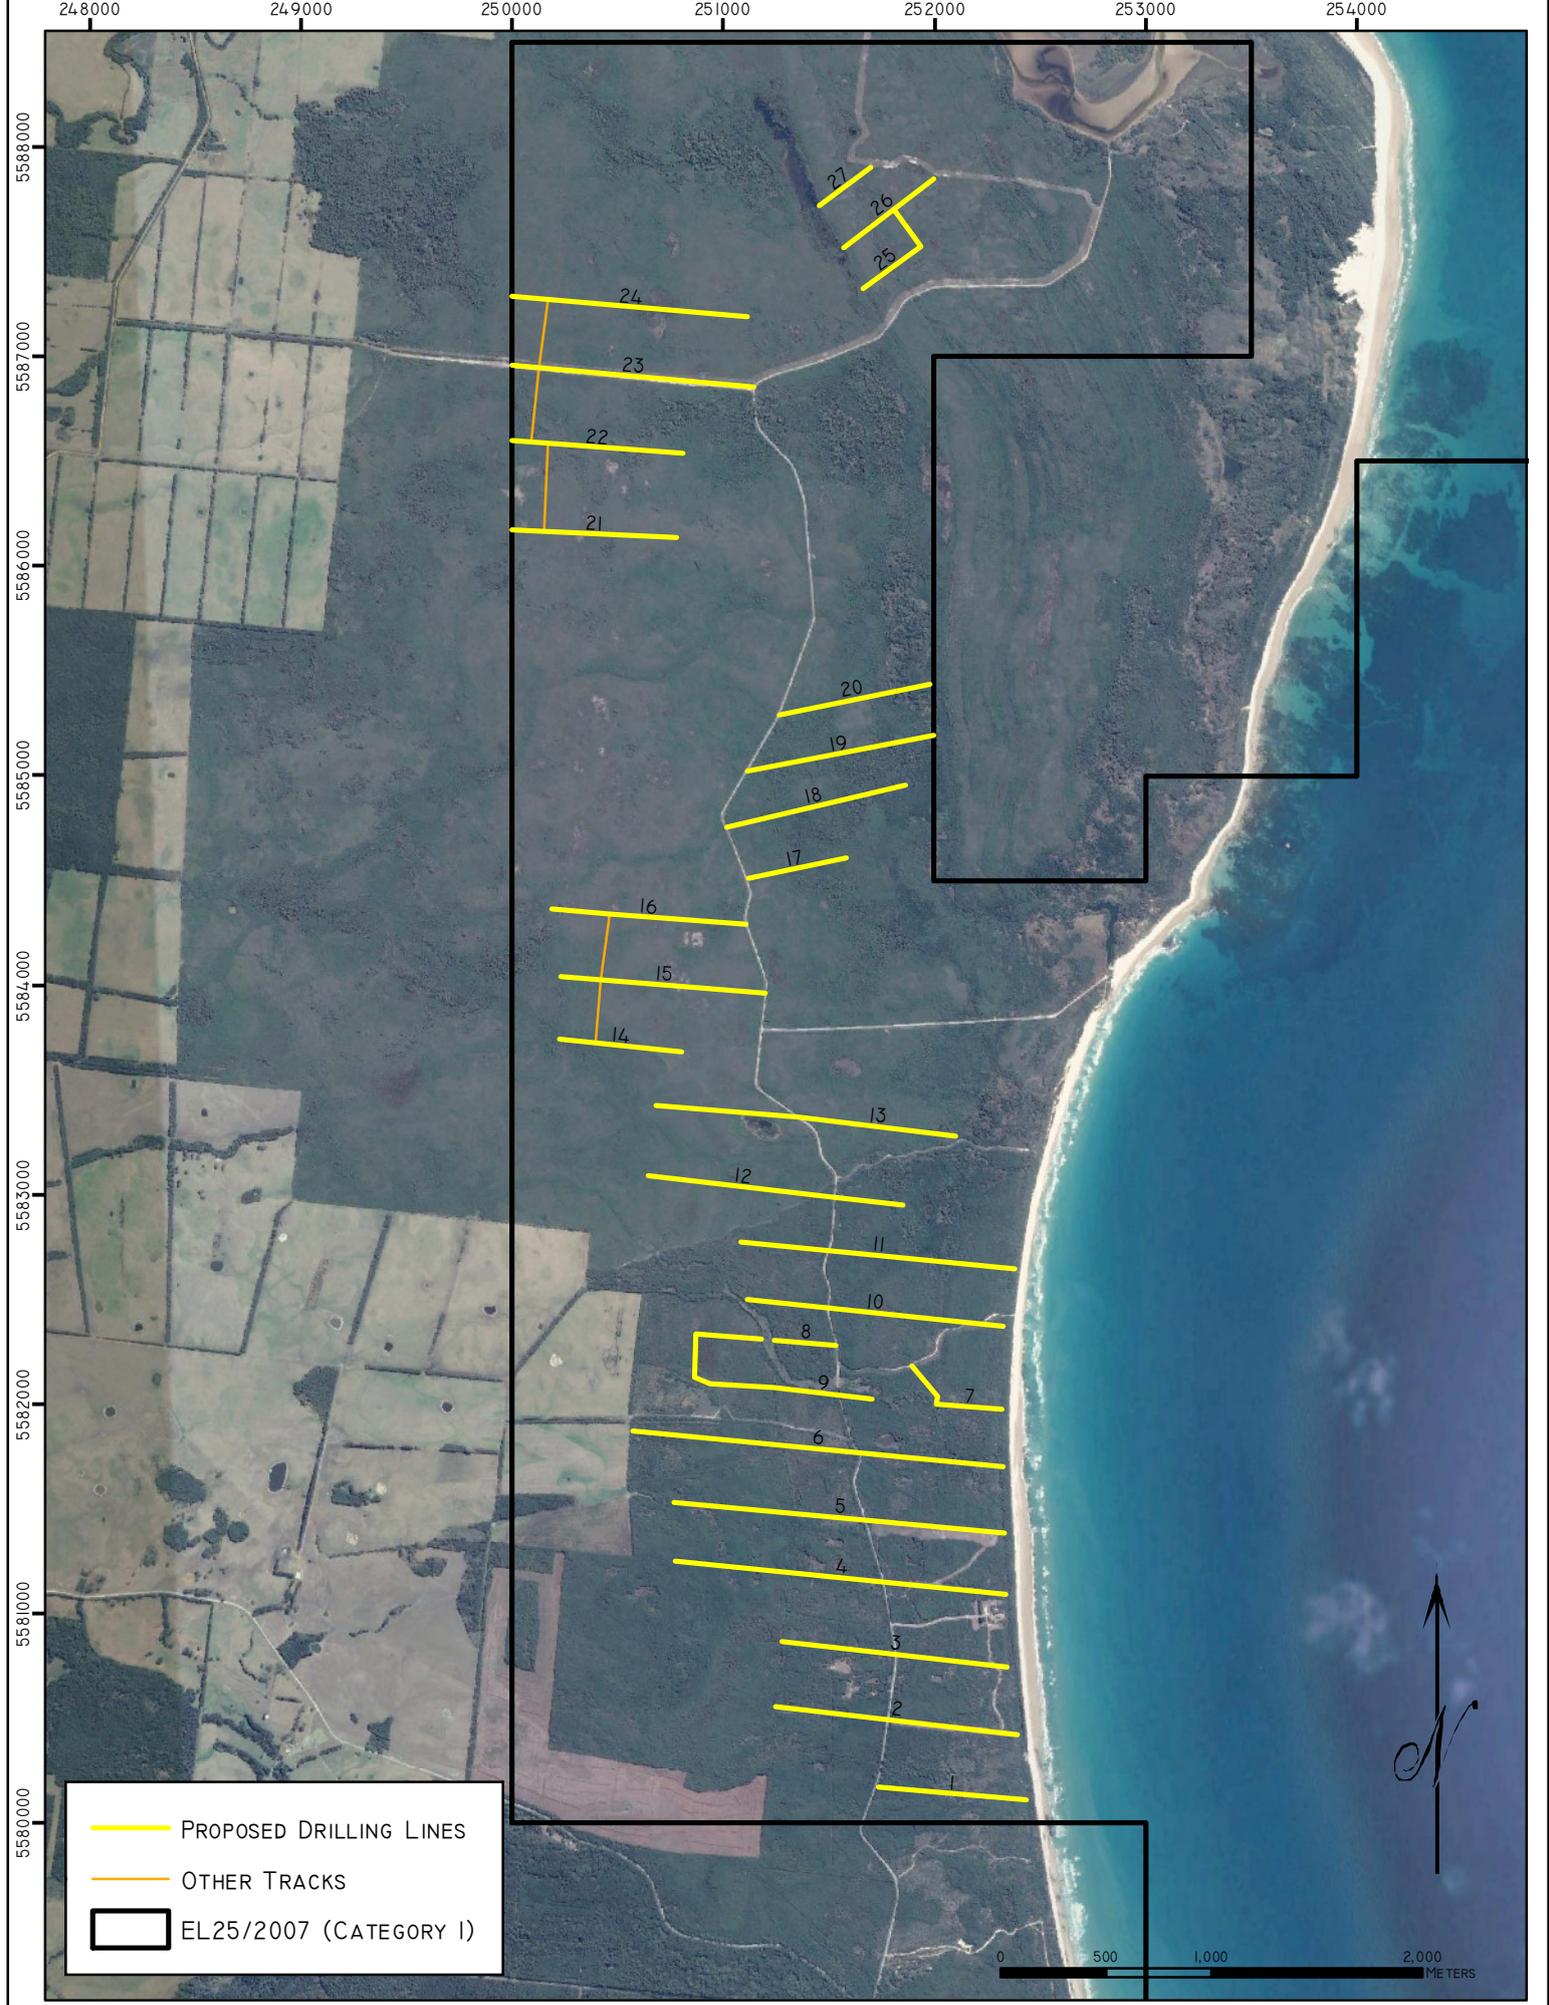
NARACOOPA MINERAL SANDS MINE  
 EL WORKS PROGRAM 2018 - DRILLING  
 FIGURE 4: PROPOSED DRILLING LINES FOR FUTURE DRILLING

— PROPOSED DRILLING LINES  
— OTHER TRACKS  
 EL25/2007 (CATEGORY I)

Figure 4 shows the exploration drill line locations on the land portion of the EL – there are 27 lines proposed to be drilled. The rationale for selecting these lines is discussed within the exploration report prepared for the geophysical works.

There are 27 drill lines proposed for the drilling program (Figure 4).

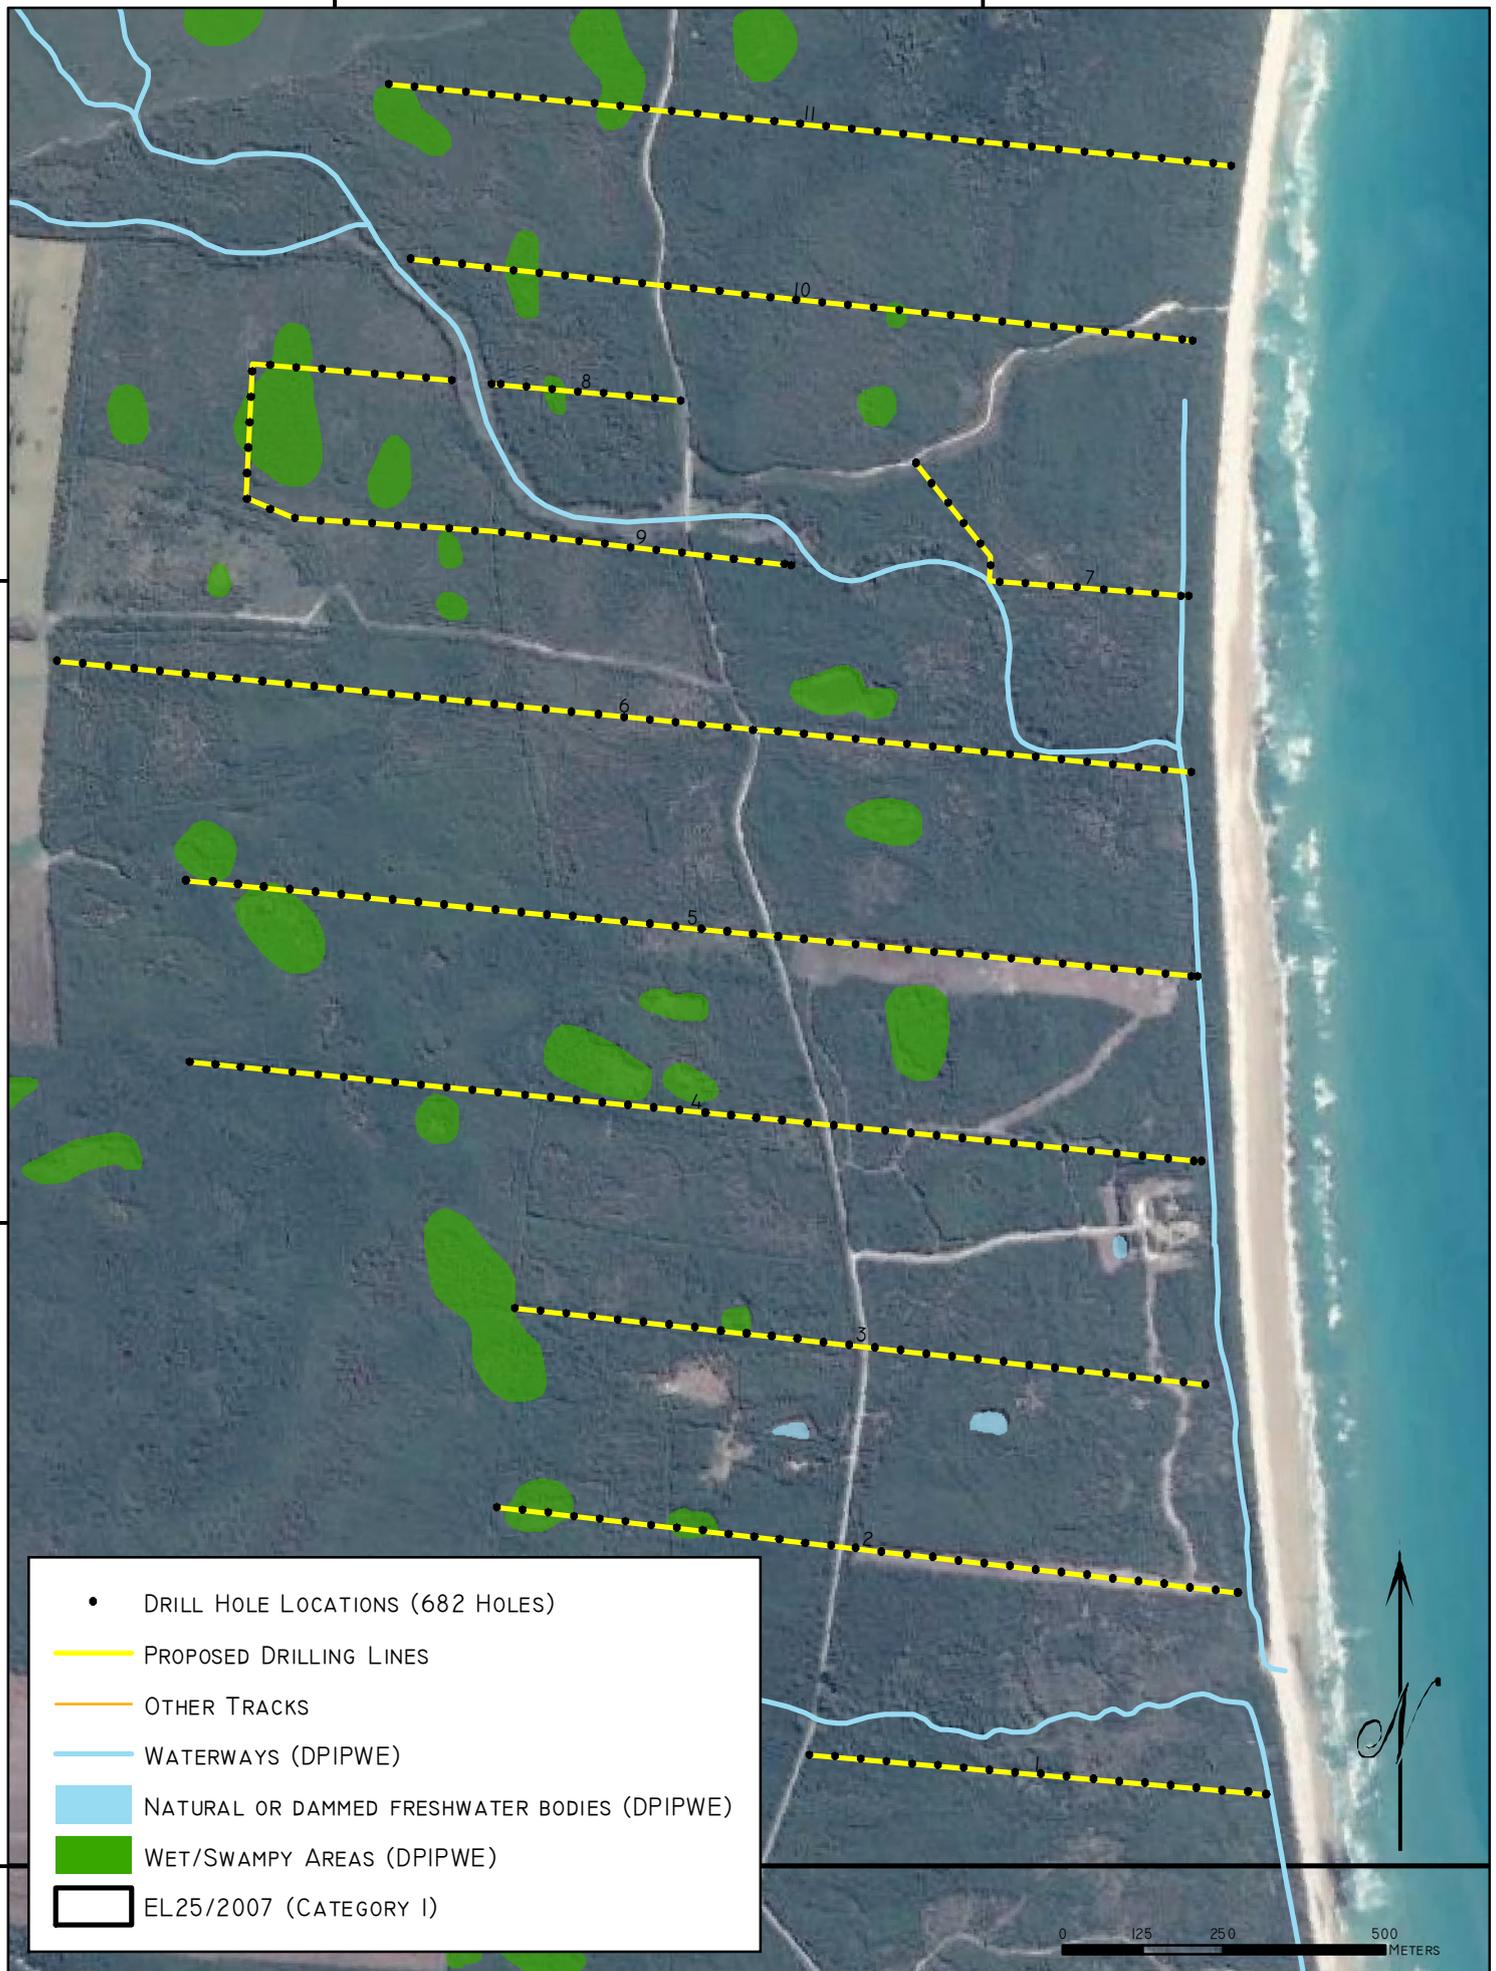
NARACOOPA MINERAL SANDS MINE  
 EL WORKS PROGRAM 2018 - DRILLING  
 FIGURE 5A: HYDROLOGY ON THE DRILLING LINES

- DRILL HOLE LOCATIONS (682 HOLES)
- PROPOSED DRILLING LINES
- OTHER TRACKS
- WATERWAYS (DPIPWE)
- NATURAL OR DAMMED FRESHWATER BODIES (DPIPWE)
- WET/SWAMPY AREAS (DPIPWE)
- EL25/2007 (CATEGORY I)

Figures 5a, b and c illustrate the general locations of watercourses, wetlands and swampy areas where surface water or wet ground may be encountered.

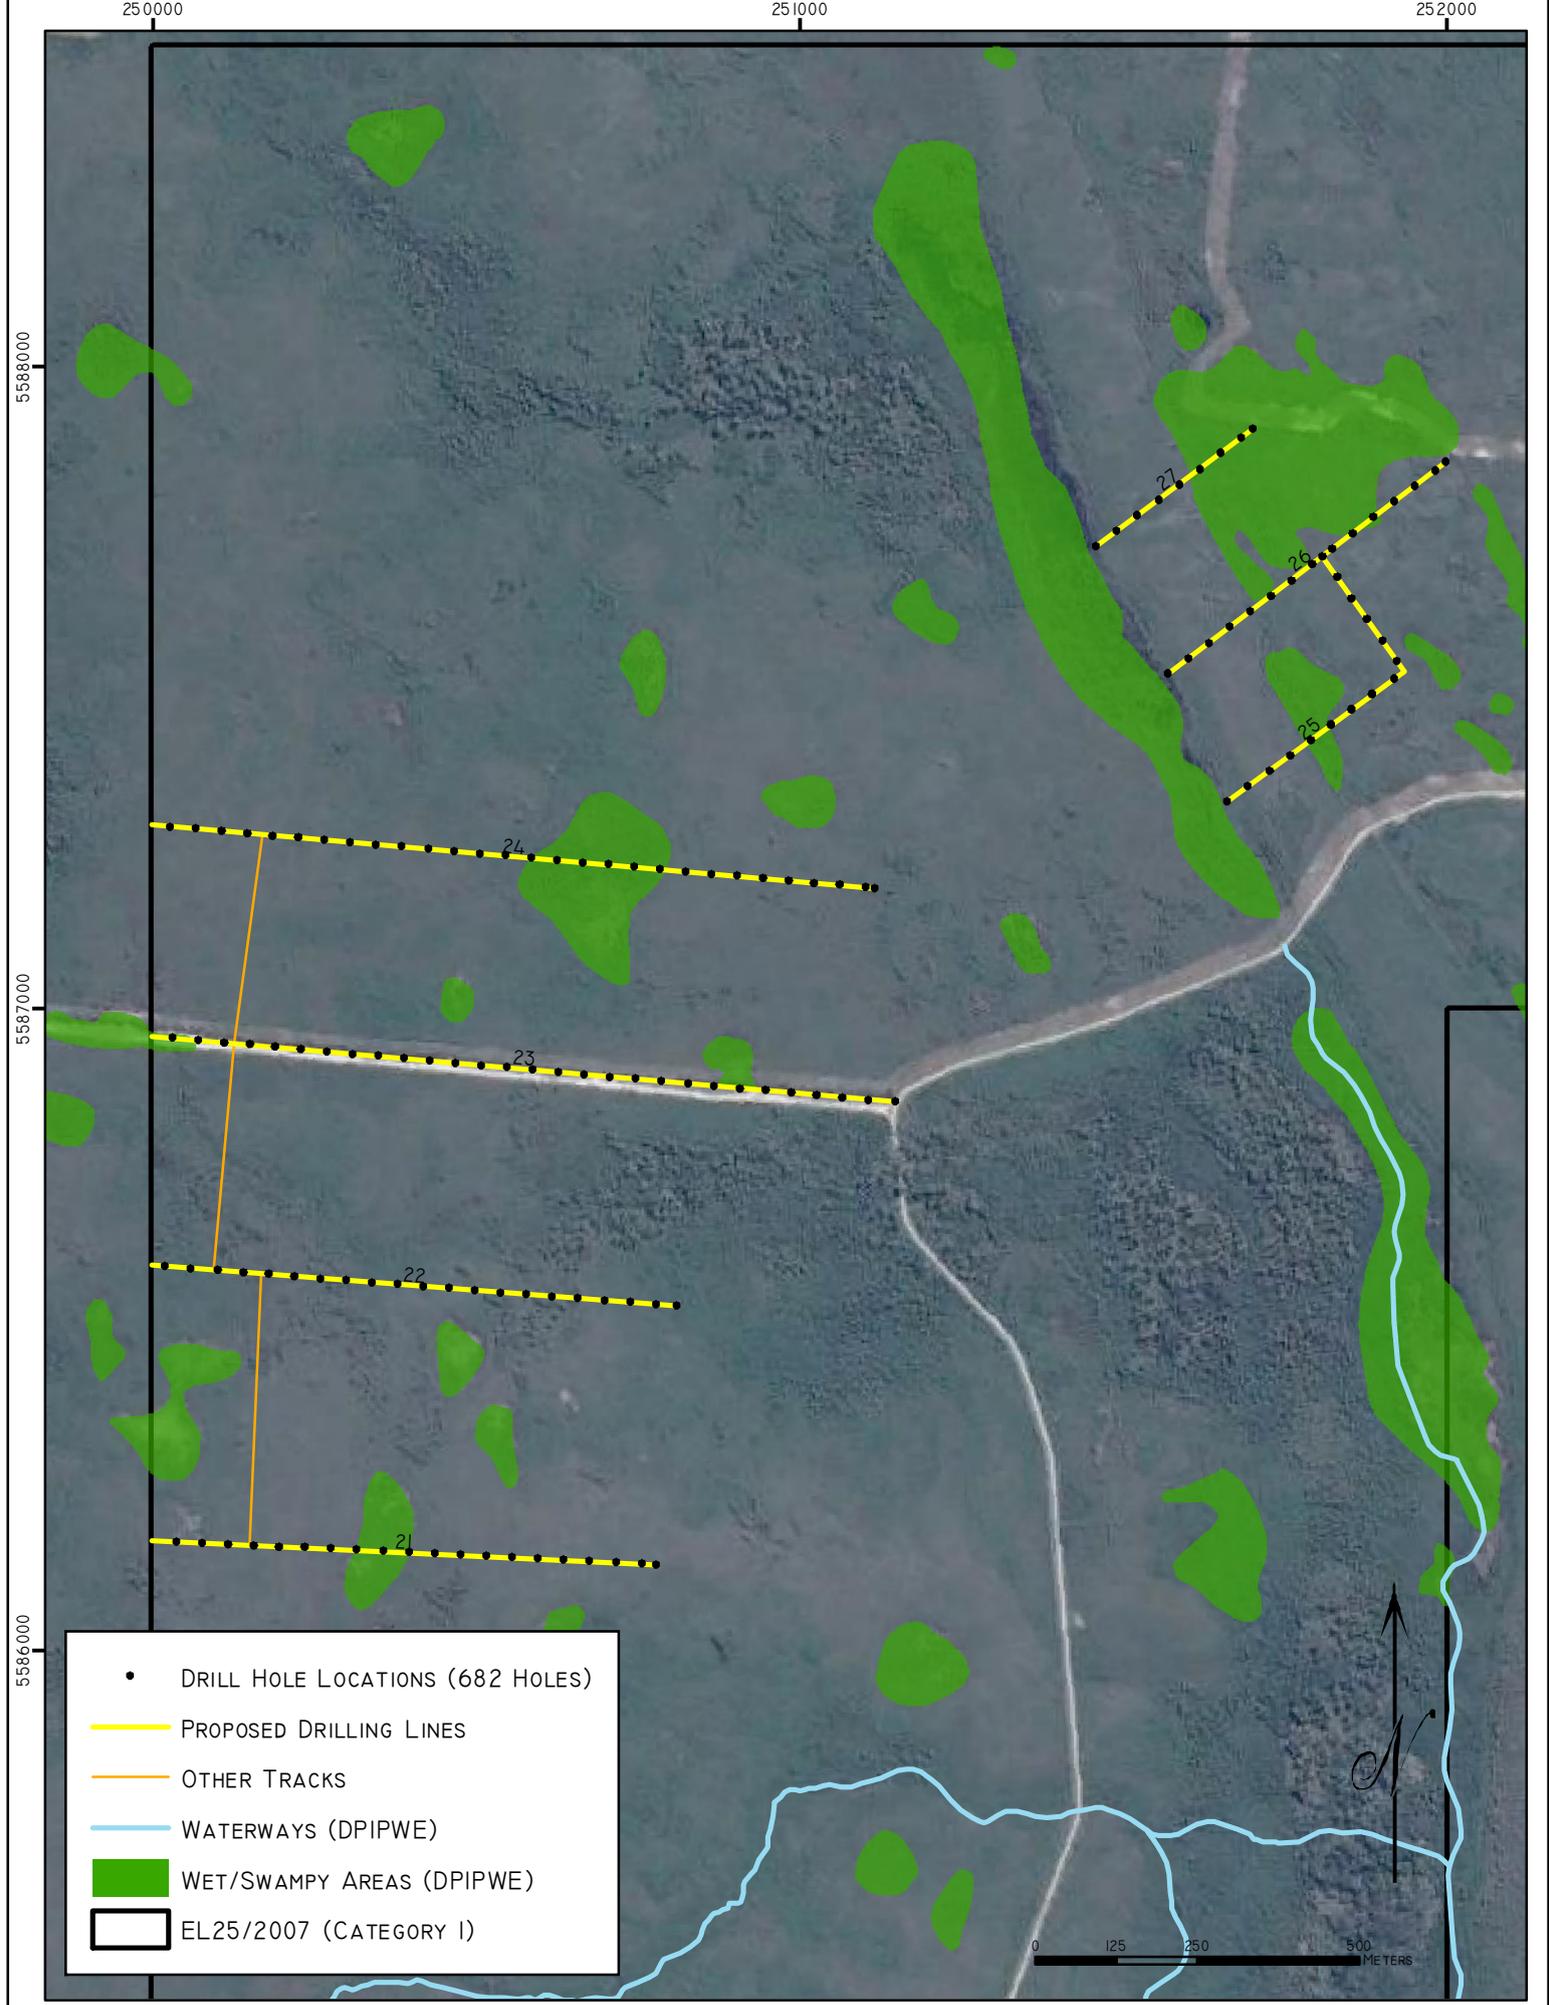
NARACOOPA MINERAL SANDS MINE  
 EL WORKS PROGRAM 2018 - DRILLING  
 FIGURE 5C: HYDROLOGY ON THE DRILLING LINES

- DRILL HOLE LOCATIONS (682 HOLES)
- PROPOSED DRILLING LINES
- OTHER TRACKS
- WATERWAYS (DPIPWE)
- WET/SWAMPY AREAS (DPIPWE)
- EL25/2007 (CATEGORY I)

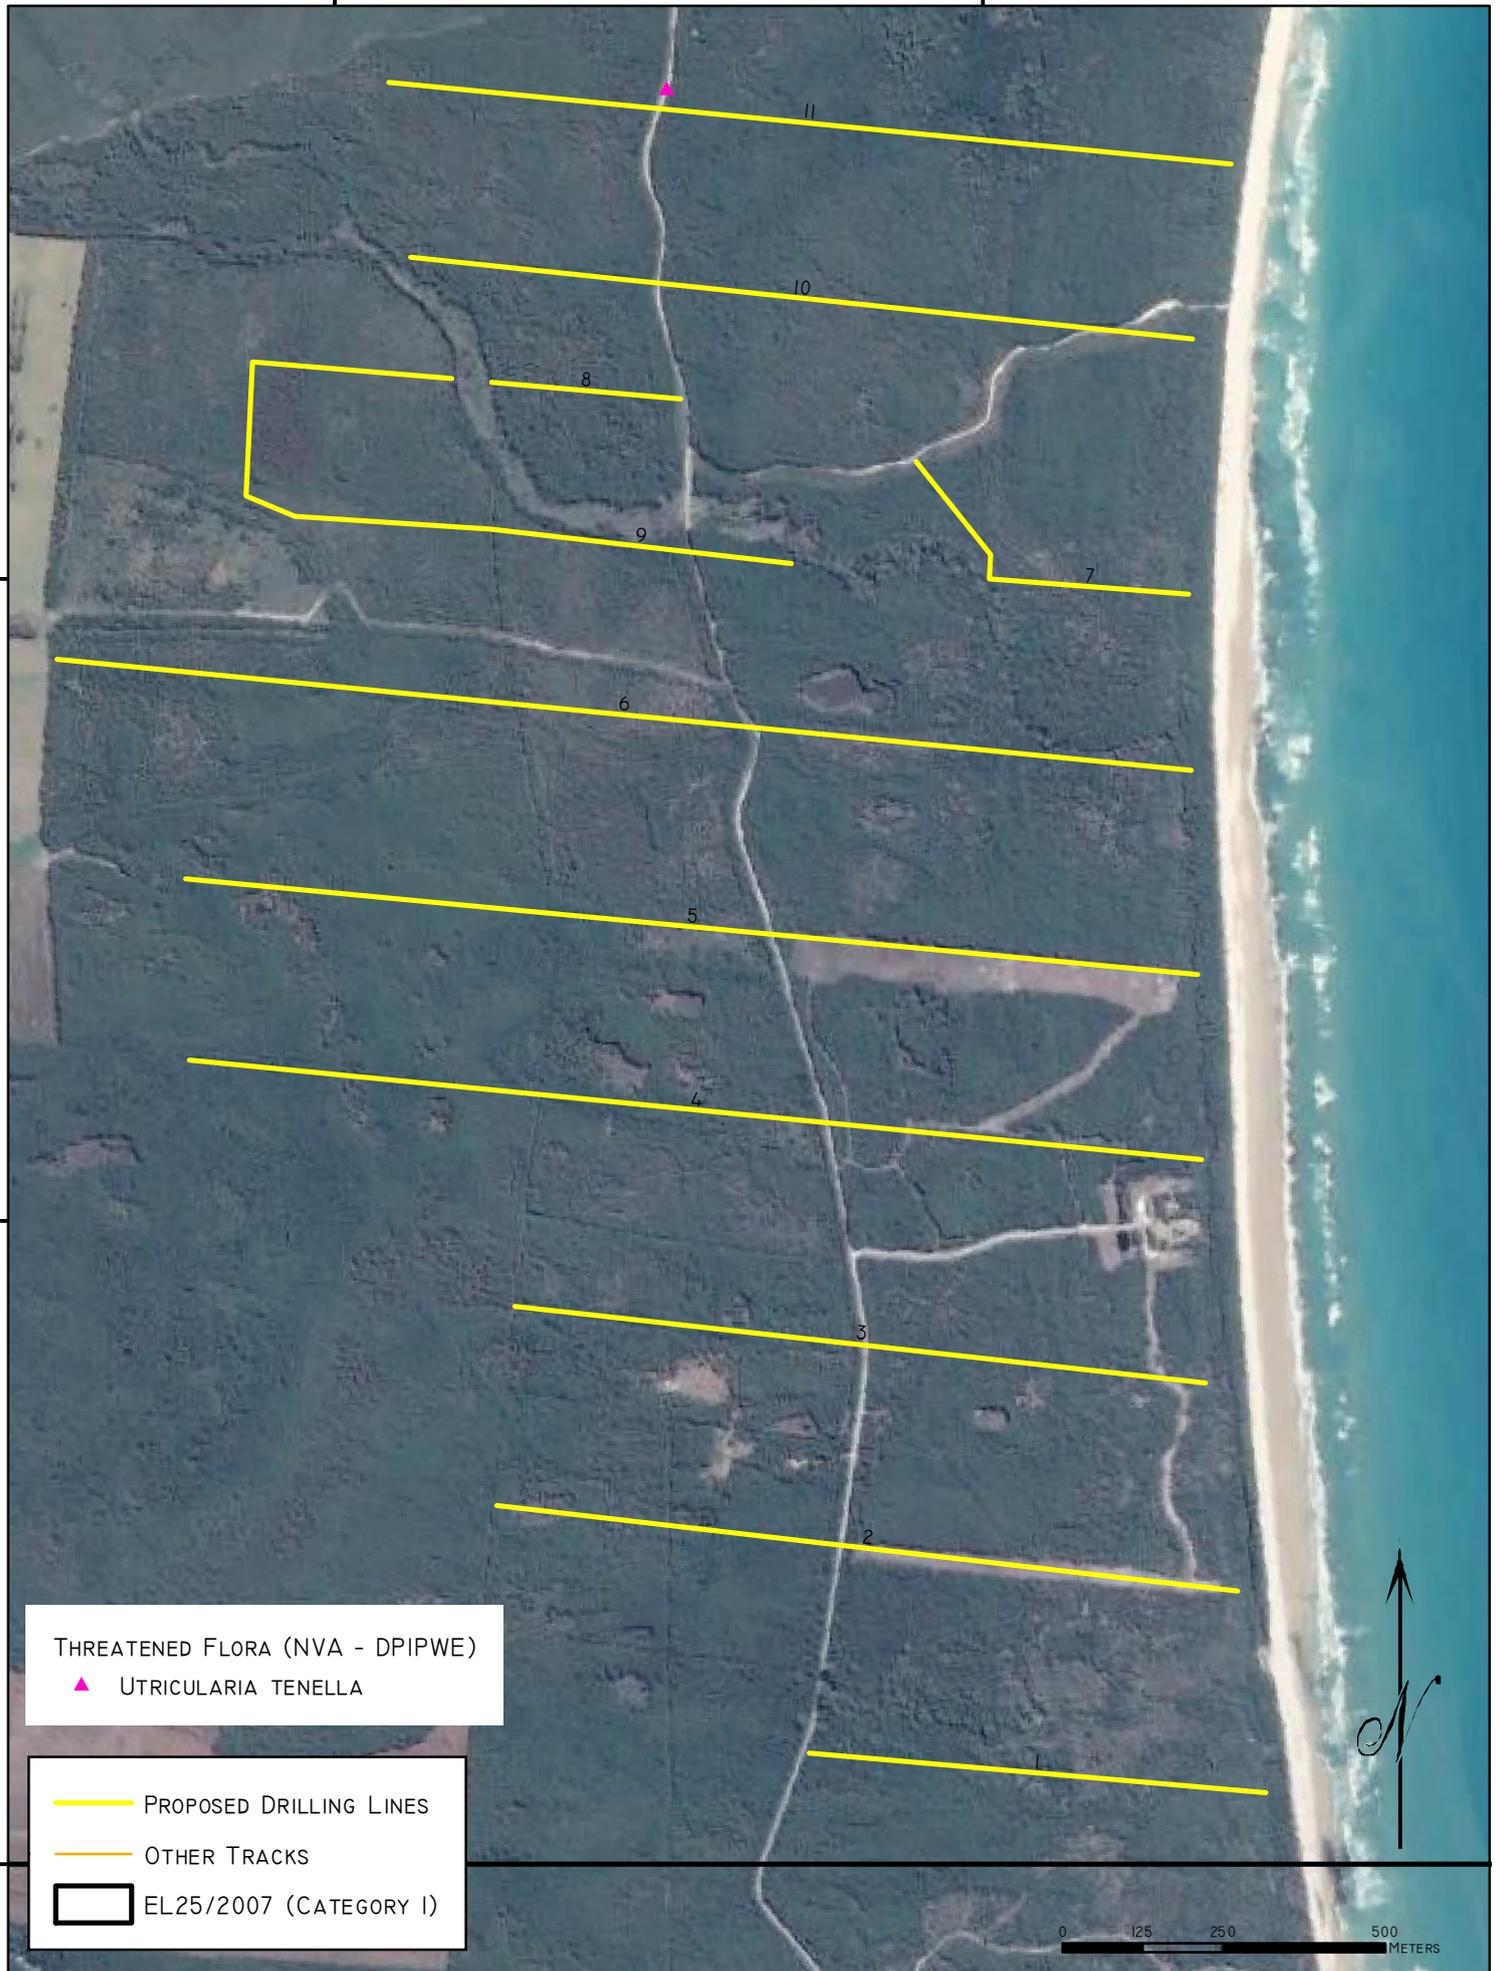
NARACOOPA MINERAL SANDS MINE  
EL WORKS PROGRAM 2018 - DRILLING  
FIGURE 6A-I: OBSERVED AND KNOWN THREATENED  
FLORA ON THE DRILLING LINES

THREATENED FLORA (NVA - DPIPWE)

▲ UTRICULARIA TENELLA

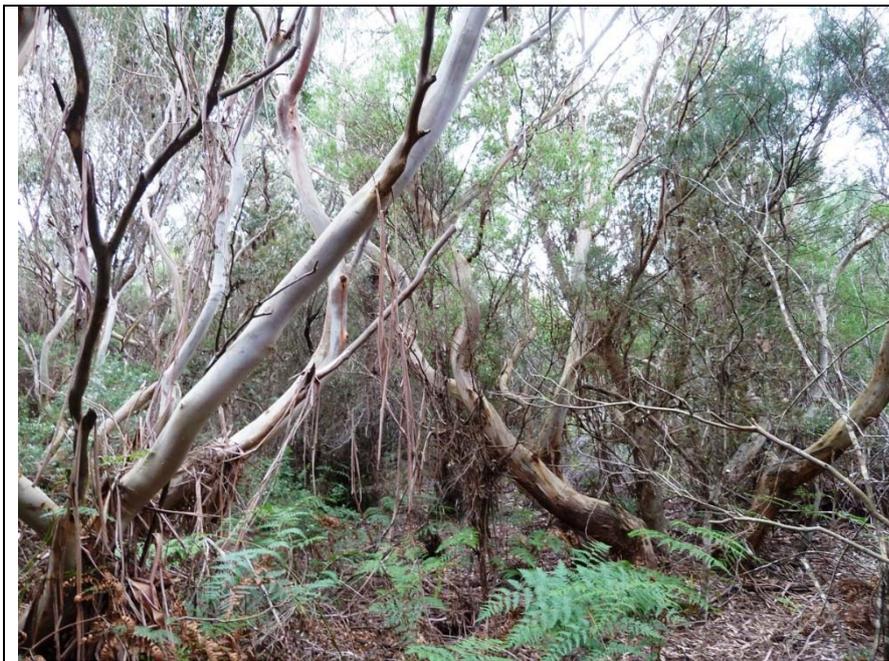
Medium-sized multi-stemmed white gums may occur on some drill lines.

Lopping of limbs should minimise the long-term effect of the exploration program to these trees.

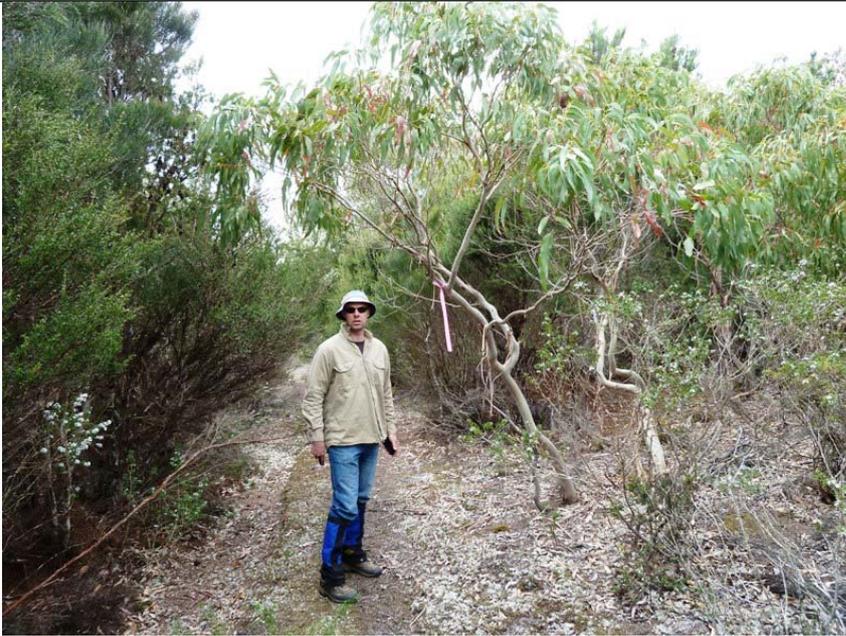
Most white gums that occur along or near the drill lines are small and multi-stemmed. Pruning of branches will enable vehicle access in most cases.

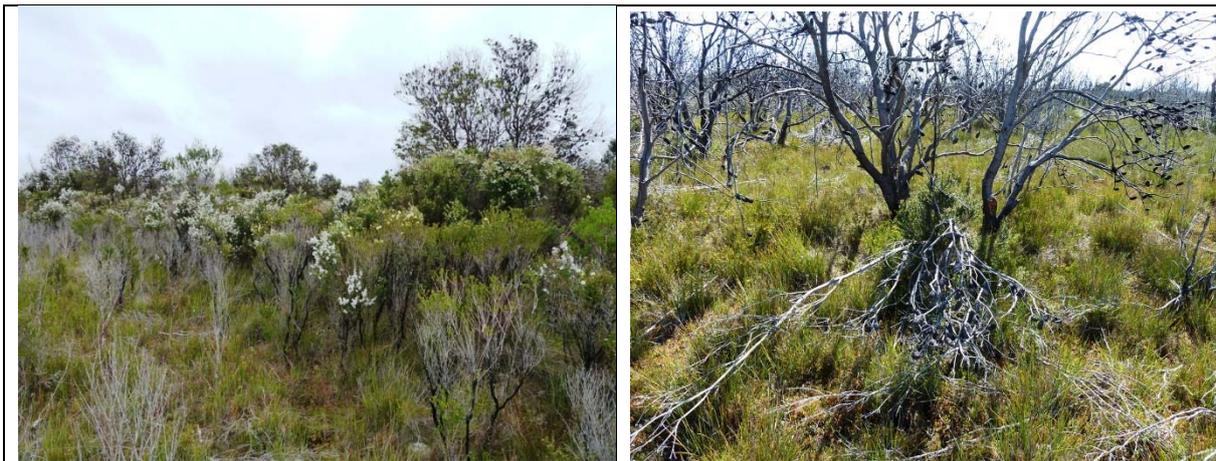
The images below show the large Banksia trees over heathland and scrub that were unburnt by the 2011 King Island bushfires (left) and the burnt remnants of a Banksia from the 2011 fires (right).

- Large living Banksia trees should not be completely removed or felled by the clearing of drill lines or Drill Sample locations;
- Large living Banksia trees should only be pruned, or branches lopped (with chainsaw, loppers or similar) to enable safe passage of machinery and vehicles along drill lines;
- No more than 50% of the branches on any single Banksia should be removed by pruning or lopping;
- Branches when pruned/lopped should be cut at a 45-degree angle to the ground to prevent rotting/fungal infection of the cut surfaces; and
- Lopped and pruned branches should be returned to the drill line once the machinery has left the area as some branches may contain cones which would aid regeneration of Banksia along the ground-disturbed route.

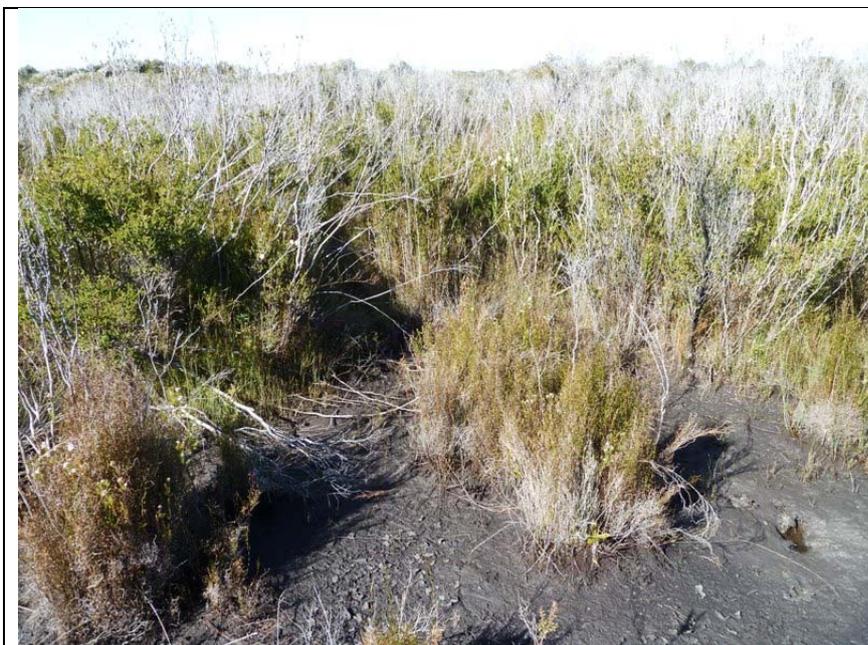
A wet area dominated by scented paperbark that has organic rich sandy to peat soils. Slash should be used to enable machinery and vehicles to cross these areas without damaging the soil profile. Slash should be removed (spread along the route) when exploration works for that drill line have been completed.
