# **NARACOOPA MINERAL SANDS PTY LTD**

**EXPLORATION LICENCE 25/2007**

**ANNUAL REPORT**

**REPORTING PERIOD: 1 JULY 2018 TO 3 APRIL 2021**

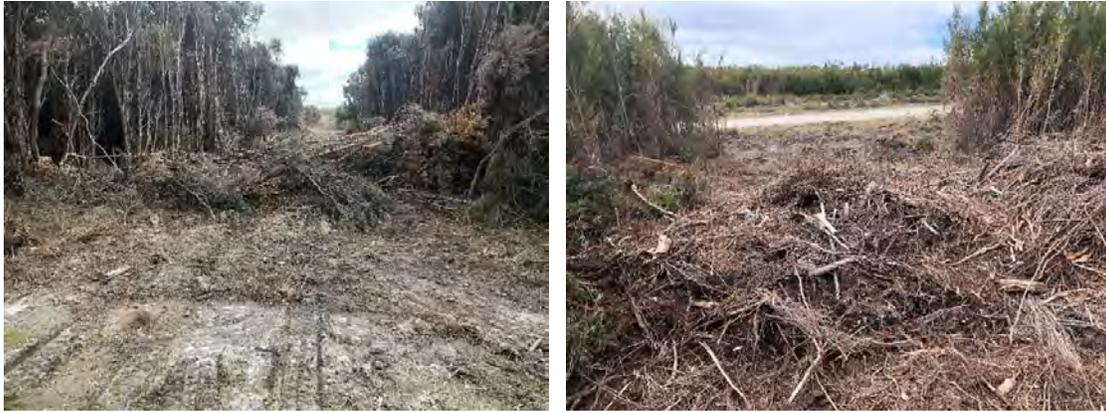
The images below show the use of slash to block vehicular access to Lines from Sea Elephant Road where access did not previously exist – this was especially the case for Crown land and NMS Pty Ltd owned land for the Lines north of Blowhole Creek Road.

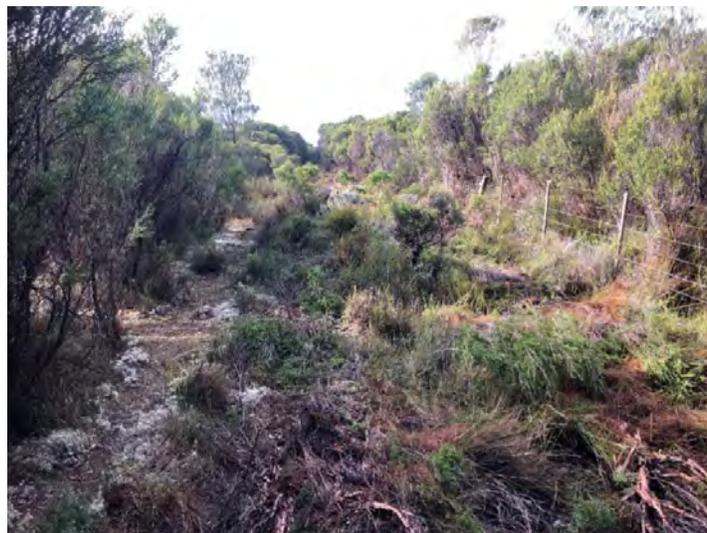
An overgrown firebreak/track adjacent to an existing fence was used to gain access to Line 5

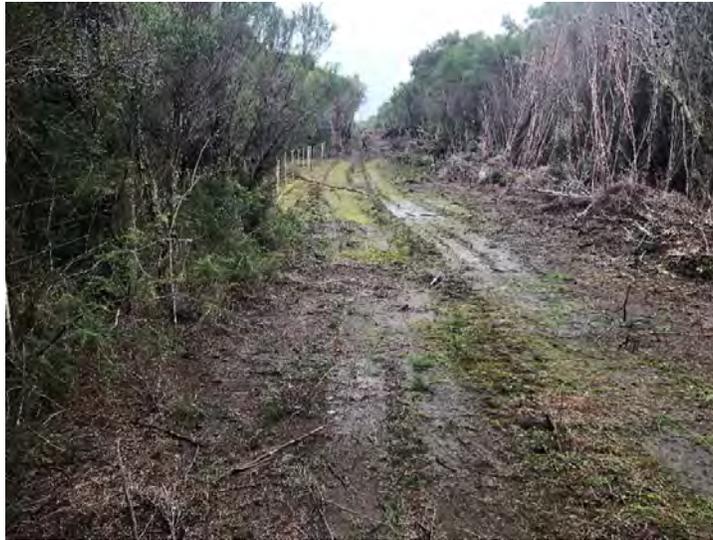
An overgrown track adjacent to an existing fence was used to gain access to Line 10

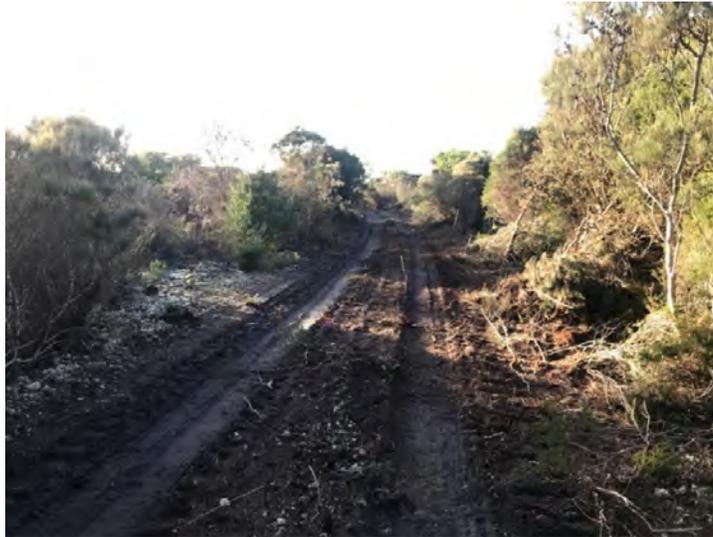
An existing track (some overgrowth vegetation) was used to access part of Line 4

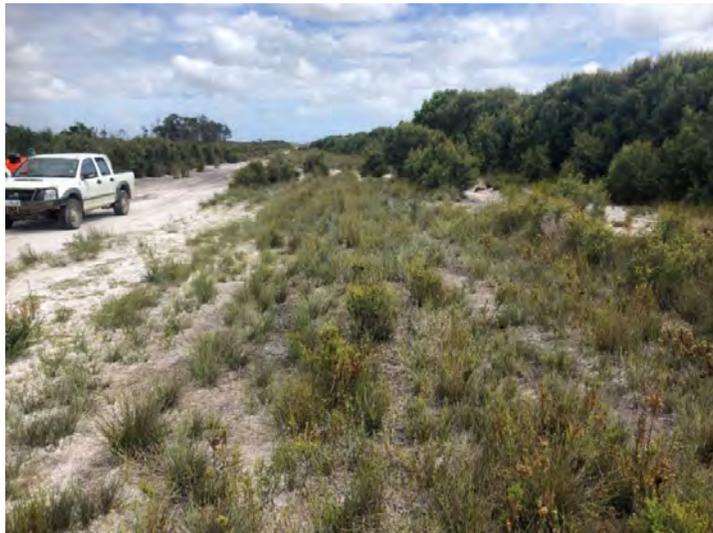
The existing firebreak/track south of the was used to gain access to Line 23, and to establish connections to Lines 22, 23 and 24

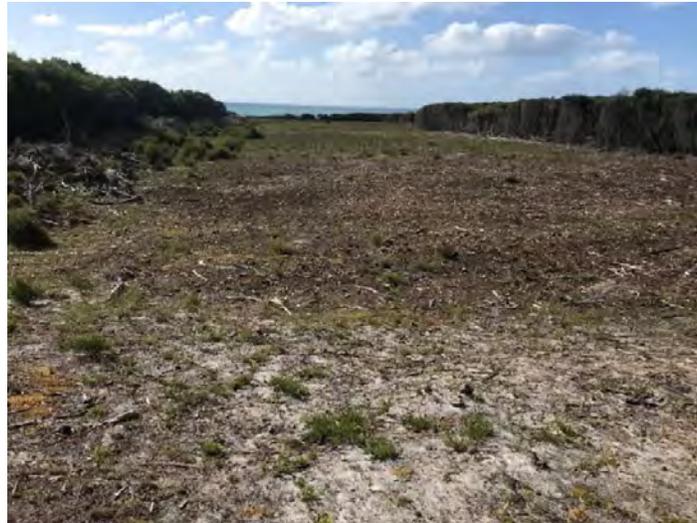
The existing firebreak between two private properties (properties each owned by A Walker and S Helbig) was used to gain access to Line 2 from tracks on the Walker property

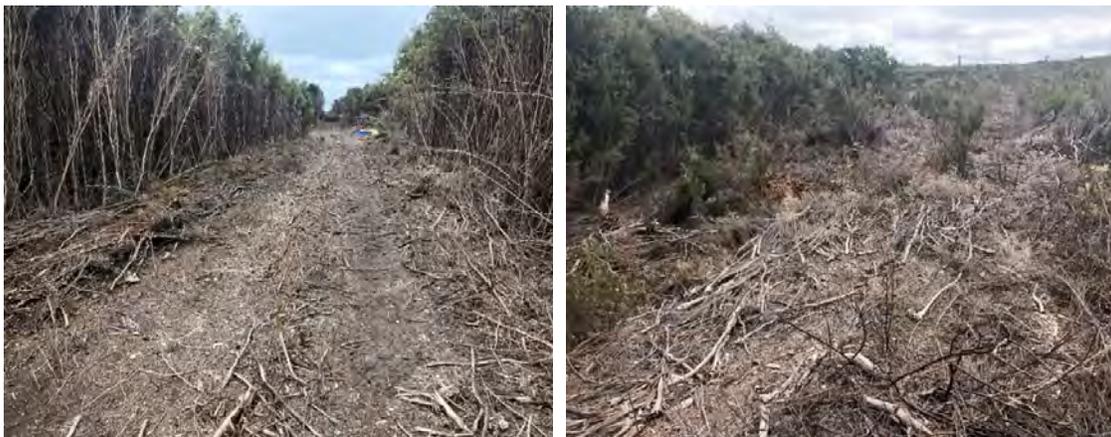
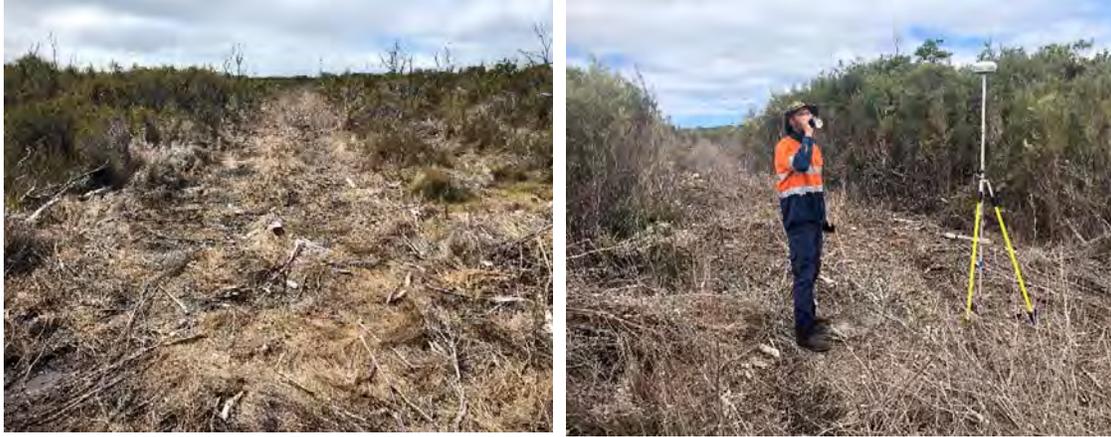
Images of cutlines established in heath and light scrub vegetation are provided below as examples of the type of clearing in these vegetation types. Very little coarse woody debris was generated, and the soil surface (and root mass) was largely left intact. Importantly, species in the genera *Melaleuca* and *Leptospermum* where present were simply broken at the base at or near ground level which meant the root stock present could quickly recover without the need for active rehabilitation works.

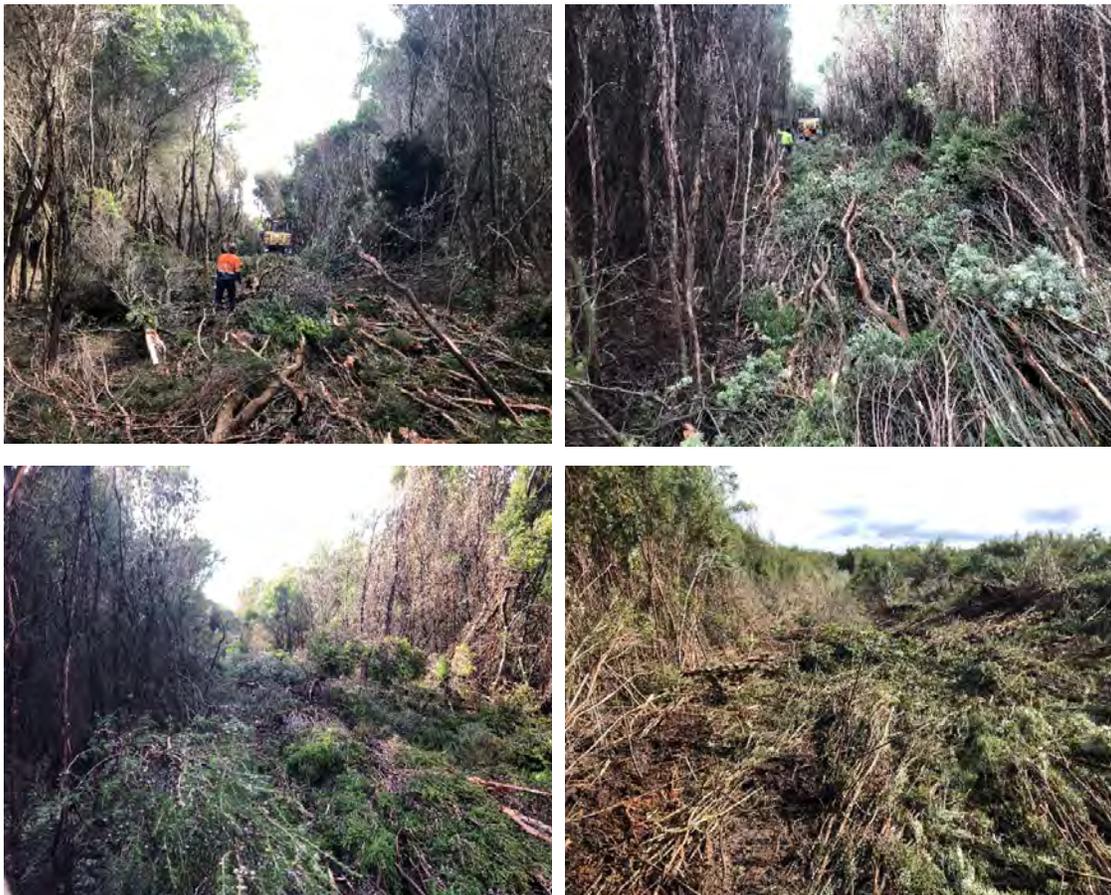
Tall scrub (4-8m tall) was often encountered on better quality deeper soils or low-lying drainage areas where water accumulates promoting longer growing periods. Images of cutlines established in tall and/or dense scrub vegetation are provided below which show the higher volume of coarse woody debris generated by Line establishment in these vegetation types. The woody debris was swept to the side of the Line to enable vehicular access along each Line; the soil surface (and root mass) was largely left intact.

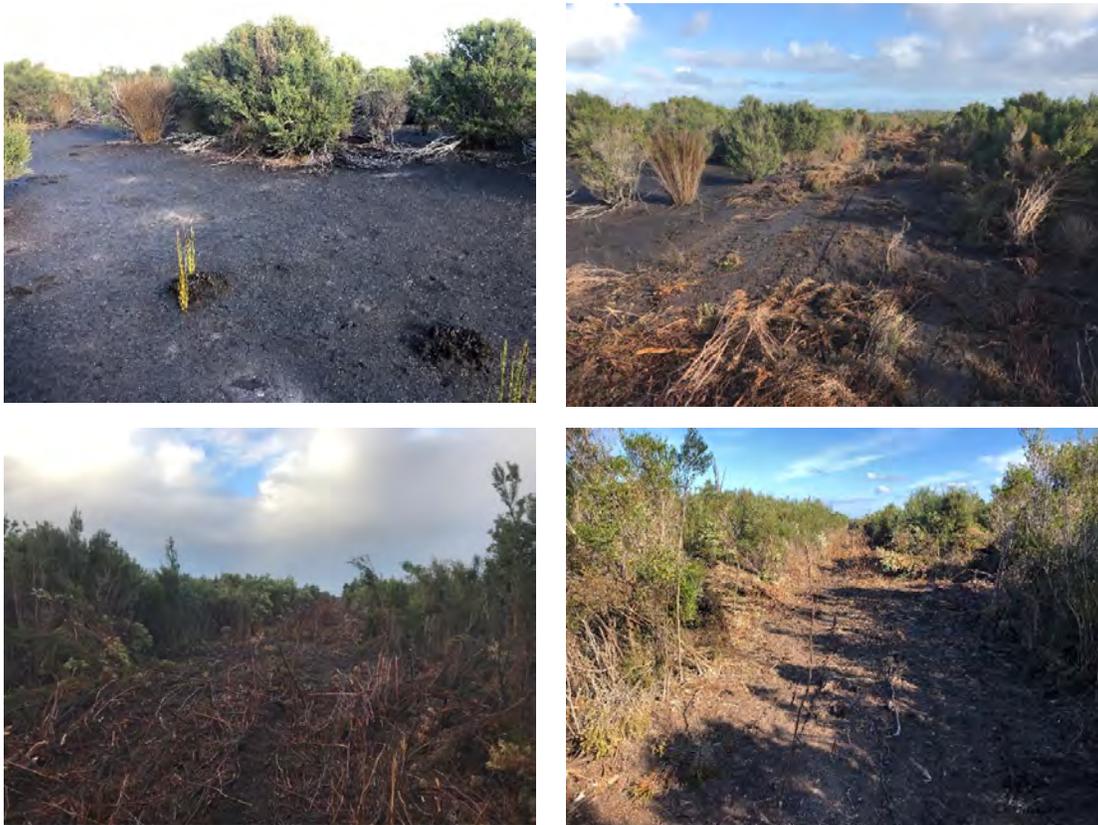
The images below show some examples of seasonally wet areas (winter-spring wet) that were dry when the Lines were established, and drilling conducted. Of note is the lack of major soil surface disturbance to the organic rich clays, especially in swampy areas where water and organic matter has accumulated.

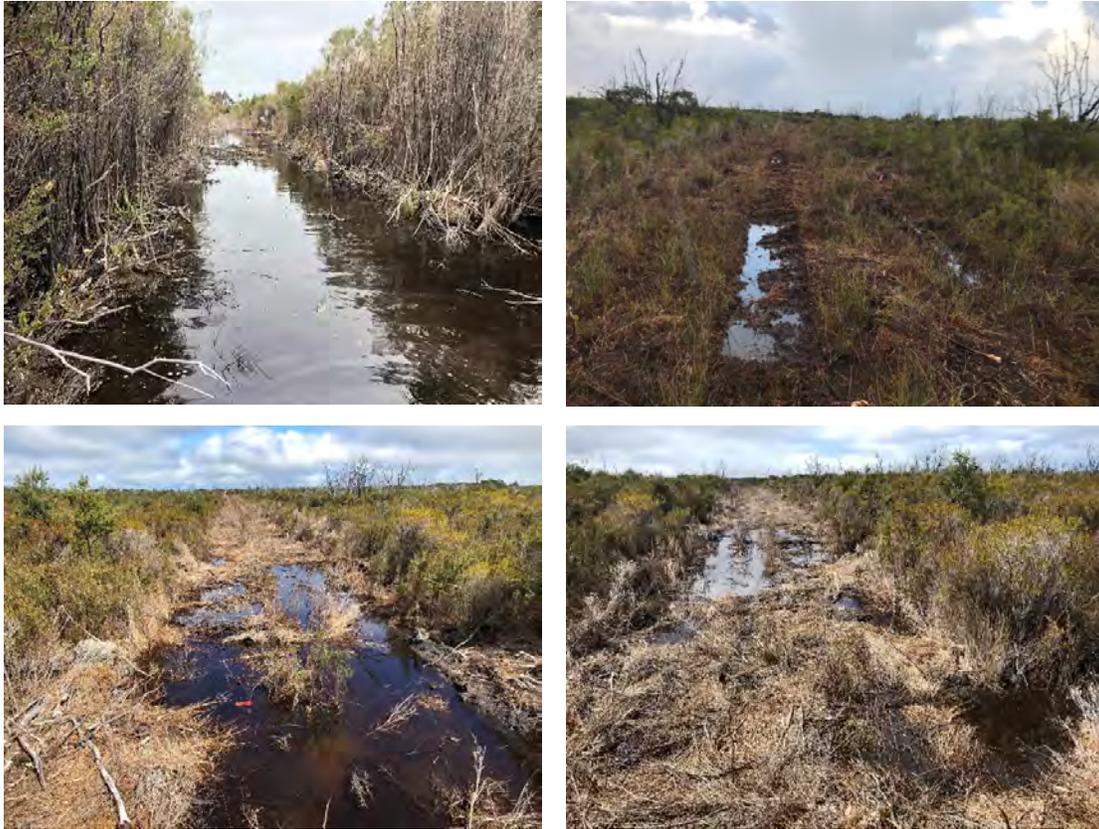
The images below show how low-lying areas on some exploration lines that filled with water during winter – spring from typical rainfall patterns. The retention of the soil surface, in a largely intact state, and surface vegetation/coarse woody debris prevented soil erosion and scouring. A low-lying topography generates a low velocity water environment which also aided the lack of erosion.

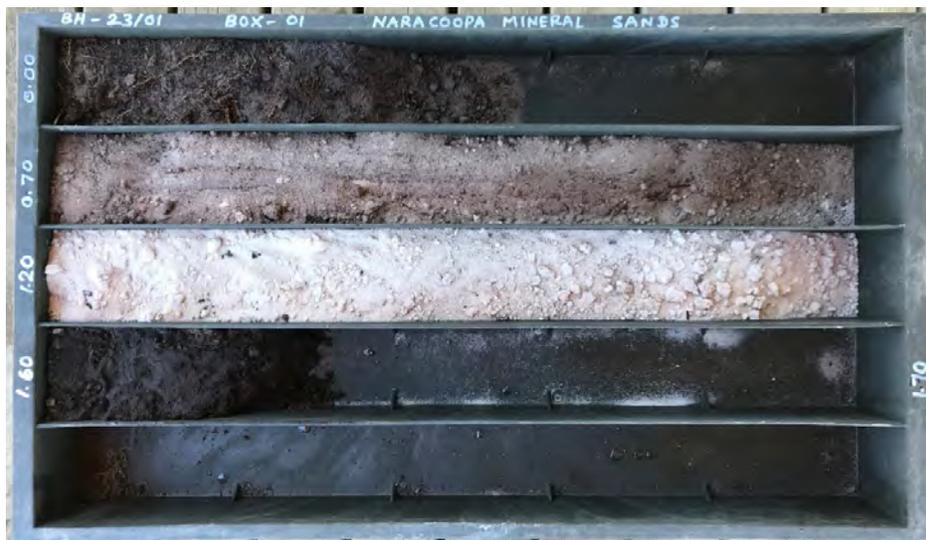
Hole 1  
Depth  
0-1.7m

The images below are sample box photos of samples collected on Line 23 to illustrate the types of sand and clay layers intersected by drilling or caused the termination of drilling at a hole. For most samples, the profile is typically an organic sandy surface layer overlaying bleached to grey sands which then terminates at a clay layer or coarse clay with some pebbles. Hole 15 intersected a distinctly yellow clay layer that contained rounded pebbles overlaying a white clay layer.

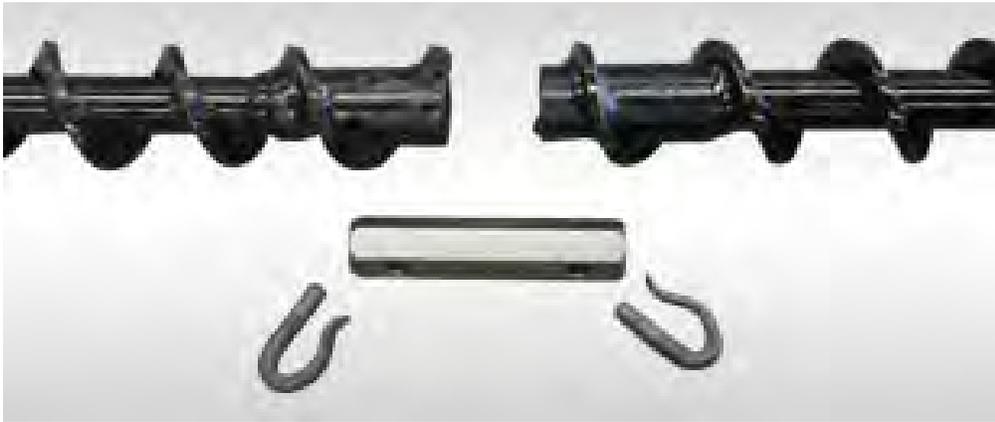
**Figure 4-2: Hex joiners and D-clips used to extend the auger**

Augers were driven into the ground with rotary motion to a specific depth and driven back to the ground and samples bagged. The auger was able to penetrate stiff clay layers. However, drilling was terminated where we found clay because our aim was to determine the properties of underlying sand layers.

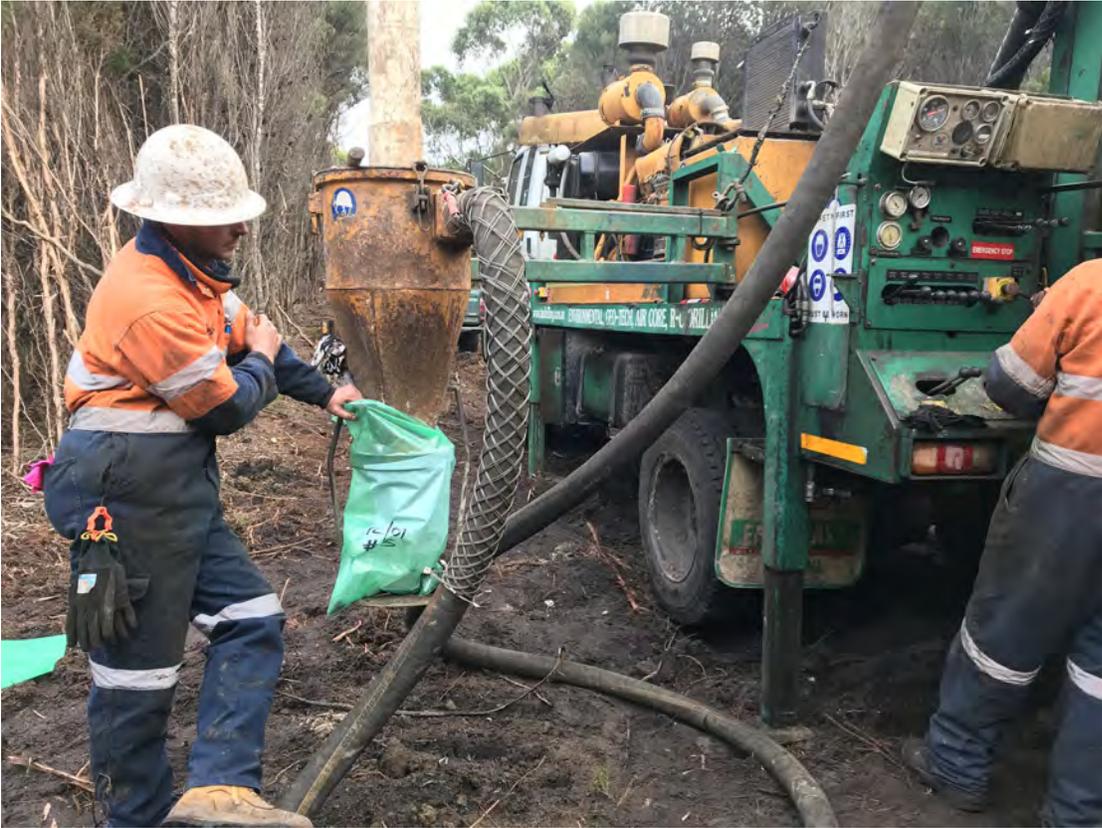
Figure 4-5: Samples were collected into plastic bags through a cyclone

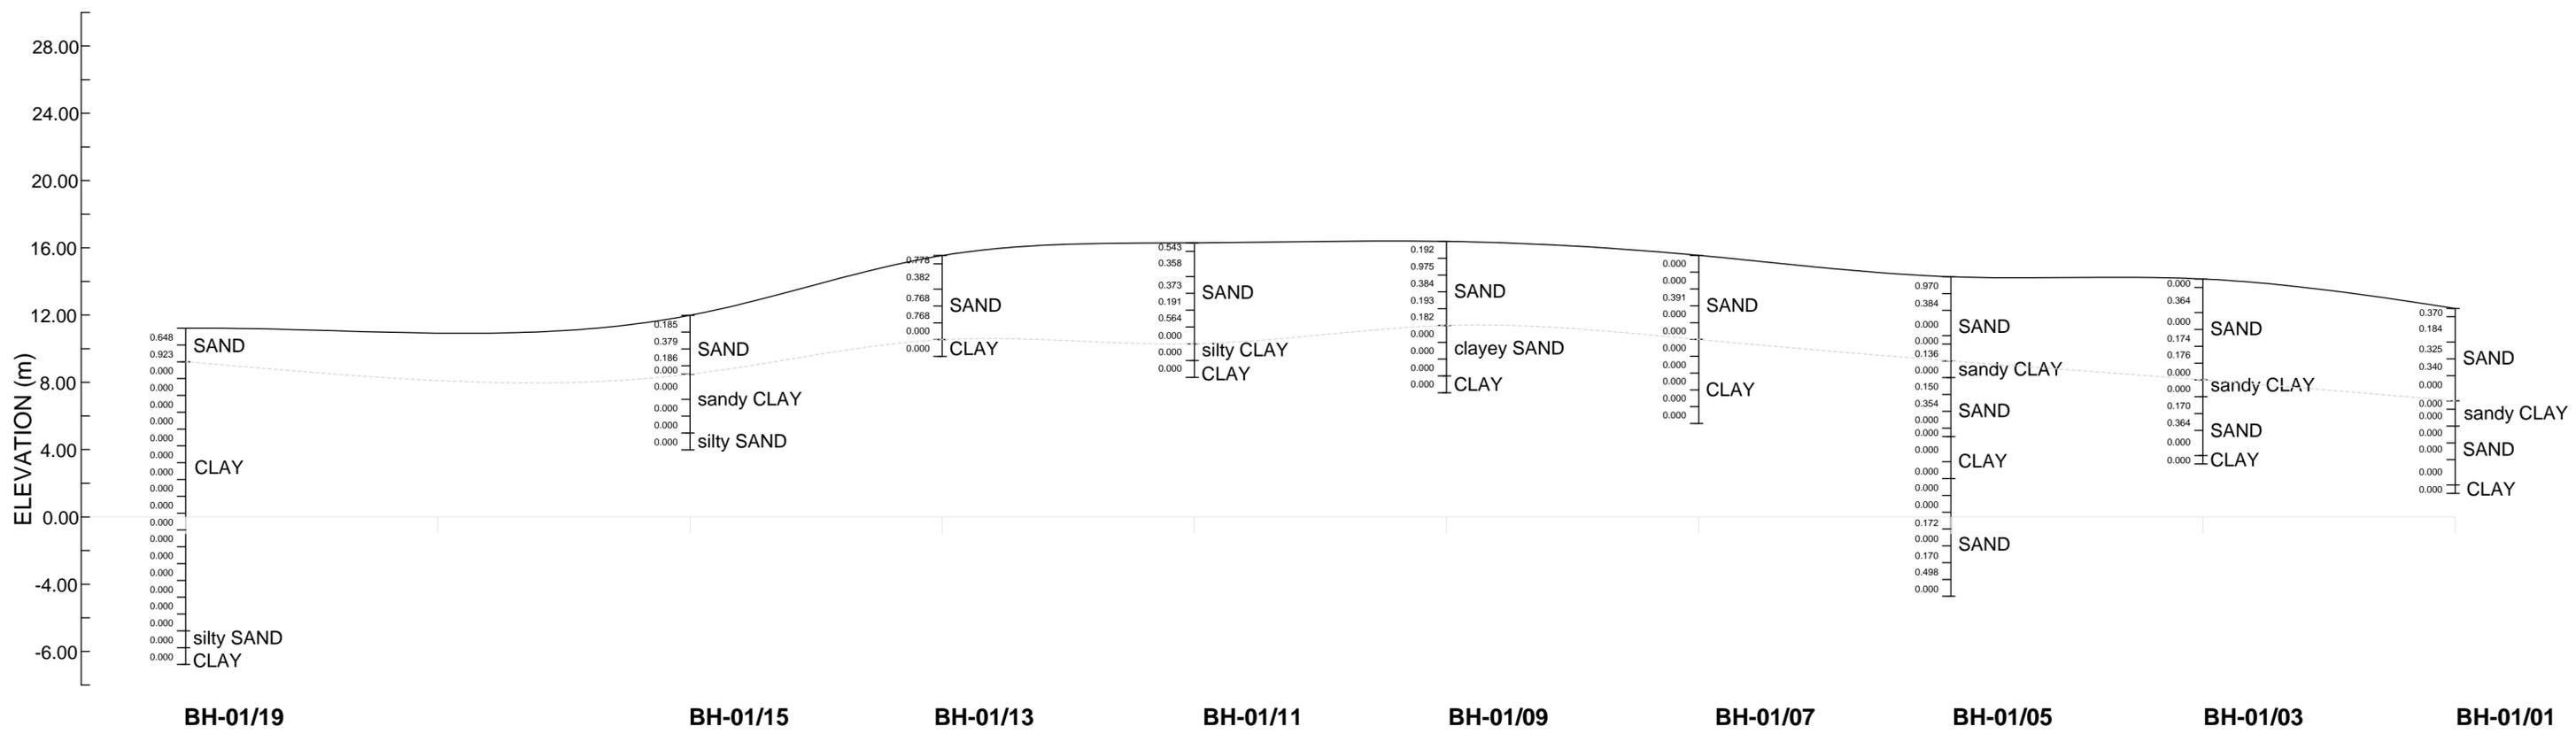
**NARACOOPA MINERAL SANDS (PVT) LTD**  
 EL25/2007  
 CROSS SECTIONS  
 LINE 01  
 FIGURE: 02  
 DATE: 29.07.2020  
 AUTHOR: INESHKA W.S.S.

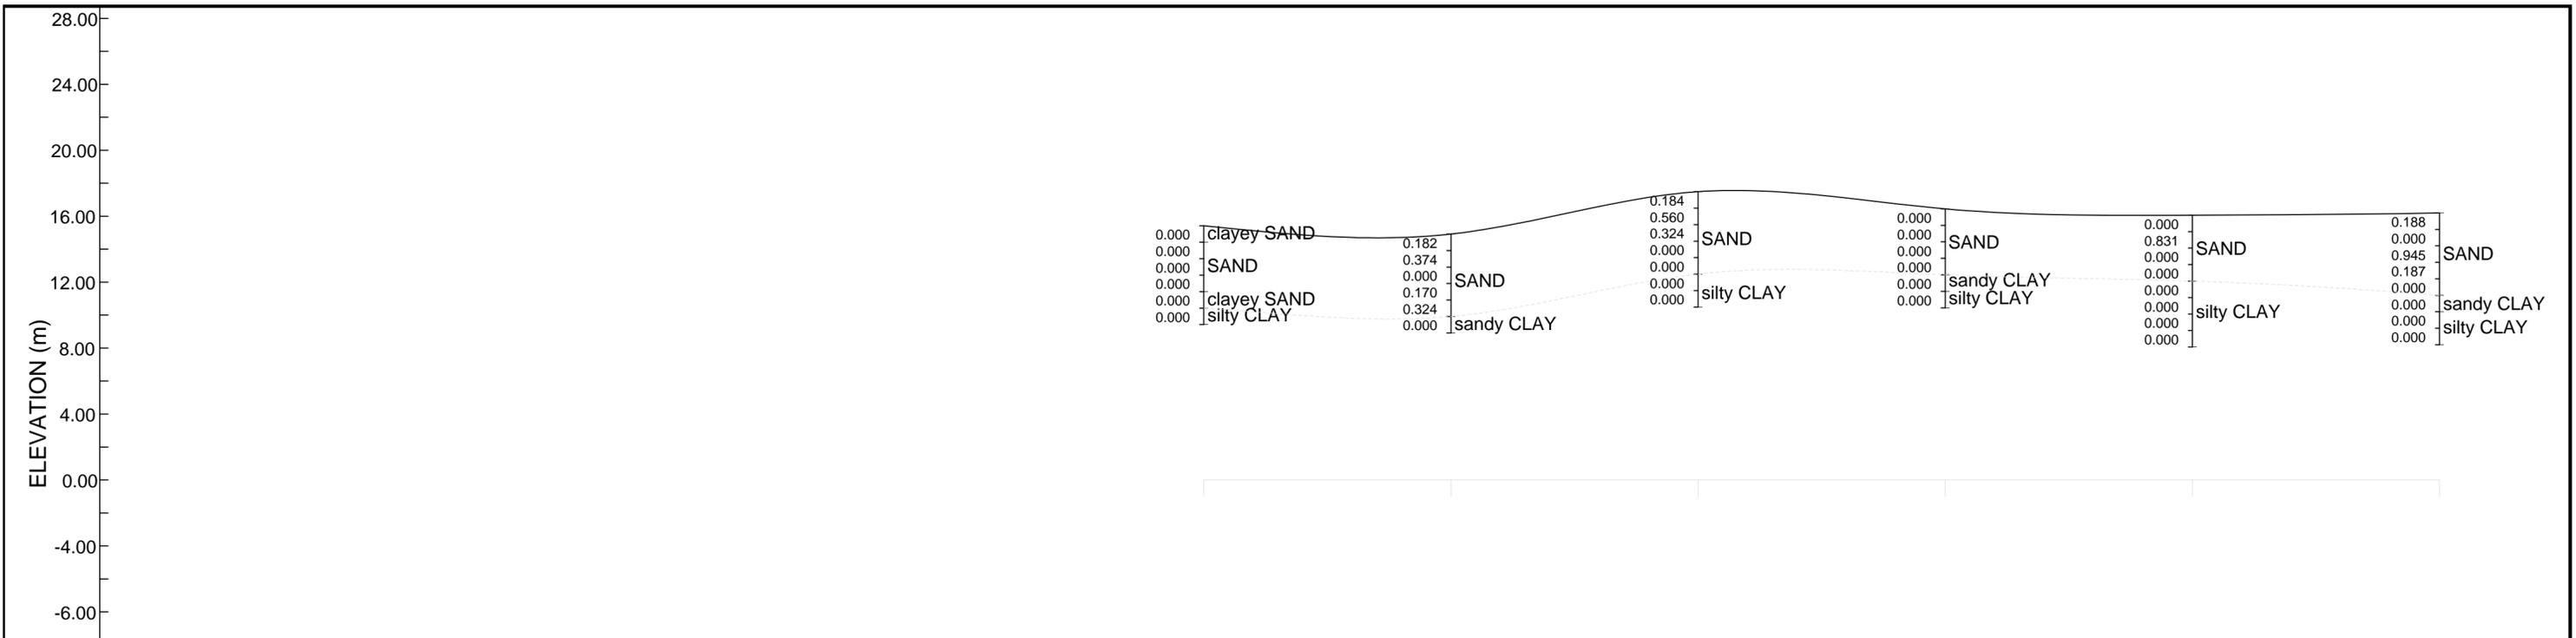
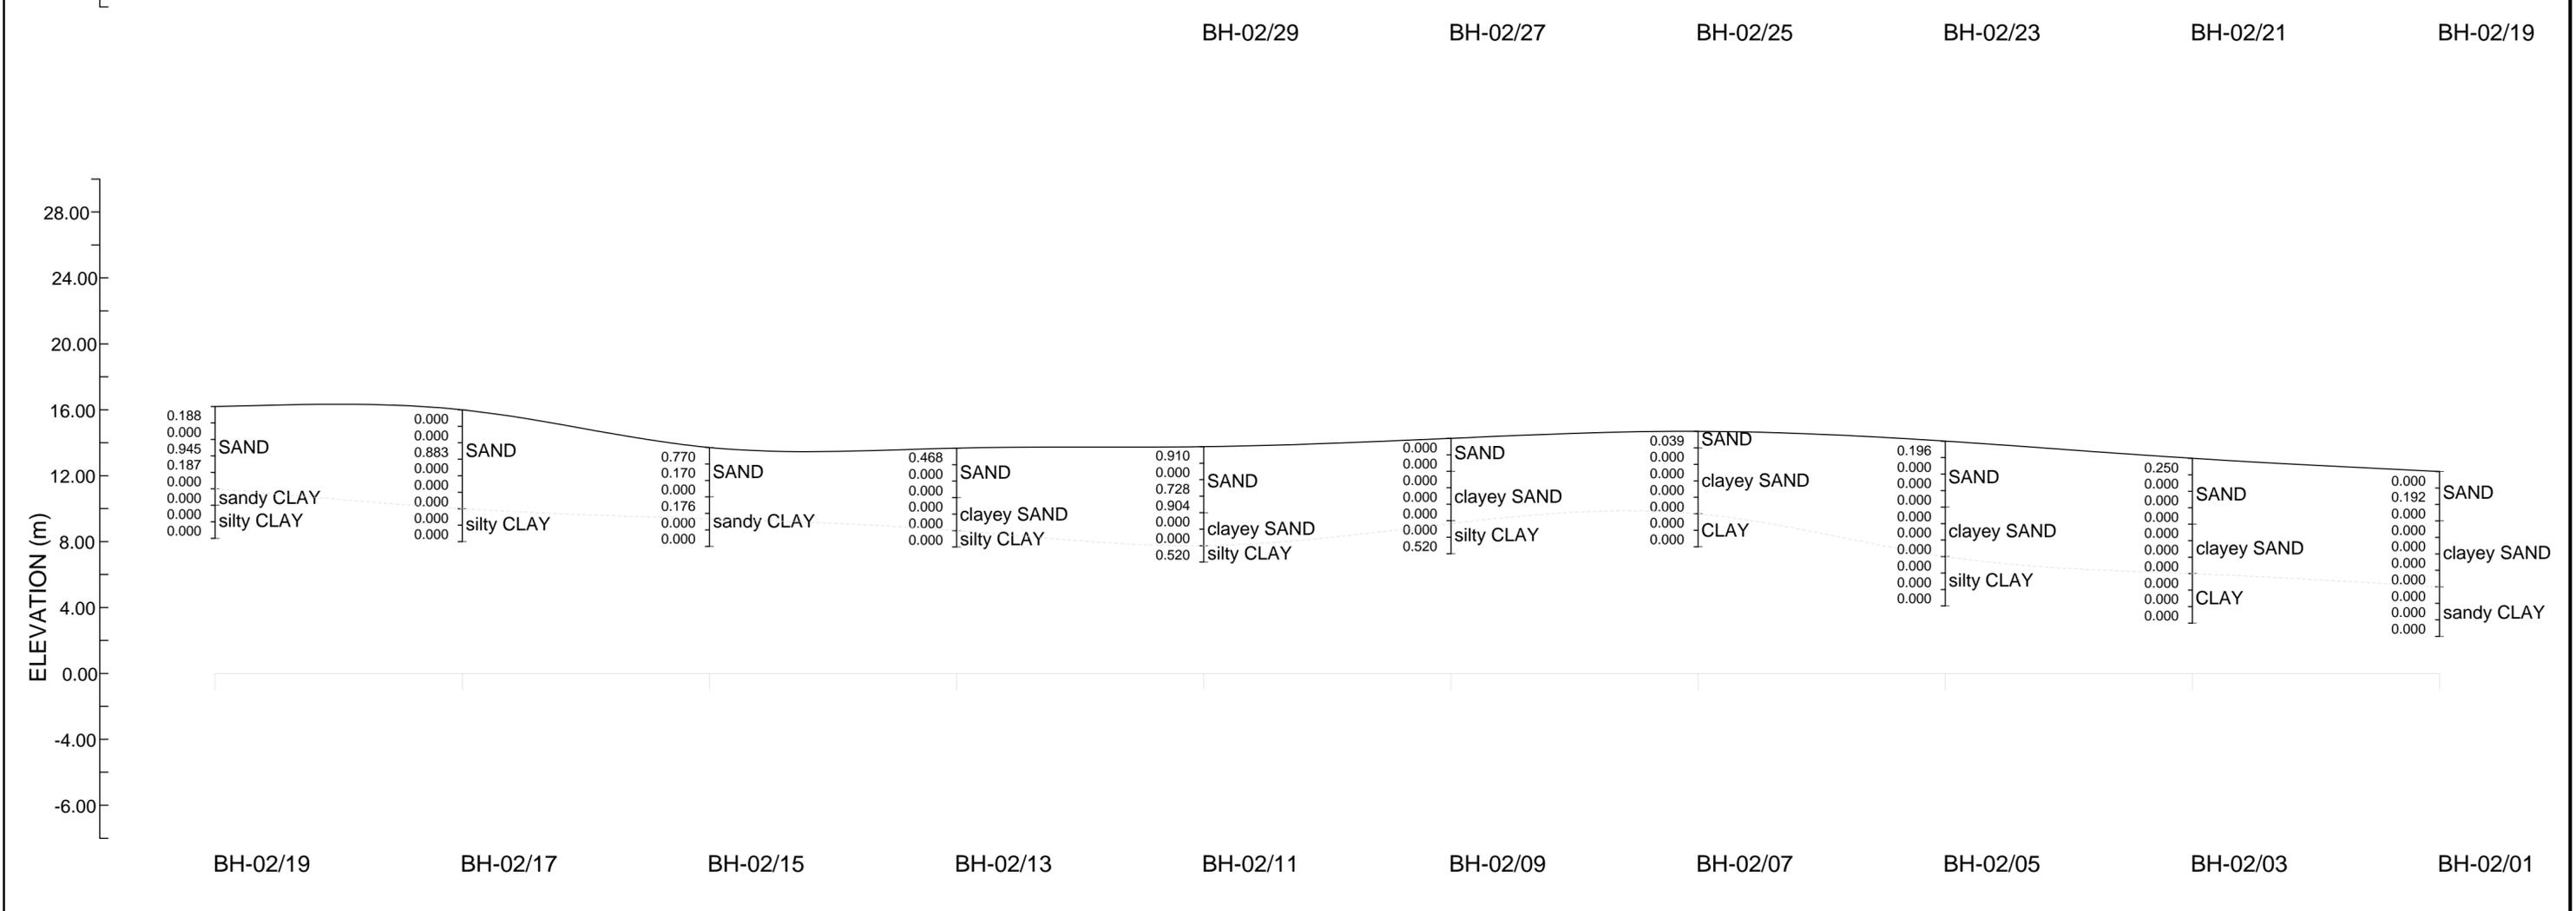
NARACOOPA MINERAL SANDS (PVT) LTD	COMMENTS	SCALE	LEGEND
EL25/2007		<b>VERTICAL SCALE:</b> 3.8mm = 1000mm  <b>HORIZONTAL SCALE:</b> 3.8mm = 4000mm	
CROSS SECTIONS			
LINE 02			
FIGURE: 03			
DATE: 29.07.2020			
AUTHOR: INESHKA W.S.S.

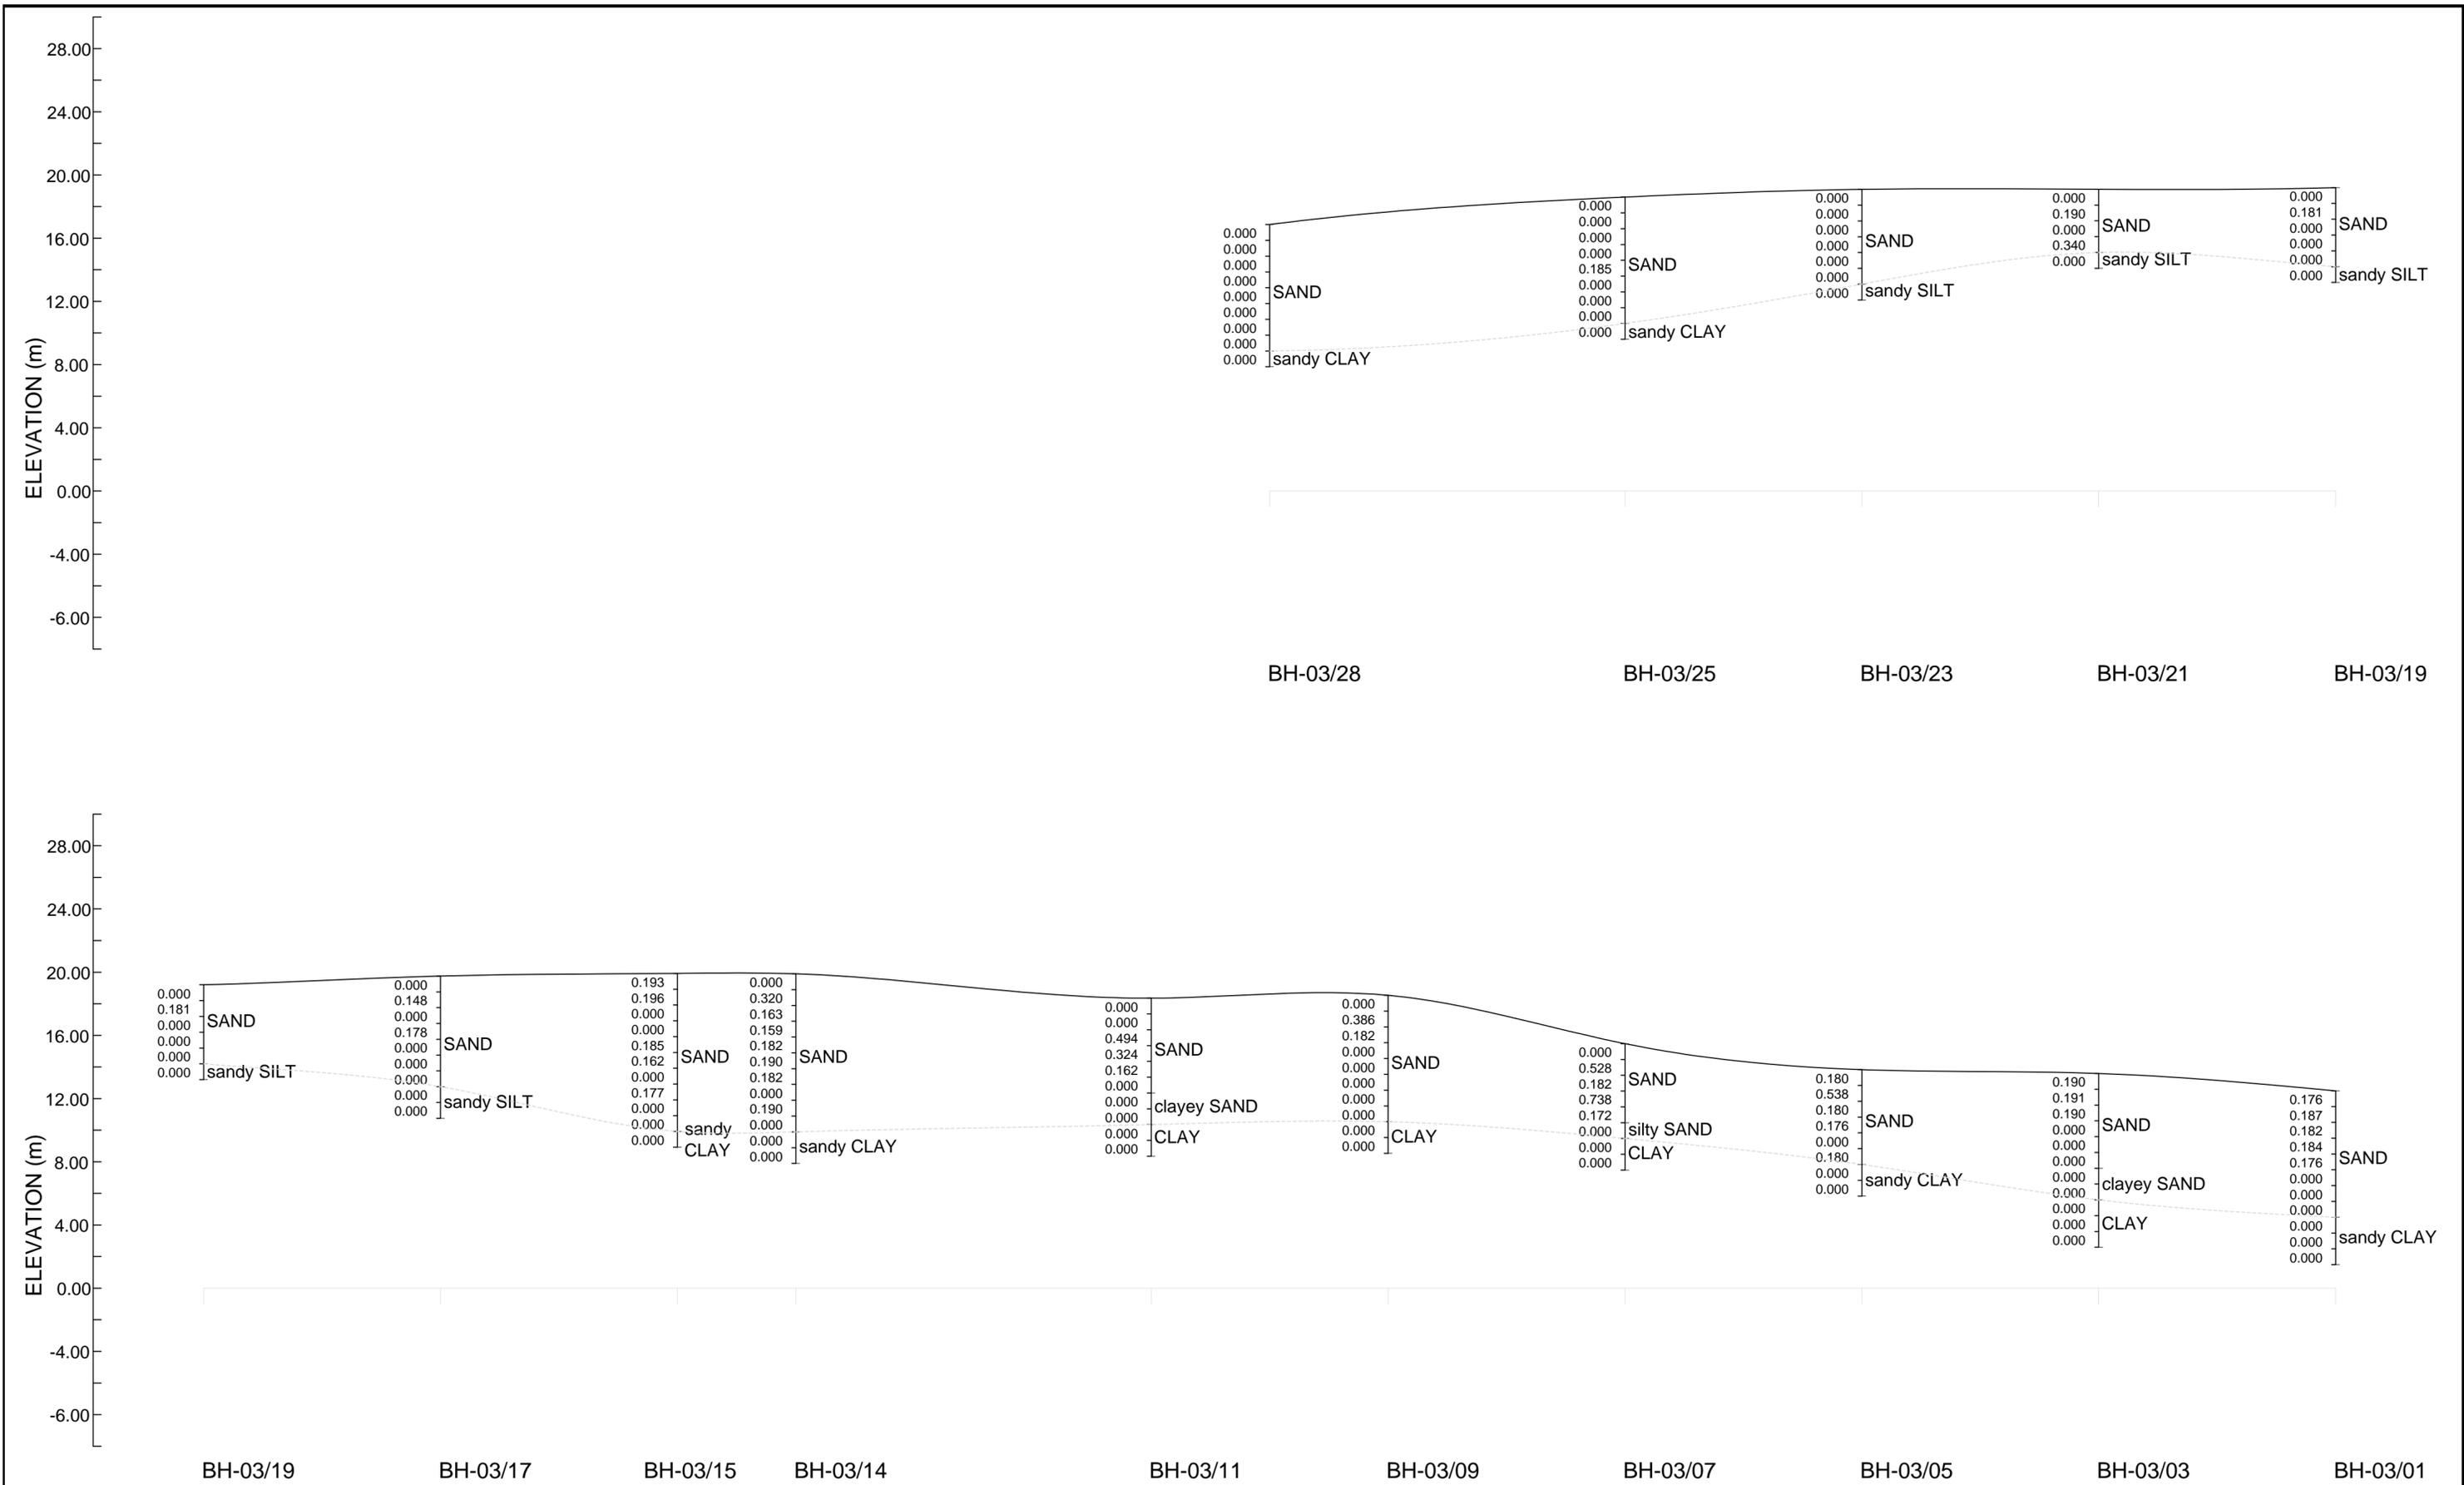
NARACOOPA MINERAL SANDS (PVT) LTD	COMMENTS	SCALE	LEGEND
EL25/2007			
CROSS SECTIONS			
LINE 03		<b>VERTICAL SCALE:</b> 3.8mm = 1000mm  <b>HORIZONTAL SCALE:</b> 3.8mm = 4000mm	
FIGURE: 04			
DATE: 29.07.2020			
AUTHOR: INESHKA W.S.S.

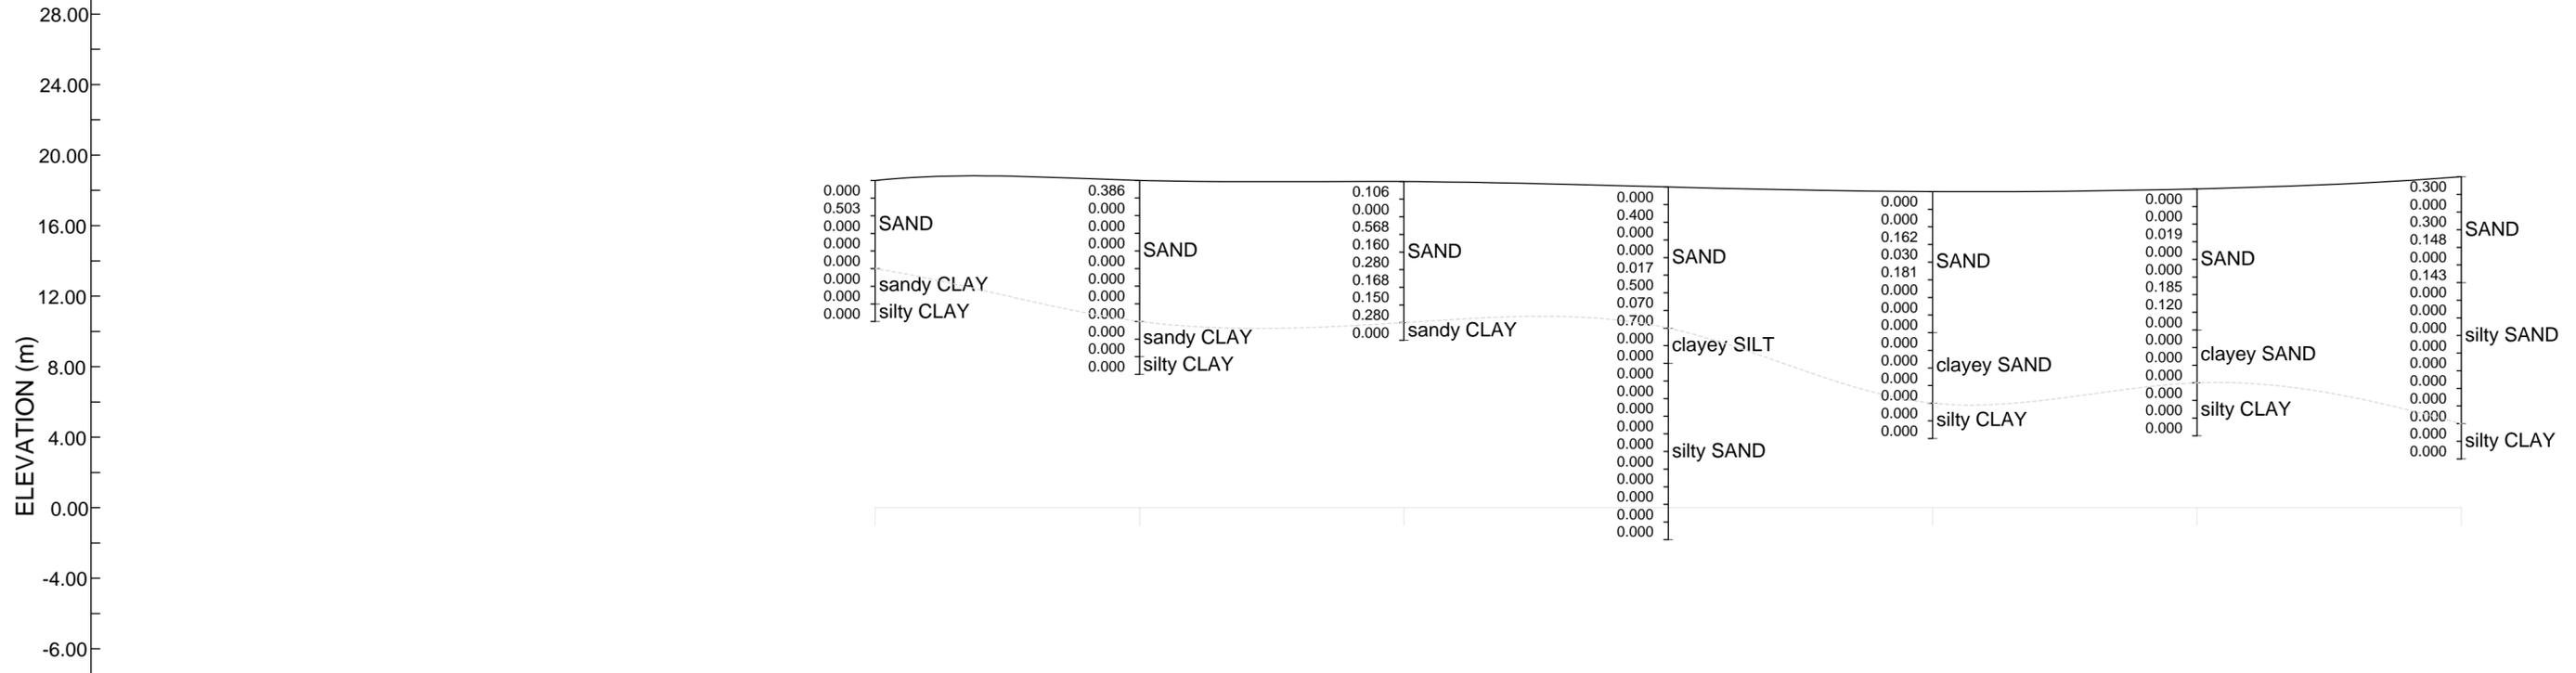
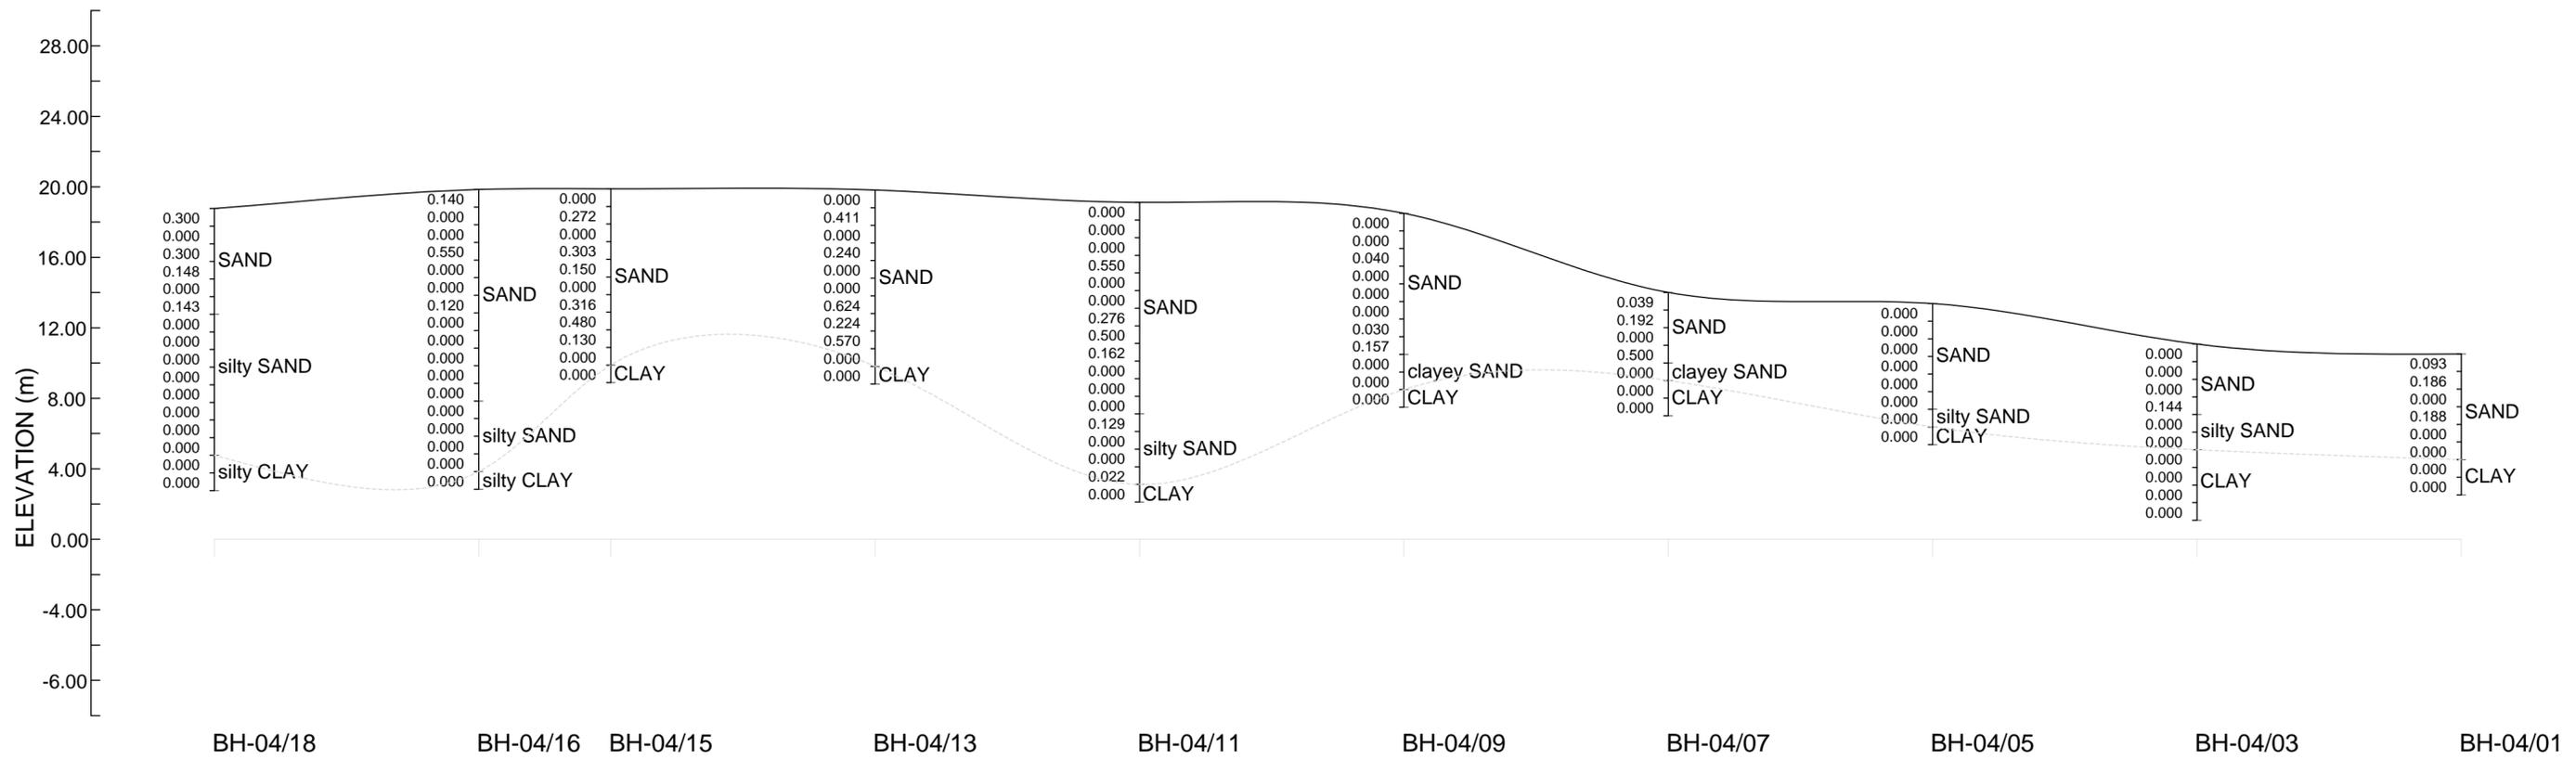
**NARACOOPA MINERAL SANDS (PVT) LTD**  
 EL25/2007  
 CROSS SECTIONS  
 LINE 04  
 FIGURE: 05  
 DATE: 29.07.2020  
 AUTHOR: INESHKA W.S.S.
