# **NARACOOPA MINERAL SANDS PTY LTD**

**EXPLORATION LICENCE 25/2007**

**ANNUAL REPORT**

**REPORTING PERIOD: 1 JULY 2018 TO 3 APRIL 2021**

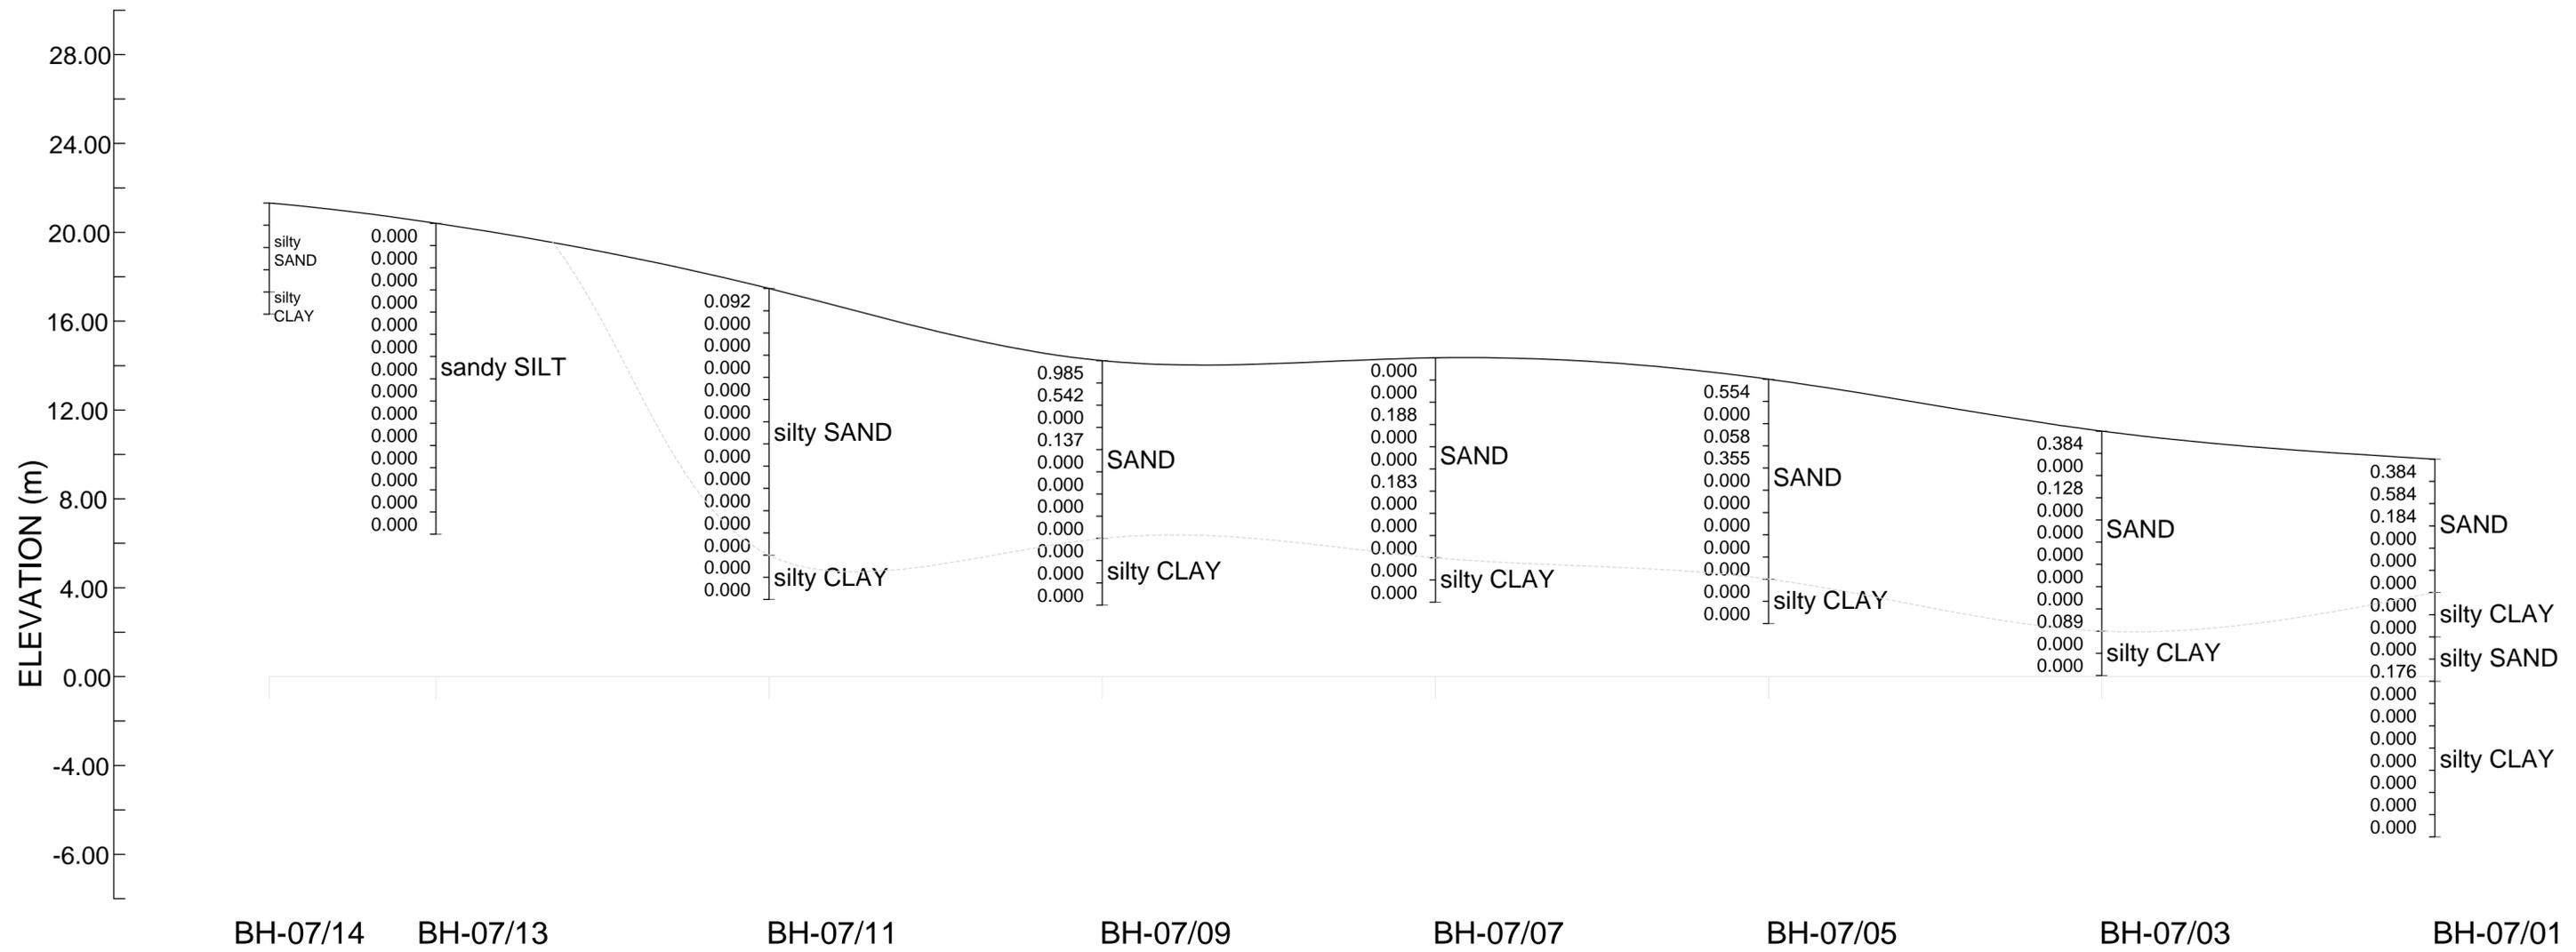
NARACOOPA MINERAL SANDS (PVT) LTD	COMMENTS	SCALE	LEGEND
EL25/2007		<b>VERTICAL SCALE:</b> 5.0mm = 1000mm	<p>HEAVY MINERAL CONTENT (%)</p> <p>0.185 0.379 0.186 0.000 0.000 0.000 0.000</p> <p>SAND</p> <p>sandy CLAY</p> <p>silty SAND</p> <p>SOIL TYPE</p>
CROSS SECTIONS		<b>HORIZONTAL SCALE:</b> 5.0mm = 4000mm	
LINE 07			
FIGURE: 08			
DATE: 29.07.2020			
AUTHOR: INESHKA W.S.S.

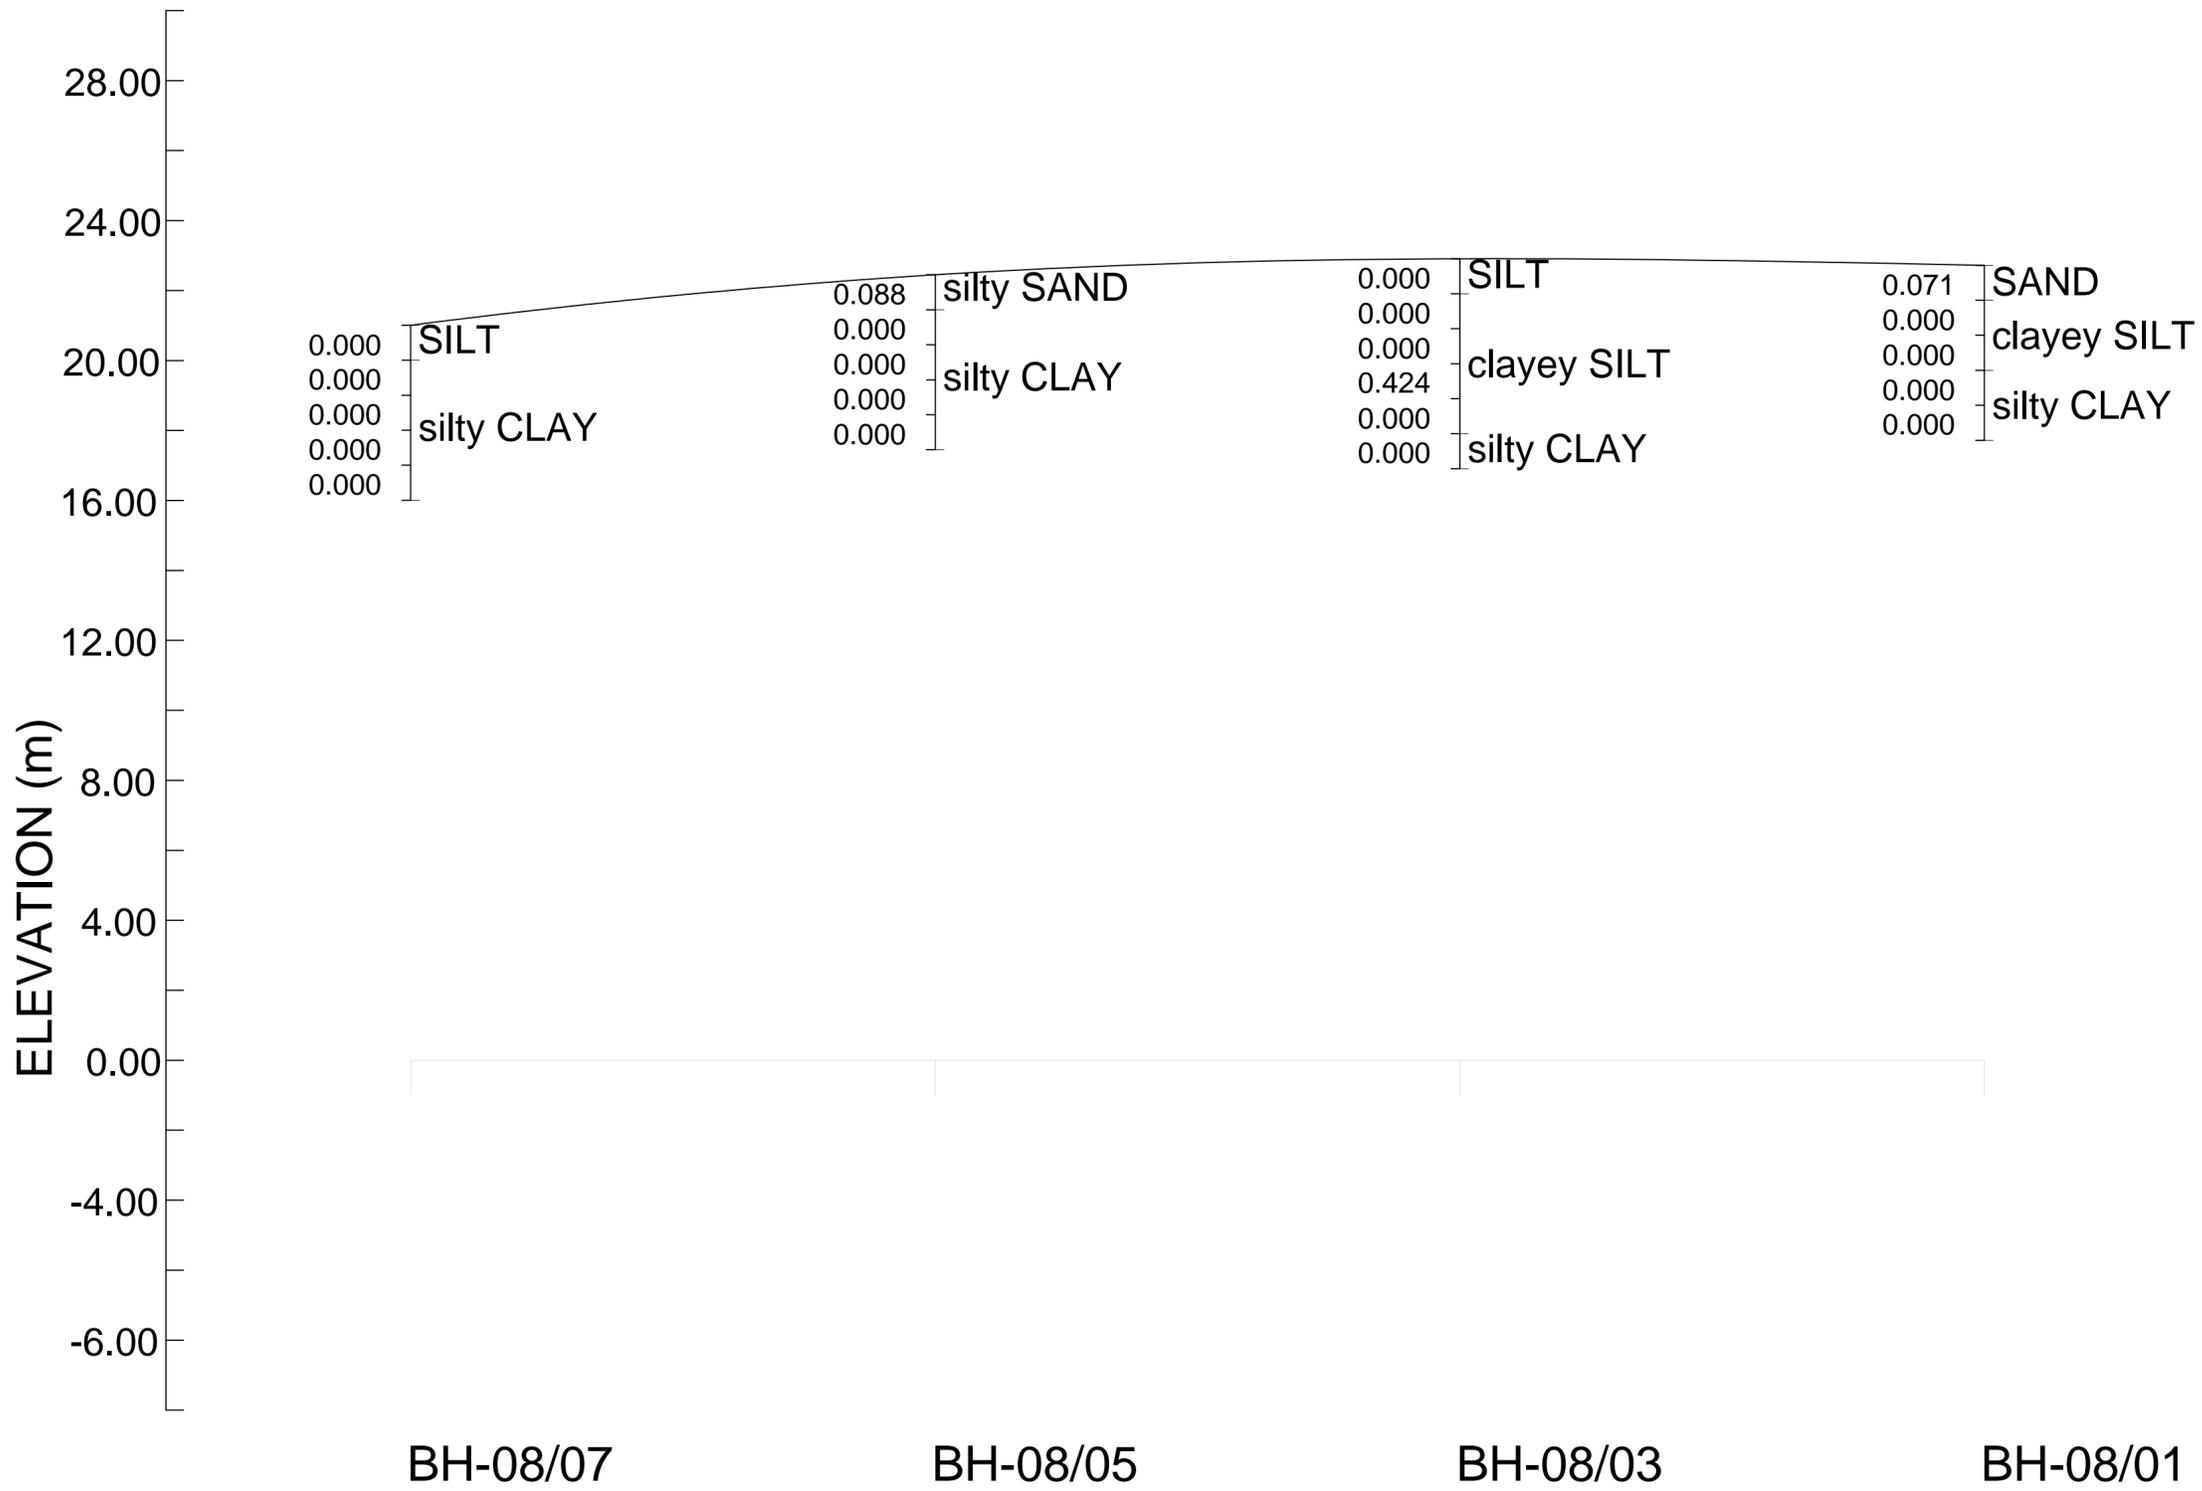
<b>NARACOOPA MINERAL SANDS (PVT) LTD</b>
EL25/2007
CROSS SECTIONS
LINE 08
FIGURE: 09
DATE: 29.07.2020
AUTHOR: INESHKA W.S.S.

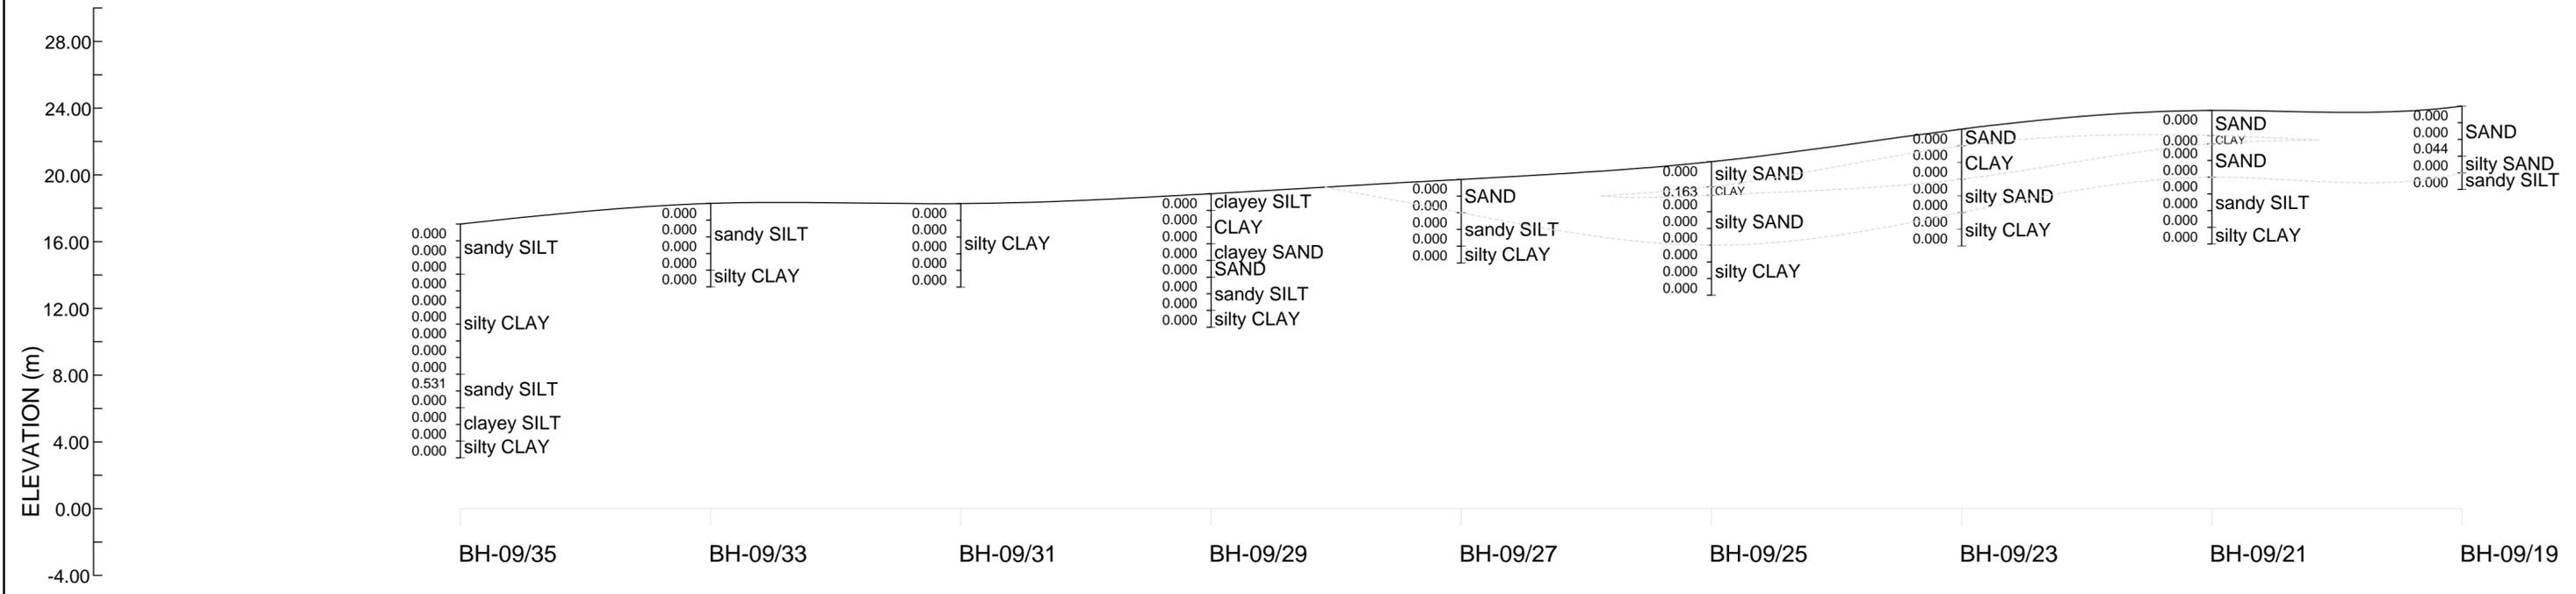
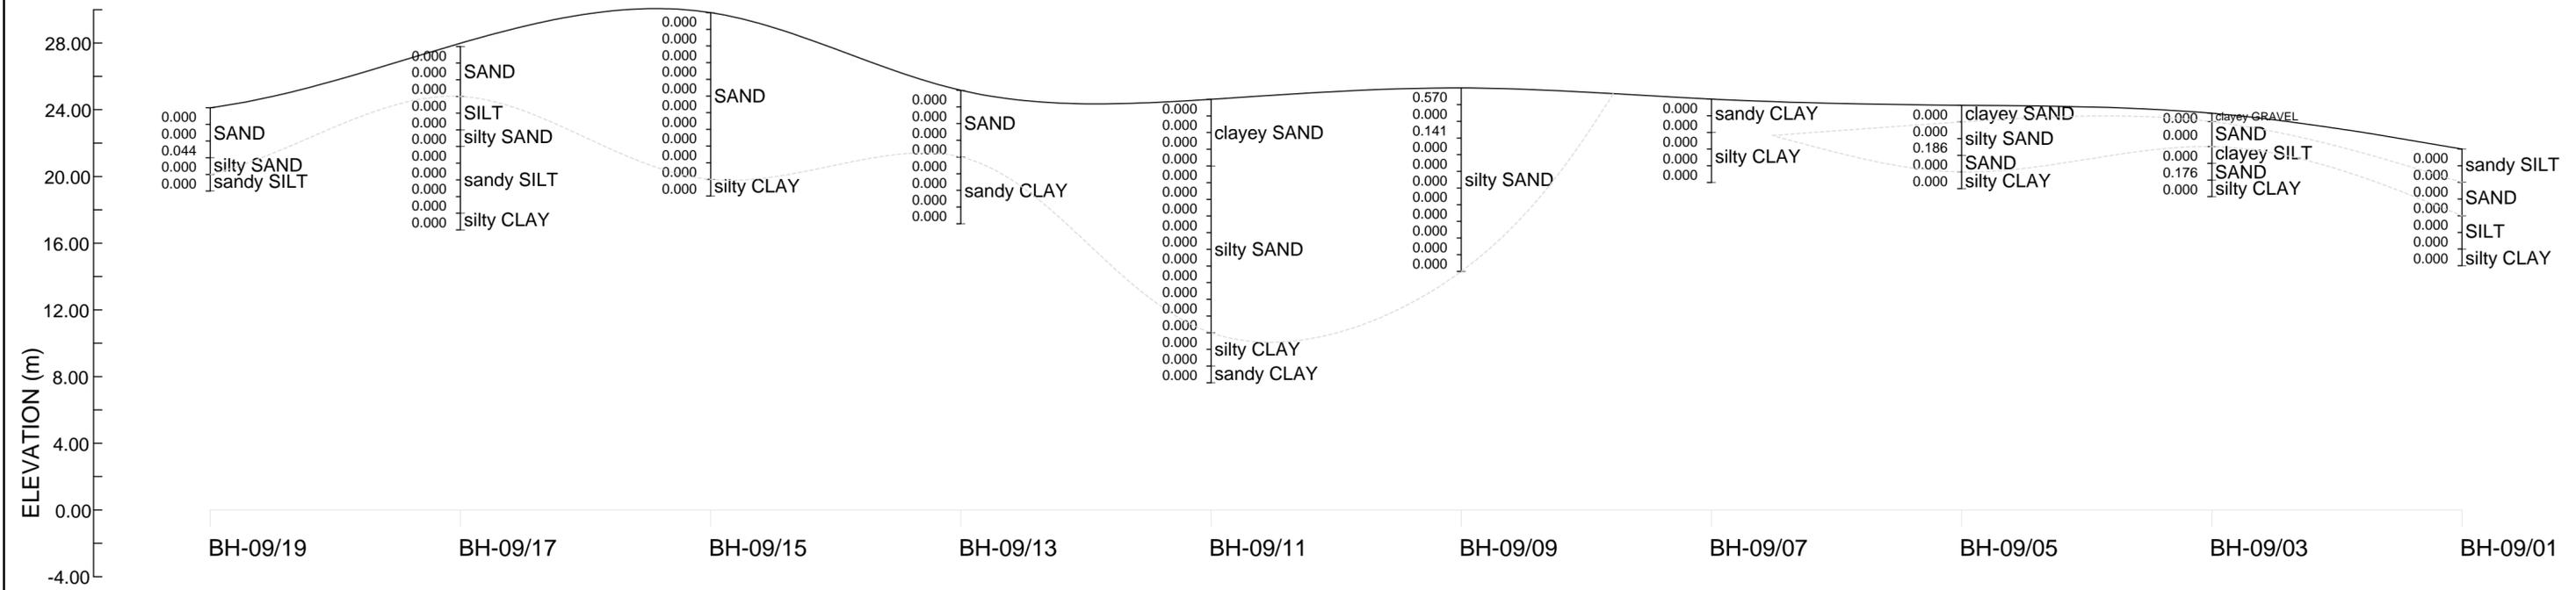
NARACOOPA MINERAL SANDS (PVT) LTD	COMMENTS	SCALE	LEGEND
EL25/2007			
CROSS SECTIONS			
LINE 09		<b>VERTICAL SCALE:</b> 7.0mm = 1000mm	0.185 0.379 SAND 0.186 0.000 sandy CLAY 0.000 0.000 silty SAND 0.000
FIGURE: 10			
DATE: 29.07.2020		<b>HORIZONTAL SCALE:</b> 7.0mm = 4000mm	
AUTHOR: INESHKA W.S.S.			SOIL TYPE

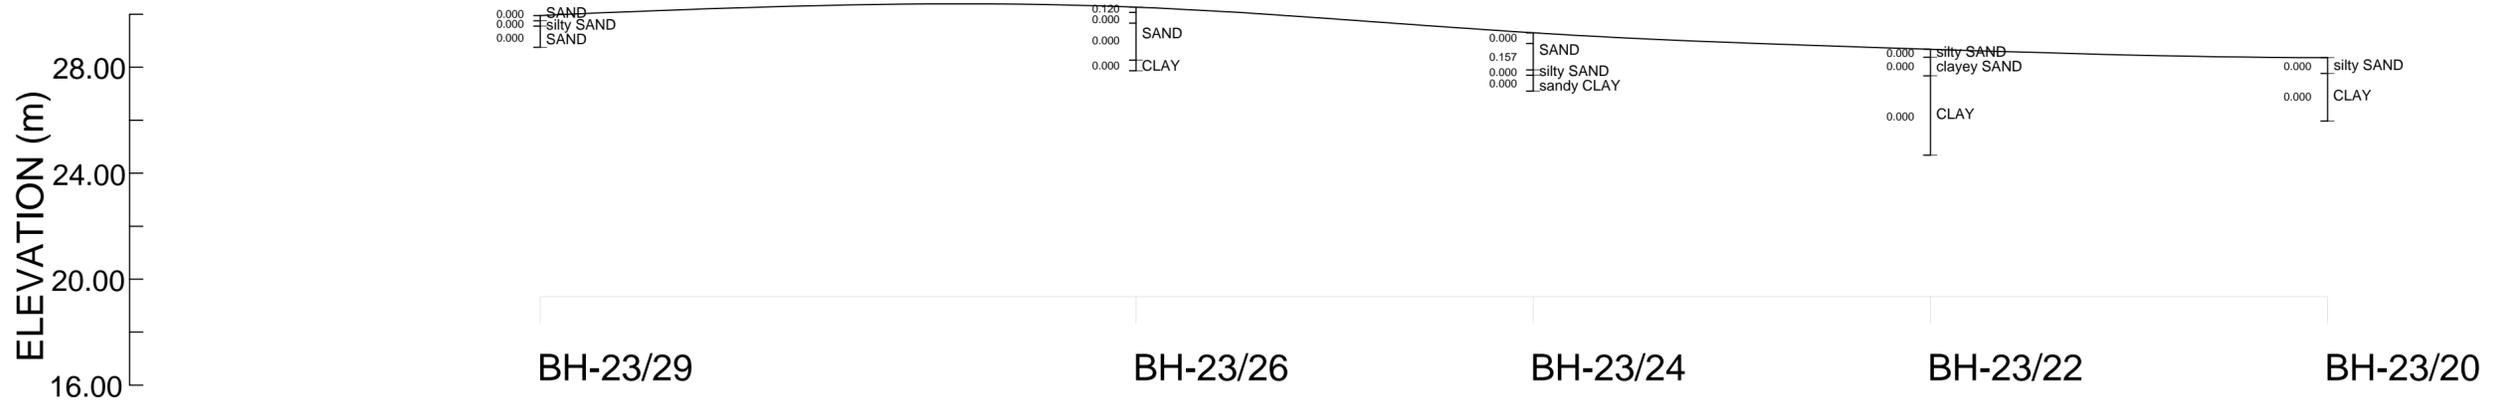
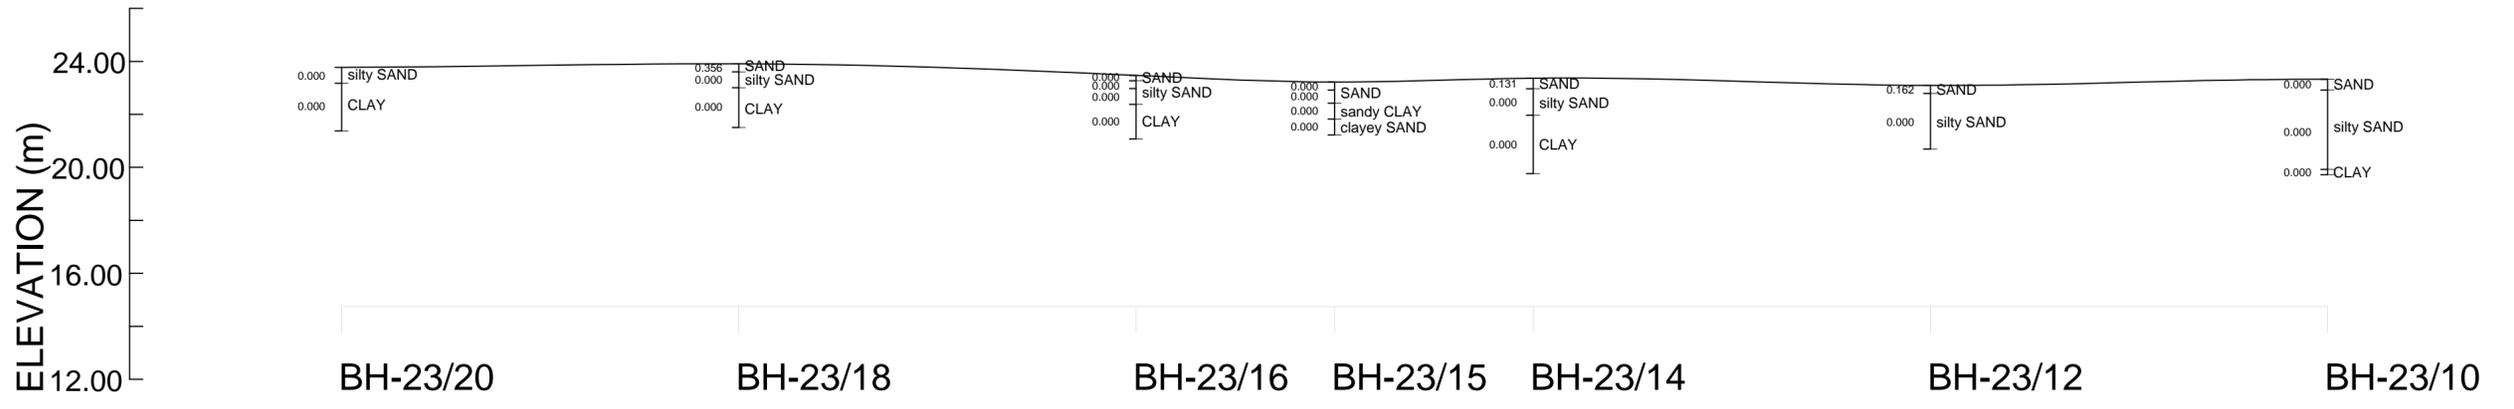
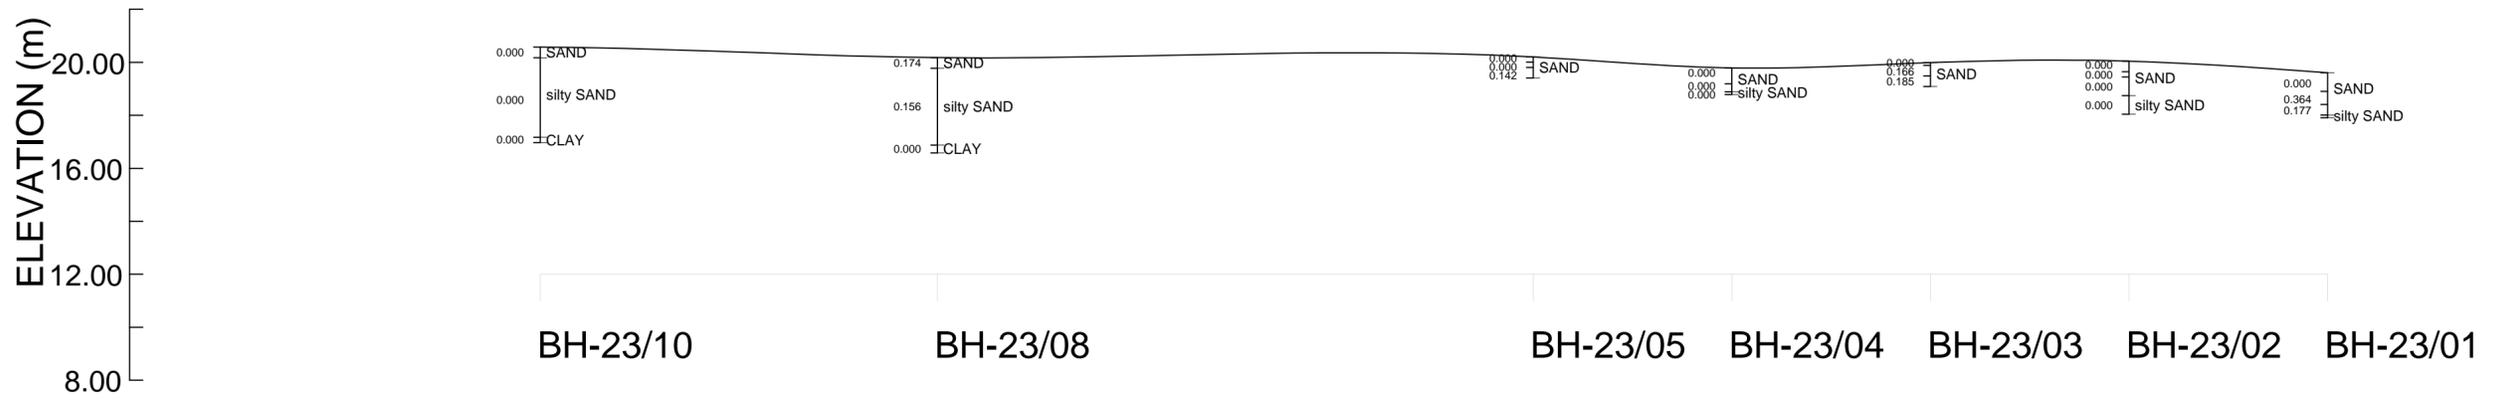
NARACOOPA MINERAL SANDS (PVT) LTD	COMMENTS	SCALE	LEGEND
EL25/2007		<b>VERTICAL SCALE:</b> 5.3mm = 1000mm	
CROSS SECTIONS		<b>HORIZONTAL SCALE:</b> 5.3mm = 4000mm	
LINE 23			
FIGURE: 21			
DATE: 29.07.2020			
AUTHOR: INESHKA W.S.S.

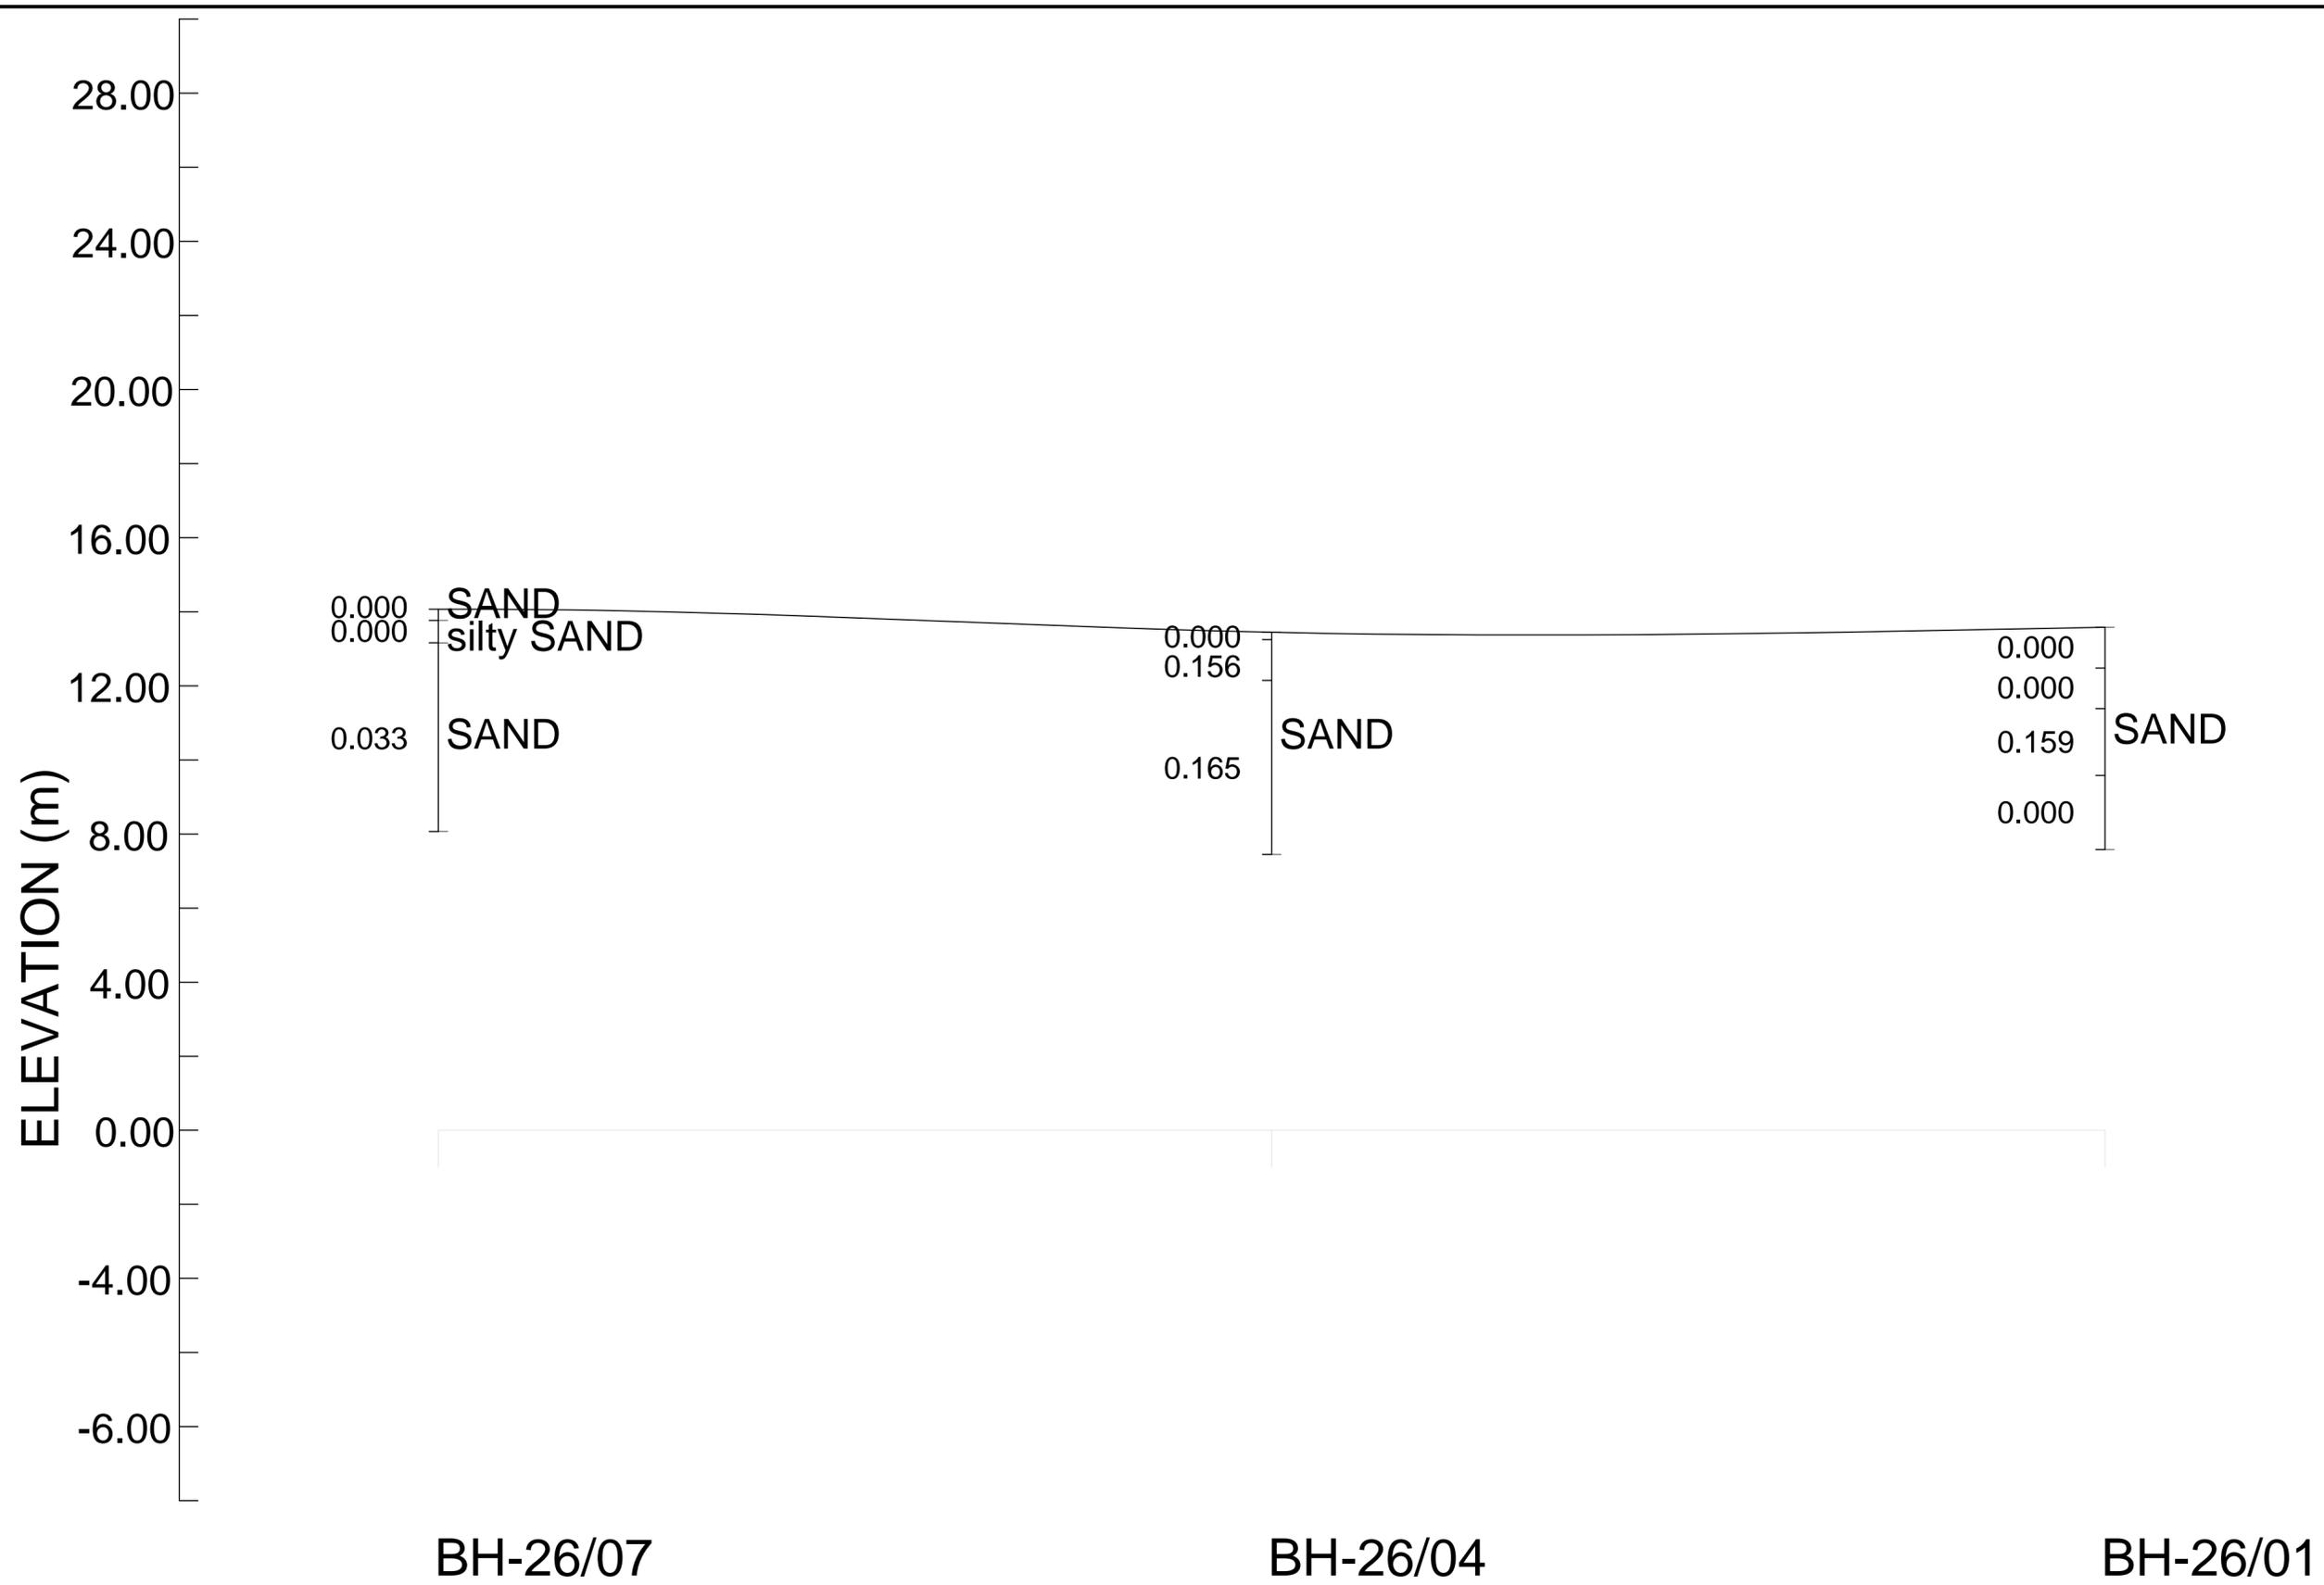
<b>NARACOOPA MINERAL SANDS (PVT) LTD</b>
EL25/2007
CROSS SECTIONS
LINE 26
FIGURE: 23
DATE: 29.07.2020
AUTHOR: INESHKA W.S.S.

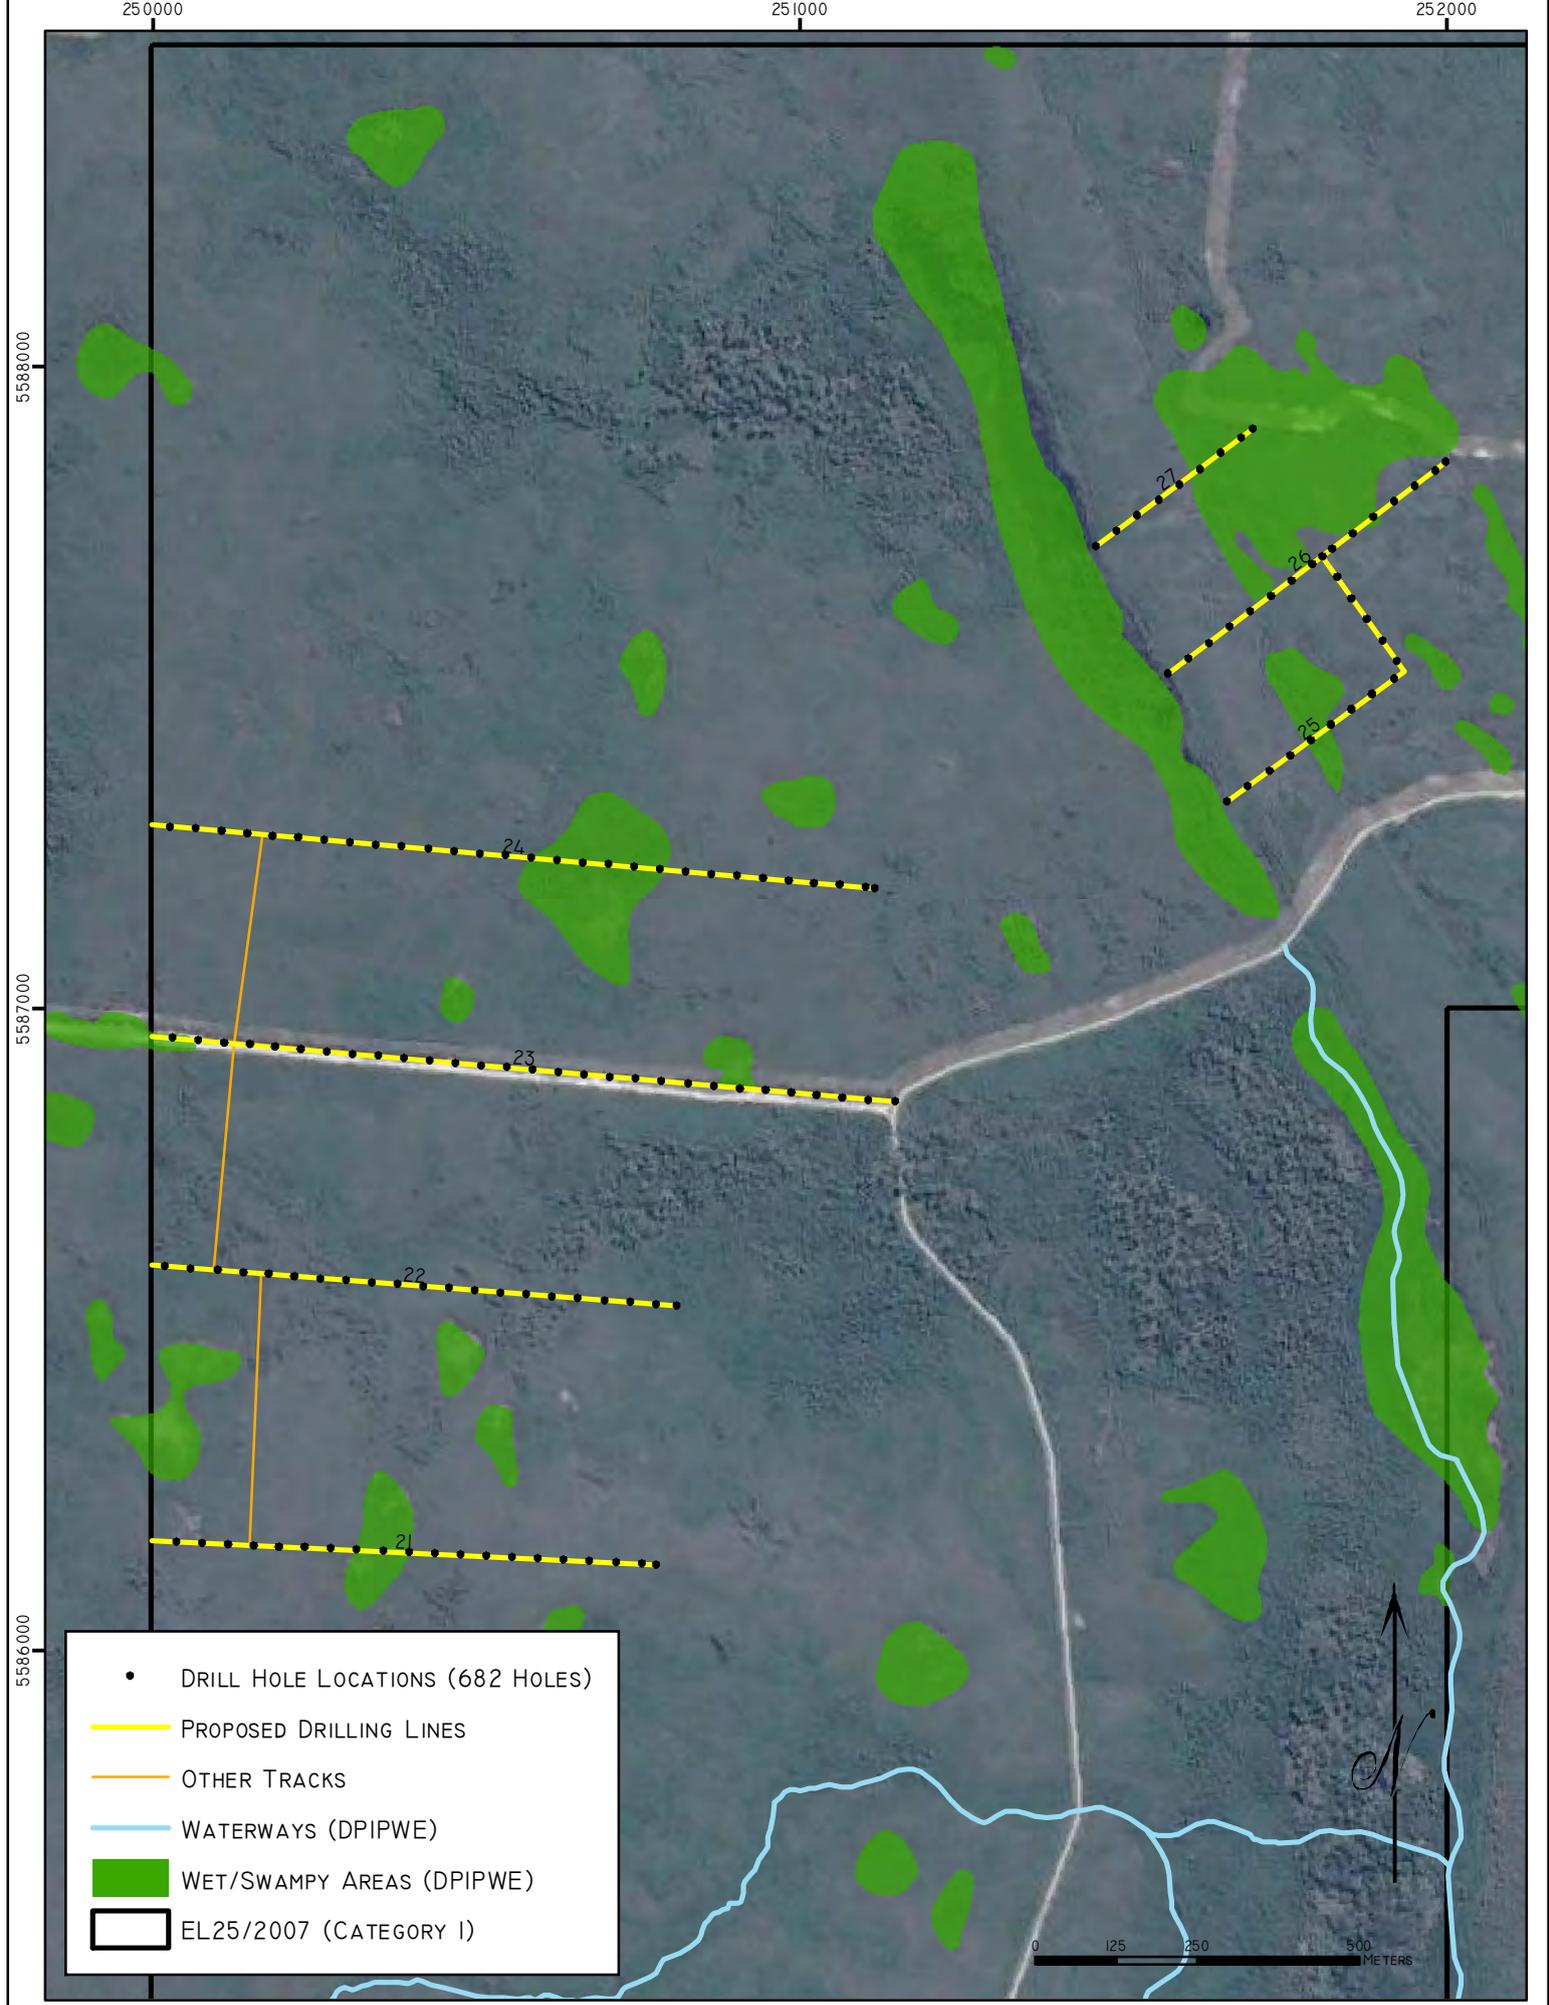
NARACOOPA MINERAL SANDS MINE  
 EL WORKS PROGRAM 2018 - DRILLING  
 FIGURE 5C: HYDROLOGY ON THE DRILLING LINES

Figures 5a, b and c illustrate the general locations of watercourses, wetlands and swampy areas where surface water or wet ground may be encountered.

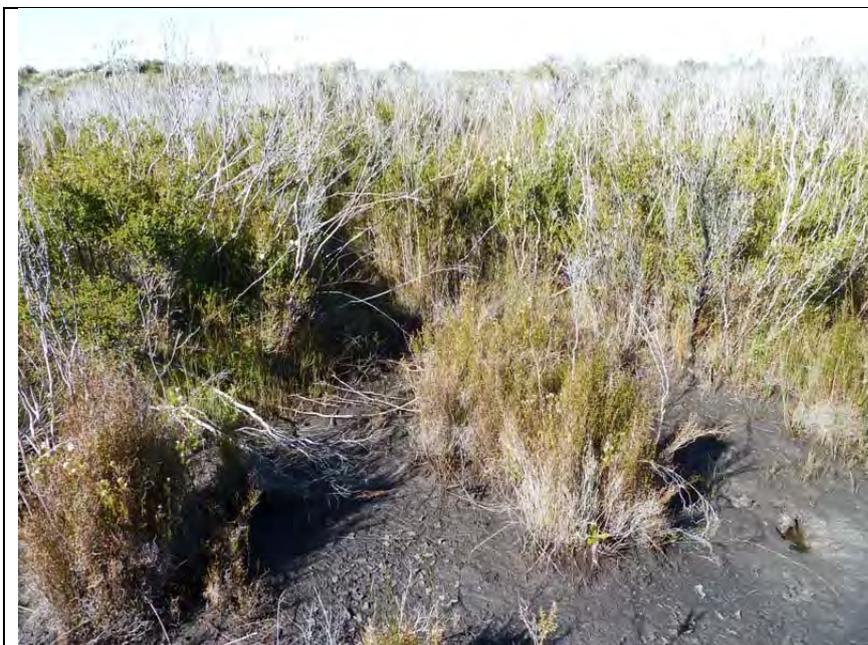
In some locations the drill lines may occur near waterways, swamps and drains or crosses watercourses. Drill lines have generally been located to avoid crossing watercourses (natural) and drains however some could not be avoided. There are also a few wet areas within otherwise dry heathland and scrub that will require the use of cut slash (tea-tree and paperbark sourced from the drill line clearing/slashing) to ensure that organic rich soils are protected whilst machinery use the drill line track.

A wet area dominated by scented paperbark that has organic rich sandy to peat soils. Slash should be used to enable machinery and vehicles to cross these areas without damaging the soil profile. Slash should be removed (spread along the route) when exploration works for that drill line have been completed.
