Cresswells Transport Pty Ltd

EL 9/2020 – Donalds Road

Year 3 Annual Report

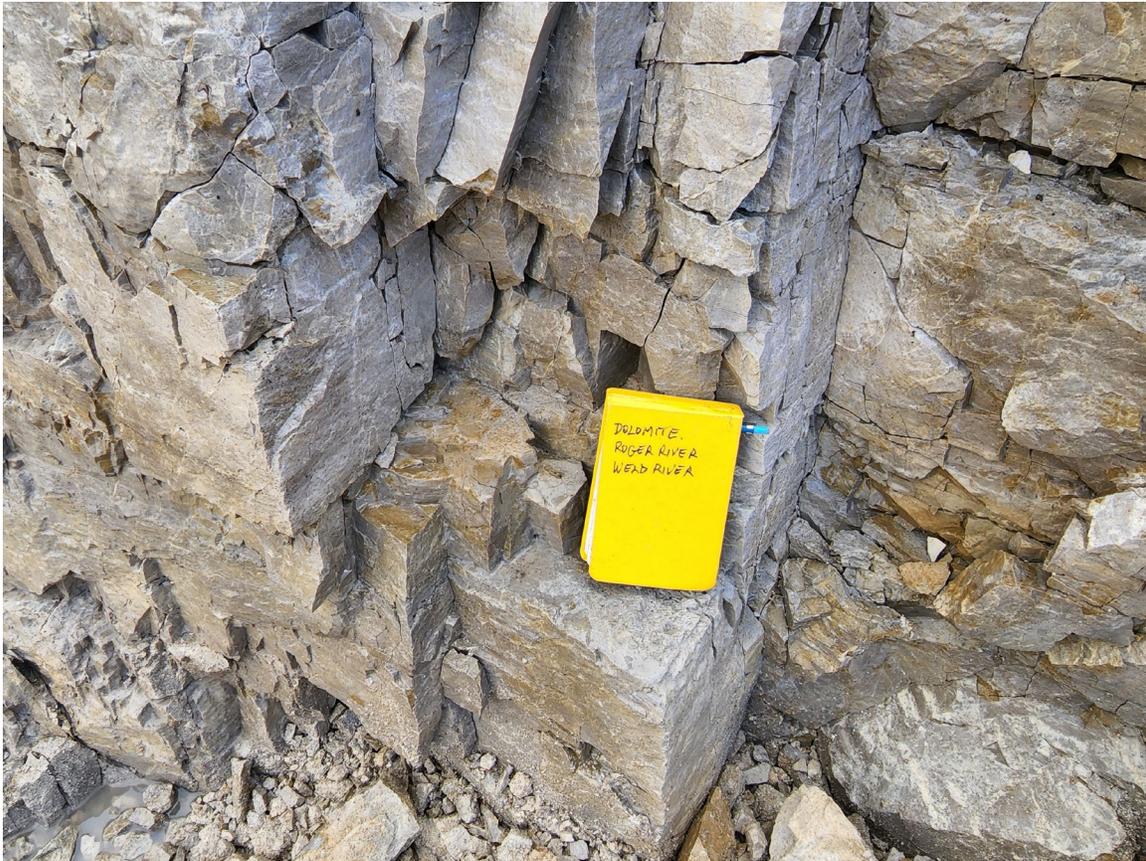
Three joint-controlled fracture directions are prominent in the western wall of the pit (see cover page photo); two sub vertical and one sub horizontal. Several compass readings on each gave the following average orientations (converted to true north bearings):

1. Strike 320 Dip 80 to NE
2. Strike 230 Dip 75 to SE
3. Strike 340 Dip 05 to NE

The residual water level in the pit was about 4 metres below surface at the time and there was no evidence of ground water transmitting through the open fractures at that depth. However, surface rain water was trickling down some of the open sub vertical fractures and slowly recharging the pit water. Not all fractures are open. Particularly in the sub horizontal set annealed insipient joints are more common than open fractures. It is not possible to tell if the open fracture have been enhanced by blasting, or even by stress release from the wall bounding the excavated void.

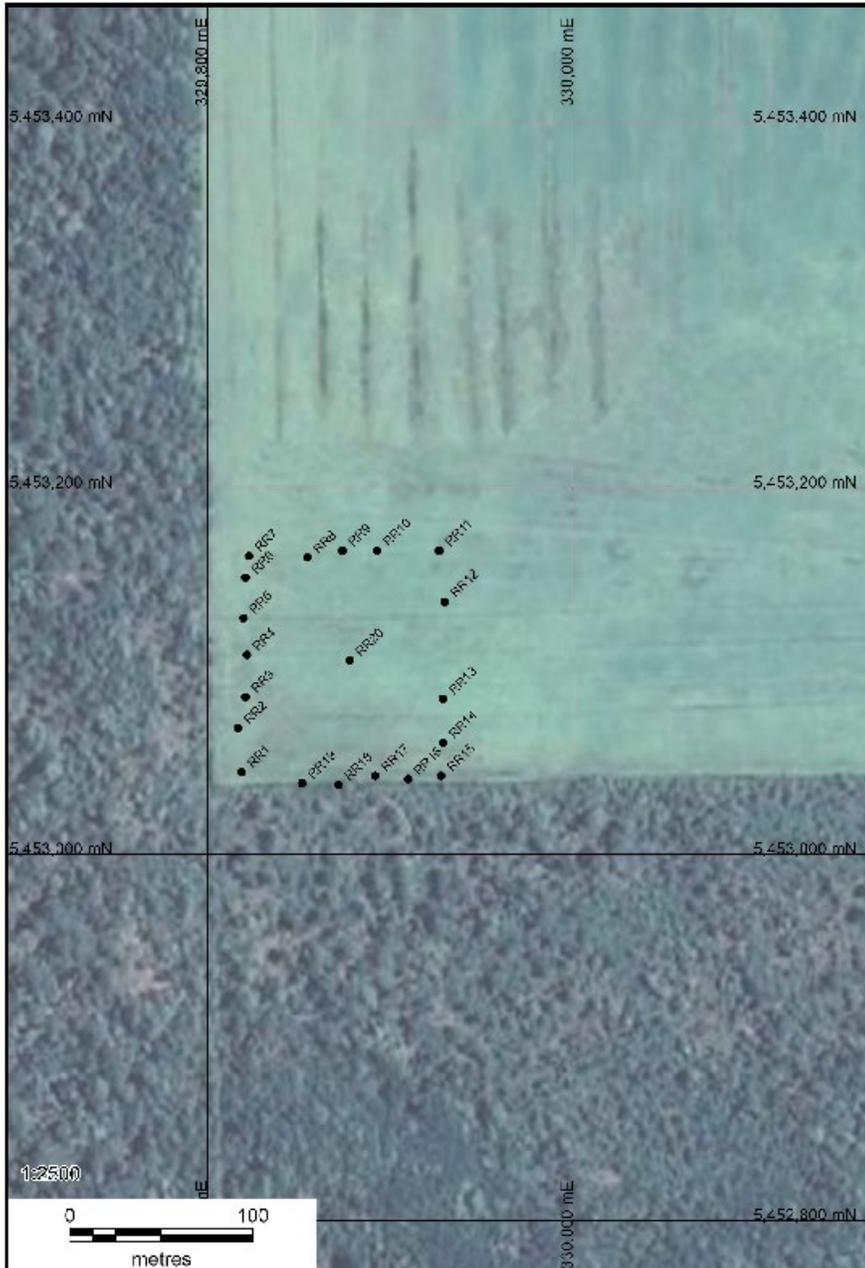
Figure 4. Drill hole locations in the SW corner of the main paddock.

percussion holes were drilled in a box-style close spaced pattern (Figure 4) using an Atlas Copco Powerroc blast hole percussion rig which drilled 90mm diameter open holes using 3.6m rods.

MRT approved a 1,000 tonne bulk sample pit to be excavated in the central part of the previous drill pattern area (Figure 4), for the dual purpose of -

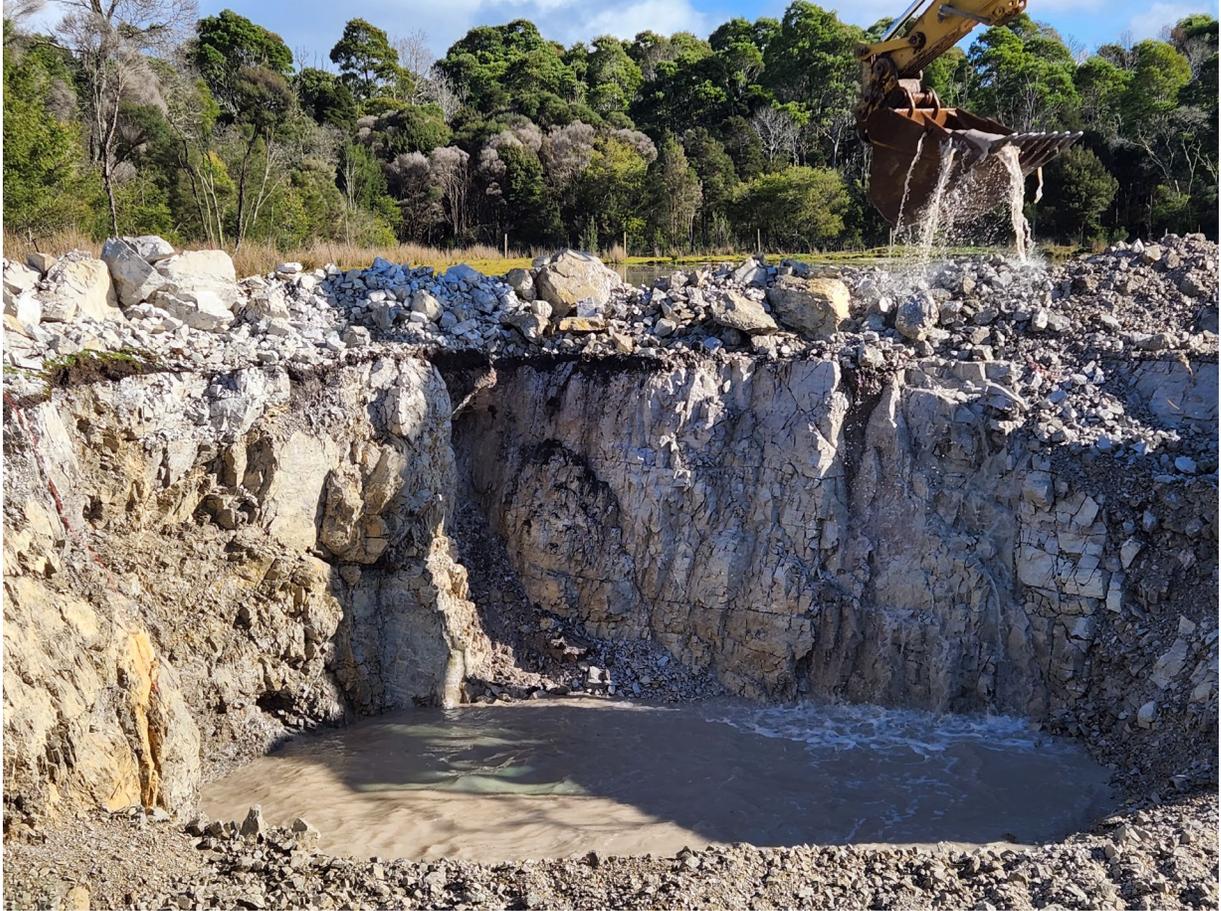
Figure 5. Removing rain water from the bulk sample pit.

The pit (Figure 5) was excavated and found to be dry down to the design depth of 5 metres, however subsequent wet weather flooded the pit and allowed important ground water observations and interpretations to be made (Cromer, 2023).

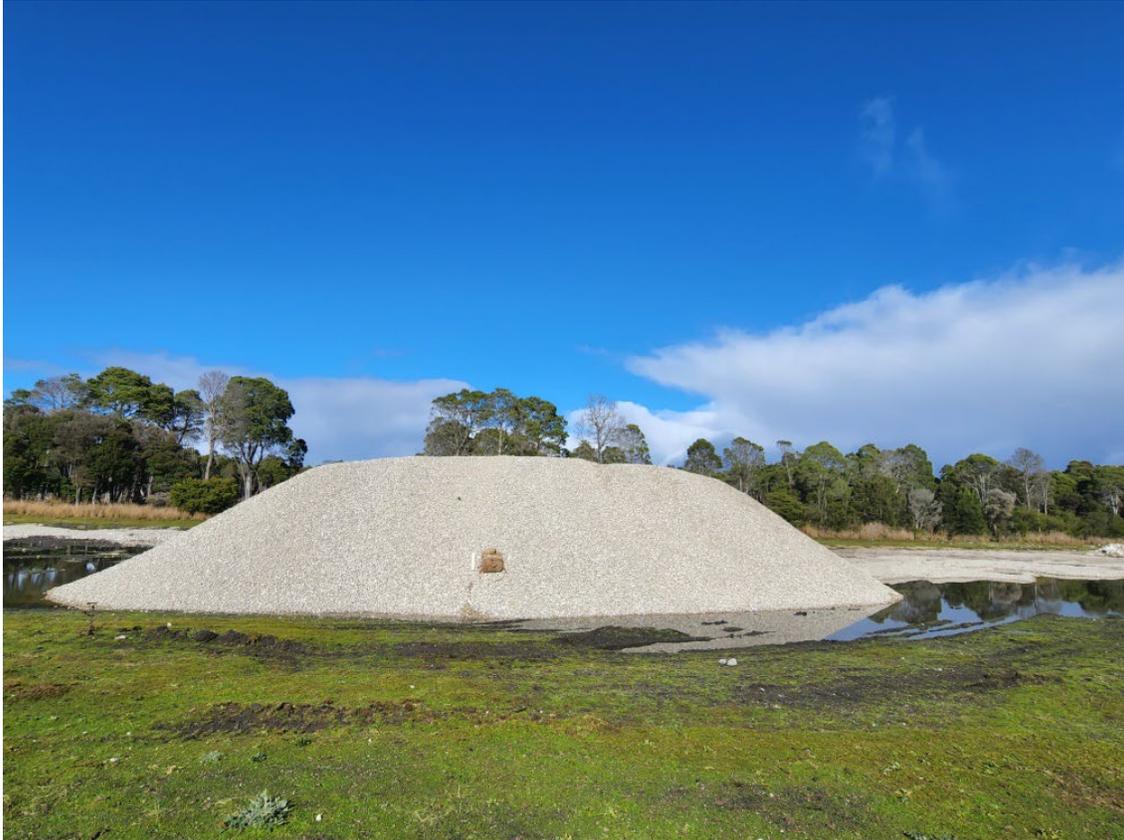
Figure 6. -40mm Stockpile, looking SW with rain water lying on the ground surface (backpack and spear scale).

An initial batch of approximately 500 tonnes of drill and blast product was extracted and crushed on site by Cresswells portable crusher, producing an estimated 400 tonnes stockpile of -40mm material. The stockpile (Figure 6) is centred at 329977E, 5453077N.

The stockpile was sampled by 20 half PVC tube spear samples spaced uniformly around the stockpile surface. The samples were combined and manually mixed on a plastic sheet, then divided into 6 equal sized calico bag samples (DRR001-006) estimated to weigh about 3-4 kg each.
