CRESSWELL'S TRANSPORT PTY LTD

PROPOSED DOLOMITE QUARRY
DONALDS ROAD, ROGER RIVER WEST

HYDROGEOLOGICAL REPORT
and
GROUNDWATER MANAGEMENT PLAN

December 2023
Revision 2

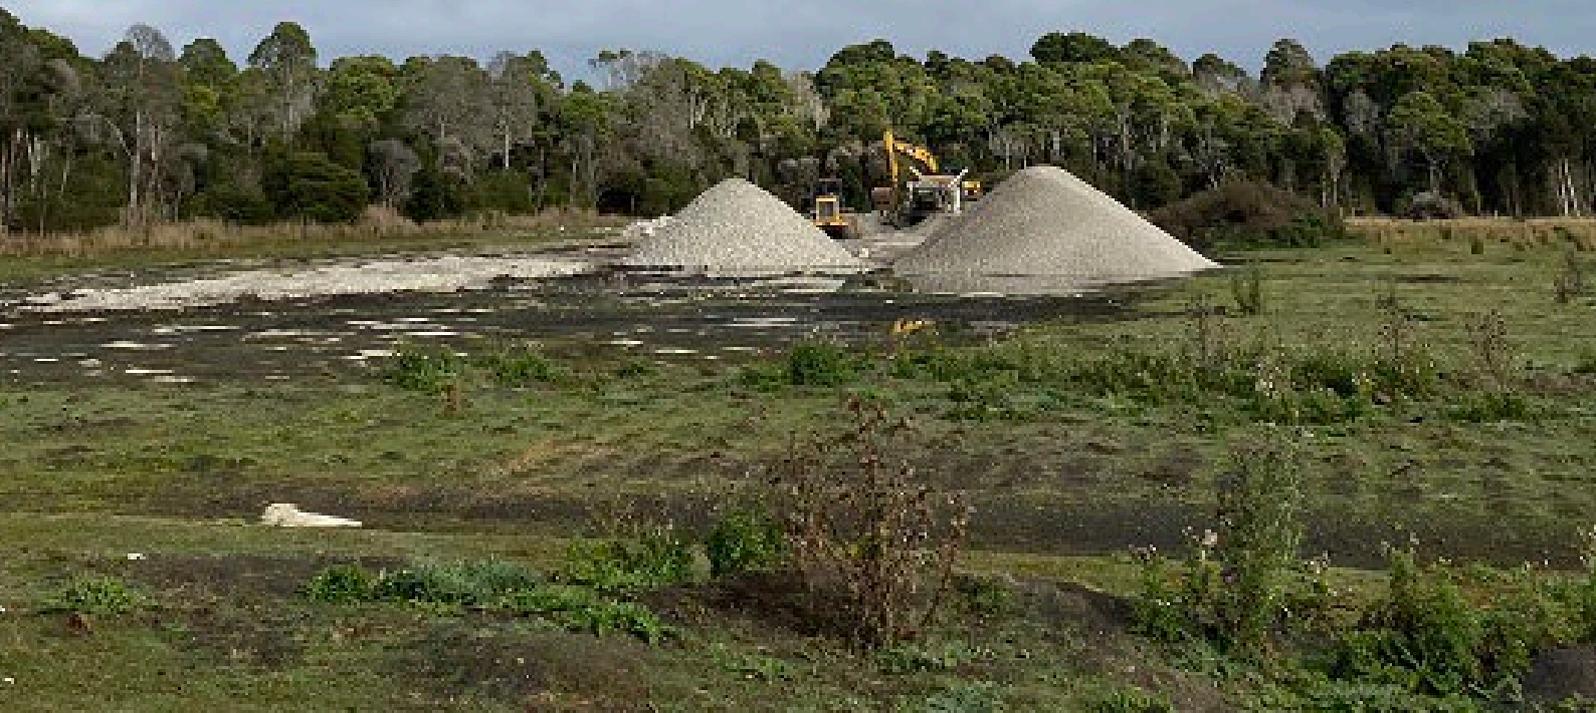
Cover photo

View west towards the proposed quarry site, showing stockpiled screened dolomite after extraction and on-site crushing during a bulk sampling trial. The excavator is near the bulk sample pit.

The ground surface (35.5mAHD) is essentially flat; the open surface drain crossing left to right in the foreground is one of a series of drains at a (LiDAR-derived) gradient of 1:1,300 (0.05°) leading to the Montagu River 500m to the north (right of photo). The white patches this side of the stockpiles, and in the drain in the foreground, is dolomite bedrock. Dolomite also crops out in the shallow (0.5m deep) drain which contains the straightened Montagu River. The rock everywhere in this area is high strength, with no or sealed fractures. The Quaternary-age alluvium and marsh deposits in the district and shown on the published *Roger* 1:25,000 geological map are absent, or less than 0.5m thick.

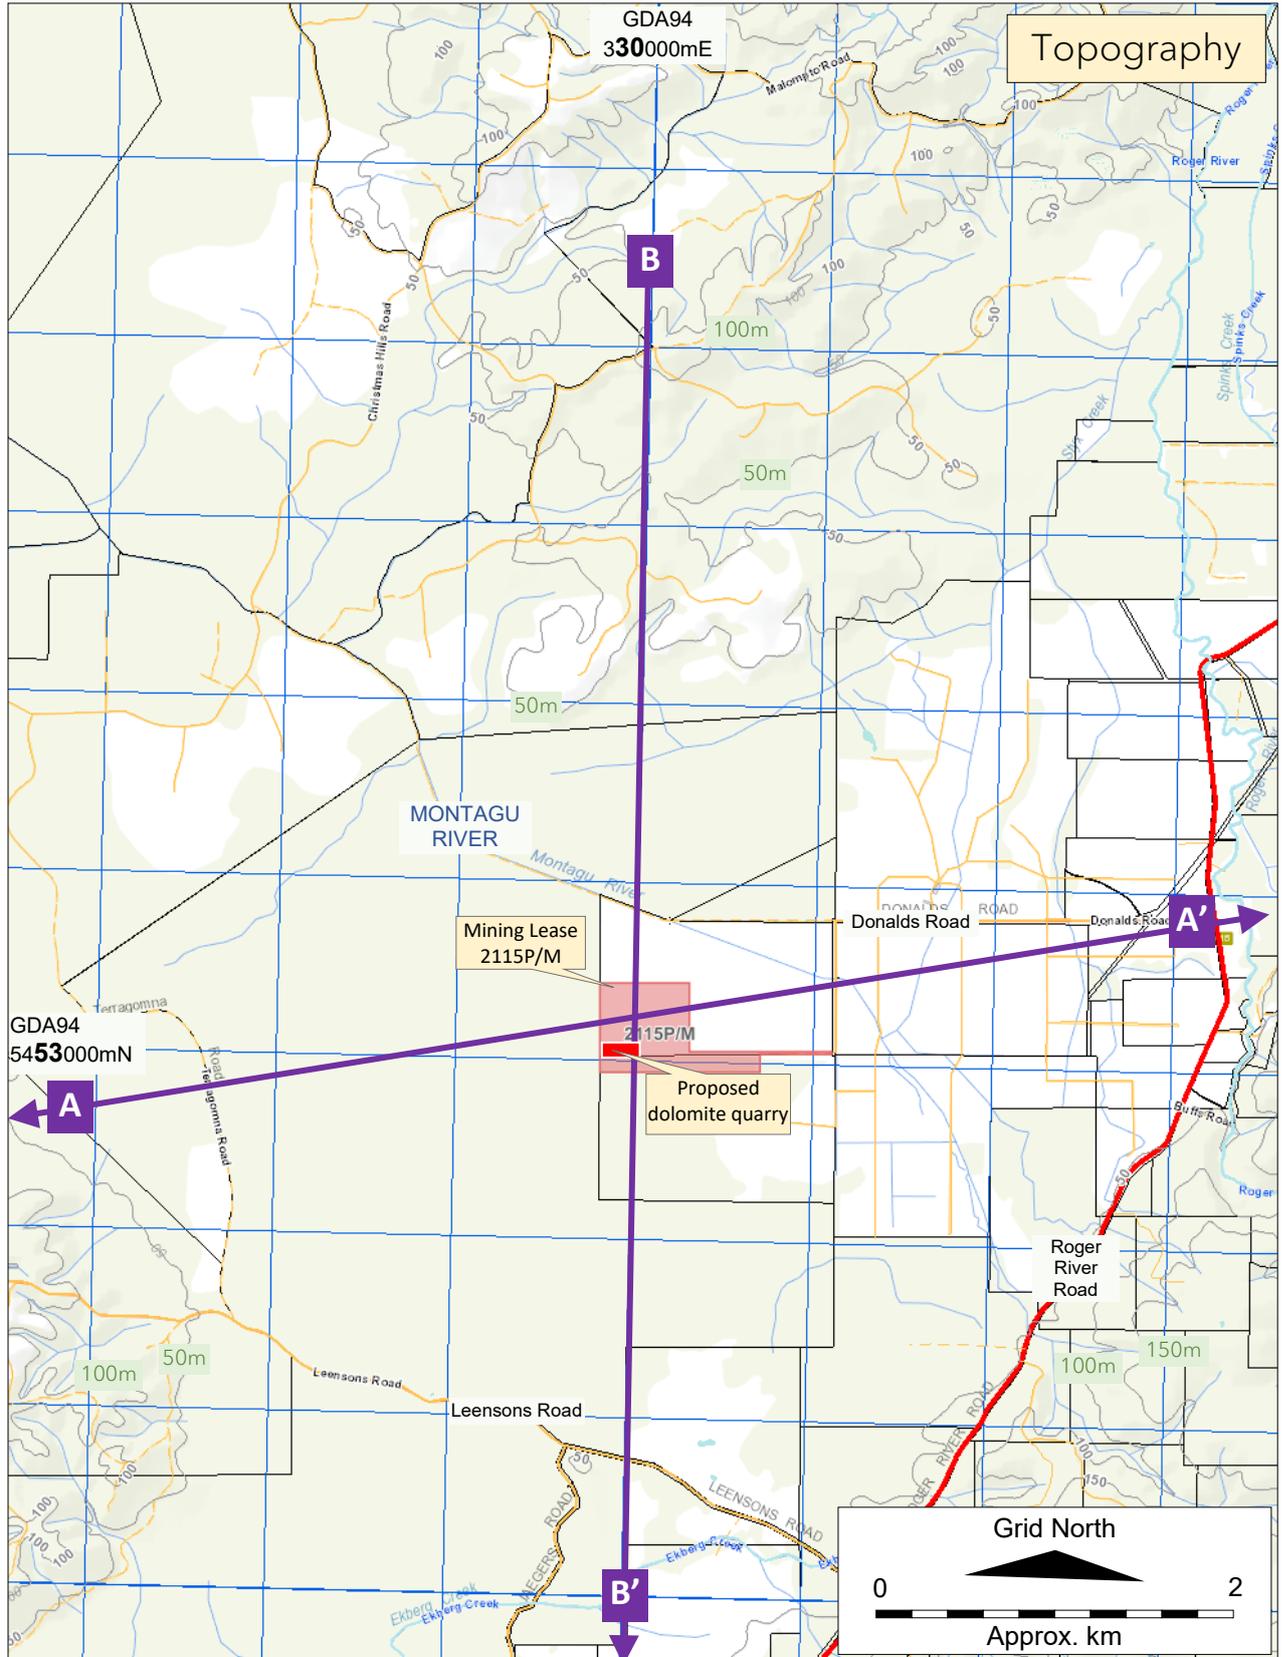
Figure 2. Location of the proposed dolomite quarry in relation to mining lease 2115P/M, roads, drainage, cadastre and topography.

Contour interval 10m. Lines A - A' and B - B' are cross section lines for the conceptual hydrogeological models in Section 3.3 (note the lines extend off the map).

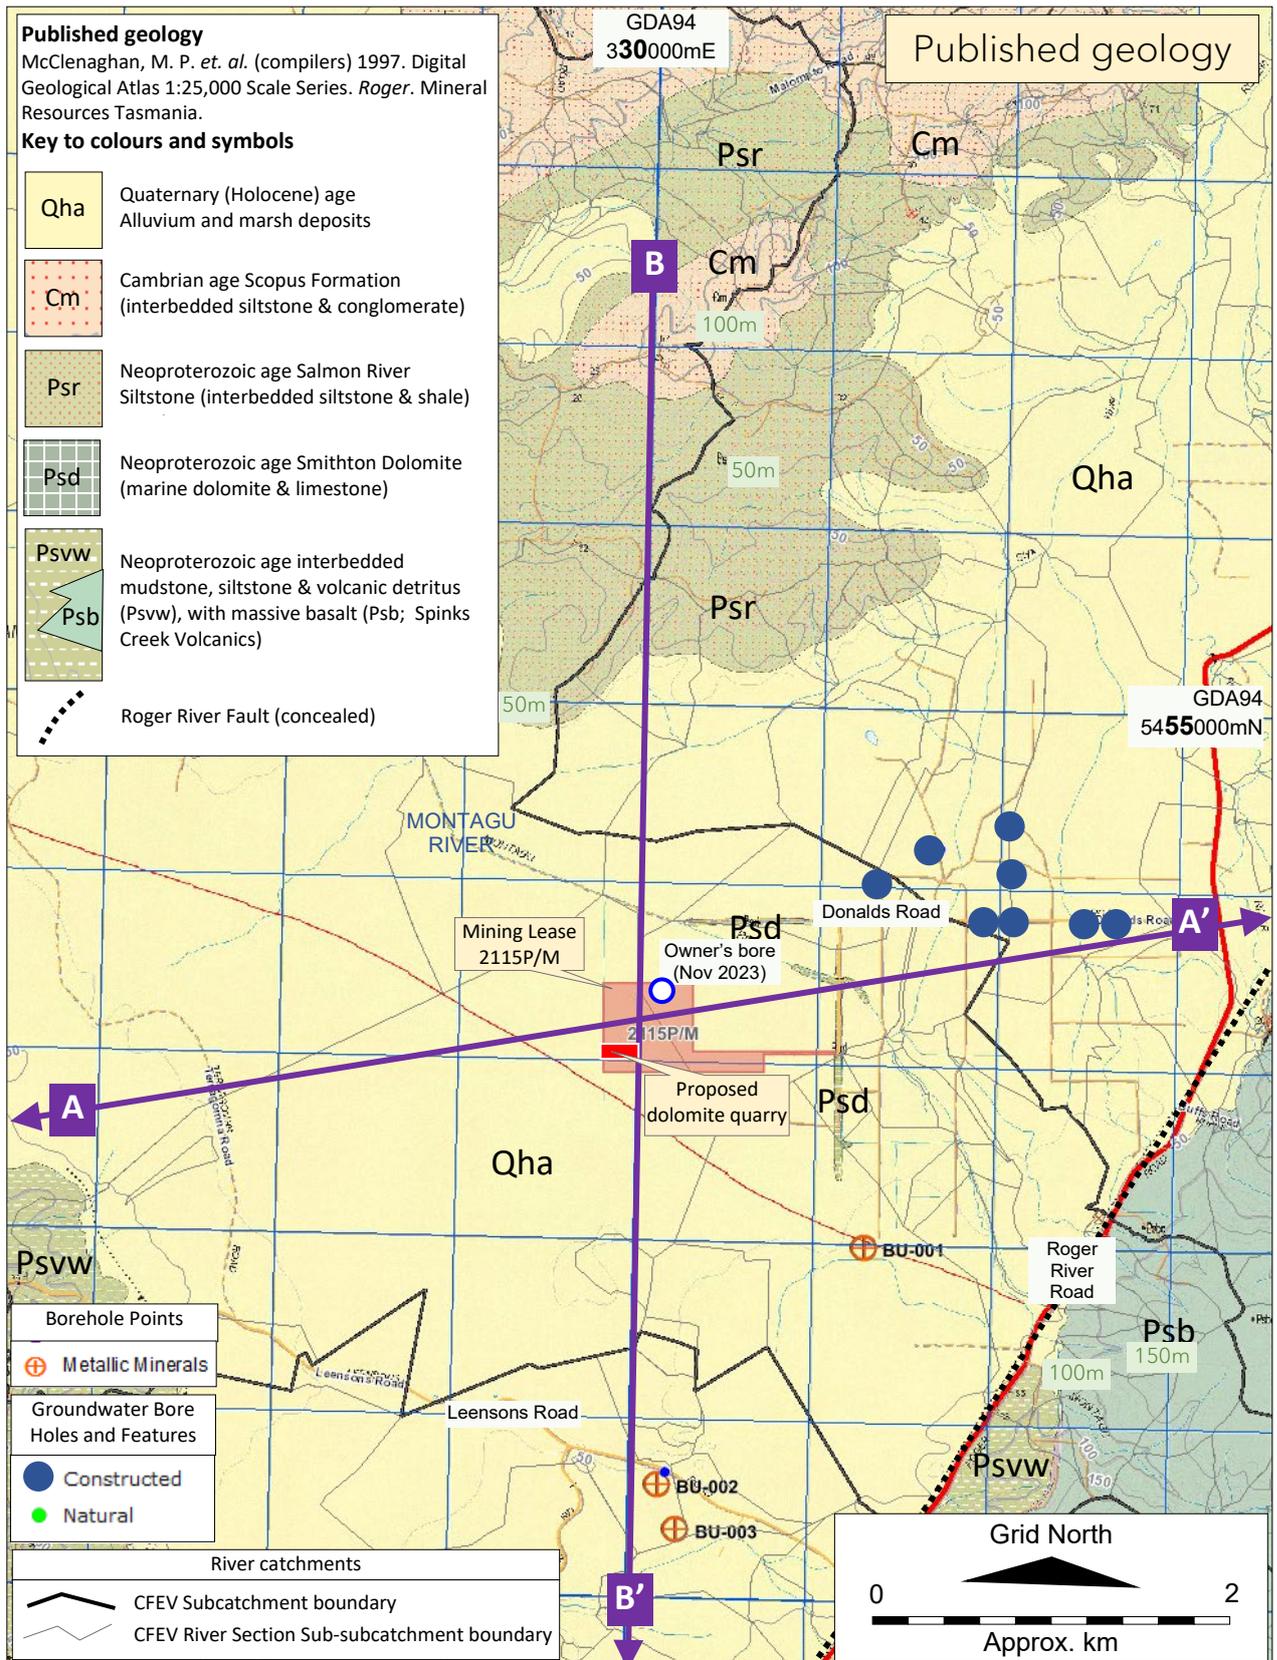
Figure 8. Published geology of the district surrounding mining lease 2115P/M. Contour interval 10m. Lines A - A' and B - B' are cross section lines for the conceptual hydrogeological models in Section 3.3 (note the lines extend off the map).

Quaternary (Holocene?)-age alluvium and marsh deposits are shown on the published geological map (Figure 8) across the flat ground in the vicinity of mining lease 2115P/M. However, these materials are less than 0.5m thick, or are absent altogether, at the proposed quarry site, and along parts of Donalds Road, and in the nearby Montagu River. Instead, Smithton Dolomite occurs as patchy outcrops and subcrops of hard, pale grey-cream, high-strength, slightly weathered flat-lying rock with sealed vertical fractures (Plates 1 – 4).

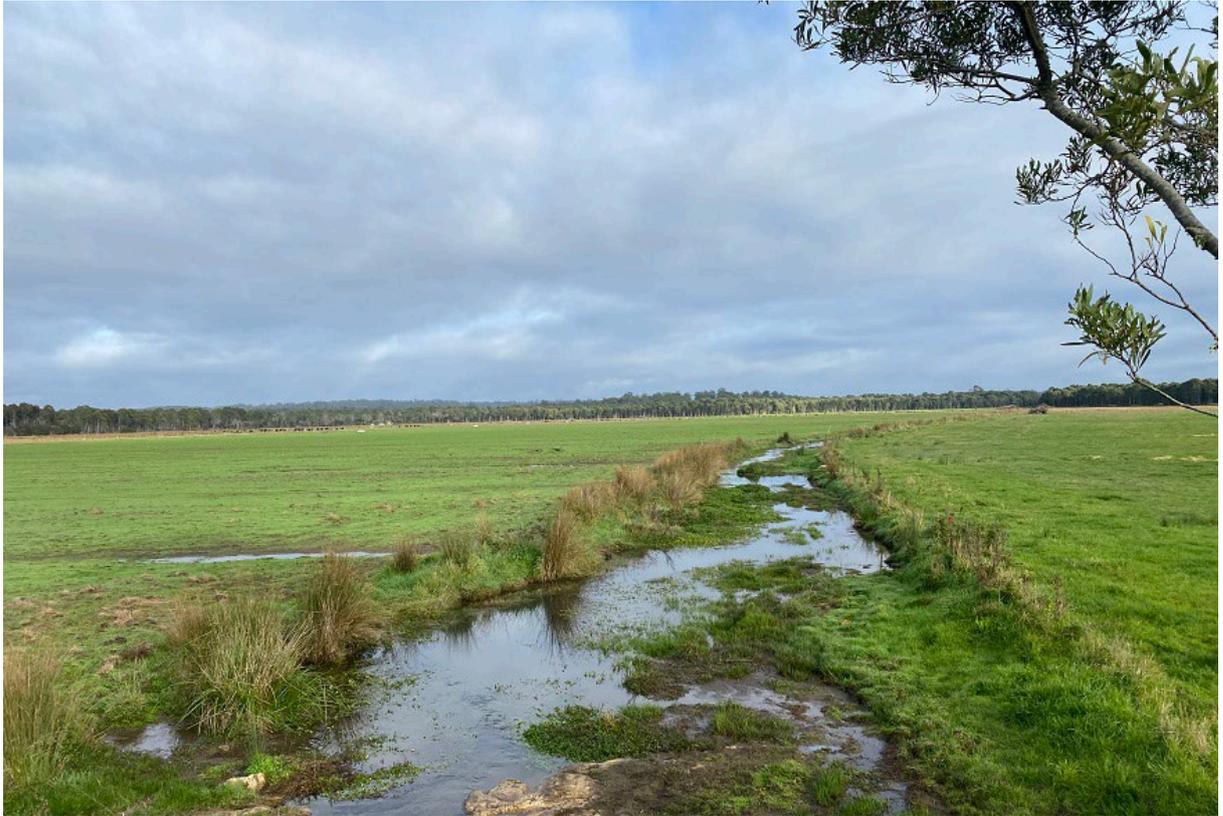
Plate 1. View northwest along the Montagu River from the small bridge on Donalds Road, about 1km east of the Cresswell site (near the tree line at left middleground). Smithton Dolomite crops out in its bed, at ground level, here and elsewhere along its artificially straightened course. (Photo: 1 May 2023)

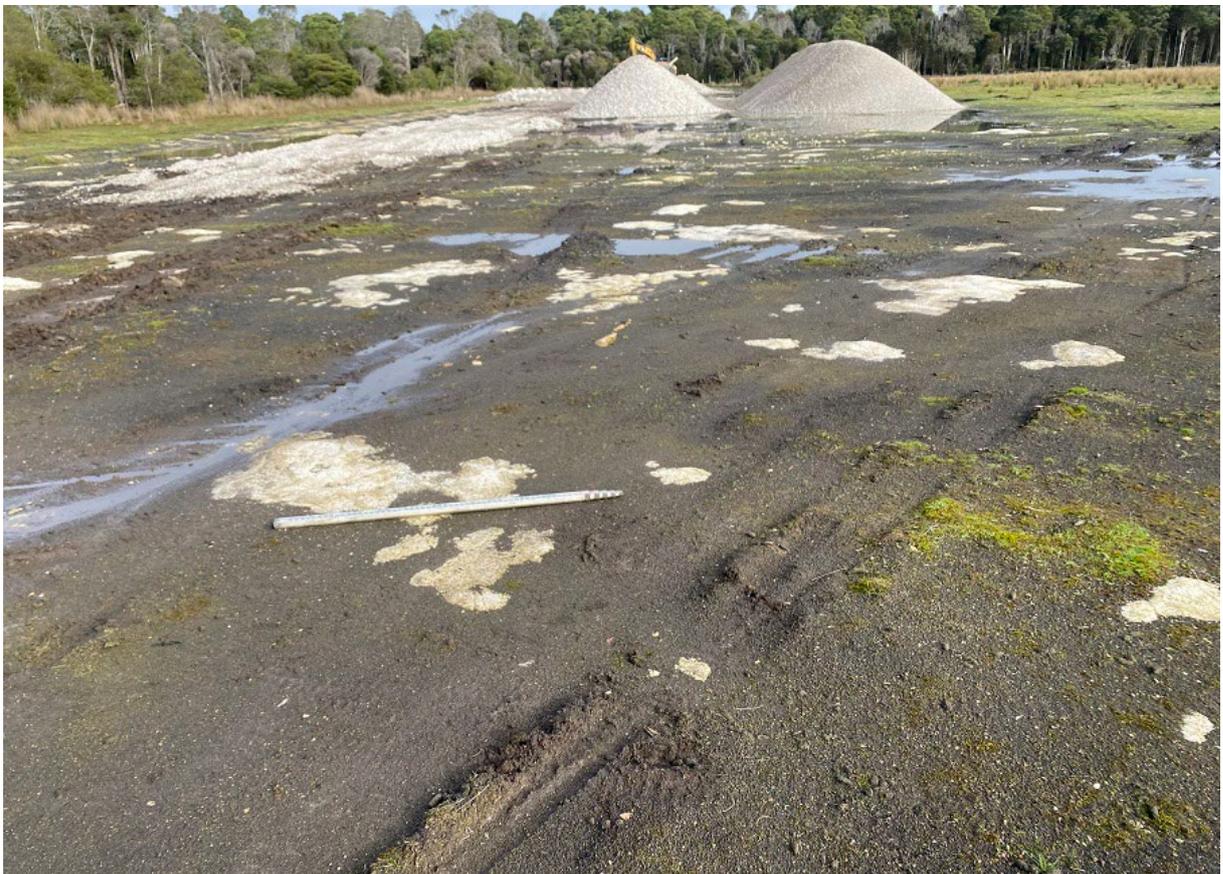
Plate 2. View looking west over the Cresswell site. Smithton Dolomite crops out at ground level throughout the immediate area. The staff is one metre long. (Photo: 1 May 2023)

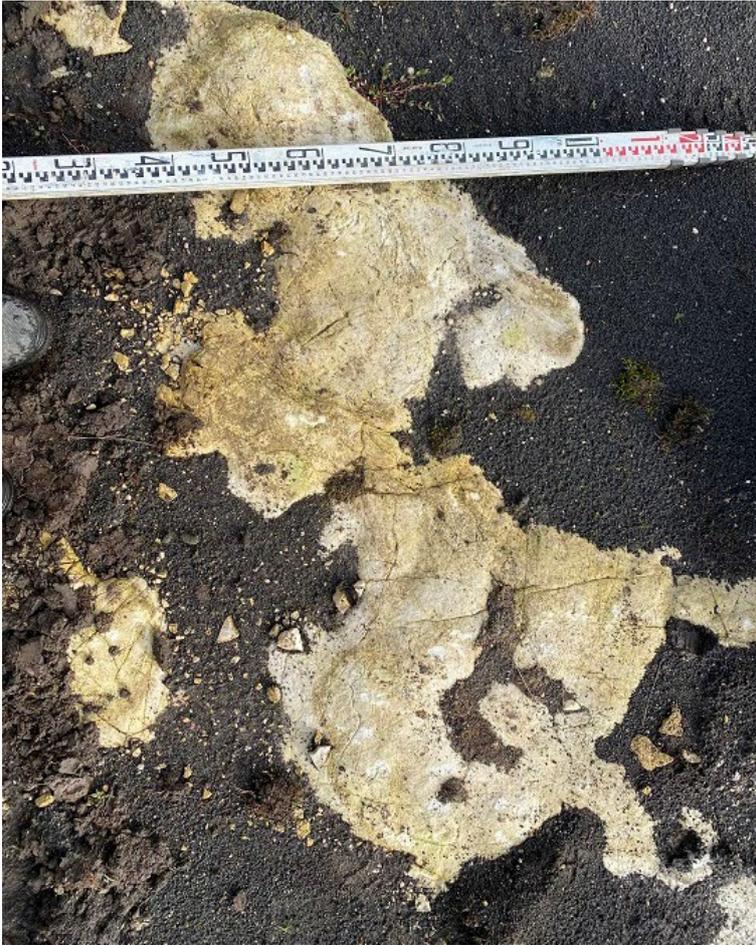
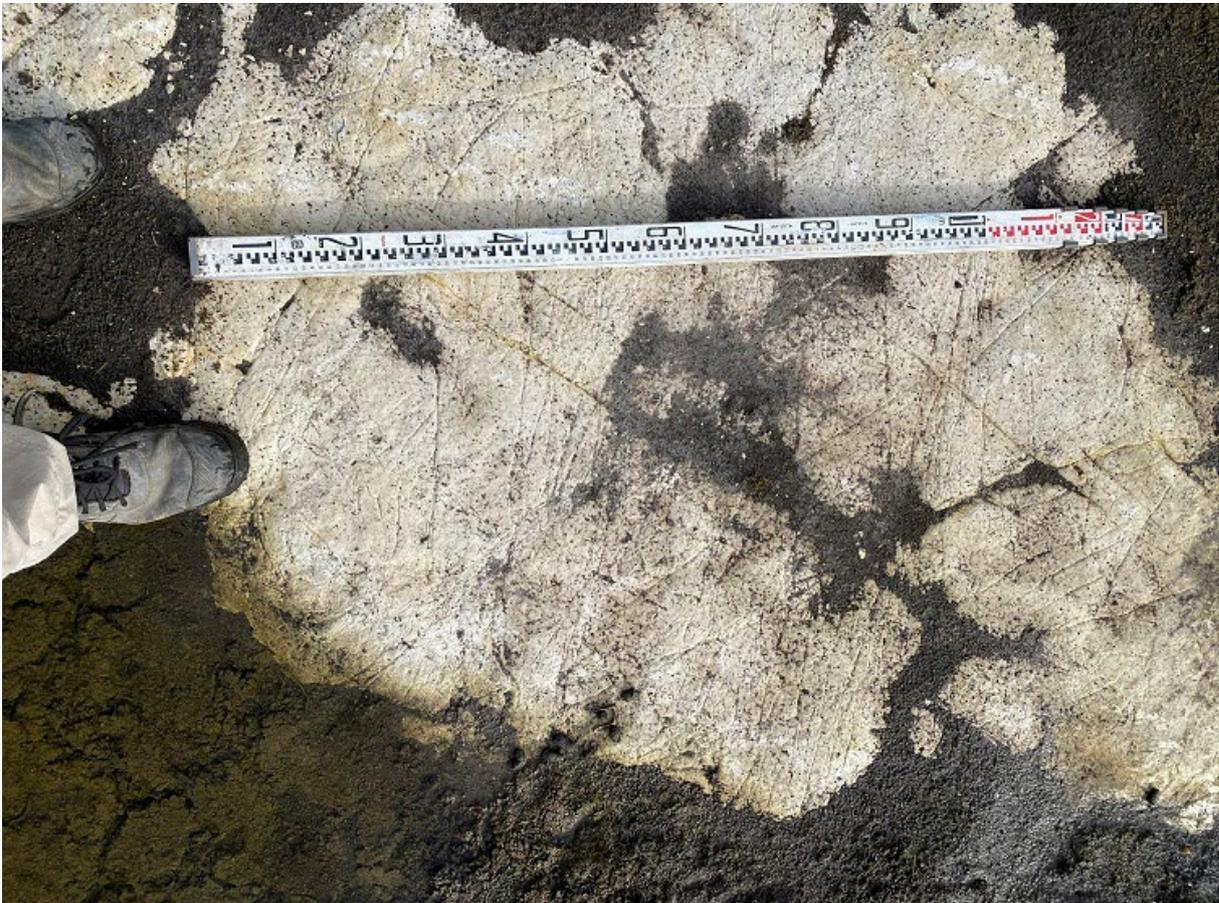
Plates 3 (left) and 4 (below). Vertical photos of outcropping Smithton Dolomite at the Cresswell site. The rock is high-strength and slightly weathered, with sealed subvertical fracturing. The staff is one metre long. (Photos: 1 May 2023)

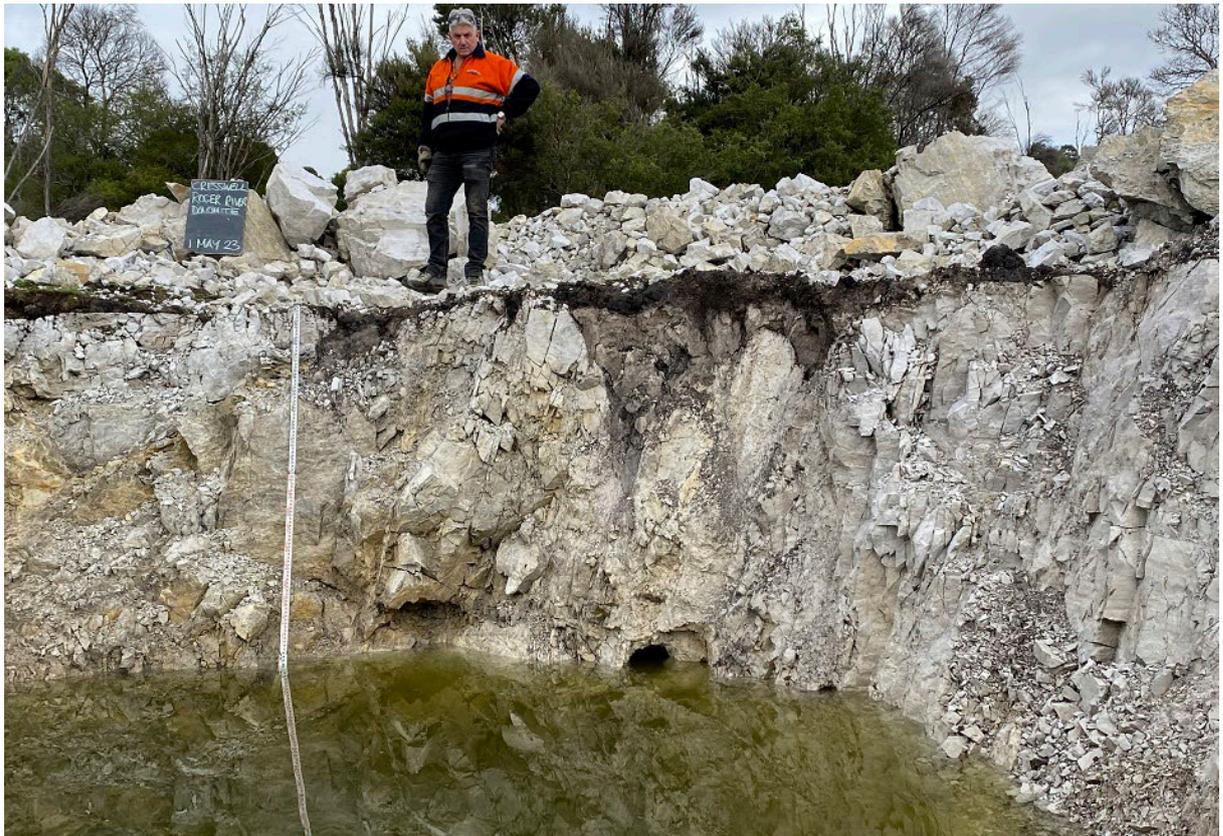
Plate 5 (above). The bulk sampling pit on 1 May 2023, looking southwest. Two metres of the staff project above the 2m deep water. The strong fracturing of the dolomite is due to blasting. The two dark circular areas at water level in the photo centre may be due to dislodgment of joint blocks, but the right hand one has some depth to it and it may be a small karst feature. The evidence is inconclusive. (Photo: Bill Cromer).

Consulting geologist Ken Morrison inspected the site and sampled stockpiles on 23 May 2023. He provided the following comments⁷ about rock properties and fracturing in the bulk sampling pit (Plate 5):

“Three joint-controlled fracture directions are prominent in the western wall of the pit; two sub vertical and one sub horizontal. Several compass readings on each gave the following average orientations (converted to true north bearings):

The residual water level in the pit was about 4 metres below surface at the time and there was no evidence of ground water transmitting through the open fractures at that depth. However, surface rain water was trickling down some of the open sub vertical fractures and slowly recharging the pit water. Not all fractures are open. Particularly in the sub horizontal set annealed insipient joints are more common than open fractures. It is not possible to tell if the open fracture have been enhanced by blasting, or even by stress release from the wall bounding the excavated void.

In the southern wall of the pit there is a sub vertical crush zone of brecciated dolomite fragments, quite tightly packed and not making water. This structure is interpreted as an annealed fault zone about 50 cm wide. Individual rock fragments look very fine grained and tightly packed, with no evidence of textural porosity or permeability. Any ground water below the depth of the pit will be transmitted through fractures. There is no evidence of karst features in the pit, which is consistent with the drilling results. The dolomite (strictly it should be called dolostone) is very consistent in texture, colour, fragment shape and softness. No cherty or shaley bands were noted in pit outcrop or on the stockpile, in contrast to some of the other Proterozoic dolomites quarried in Tasmania.”

Approximately 2m depth of water was present in the bulk sampling pit during the site inspection on 1 May 2023, and the water level was 2.1m below ground (Plate 5). The water level was at the ground surface in mid-November 2023 (Plate 6). It is not clear whether these levels represent a fluctuating water table, or whether the water is all or part groundwater because the pit had been subject to rain runoff before the visits.

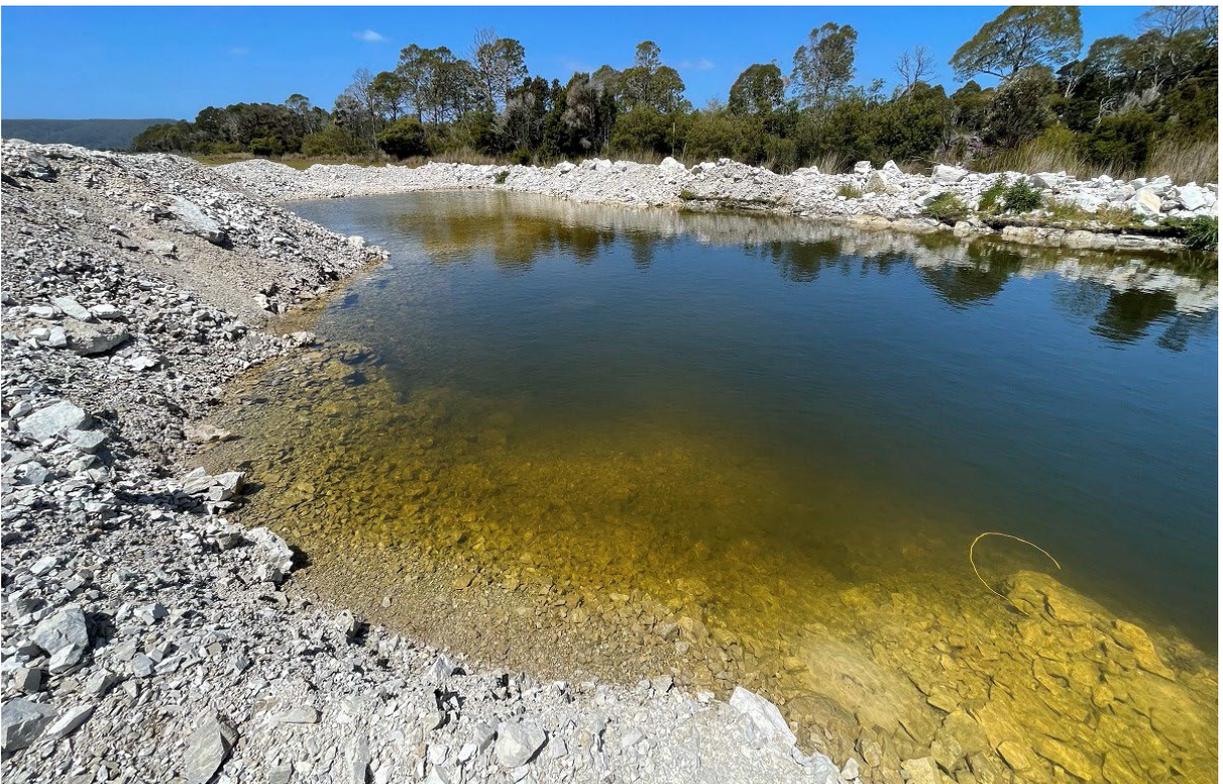
Plate 6 (below). The bulk sampling pit on 14 November 2023, looking east from the same location as Plate 5. It is likely the full water level is mainly due to surface runoff from surrounding ground. (Photo: Maja Aspaas, ES&D).

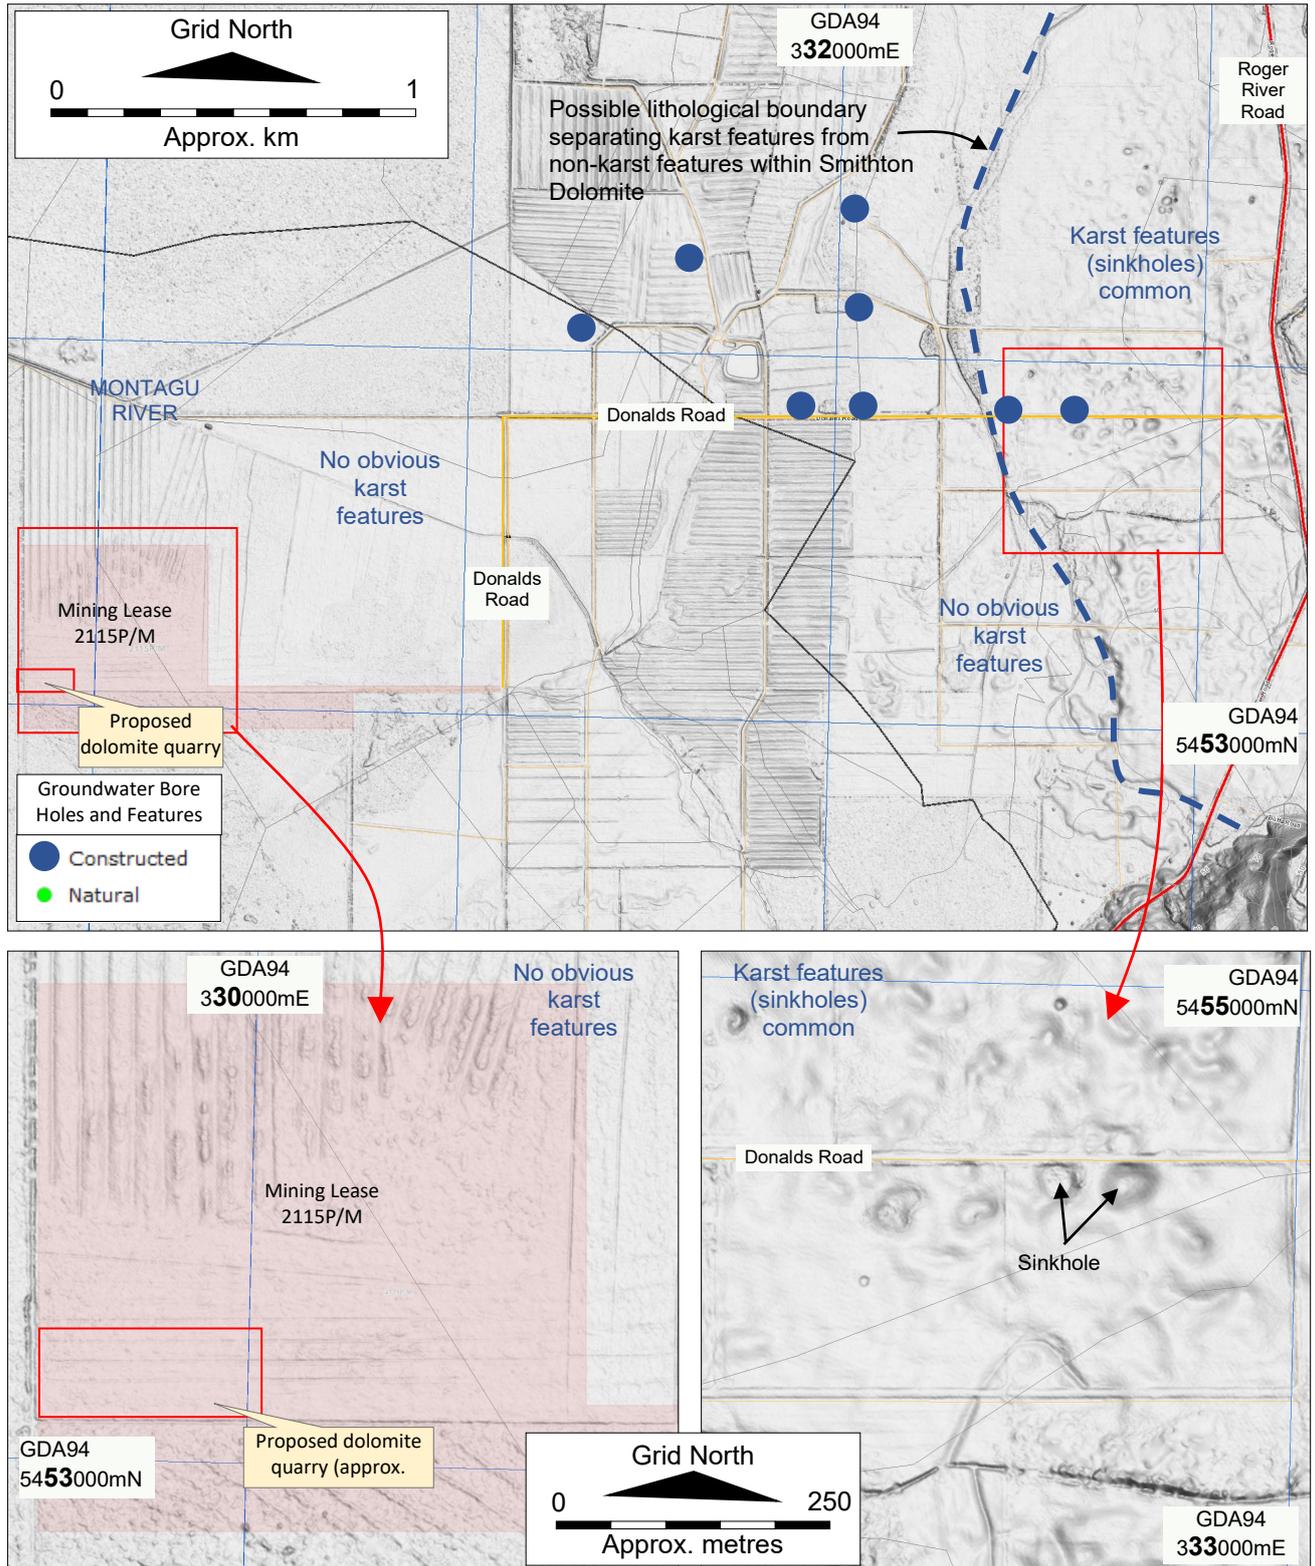
Figure 10. Hillshading in the vicinity of the proposed dolomite quarry, showing karstic features (sinkholes) in the Smithton Dolomite near the Roger River Road-Donalds Road intersection, but an apparent absence of similar features near the proposed quarry.

⁹ Dolomite is less soluble than limestone: the areas of sinkholes in Figures 10 and 11 may reflect rocks with less magnesium content compared to those further to the west.

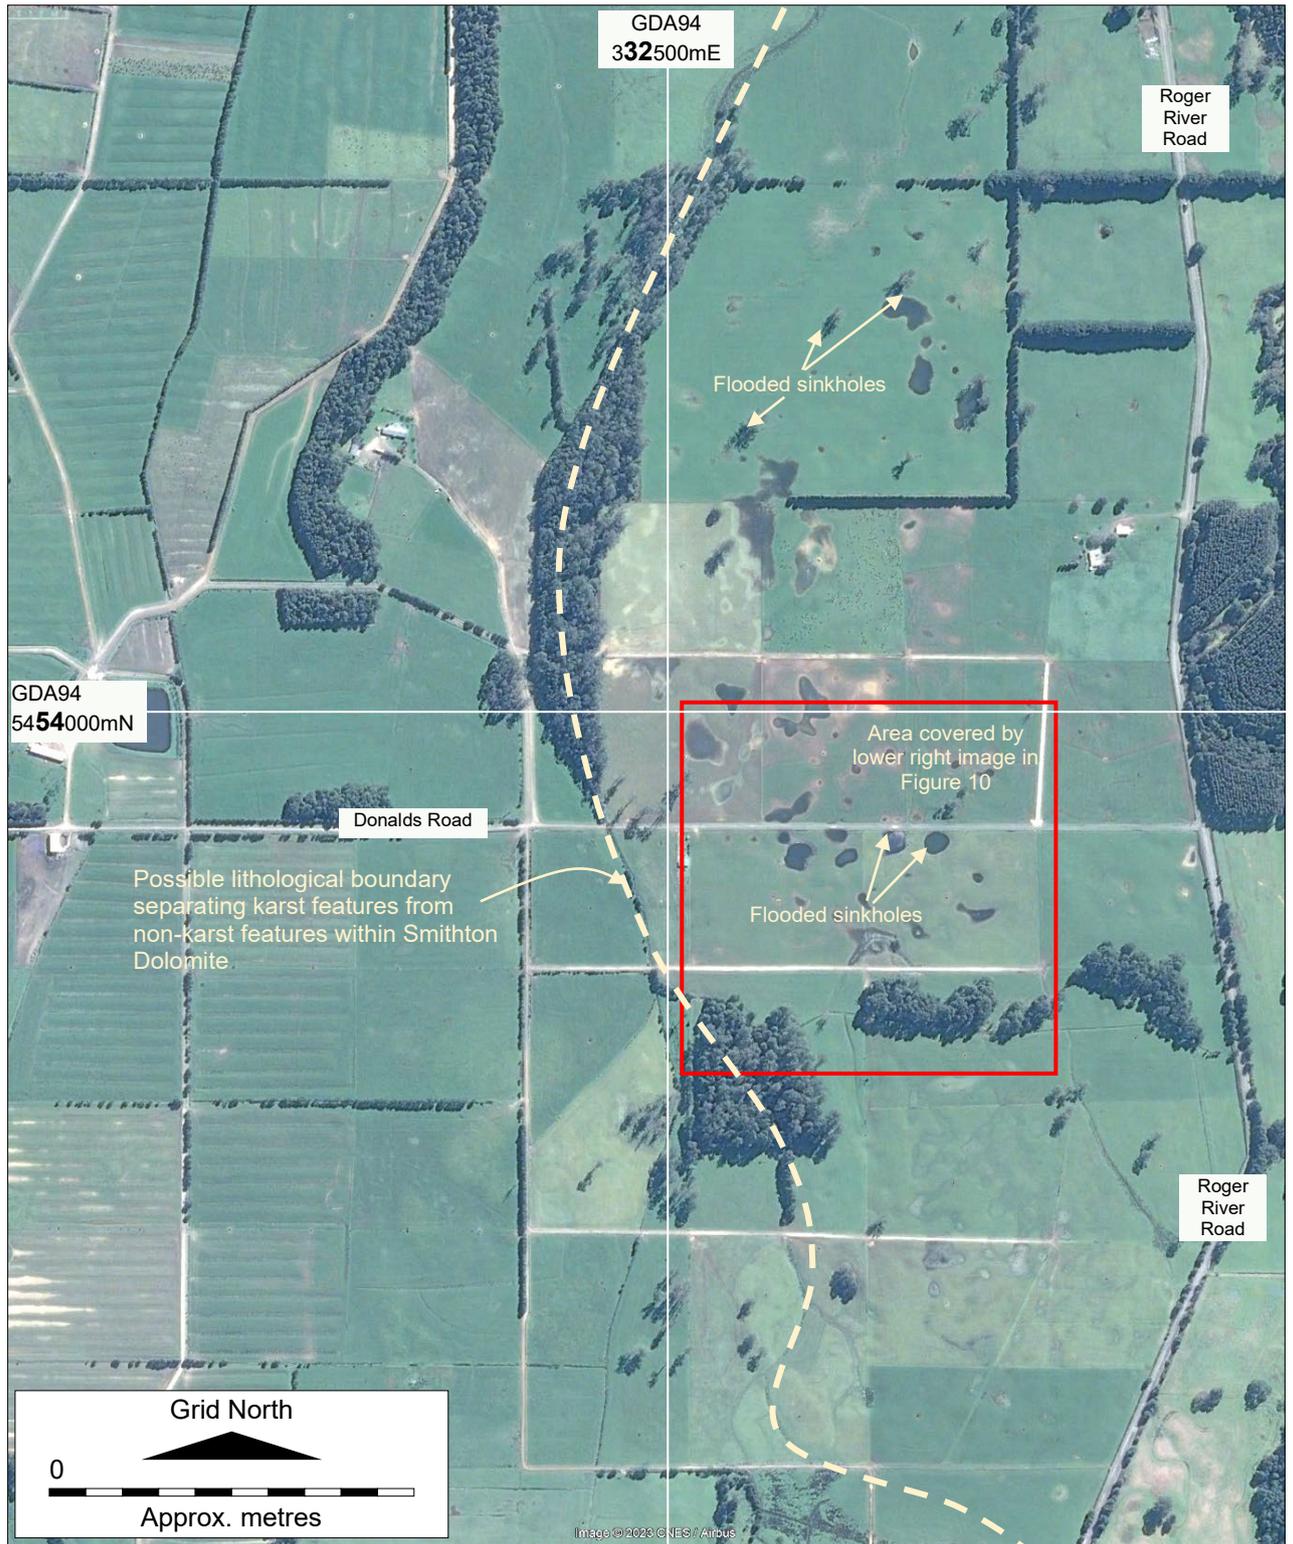
Figure 11. Flooded sinkholes on 12 September 2013 near the Roger River Road - Donalds Road intersection. This situation very likely reflects a high groundwater table related to unusually heavy rain: Table 1 shows that the 382mm of monthly rain recorded in August 2013 at Edith Creek was the highest since records began in 2011. This followed 228mm in July 2013, also a 90%ile rain month.
Source: Google Earth

Adding further to the uncertainty of local-scale groundwater conditions is that if unusually high rain events raise the water table closer to the surface (as shown in Figure 11) the flat-lying areas would have almost no water table gradient. Under these conditions, irrespective of aquifer permeability, local-scale groundwater flow in any direction would almost not occur.

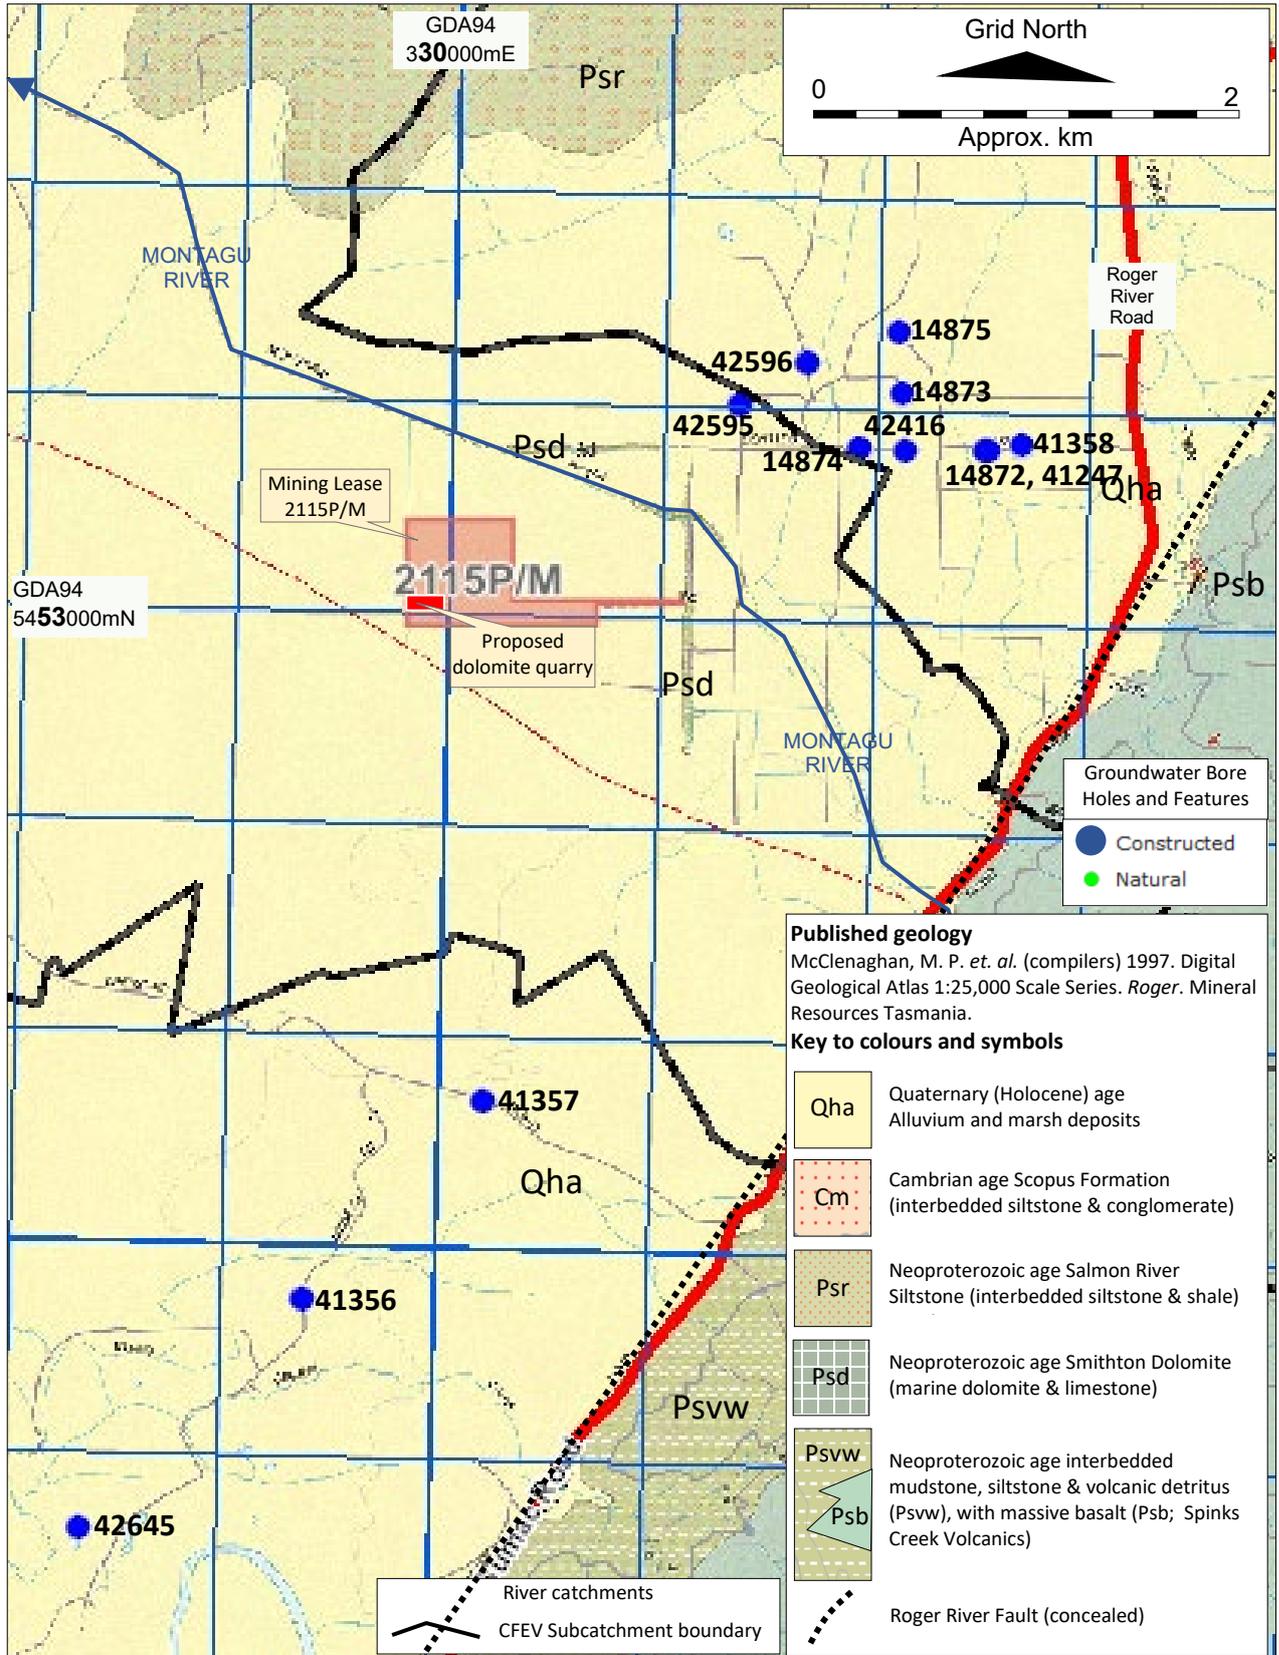
Figure 13. Locations of water bores drilled in the vicinity of mining lease 2115P/M. Bore numbers correspond to those in Table 2. Source: DPIWPE <https://wrt.tas.gov.au/groundwater-info/>

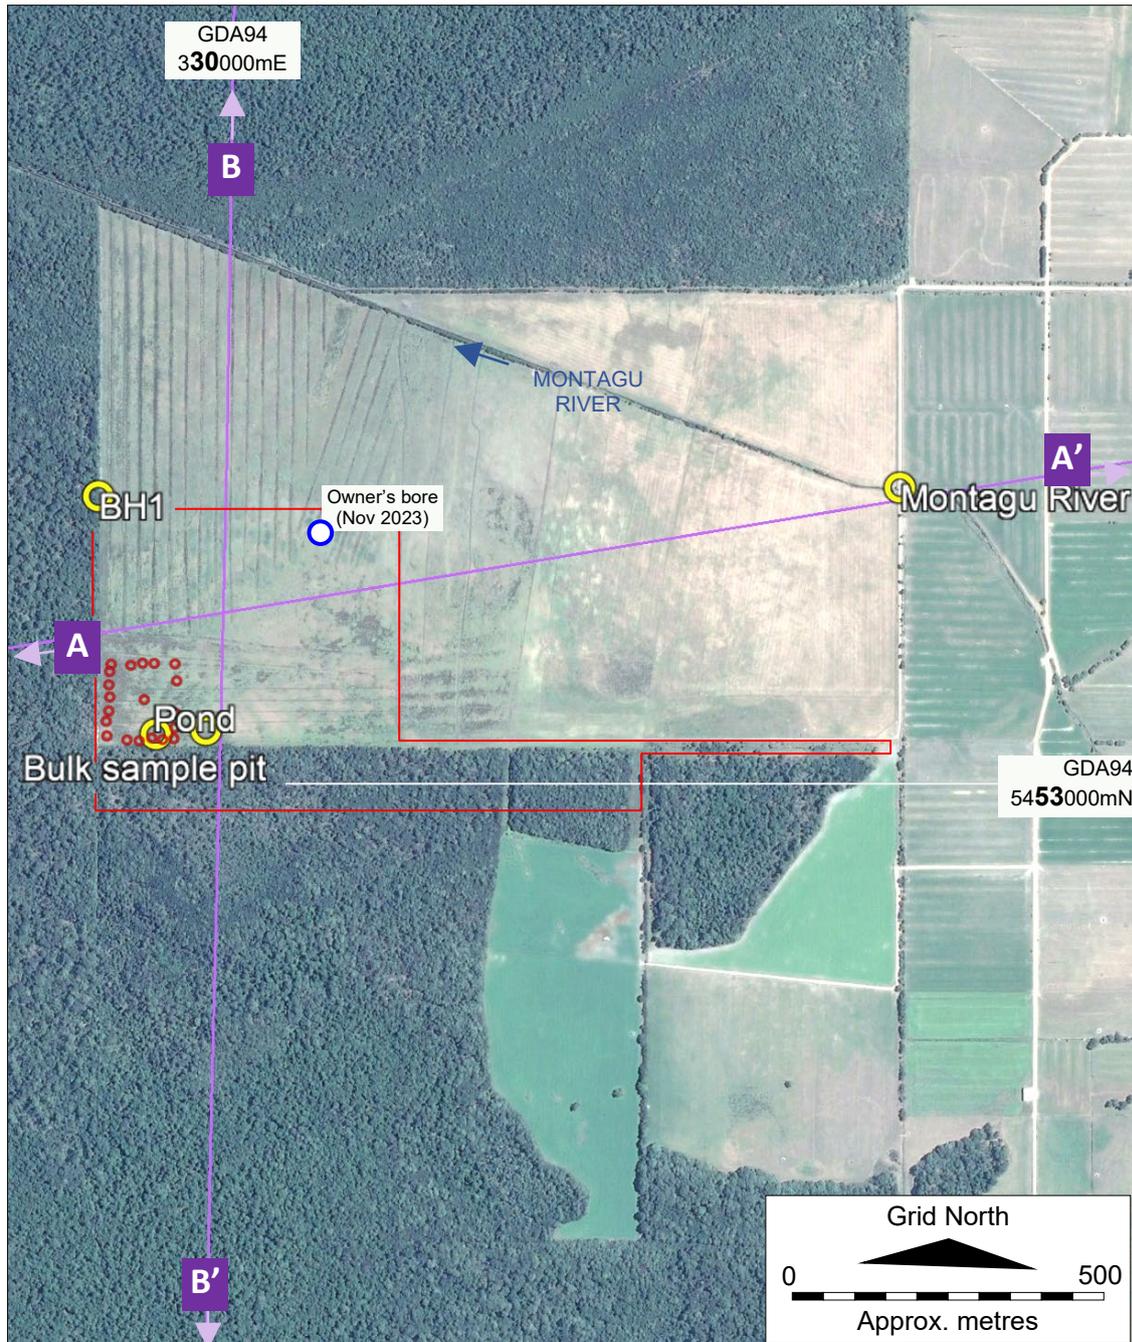
Figure 14. Water sample locations (yellow and white circles) during the site inspection of 1 May 2023 and (except for the Pond) the follow-up sampling event of 14 November 2023. Also shown are exploration rotary-percussion drill holes RR1 - RR20 (red circles) drilled February 2021 (Morrison, 2022). Mining lease 2115P/m is bordered in red.

Lines A - A' and B - B' are cross section lines for the conceptual hydrogeological models in Section 3.3 (note the lines extend off the map).
