CRESSWELL'S TRANSPORT PTY LTD

PROPOSED DOLOMITE QUARRY
DONALDS ROAD, ROGER RIVER WEST

HYDROGEOLOGICAL REPORT
and
GROUNDWATER MANAGEMENT PLAN

December 2023
Revision 2

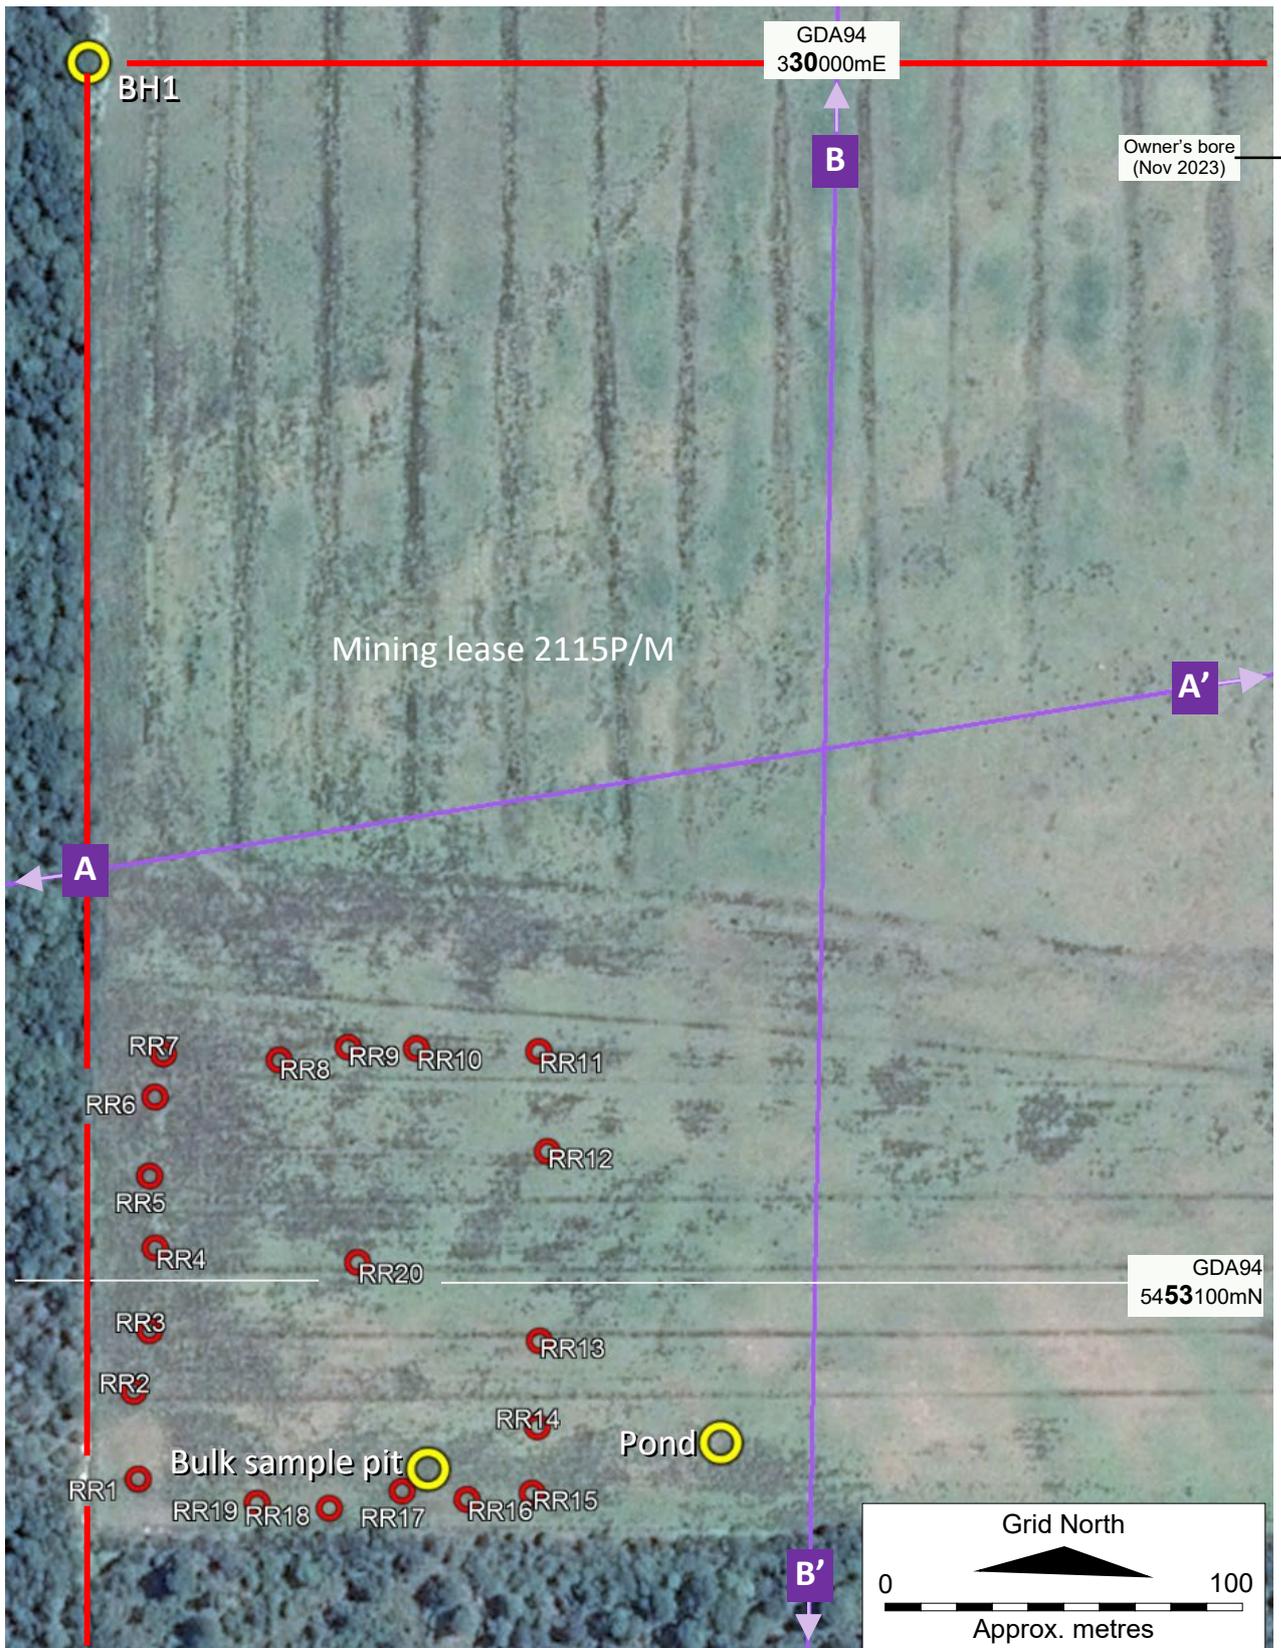
Figure 15. Water sample locations (yellow circles) during the site inspection of 1 May 2023, and exploration rotary-percussion drill holes RR1 - RR20 (red circles) drilled February 2021 (Morrison, 2022). The red line is the border to 2115P/M.

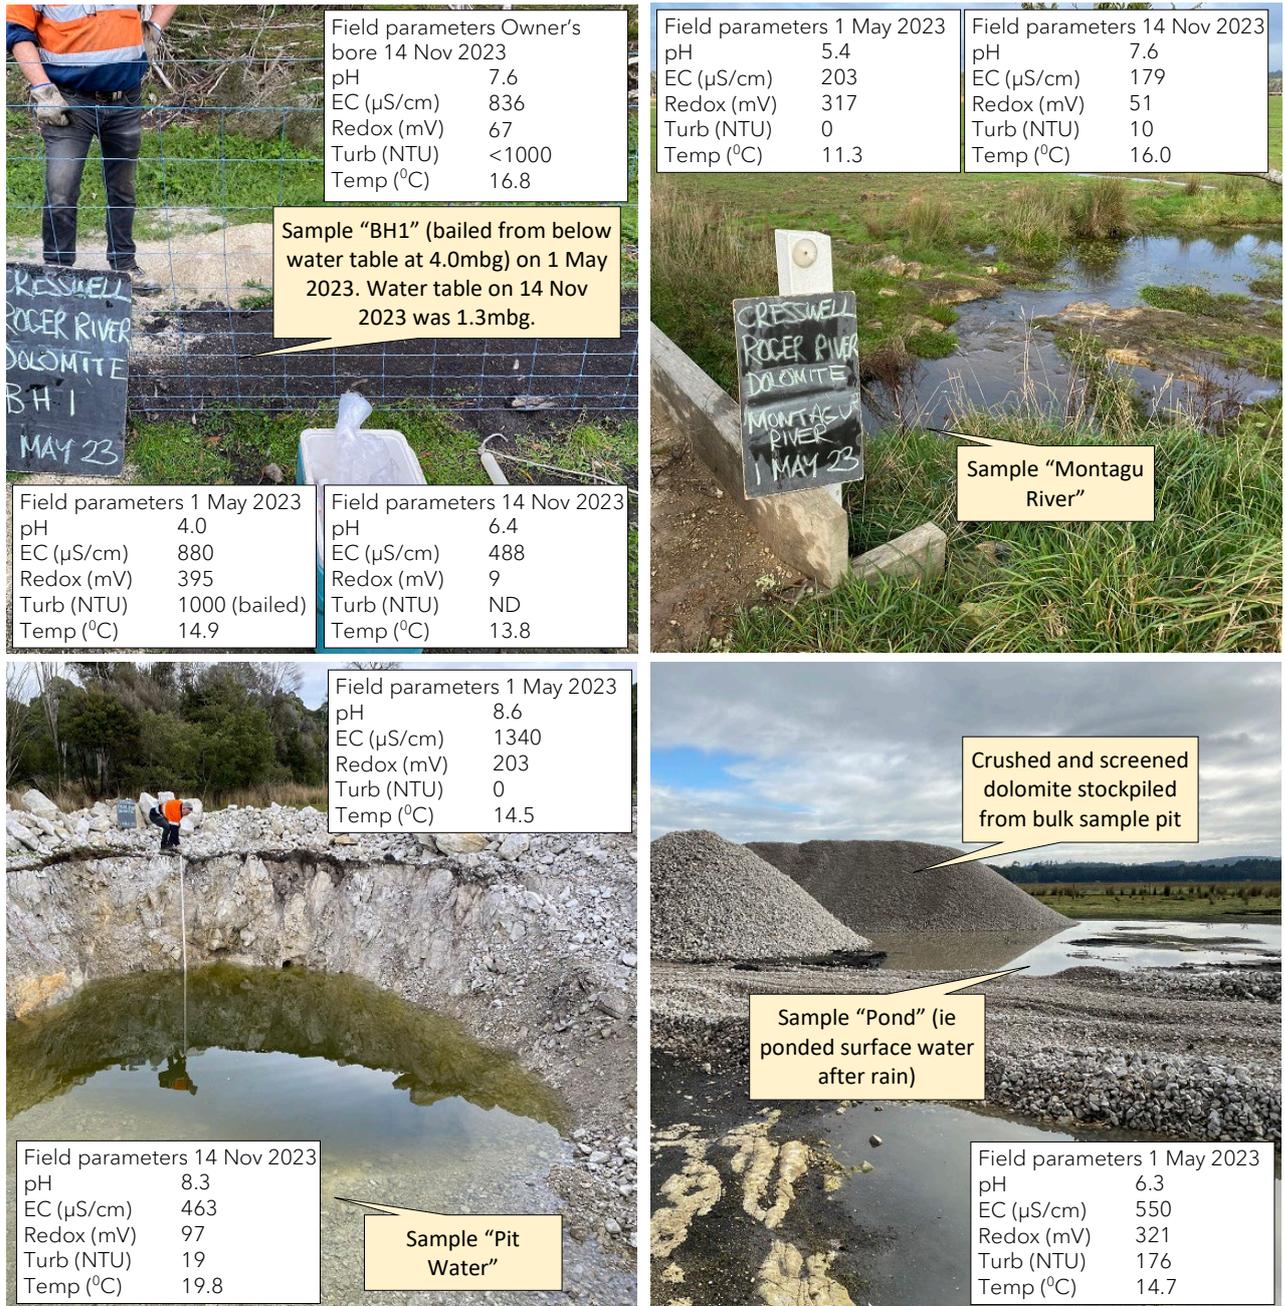
Figure 16. Photographs of water sample locations of the site inspection of 1 May 2023, and field parameters for 1 May and 14 November 2023 sampling events.

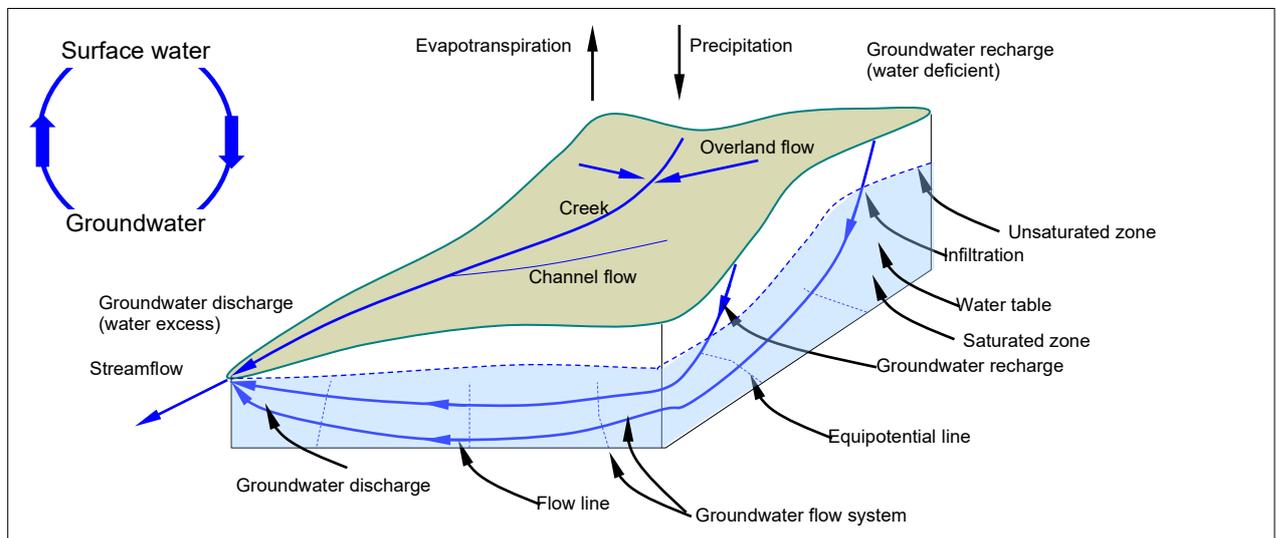
Figure 18. Aspects of the land-based hydrological cycle

In unconfined, fractured rock environments, Figure 18 illustrates different components of the land-based part of the hydrological cycle¹⁴ at the scale of a single catchment or smaller. Effective rain (precipitation less evapotranspiration) flows overland to surface streams, or in recharge areas infiltrates (at a rate determined by soil and rock permeability) through the unsaturated zone to the water table. An important aspect of Figure 18 is the interconnectivity between surface water and groundwater.

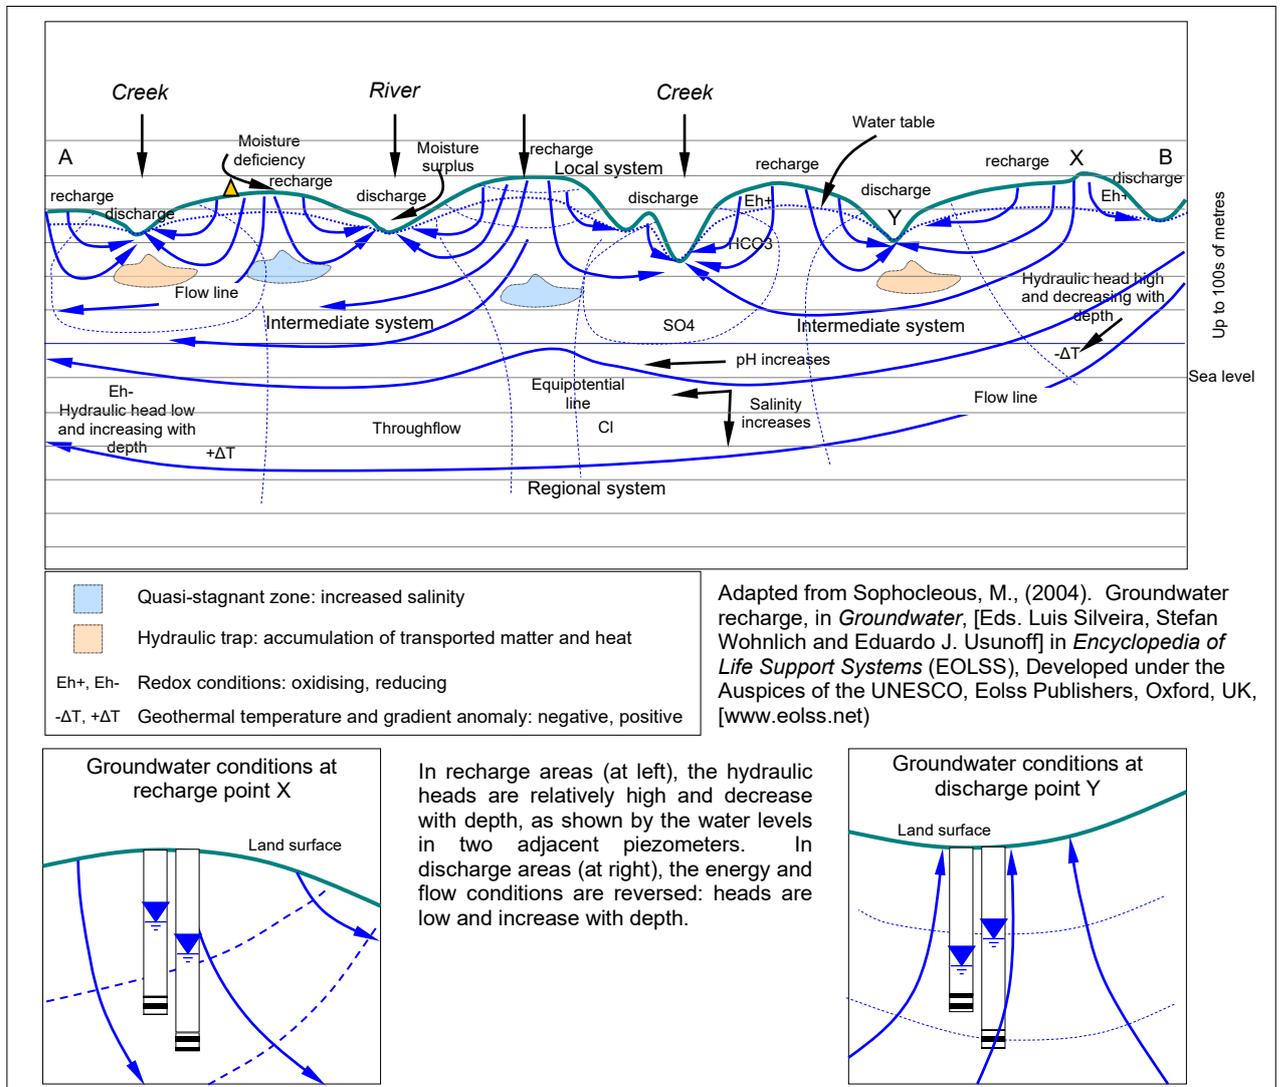
Figure 19. Fundamentals of groundwater hydrology in a gravity-driven groundwater system. Vertical exaggeration for the top section is about 5.

The fundamentals of groundwater movement in an unconfined, gravity-driven groundwater flow system (GFS) are depicted schematically in Figure 19. Important points are:

- the hydraulic heads in recharge areas are relatively high and decrease with depth. In discharge areas, the energy and flow conditions are reversed; heads are low and increase with depth. In between, the throughflow is almost horizontal as shown by the steeply dipping equipotential lines.

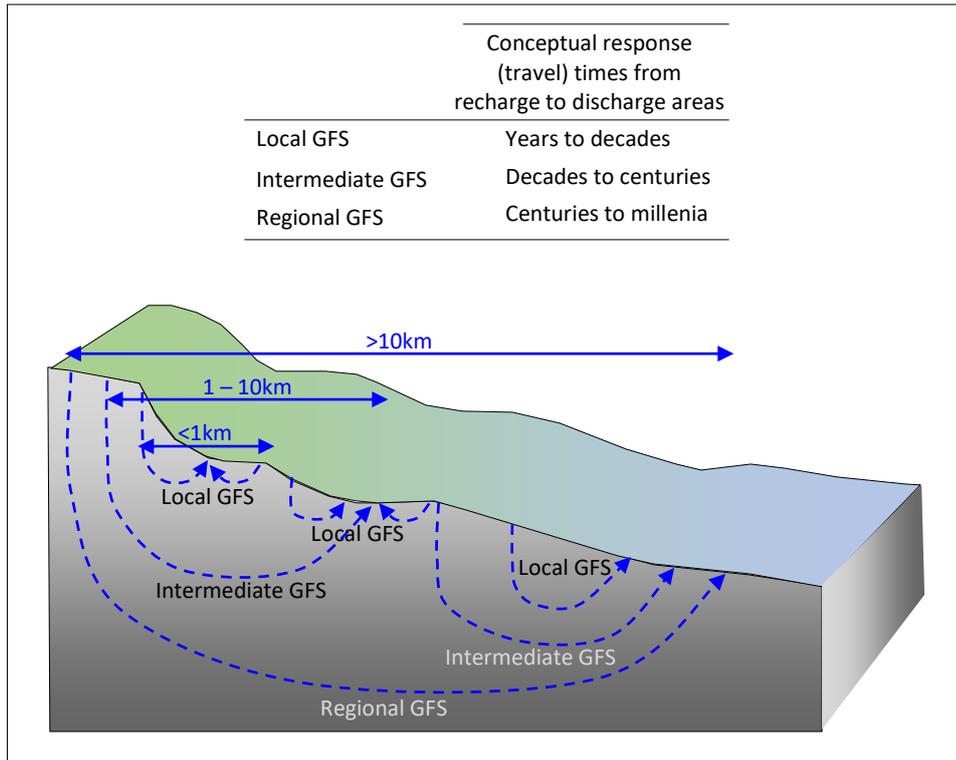
Figure 20. Conceptual sizes and response (travel) times for groundwater in Tasmanian local-, intermediate- and regional- GFS's. Blue dashed lines are some idealised groundwater flow lines. Adapted from Hocking et. al. (2015; Table 1 and Figure 15)

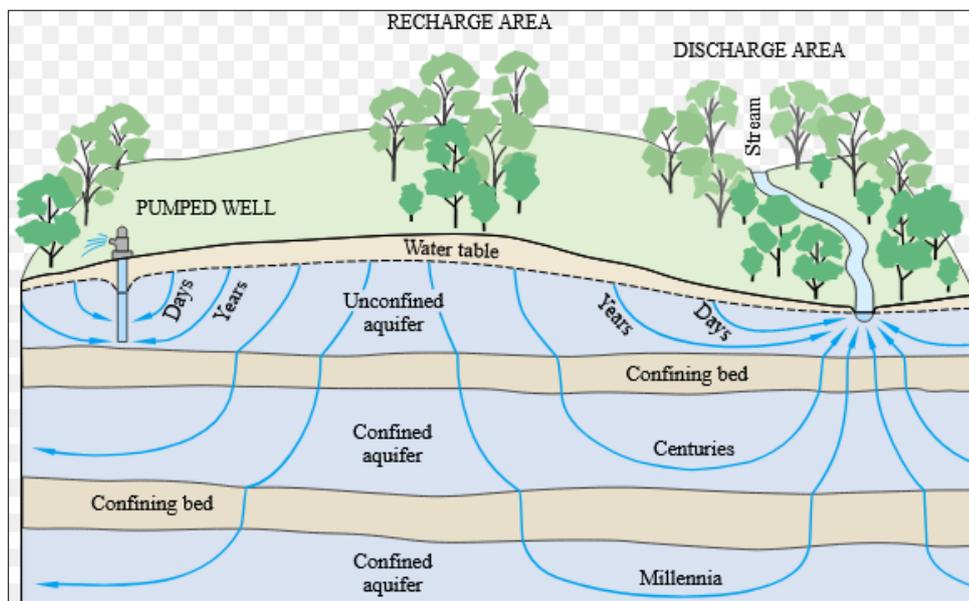
Figure 21. A schematic diagram showing that inferred travel times for groundwater flow (blue lines) in interbedded unconfined and confined conditions may range from days to millennia depending on the travel distance. Source: <https://en.wikipedia.org/wiki/Groundwater>

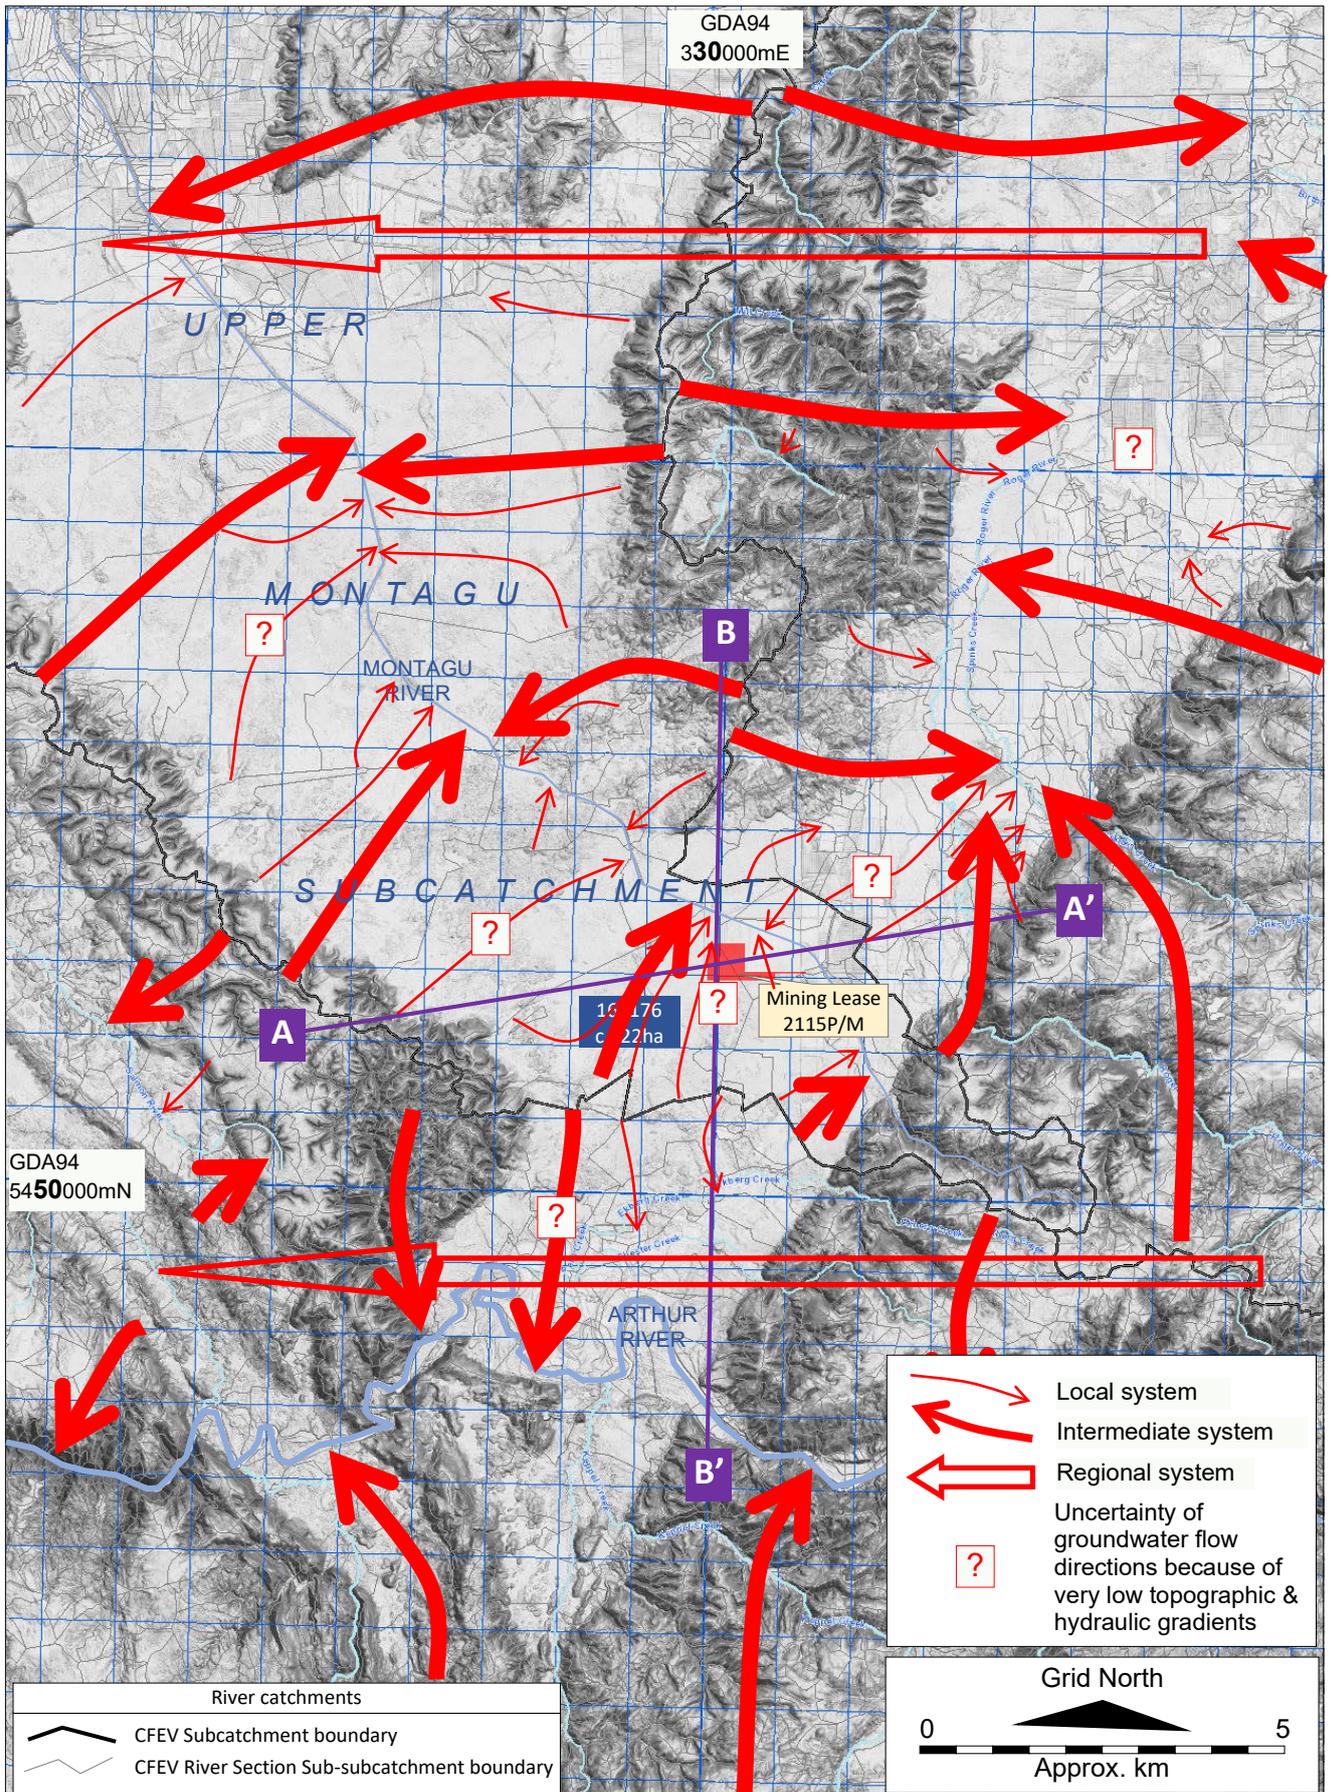
Figure 23. Inferred and approximate local, intermediate, and regional groundwater flow directions in the southern part of the Smithton Basin, including mining lease 2115P/M. Source for hillshading: www.thelsit.tas.gov.au.

Figure 23 indicates local (and intermediate) groundwater flow is northeasterly to the Montagu River. However, this is uncertain. In early May 2023, the water table in bore BH1 was estimated to be at least 3m lower than the water level in the Montagu River, and in the bulk sampling pit water level was perhaps a metre lower. In November 2023, the water table in BH1 was at a depth of 1.3m (Figure 16). The seasonal and longer variability in water table depth is unknown, but so long as the observed differences in water levels are maintained, shallow groundwater from mining lease 2115P/M cannot report to the Montagu River.

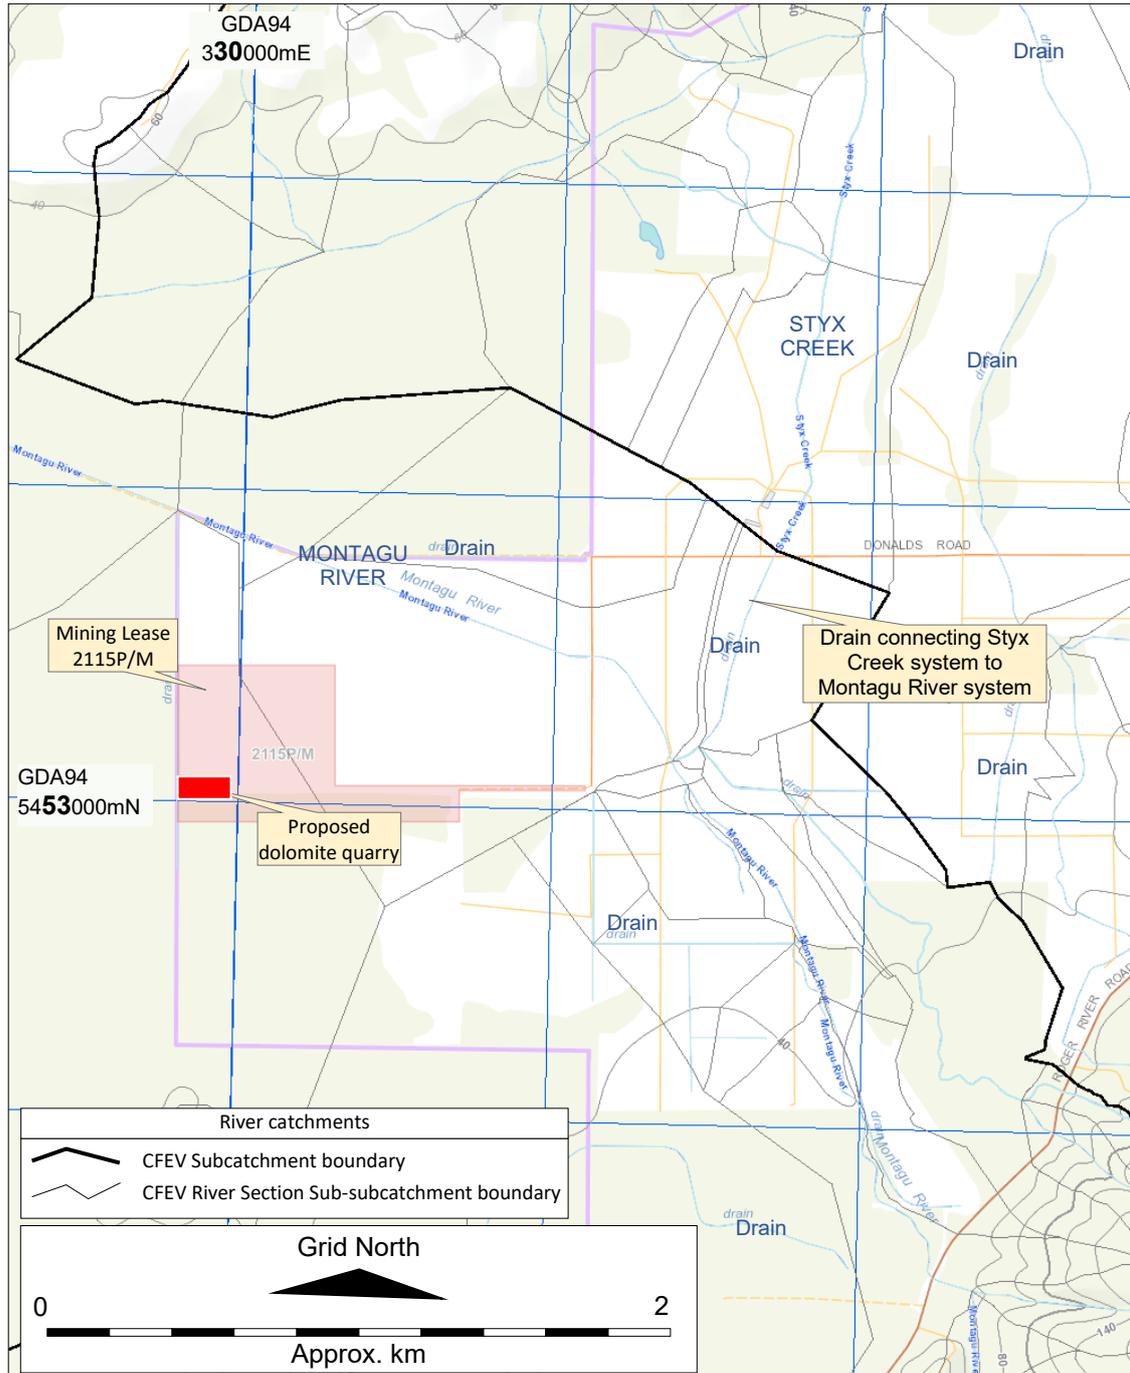
Figure 24. Artificial drains in the vicinity of mining lease 2115P/M.
Source for base map: www.thelsit.tas.gov.au.

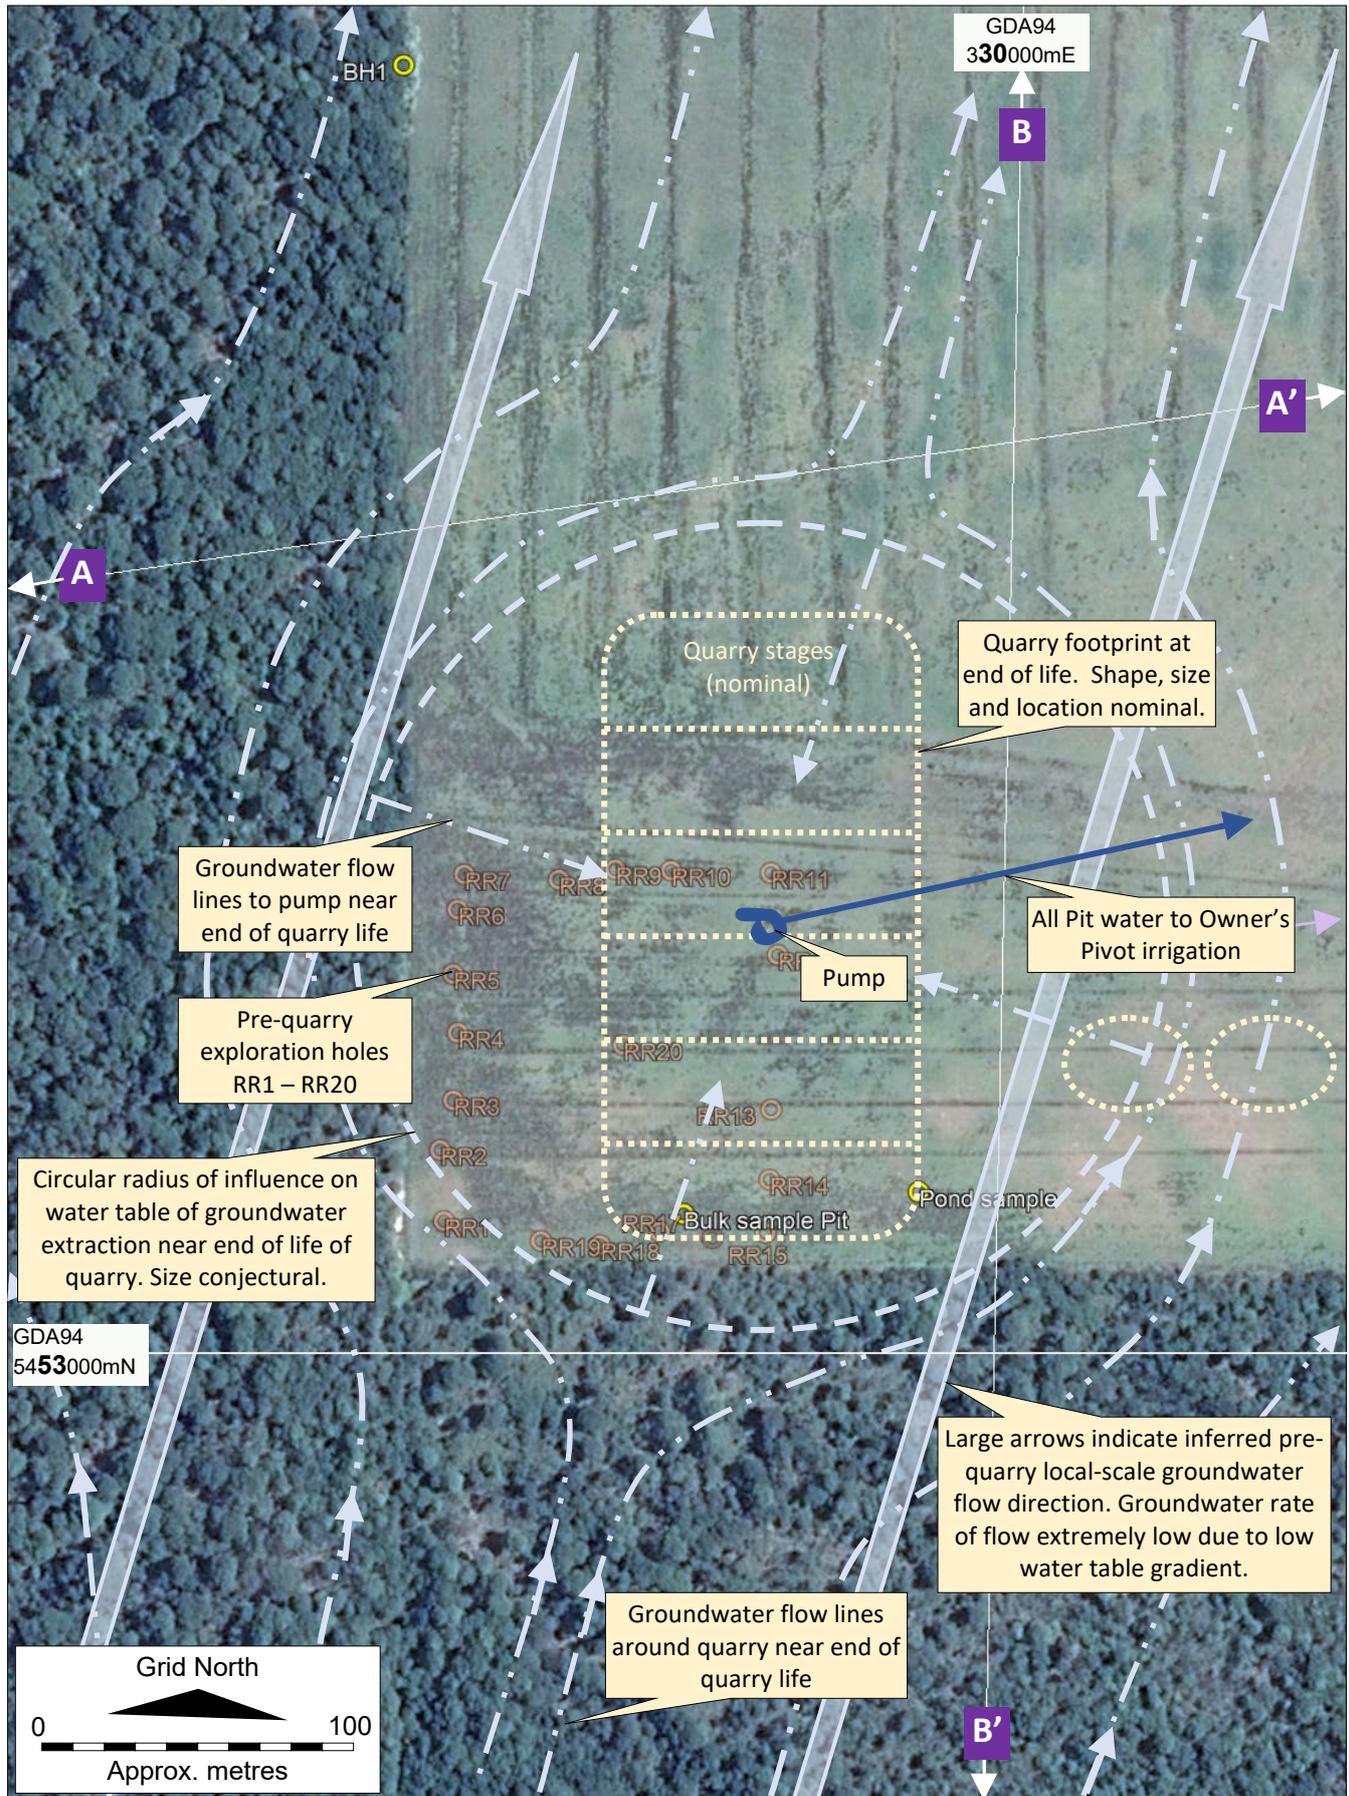
Figure 25. Conceptual interpretation of effect on groundwater conditions of groundwater extraction from the quarry near the end of quarry life, assuming a 5m deep excavation over the footprint, and the need to dewater the pit.

These observations and inferences are schematically depicted in Figure 25, showing current and inferred operational groundwater conditions towards the end of quarry life.

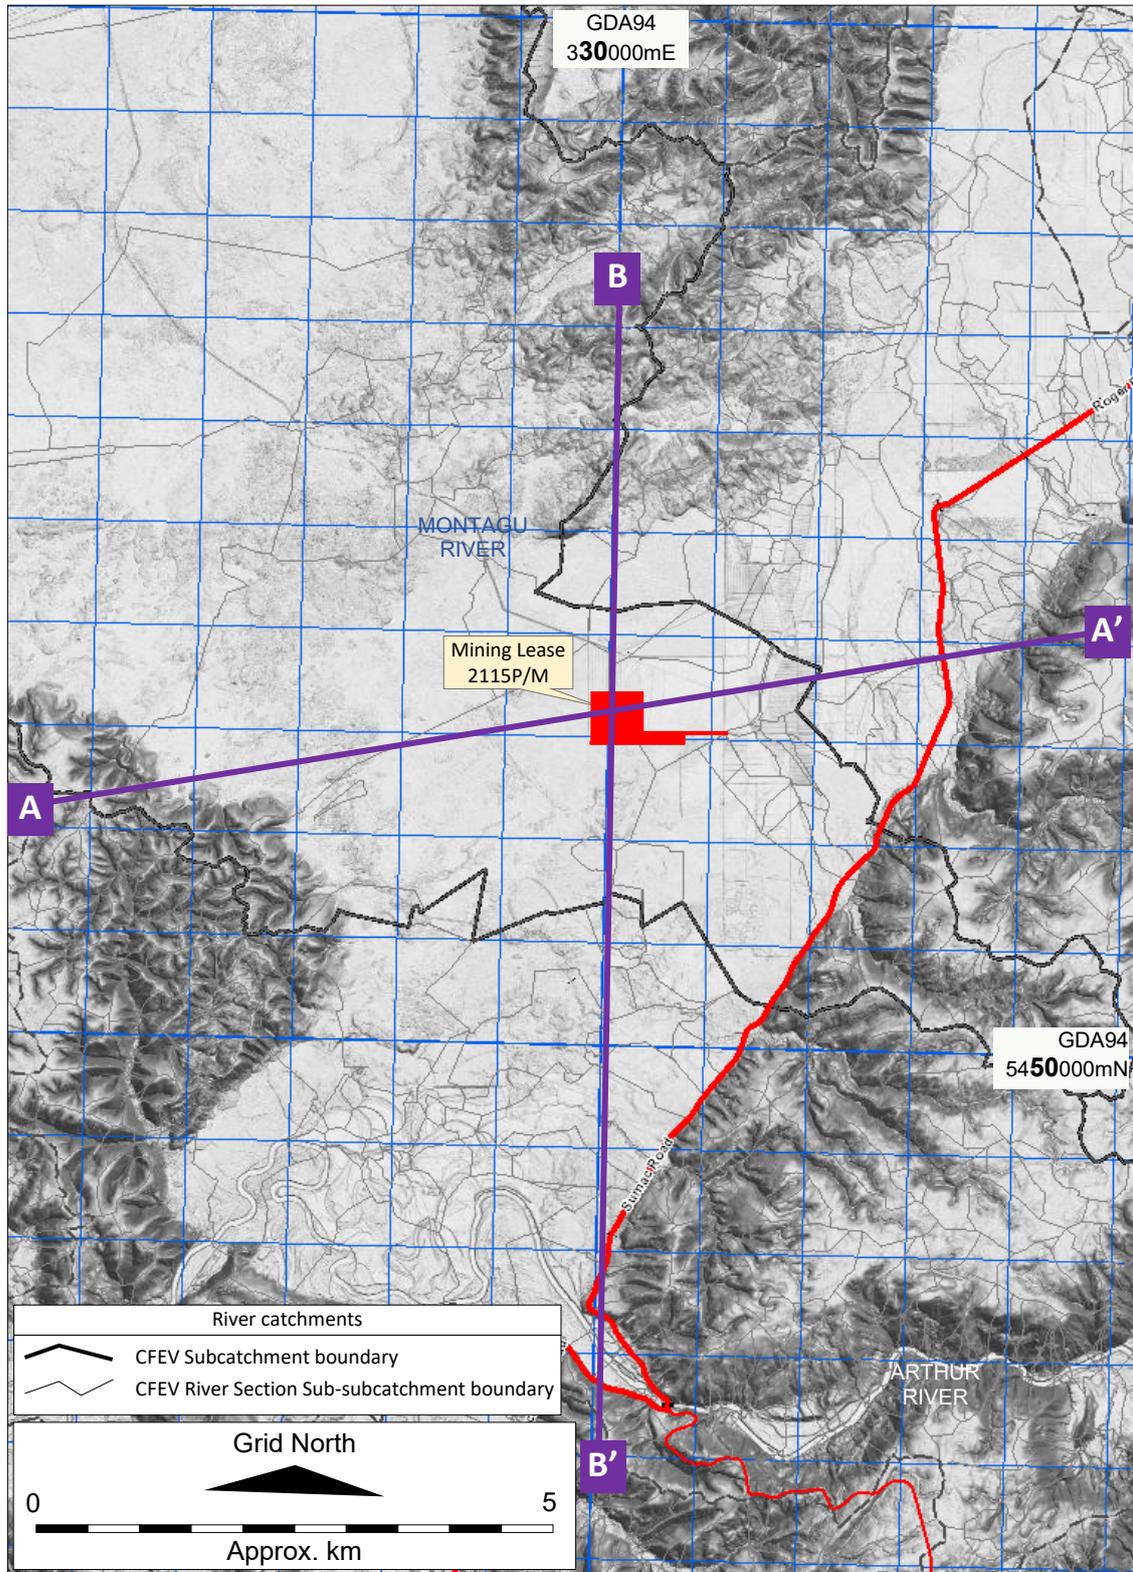
The locations of the two section lines are shown on the hillshade image on the following page, and also on various other maps in the report. Section line A – A' is aligned WSW – ENE (not west-east and not orthogonal to line B – B') to include elevated ground at both ends within a 10km length, and also karst features in the Smithton Dolomite near the Roger River Road-Donalds Road intersection.
