ANNUAL REPORT

RETENTION LICENCE 8802

CONSOLIDATED MINING LEASE 46M/90

MAIN CREEK, SAVAGE RIVER, TASMANIA

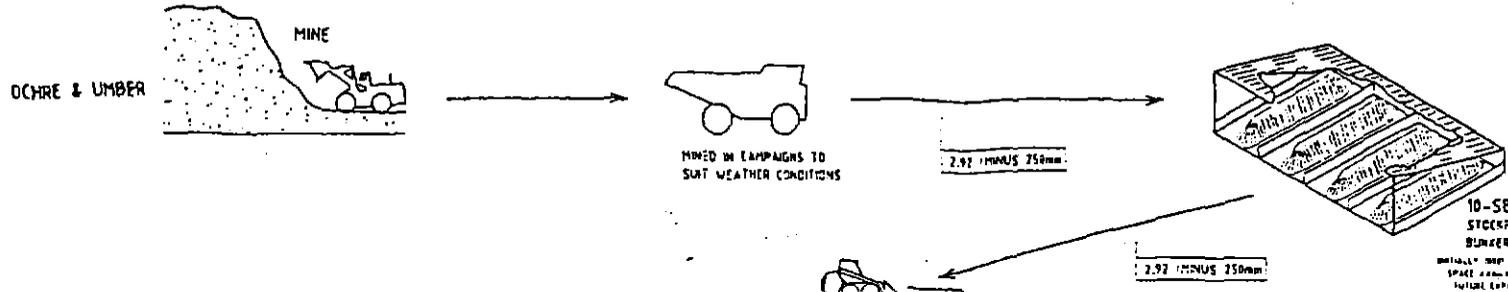
PLANT DESIGN CAPACITY FOR
3000 Tonnes per Year Dry Finely Ground Product

Saved on:
 8 Mo, 5 d/wk, 48 wks/y = 1920 wks/y
 Plant Throughput of 100% availability = 1.50 tpm
 Plant Throughput of 98% availability = 1.71 tpm

Reference is made to the flowsheets 10-F-001 to 70-F-001. The plant capacity is 1.75 tph (dry); the process route can be broken down into five basic components:

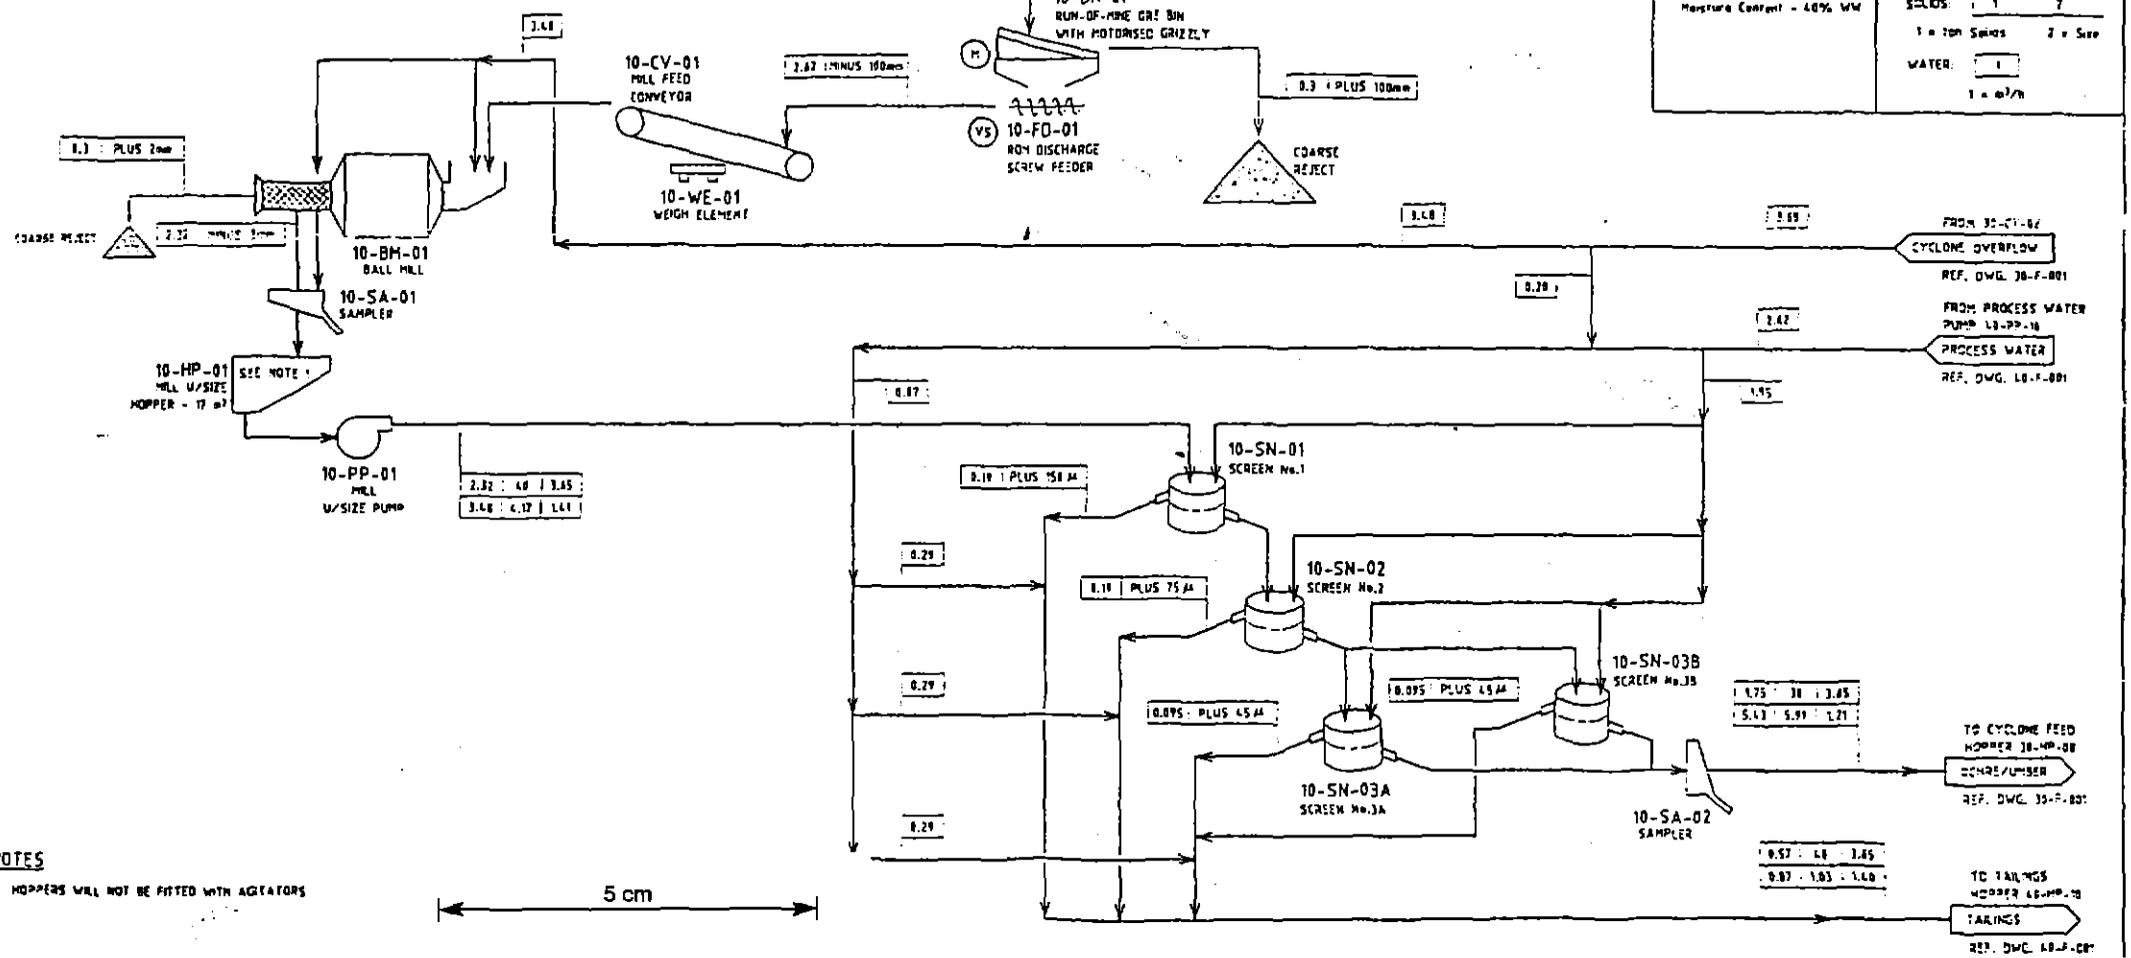
PLANT DESIGN CAPACITY = 1.75 tpm

NOTES
 1. HOPPERS WILL NOT BE FITTED WITH AGITATORS

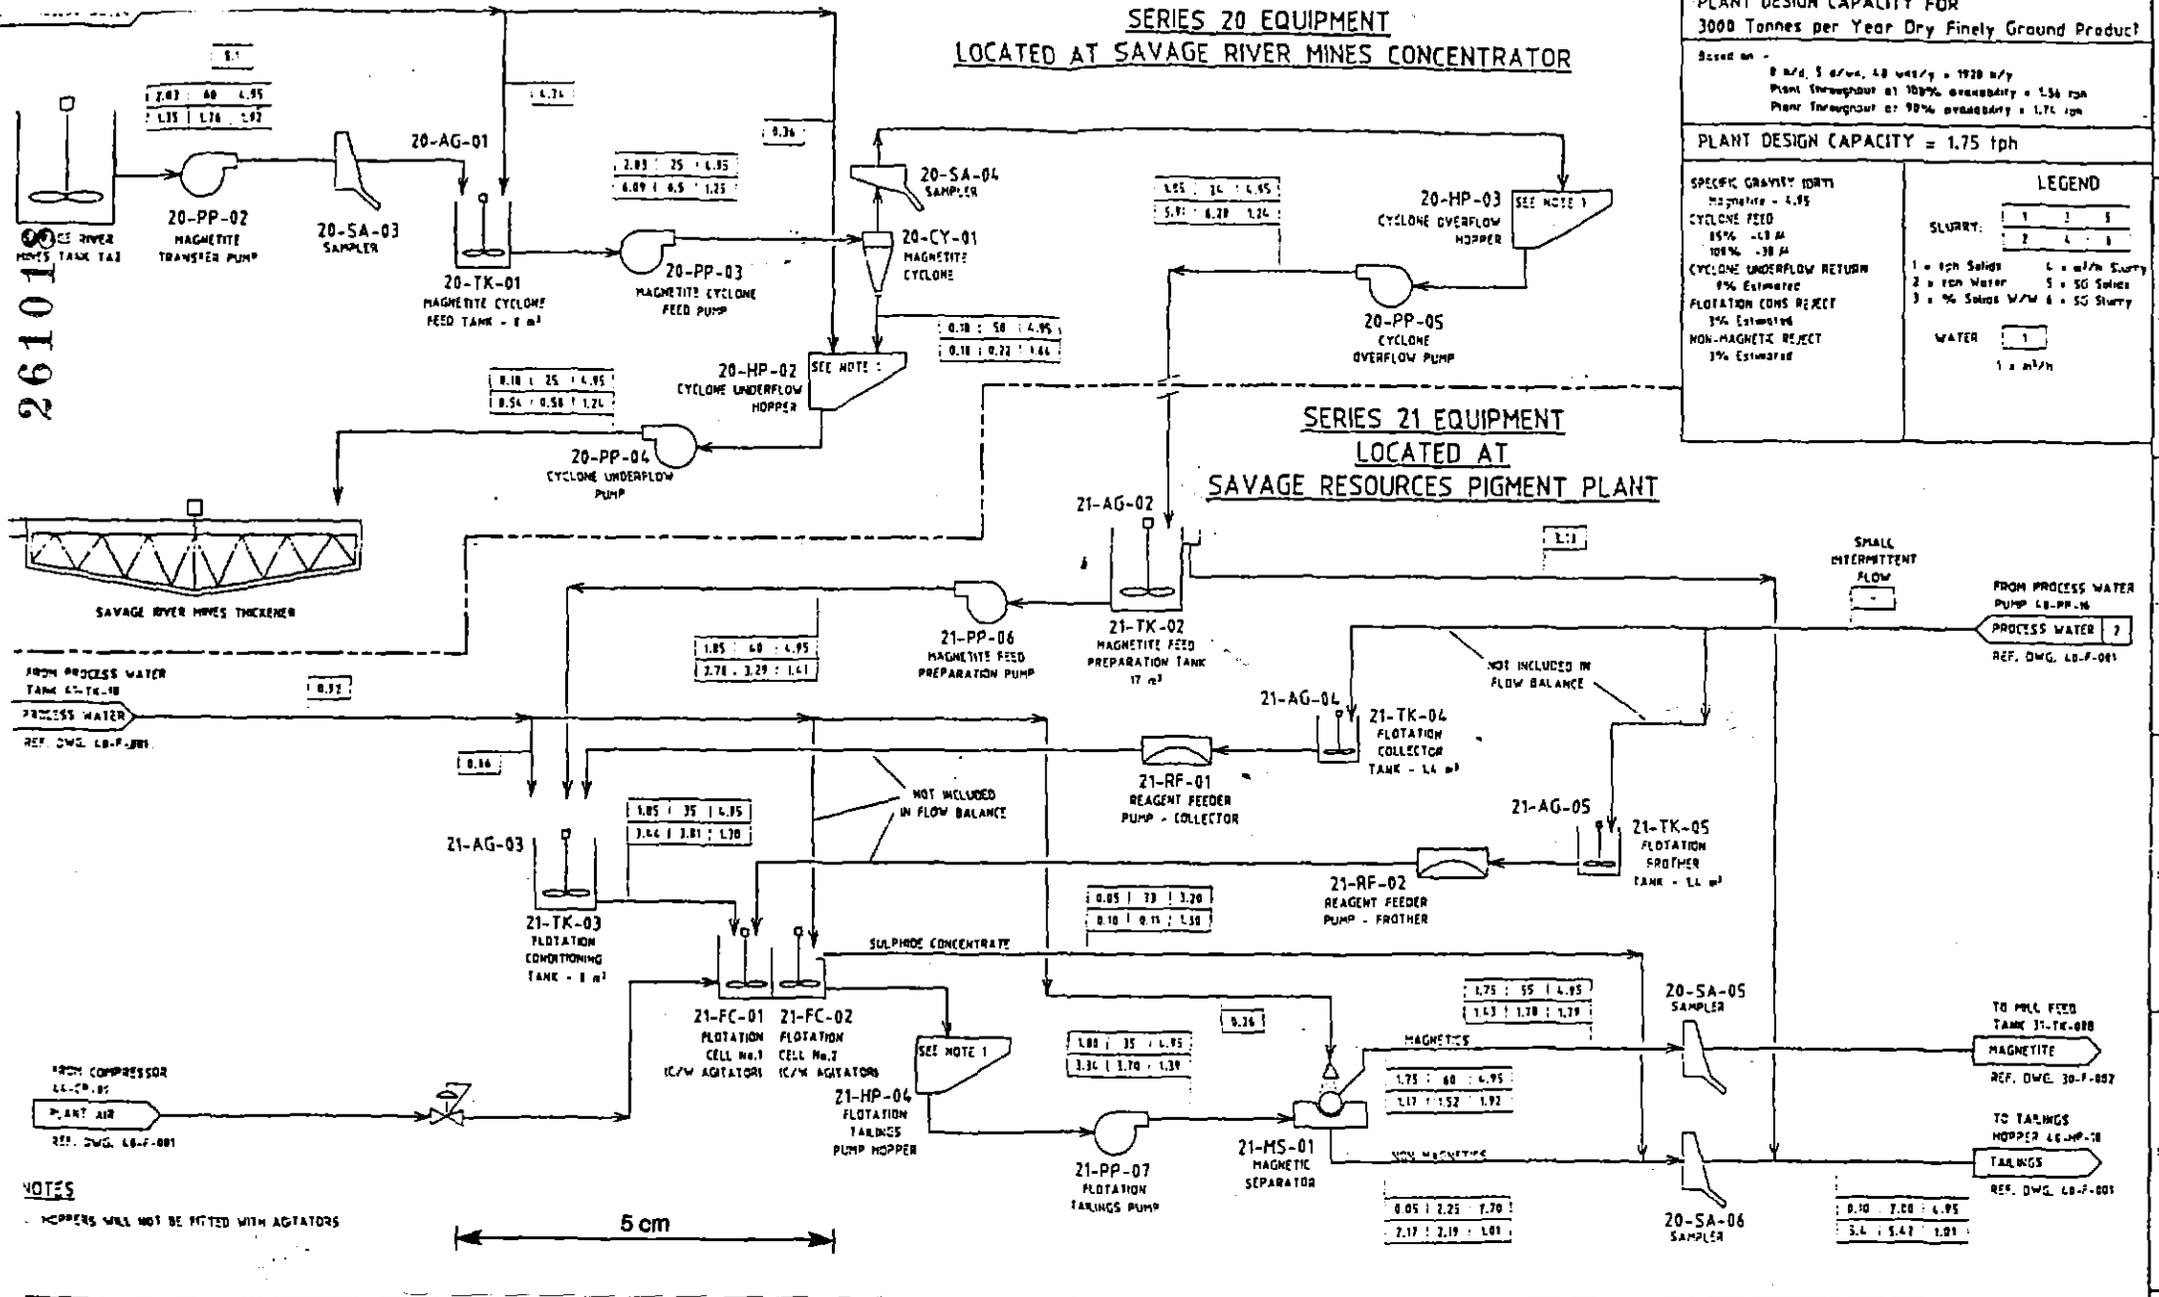
20-F-001 A

NOTES
 - HOPPERS WILL NOT BE FITTED WITH AGITATORS

SAVAGE RESOURCES LIMITED
 MAIN CREEK, T.A.S. - SAVAGE RIVER FACILITY
 IRON OXIDE PIGMENT PROJECT
 MAGNETITE FEED PREPARATION
 PROCESS FLOW SHEET

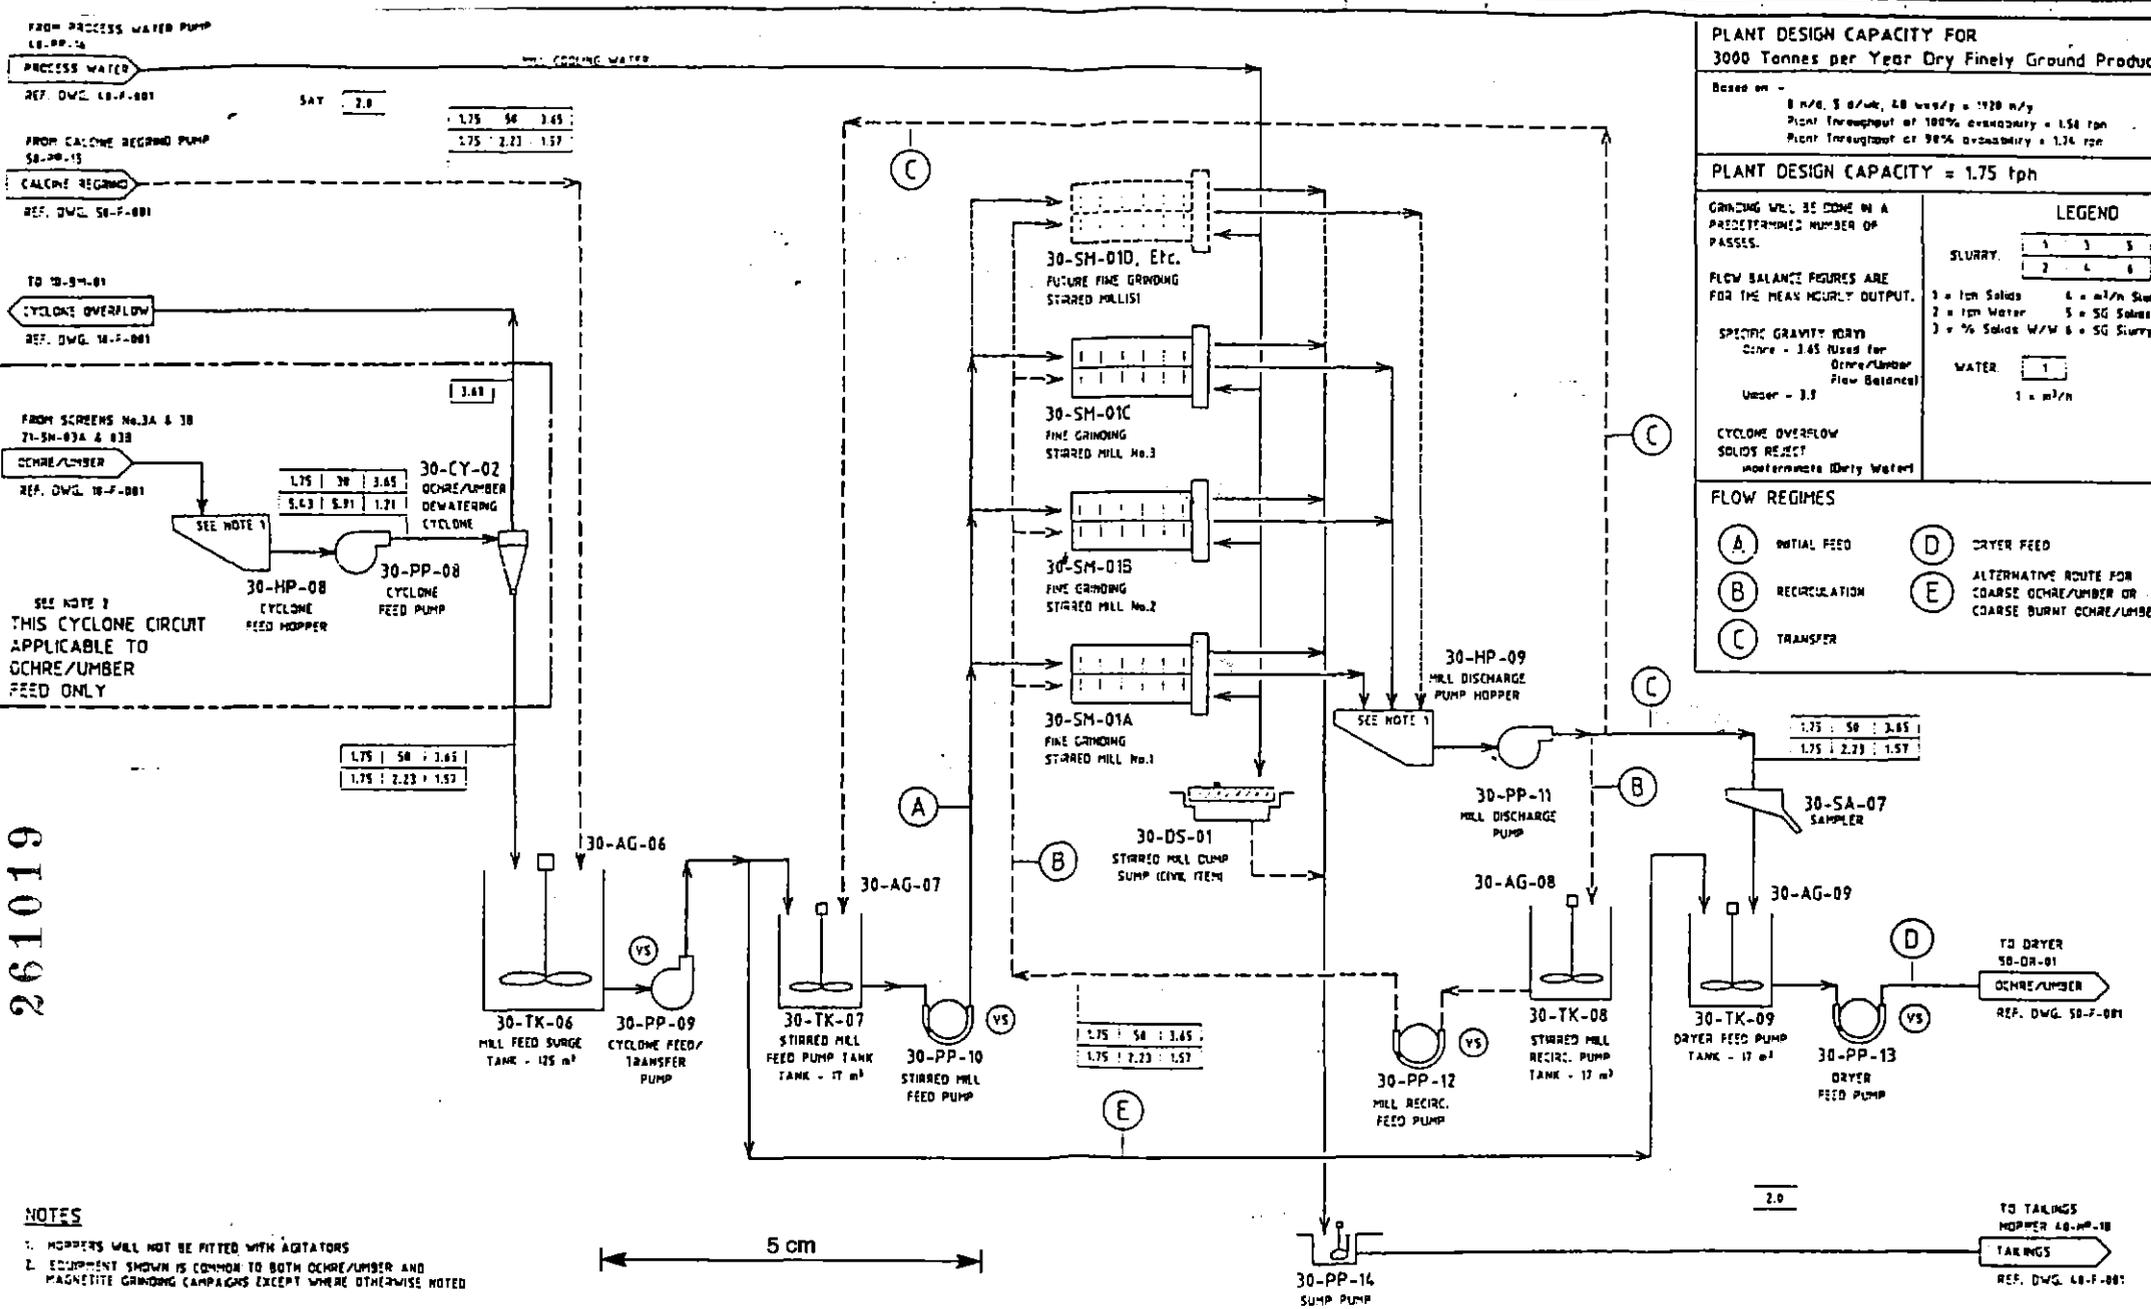
30-F-001

PLANT DESIGN CAPACITY FOR 3000 Tonnes per Year Dry Finely Ground Product

Based on -
 8 m/h, 5 d/wk, 48 hrs/d = 1728 m/y
 Plant Throughput at 100% availability = 1.54 t/h
 Plant Throughput at 98% availability = 1.74 t/h

(A) INITIAL FEED (D) DRYER FEED
 (B) RECIRCULATION (E) ALTERNATIVE ROUTE FOR COARSE OCHRE/UMBER OR COARSE BURNT OCHRE/UMBER
 (C) TRANSFER

1. HOPPERS WILL NOT BE FITTED WITH AGITATORS
 2. EQUIPMENT SHOWN IS COMMON TO BOTH OCHRE/UMBER AND MAGNETITE GRINDING CAMPAIGNS EXCEPT WHERE OTHERWISE NOTED

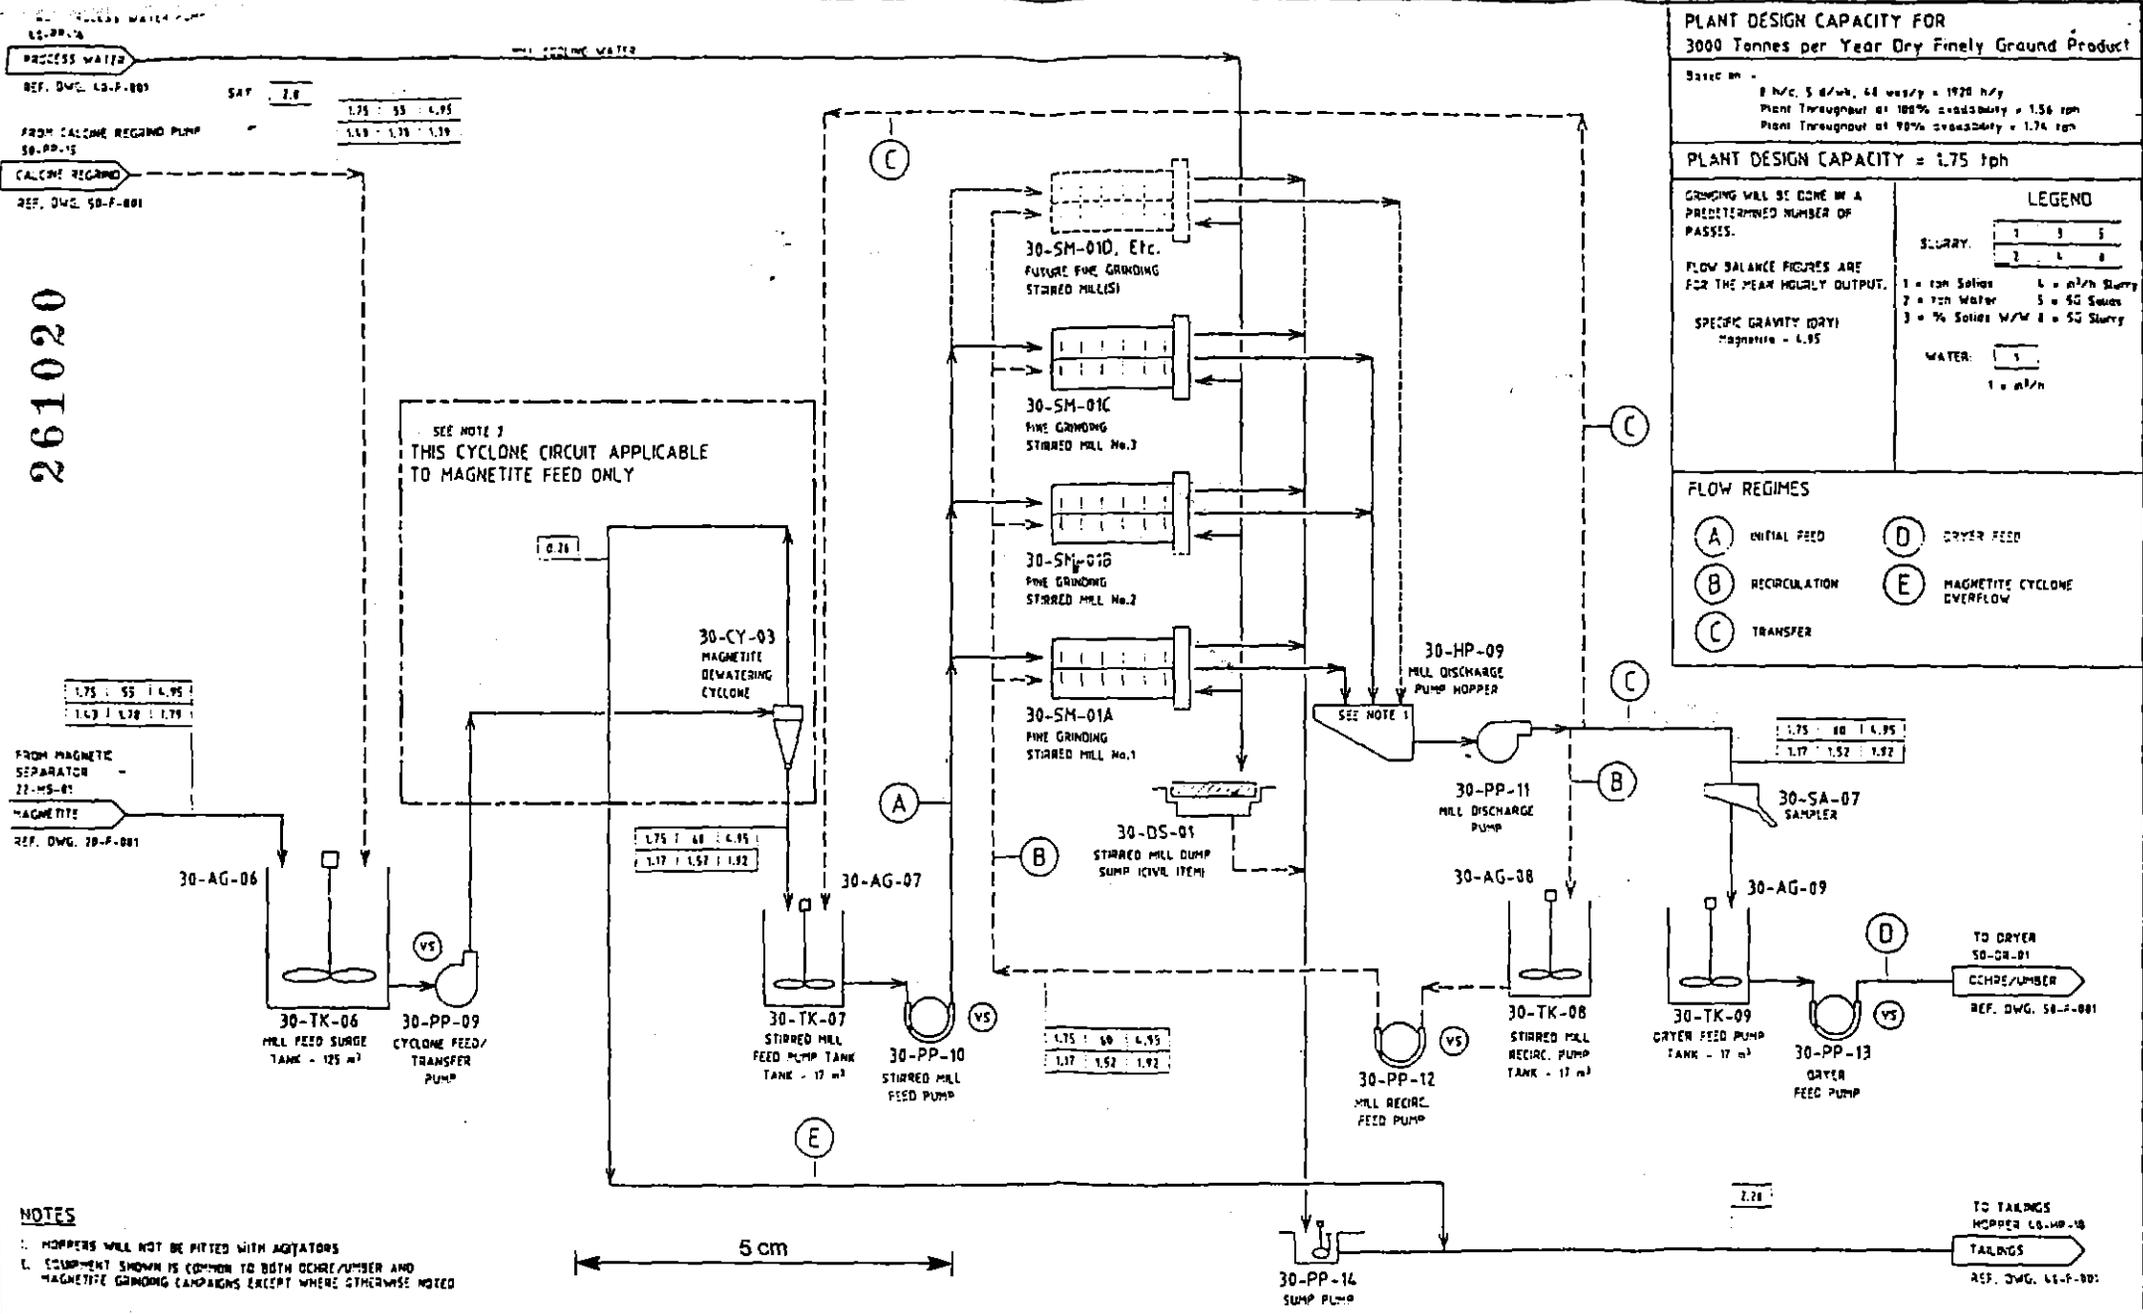
30-F-002

- HOPPERS WILL NOT BE FITTED WITH AGITATORS
- EQUIPMENT SHOWN IS COMMON TO BOTH OCHRE/LUMBER AND MAGNETITE GRINDING CAMPAIGNS EXCEPT WHERE OTHERWISE NOTED
