**Archaeological reconnaissance of Storeys Creek and Aberfoyle mines
Rossarden, Tasmania**

Mine site rehabilitation: phase 1

**Report to Industry Safety and Mines Division,
Tasmania Development and Resources**

**Archaeological Survey
Report 1995/01**

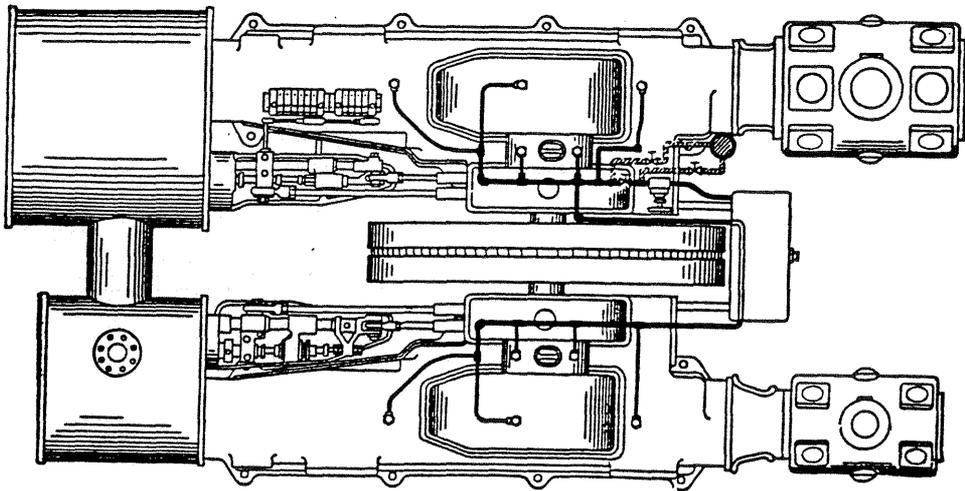
Figure 2: Ingersoll-Rand Duplex, Steam-driven Compressor (Peele 1945:p.14)

The machinery site lying to the north of the tailings dump retains a number of features which relate to the period of mine operations between 1937 and 1971. One of the principal features is a steam driven duplex compressor, partially buried by mine tailings and obscured by weeds although the twin horizontal pistons and large central flywheel are still visible. The remains of what appears to be a vertical wood gas producer for the compressor protrudes from the tailings several metres to the south-west. A number of iron pipe and vessel fragments, possibly associated with the compressor and power plant, lie partially concealed between the two in situ features. (See figure 2 for an example of a duplex compressor).

The compressor and gas producer are incomplete but, where exposed, appear to be in a reasonable state of preservation. Where the mine tailings are in contact with the relics corrosion is fairly advanced resulting in blistering and fretting of the metal surfaces.

Excavating the accumulated tailings from around the machinery will remove the principal cause of metal corrosion, although it will expose the pitted metal surface to the elements.

- * The Tailings and weeds enclosing the compressor and associated machinery should be removed.
- * An archaeologist should be on site during the removal of the tailings in order to prevent damage to the plant or any associated features. The archaeologist should be able to assess the physical condition of the features and determine if further conservation action is required following the exposure of the plant.
- * The advice of Conservators from The Queen Victoria Museum in Launceston should be sought, where necessary, regarding the use of surface treatments for retarding the decay of exposed features.

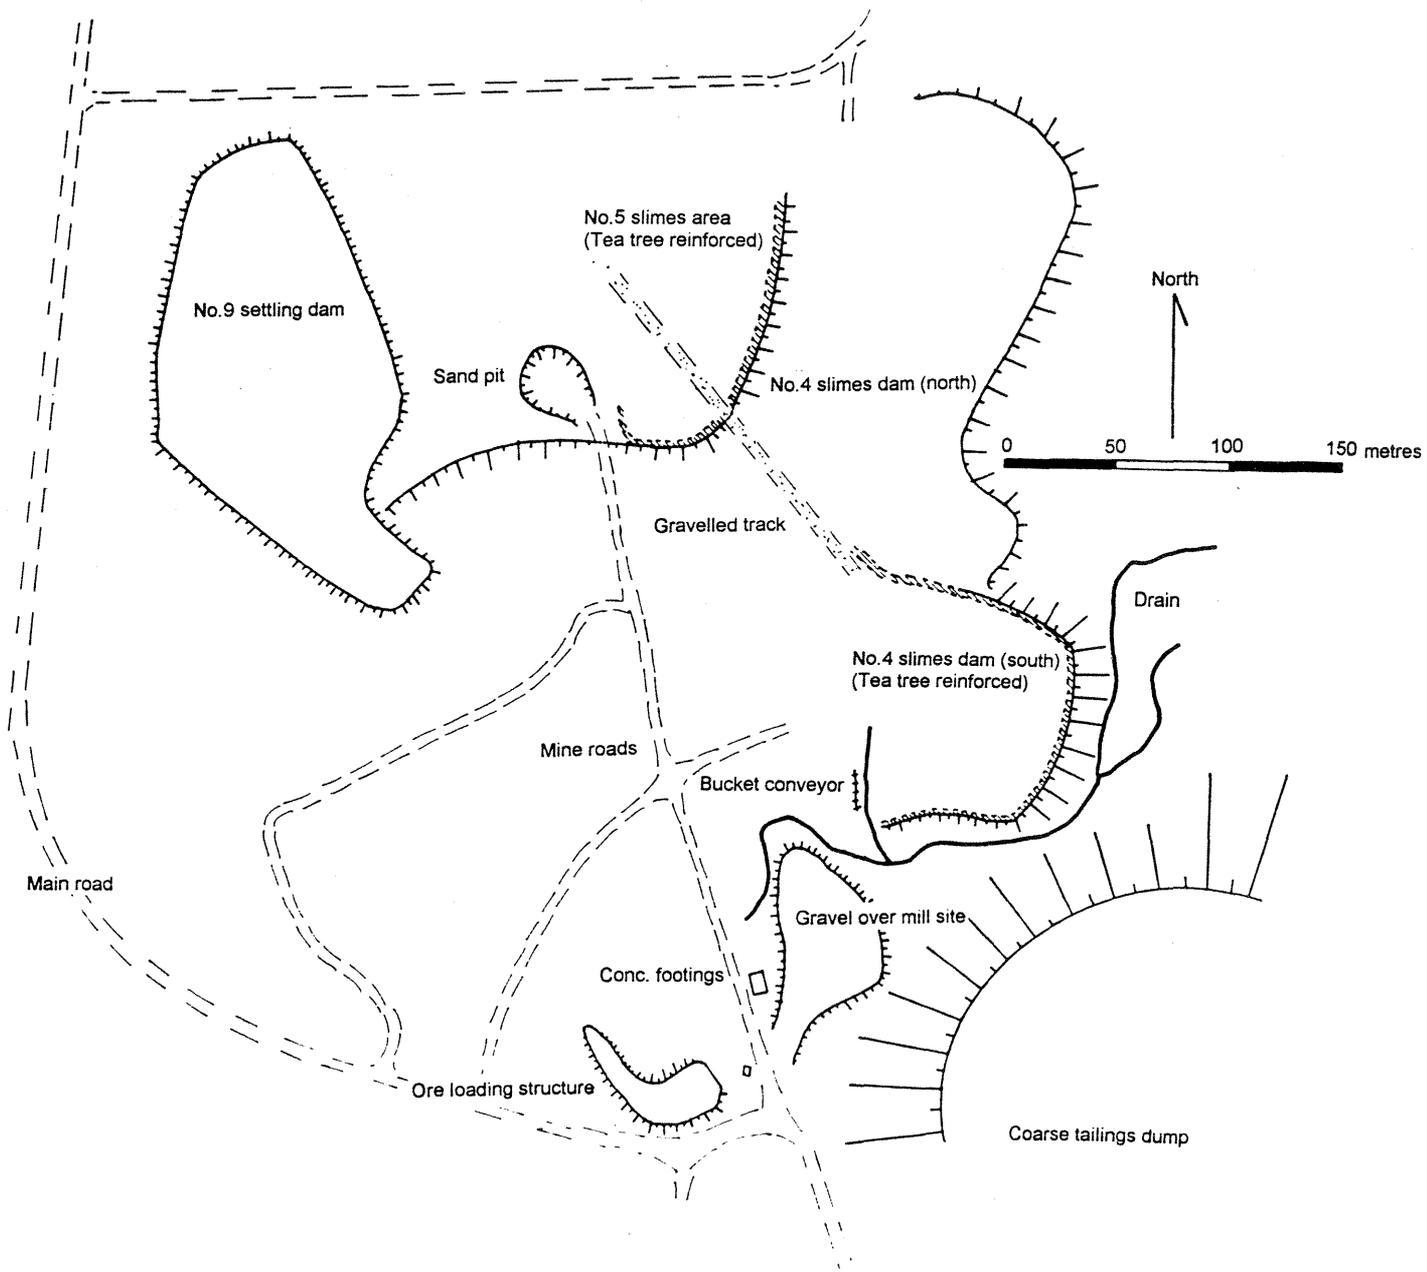
Figure 10: Plan of Aberfoyle mine site showing location of items referred to in text (Plan modified from Thompson & Brett, 1994)

To this end the collapsed ore bin requires consideration. Whilst the structure is of significance in that it further illustrates part of the ore storage and handling process, in its current state it represents something of a hazard. The stability of the feature is not likely to improve with time.

The slime dams at Aberfoyle, arguably dating to the 1930s, illustrate the final stages of ore processing and waste disposal and are able to provide information not only about the technology applied in their construction but also the nature of the process of waste disposal around the site. Although the construction method may appear curious it is by no means unique. The technique of terra forming using alternate layers of earth and vegetation has great antiquity. Notably, examples from the same time period in a better state of preservation, and less hazardous to the environment, exist elsewhere in Tasmania (ie. Georges Bay mine, St Helens). The heritage value of the number 4 slimes dam is offset by several important factors:

For these reasons, and despite the nominal heritage value of the site, it is considered inappropriate to leave the dam in its current condition.

- * The loading ramp should be retained.
- * The chute steelwork in the reclaim tunnel should be repaired and made secure.
- * The excess tailings piled at the entrance to the reclaim tunnel should be removed and protective mesh fencing place at the tunnel openings to prevent access.
- * The gravel piles beneath the ore chutes should be left in their current form.
- * Protective fencing may be installed at the top of the loading ramp.
- * The collapsed ore bin may be removed.

- * Stabilisation of the number 4 slimes dam may proceed as proposed.
- * The bucket conveyor may be extracted from its current position and replaced at an appropriate location subsequent to site rehabilitation.
