**Archaeological Survey Report
2004/01**

**An archaeological inspection
of the Silver King main shaft
area at Zeehan**

By A. E. Webster

November 2004

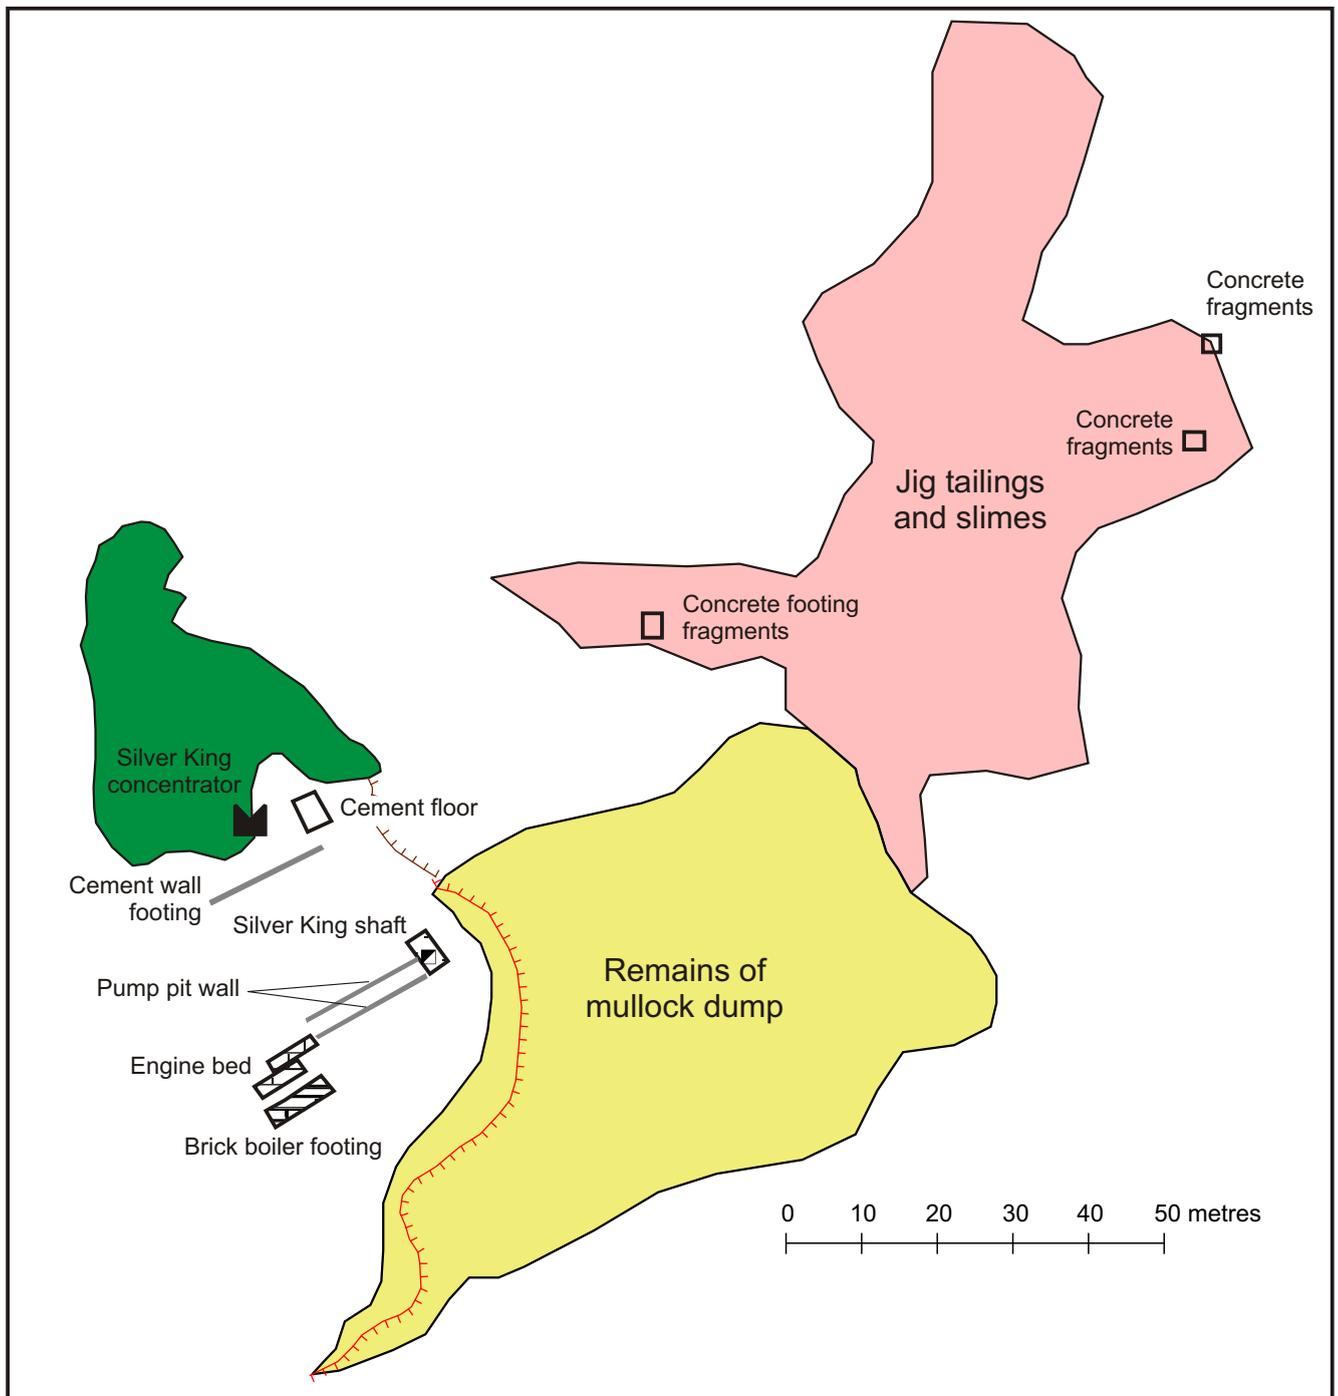
Figure 2. Silver King mine site.

The surface area of the site was examined in detail and all features that were found were recorded by GPS, with significant features being recorded photographically. All information has been added to MRT's GIS heritage project for the Zeehan area. Site plans were compiled from GPS surveys (fig. 2).

low-lying swampy area to the east of the shaft. The lowest areas of the swampy ground are covered in a thick deposit of concentrator slimes at the base, with a cover of coarser jig tailings (fig. 2). The mine mullock dumps were probably built up from timber trestles extending eastwards from the sky shaft of the head frame (plate 8).
