Mineral Resources Tasmania
STORYS CREEK
PRECIPITATE DAM DRILLING
REPORT

29 September 1998

Mineral Resources Tasmania : Storys Creek
precipitate dam drilling report / John Miedecke
and Partners Pty Ltd 1998

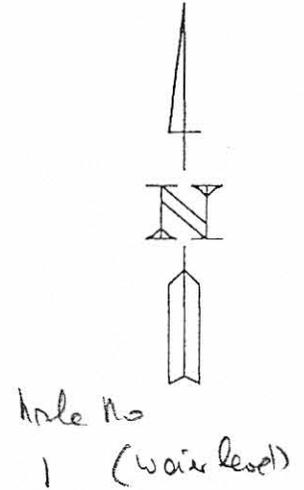
Storys Creek Precipitate Dam
Auger Drilling Location Plan

The location of the seven holes are illustrated on Figure 1 and the reduced level (to an arbitrary datum) surveyed. Each hole was logged and the results are shown in Table 1. The bottom of each hole was noted for quantity survey purposes. Composite samples were taken of representative materials throughout the profile for geochemical testwork.

The water table within the storage was monitored by measuring the standing level in the boreholes (water levels are noted in Figure 1). This indicates that the tailings dam phreatic level is quite deep near the embankment, but rises sharply away from it. This is consistent with a dam constructed by spigotting tailings from the embankment. Water movements are expected to be through the storage, and expressed as the leakage at the base of the dam wall.
