**REHABILITATION OF MINING LANDS TRUST FUND**  
**Report on Works undertaken ~2000 - 2001 Financial Year**

By Revel Munro  
October 2001

# **1 Cat Gully area adjacent to Blue Lake, Endurance Mine, South Mt Cameron.**

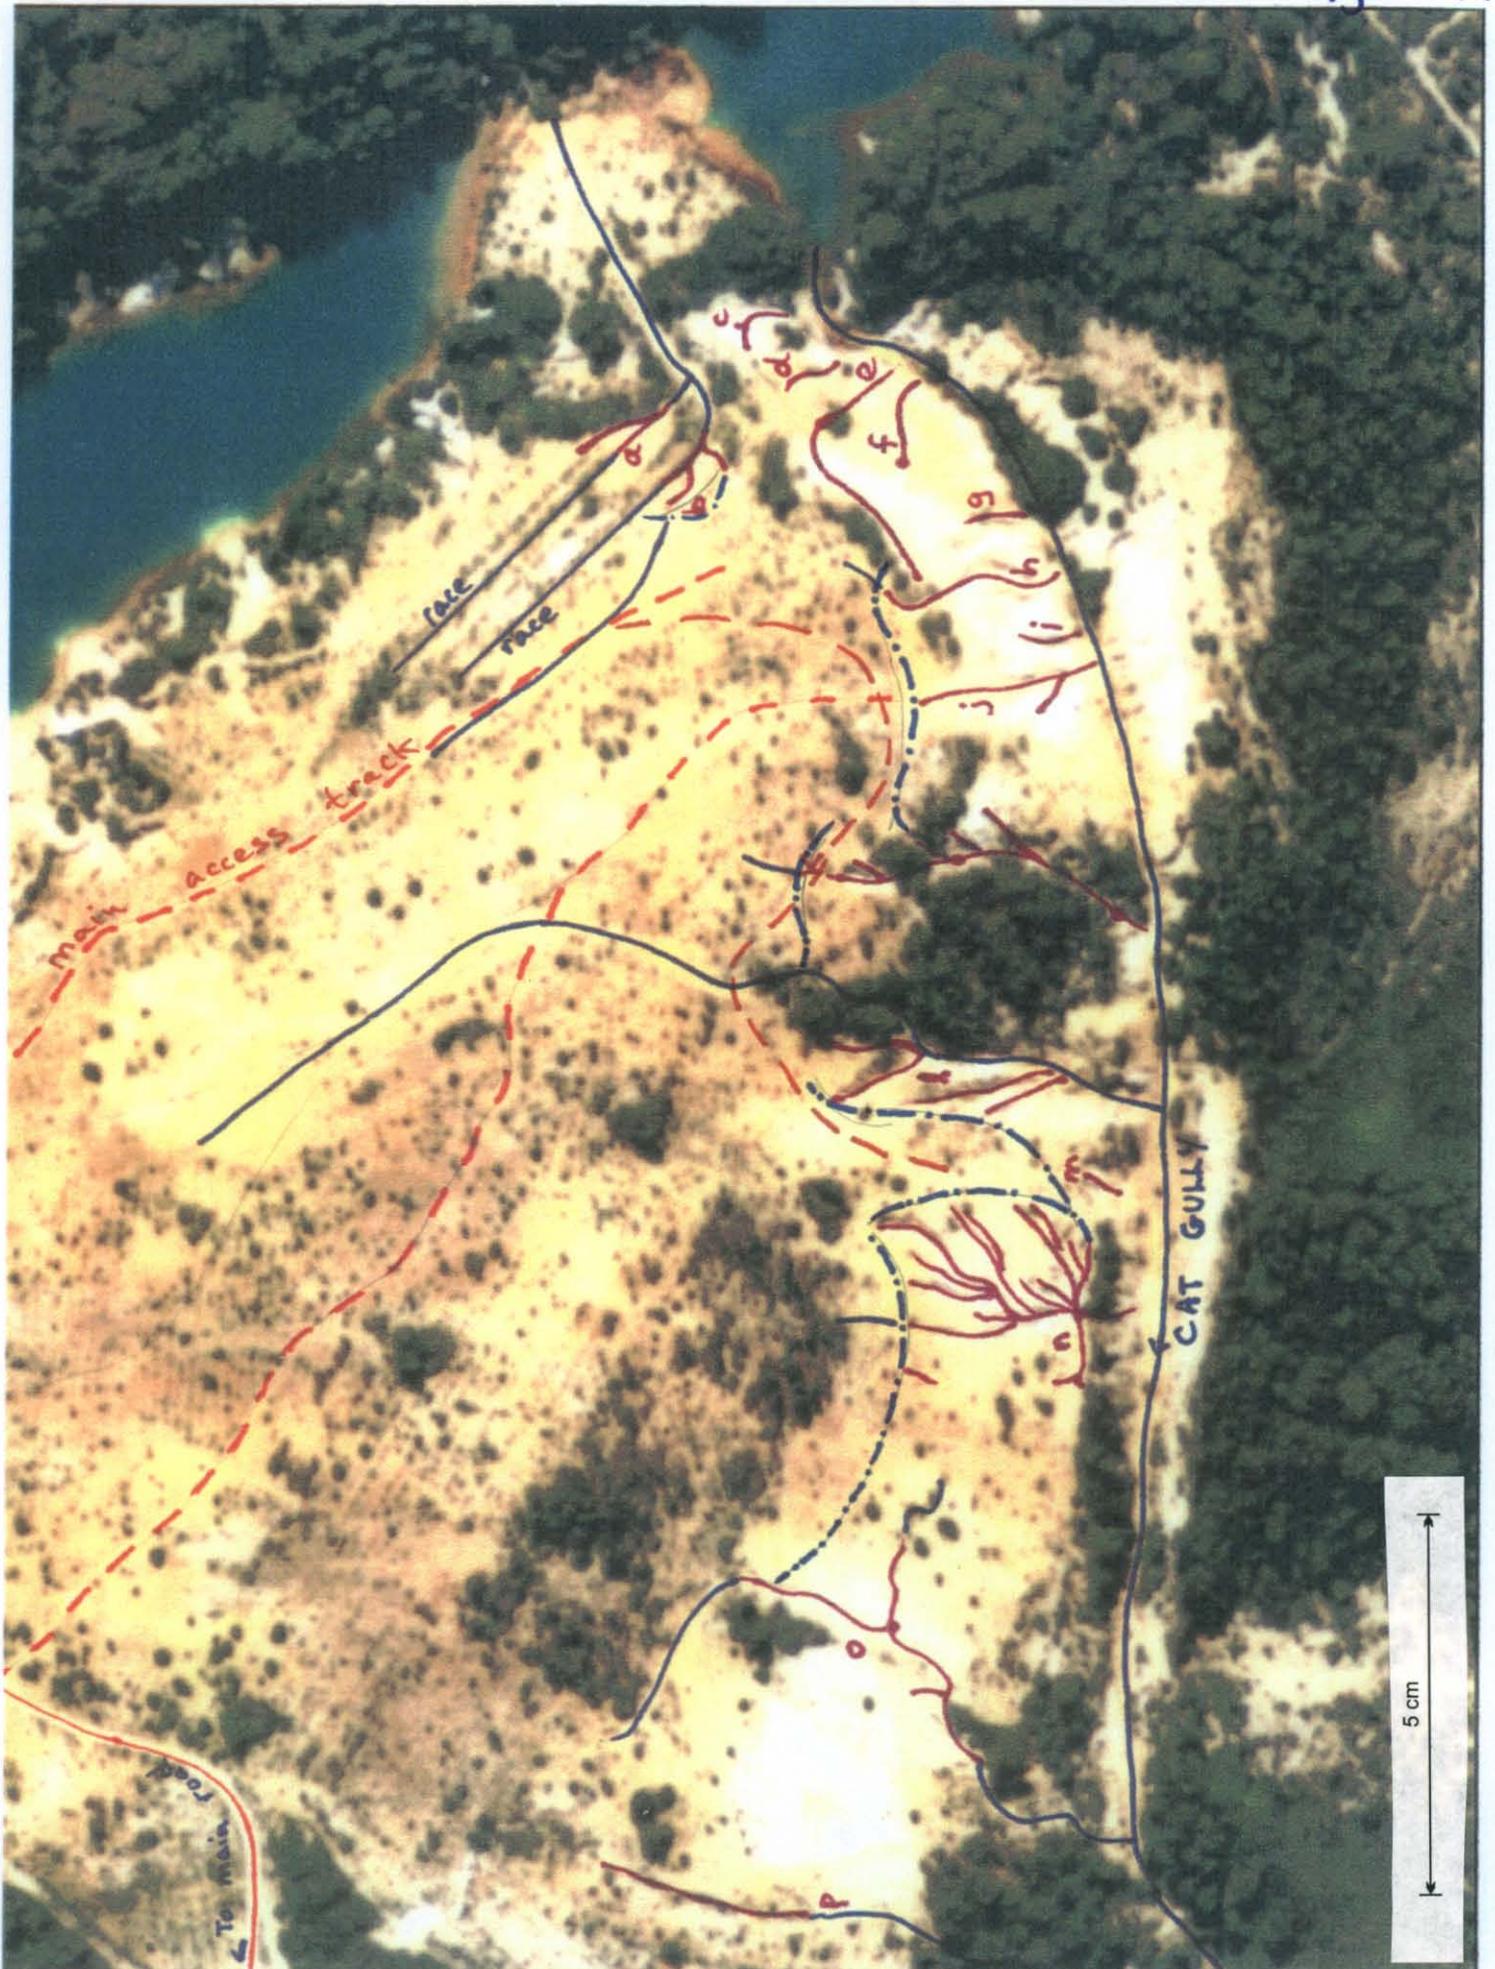
Figure 2

Features of this Project area are shown on Figure 1 of this report, while figure 2, an aerial photo enlargement depicts the gully erosion present.

Photograph shows gullies (numbered according to table in report)

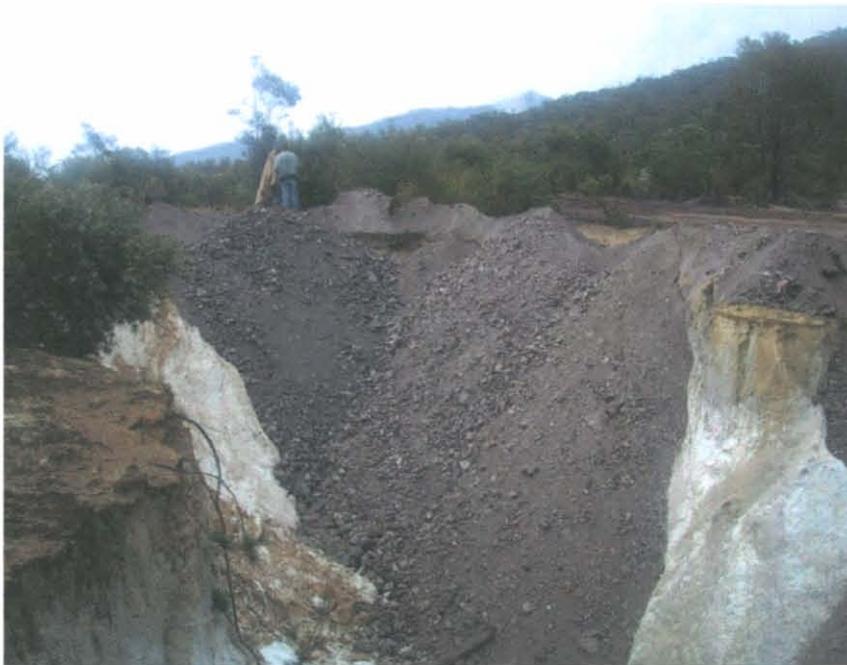
Tertiary vegetation remnants and slucebox remains were common. The photo to the left shows the surface rock to be oxidized. The heaps just below the surface are pyritic, and the sulfurous nature of the material is not conducive for plant growth.

**Action:** photo shows some of the hundreds of m<sup>3</sup> of mine waste with piles of tailings, (also grey) positioned to cover the mine waste.

A veneer of less pyritic tailings now covers the highly sulfurous mine debris in all the gully heads.

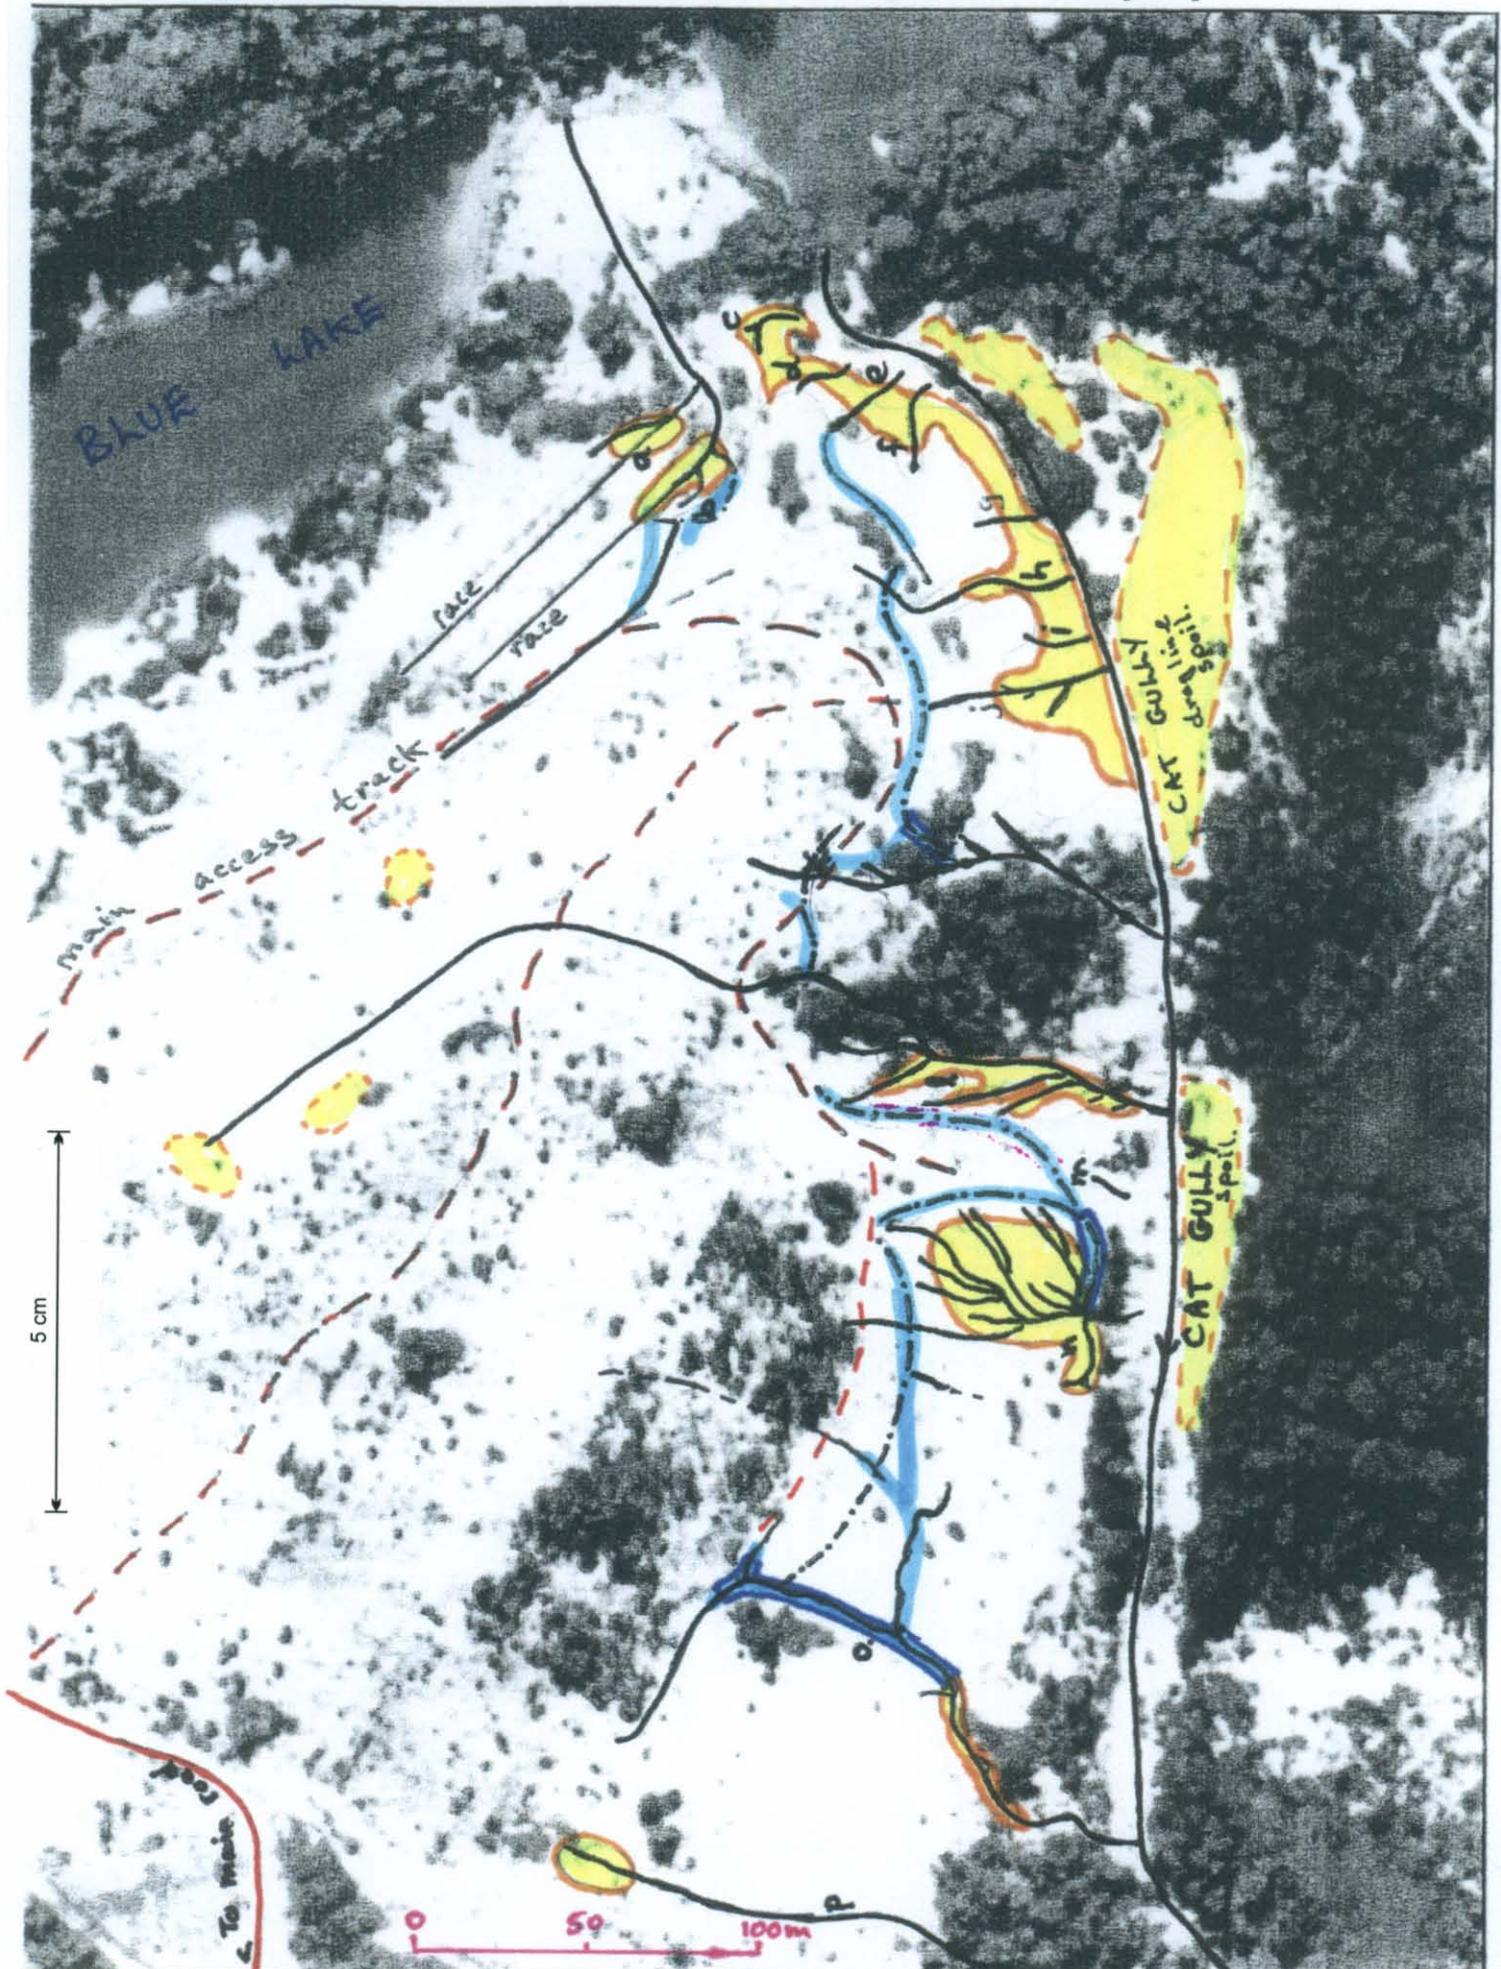
Figure 3

**Action: Uncontrolled drainage to the heads of gullies has been eliminated. This has been a major component of this project. Contour and cutoff drain locations are shown on figure 3. They total some 600m in length. Such drains vary in their construction method according to resources, catchment area and occurrence of surface indurated horizons.**

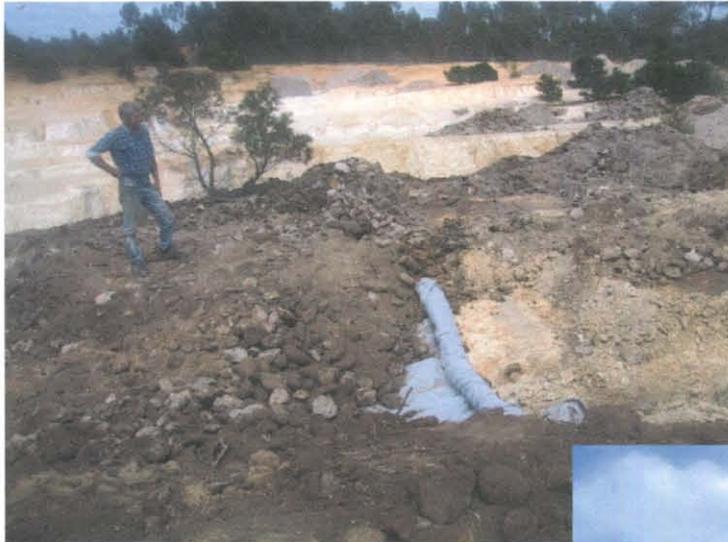
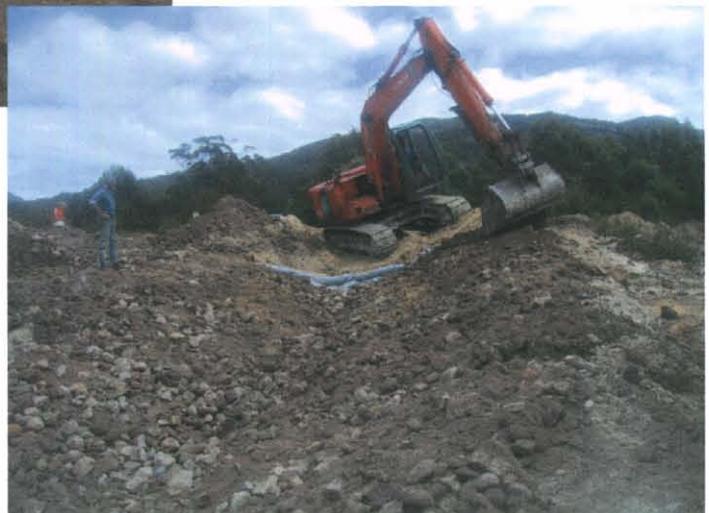
- Steeper rock armoured "drop off" drains with a geotextile underlay.

Action: Approximately 60 metres of such drains were constructed where cutoff drains 'dropped' into gullies [k] and [n]. These shallow v shaped, rock over geotextile, 20% slope drains were constructed by excavator, pictured left and below.

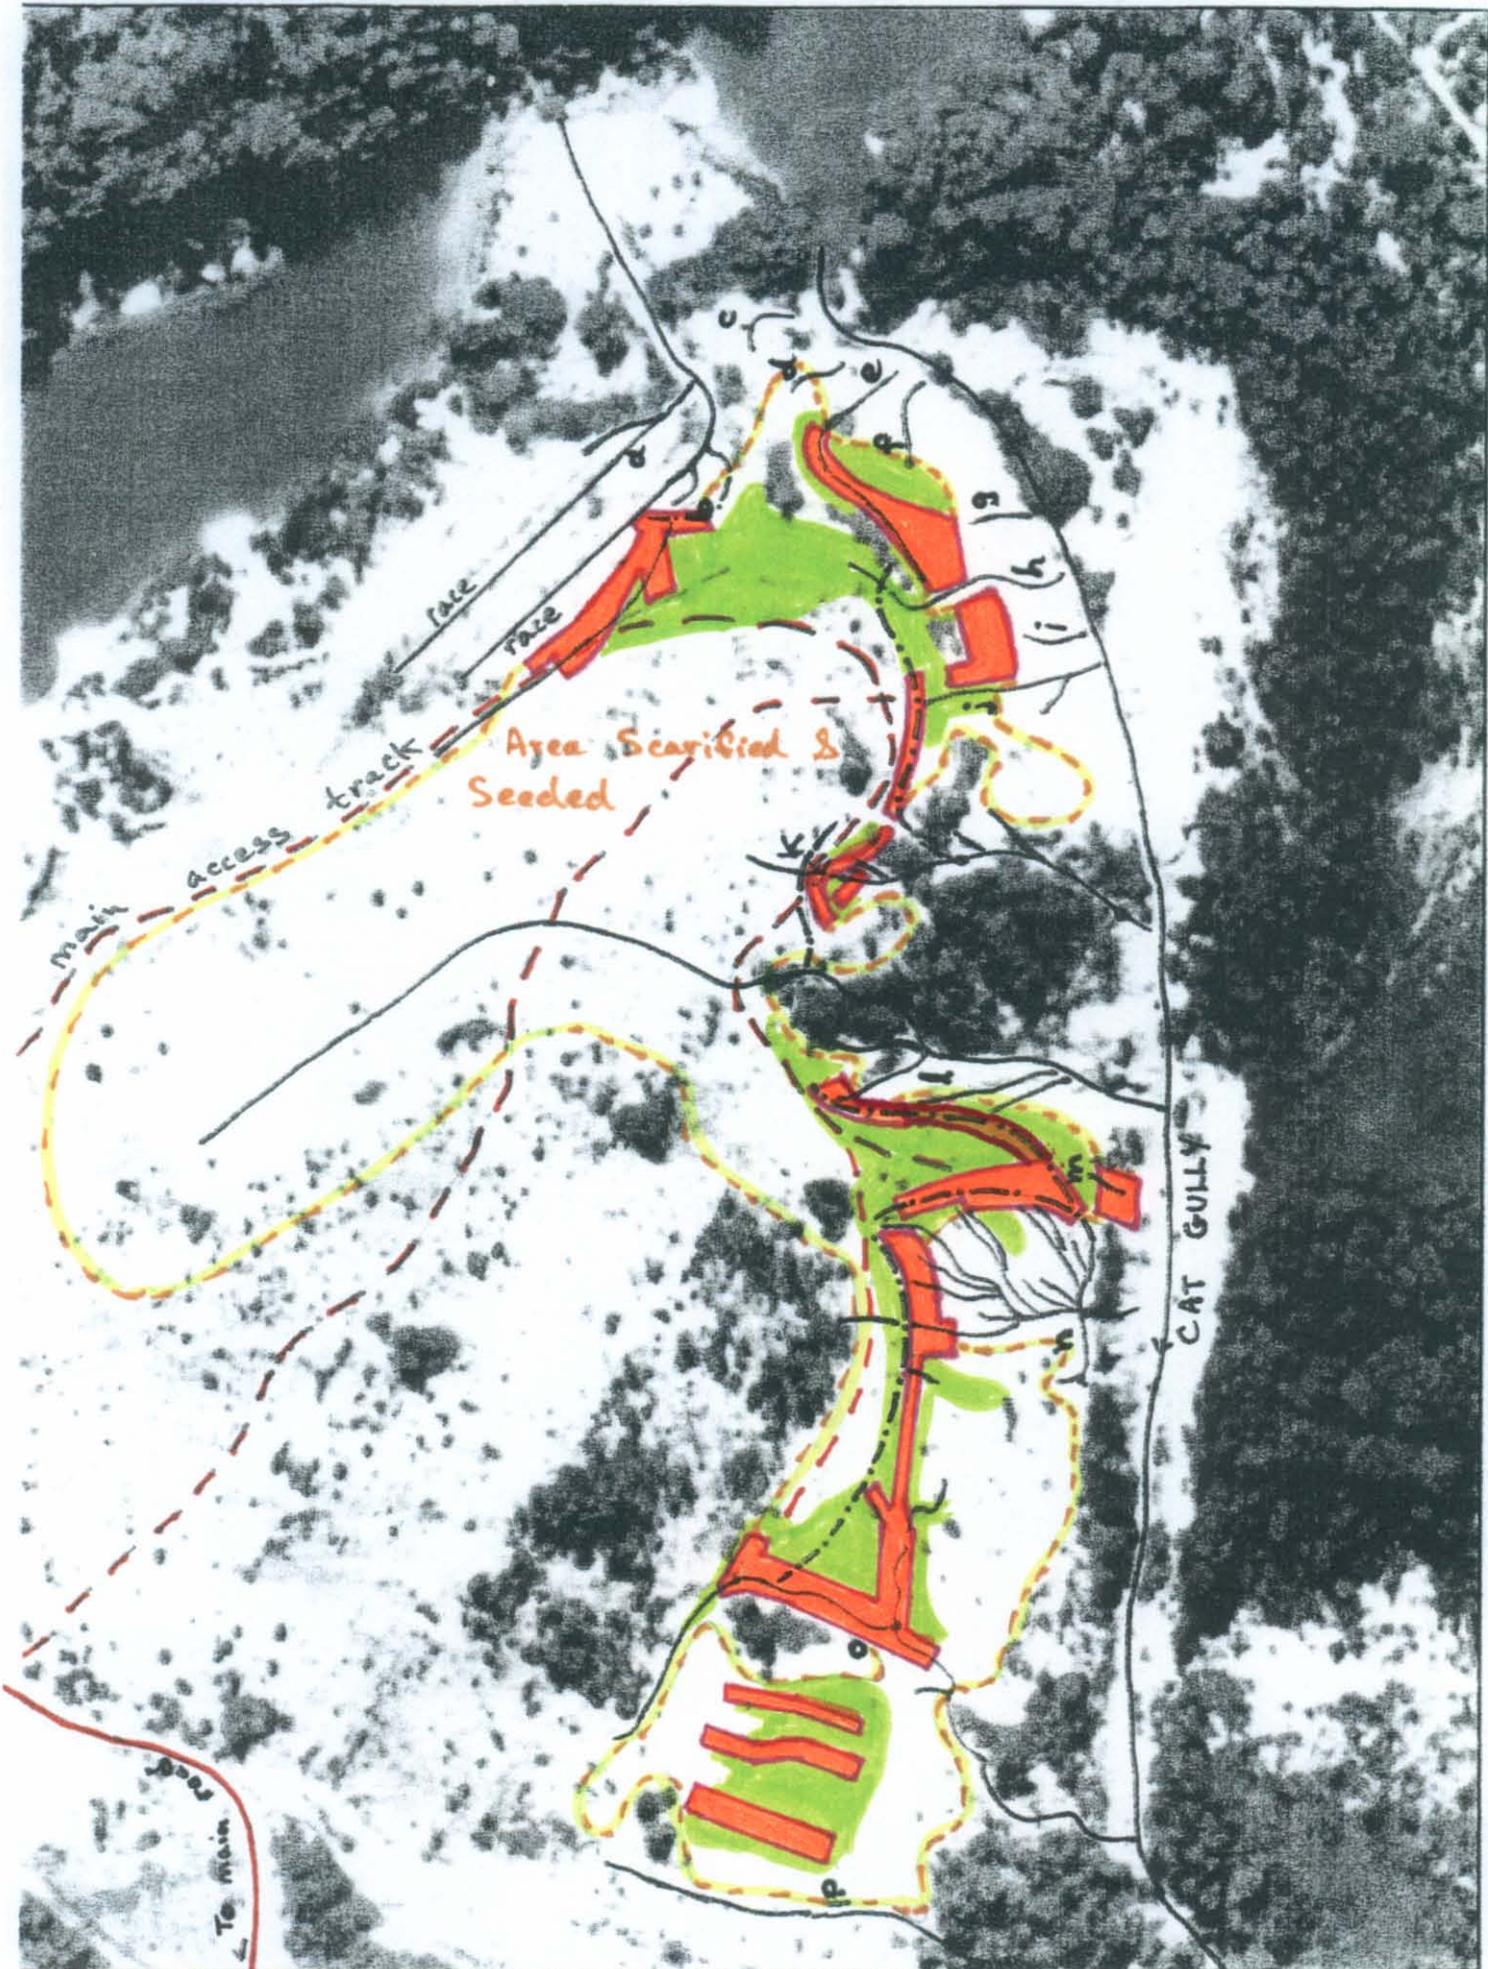
# Figure 4 ~ Treatment of Gullies

**Action:** Figure 4 shows the areas so treated in green. Bare areas, were thoroughly scarified with the tractor pictured. Mine tailings were added to improve the structure/permeability of a smaller area adjacent to some gullies. Thick applications of pyrethrum, fertilizer and lime together with native native seed were applied.

**Action:** Figure 4 shows the areas so treated in orange. Large areas were covered with jute matting using about eleven bales (about 6000m<sup>2</sup>) of material. Large quantities of small square and 5x4 foot round bales were used.

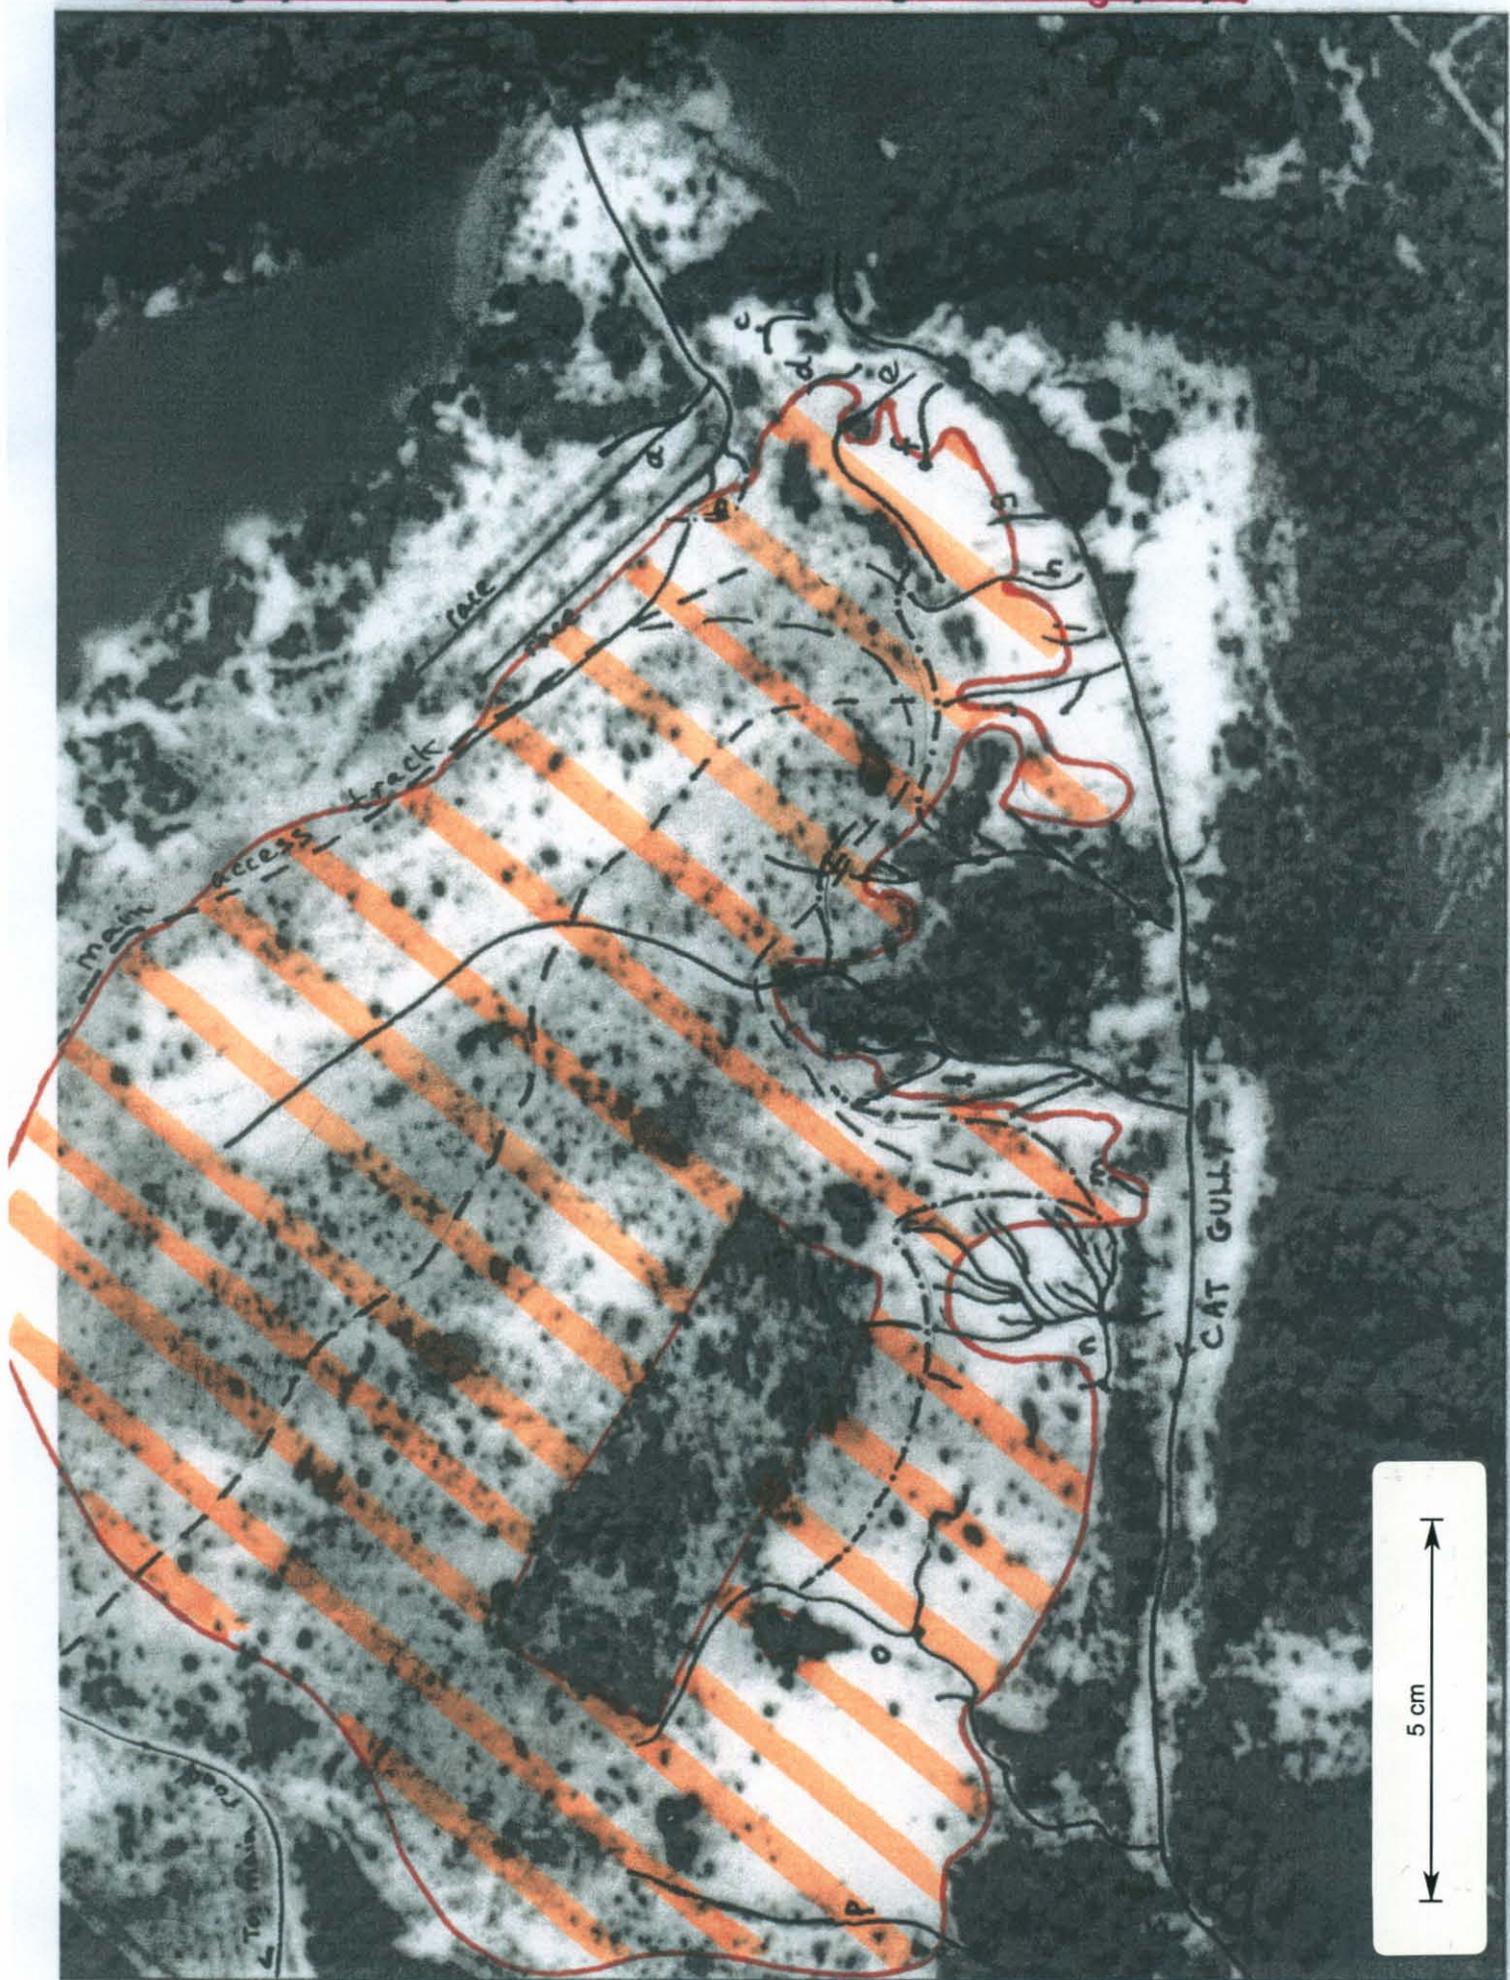
Broad acre treatments Figure 5

**Action:** Figure 5 shows an area of about 15 hectares subject to broad acre treatment hatched in orange. Pyrethrum ~ 360 m<sup>3</sup> (6 walking floor truckloads, pictured), 40 m<sup>3</sup> of lime, and 6t of fertilizer were applied by truck and Fast track tractor, both pictured. The fertilizer applied by truck was not the intended high analysis 10.17.8.1. An error by Impact Fertilisers resulted in the cheaper, low grade, 'potato mix' 8.4.10.14 being used. These soil conditioners were

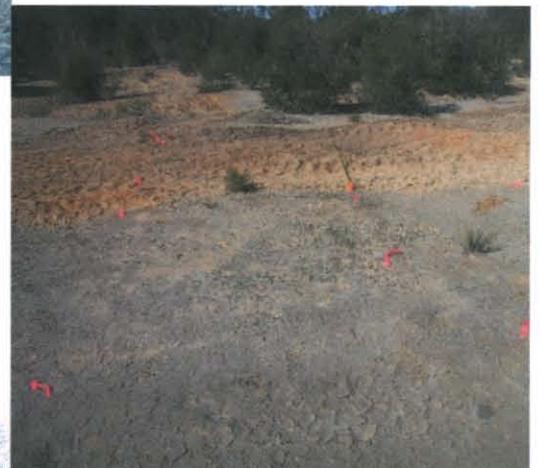
Pictured right are markers delineating a monitoring site that was subject to a range of treatments with respect to scarifying, liming, fertiliser application and seeding. Unfortunately the site was partially destroyed by a bogged fertiliser truck and winter rains inundation has flooded other portions.

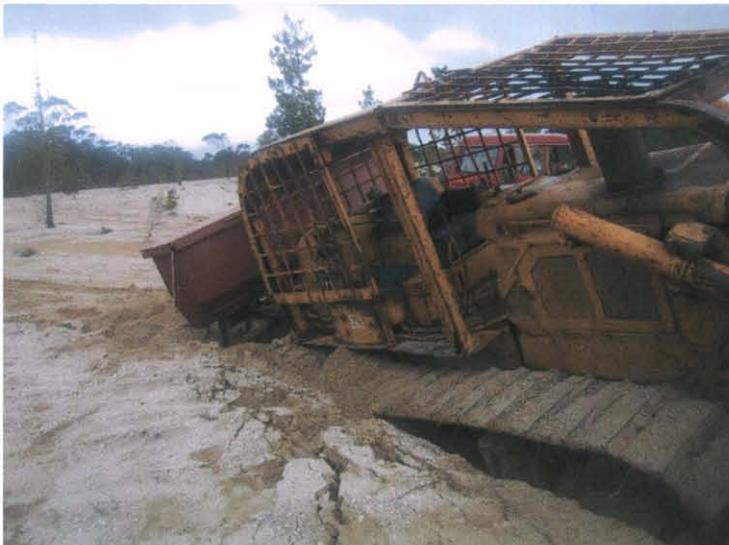
slimes had often filled earlier workings. In places a thin crust masked thick accumulations of slimes. Pictured are photos of major bogged event No.1 where an excavator was eventually required to dig the machine out on day three of lost time. Much time and energy was earlier expended on placing large quantities of materials under the tracks in an effort to keep the machine from

sinking into oozing silt. (Years ago an excavator meet a similar fate, being essentially ruined by the seepage of silts into the engine etc.)

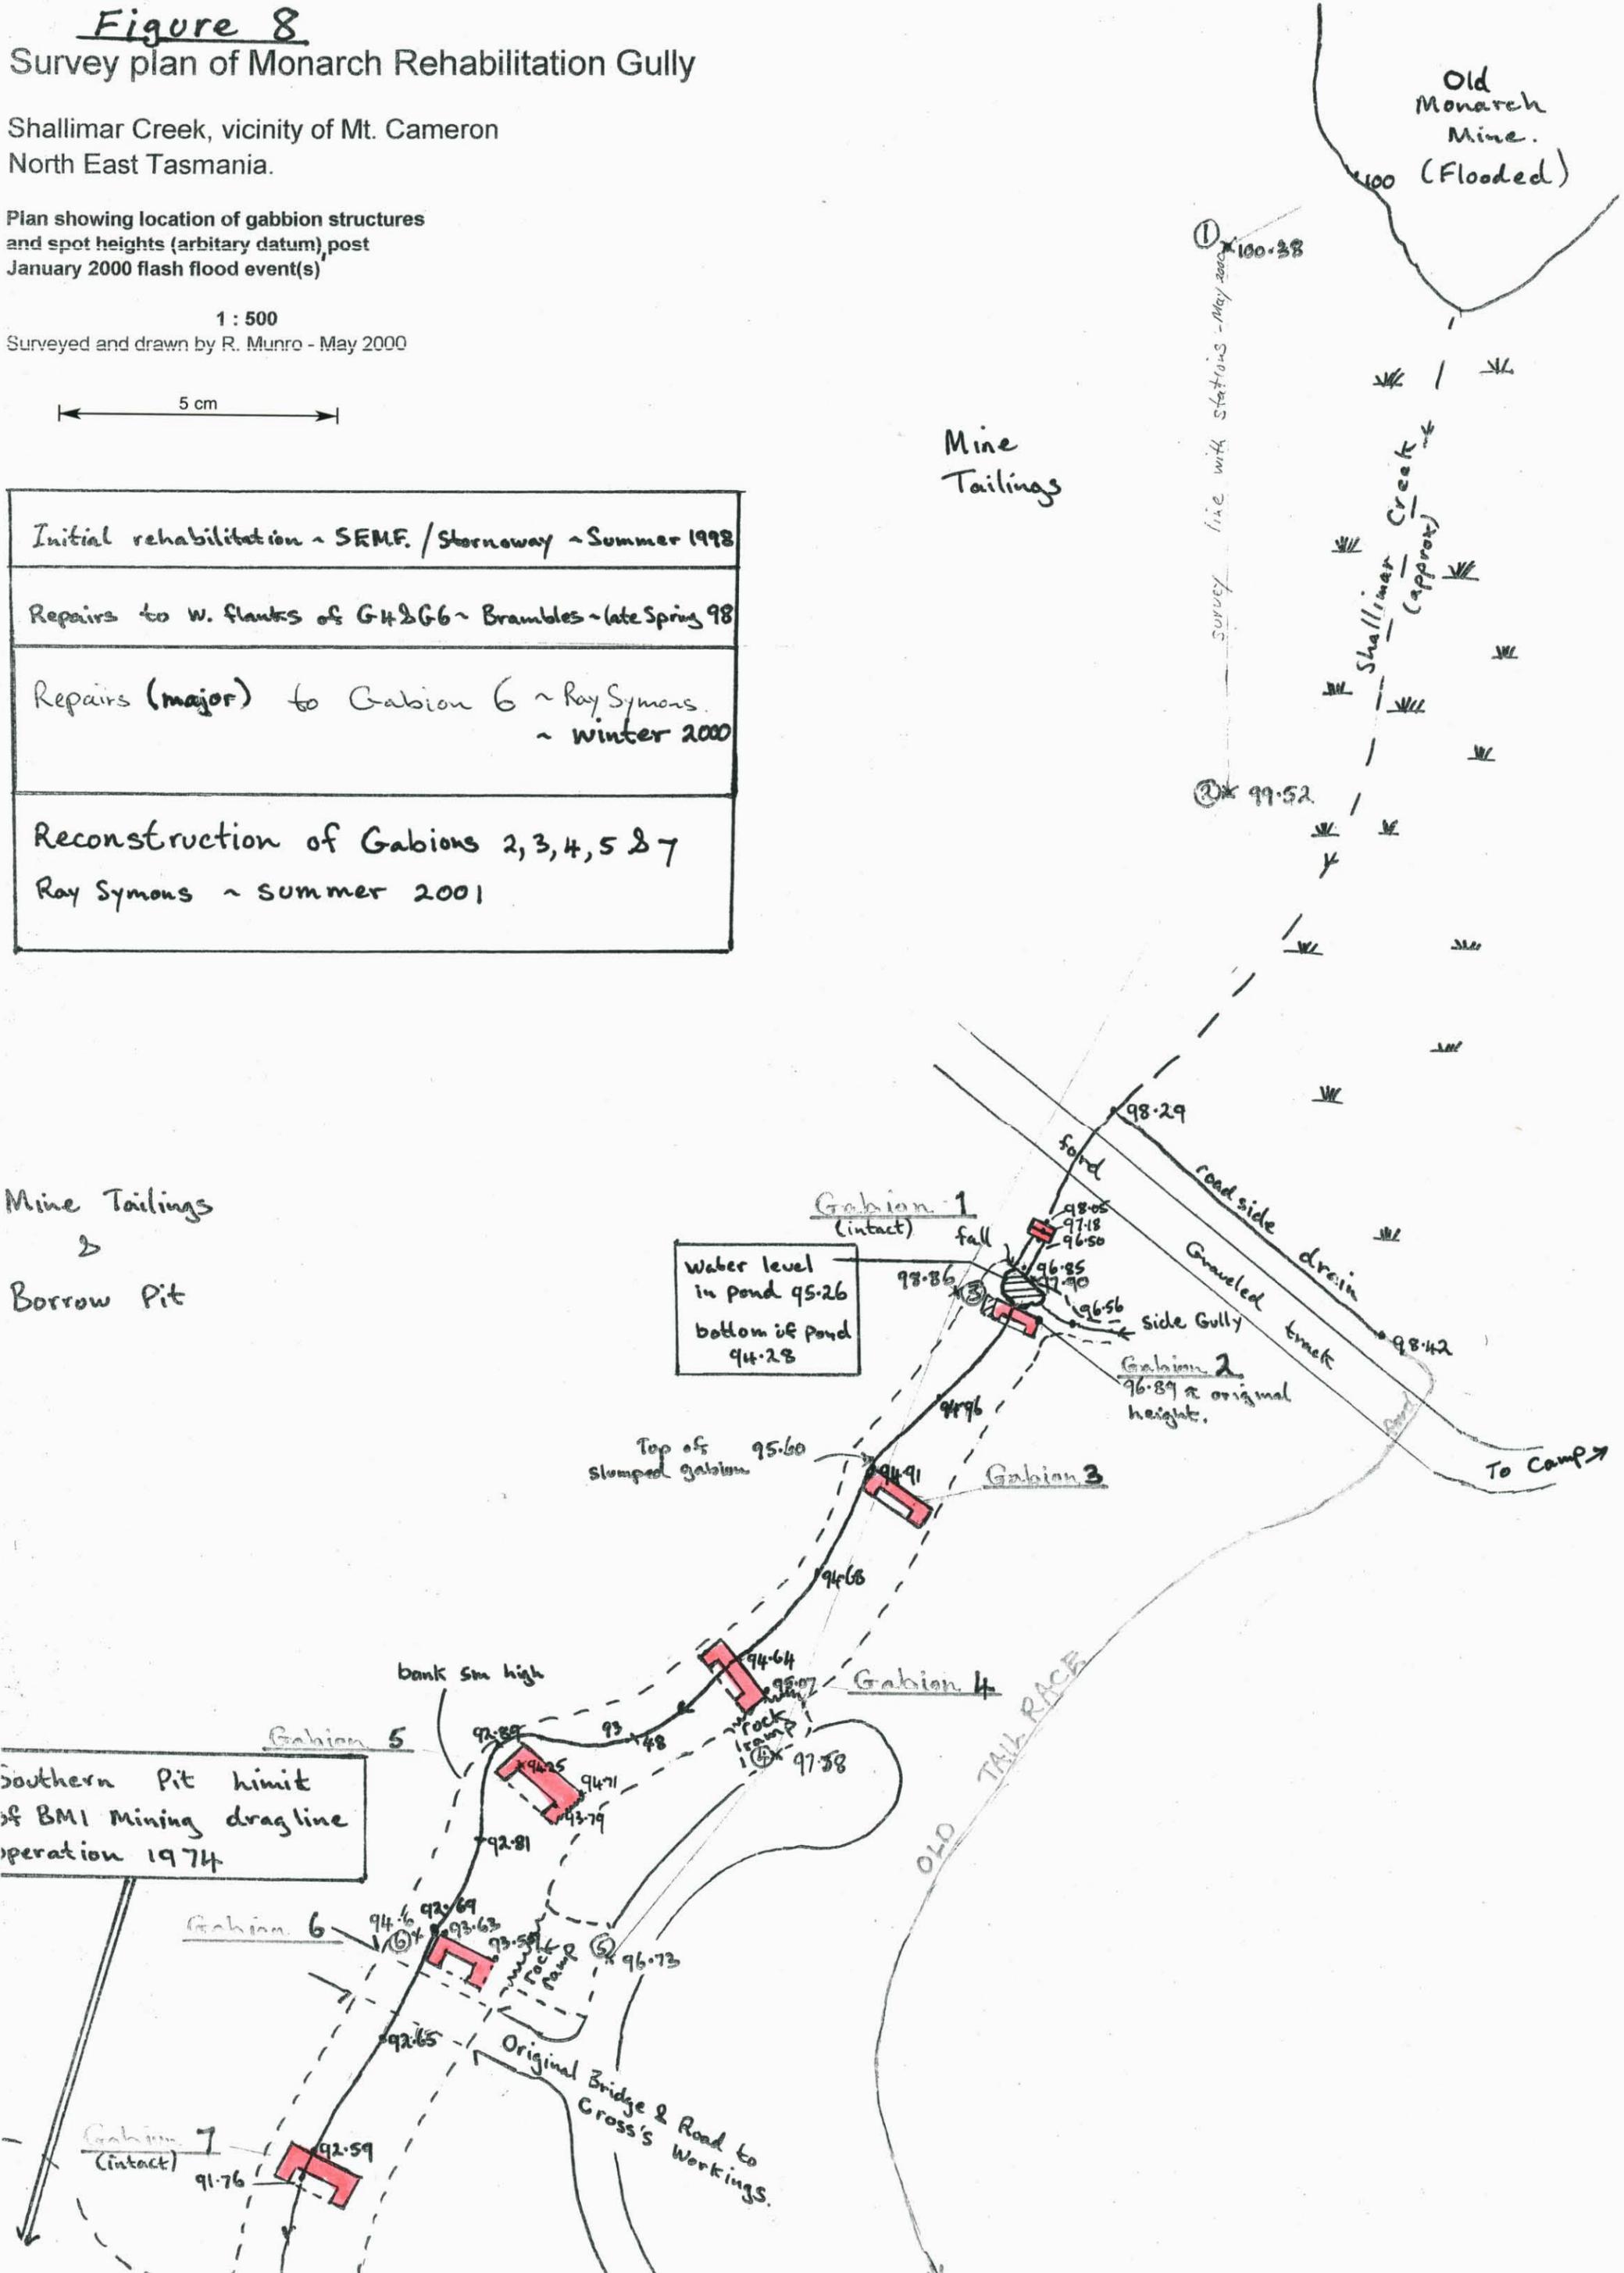
# Figure 8 Survey plan of Monarch Rehabilitation Gully

Inadequacies of the gabion structures were apparent from the onset of the first winter rains. The western margins Gabions 4 and 6 were breached, temporarily repaired and subsequently repaired and strengthened with rock armor. During a flash flood on January 4<sup>th</sup> 2000 the other margin of gabion 6 was breached. Possibly in domino fashion, Gabions 5, 4, 3, & 2 slumped and were subsequently breached as their supporting reno mattresses also slumped. Large volumes of the supporting tailings were rapidly eroded by the flash flood. The photos below show the resultant damage.

Initial rehabilitation - SEMF. / Stornoway - Summer 1998
Repairs to W. flanks of G4 & G6 - Brambles - late Spring 98
Repairs (major) to Gabion 6 - Roy Symons. ~ Winter 2000
Reconstruction of Gabions 2, 3, 4, 5 & 7 Roy Symons - Summer 2001

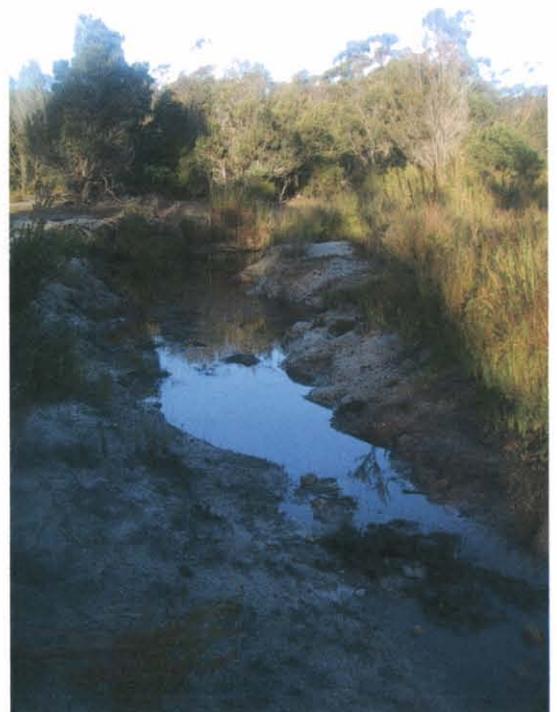
To allow for easy repairs to Gabion 6, Shallimar Creek was diverted with a short drain (pictured right) into an adjacent old tailrace. This diversion was left in place for almost a year. Indeed it could have been a very cheap solution to the total gully problem! The course of the diverted water is shown on Figure 7. Thick *gahnia radula* regrowth on sedgeland flats together with a long and very gentle gradient ensured that the bypass outlet did not erode.

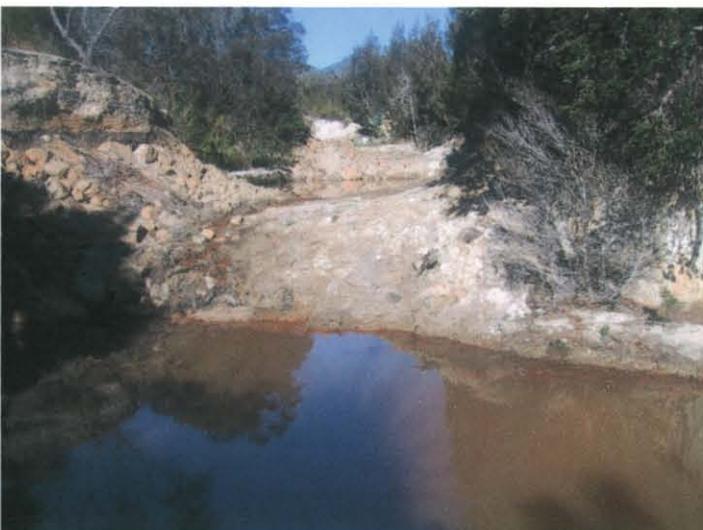
Gabions 2 and 3 were the most seriously affected control structures. The distorted wire baskets have now been buried and replaced with a continuous rock ramp (pictured left) that has been keyed at depth. Extensive channel armoring, and a design to incorporate a side flood overflow channel are part of the latest works.

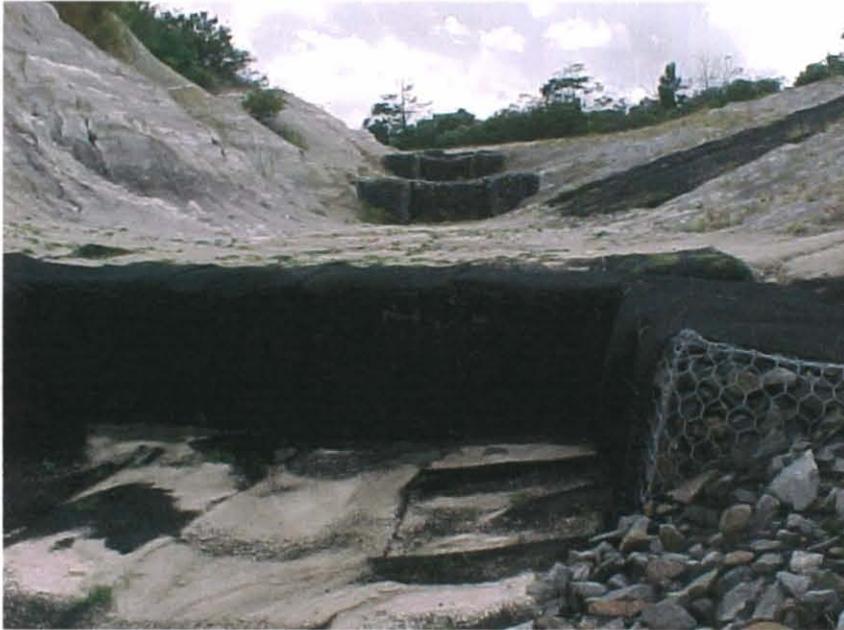
Major landscaping and gabion structures were constructed (see pictures taken in 1999, left and below). Attributes of this project are shown on Figure 9. Ongoing modifications and maintenance have been necessary.

Such activities has recently (the year 2000) involved labour intensive laying of scrub and straw, construction of small drainage control of structures, reinforcing the gabions and heavy fertiliser applications.

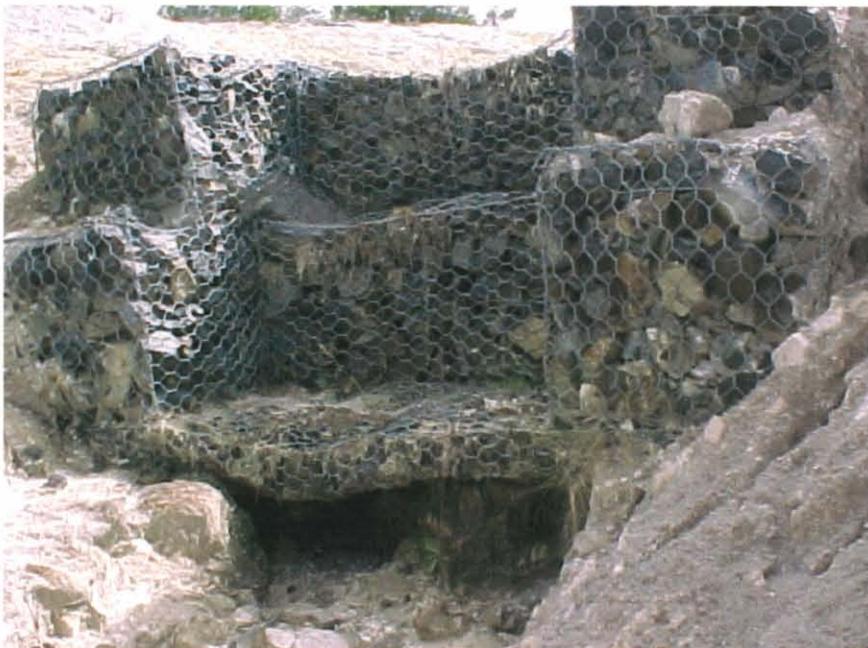
These measures have been most successful. Erosion is minimal and regrowth is steady.

The area has again been top dressed by hand this year with high analysis [10.17.8.1] fertiliser.
