**REHABILITATION OF MINING LANDS TRUST FUND**  
**Report on Works undertaken ~2000 - 2001 Financial Year**

By Revel Munro  
October 2001

# **1 Cat Gully area adjacent to Blue Lake, Endurance Mine, South Mt Cameron.**

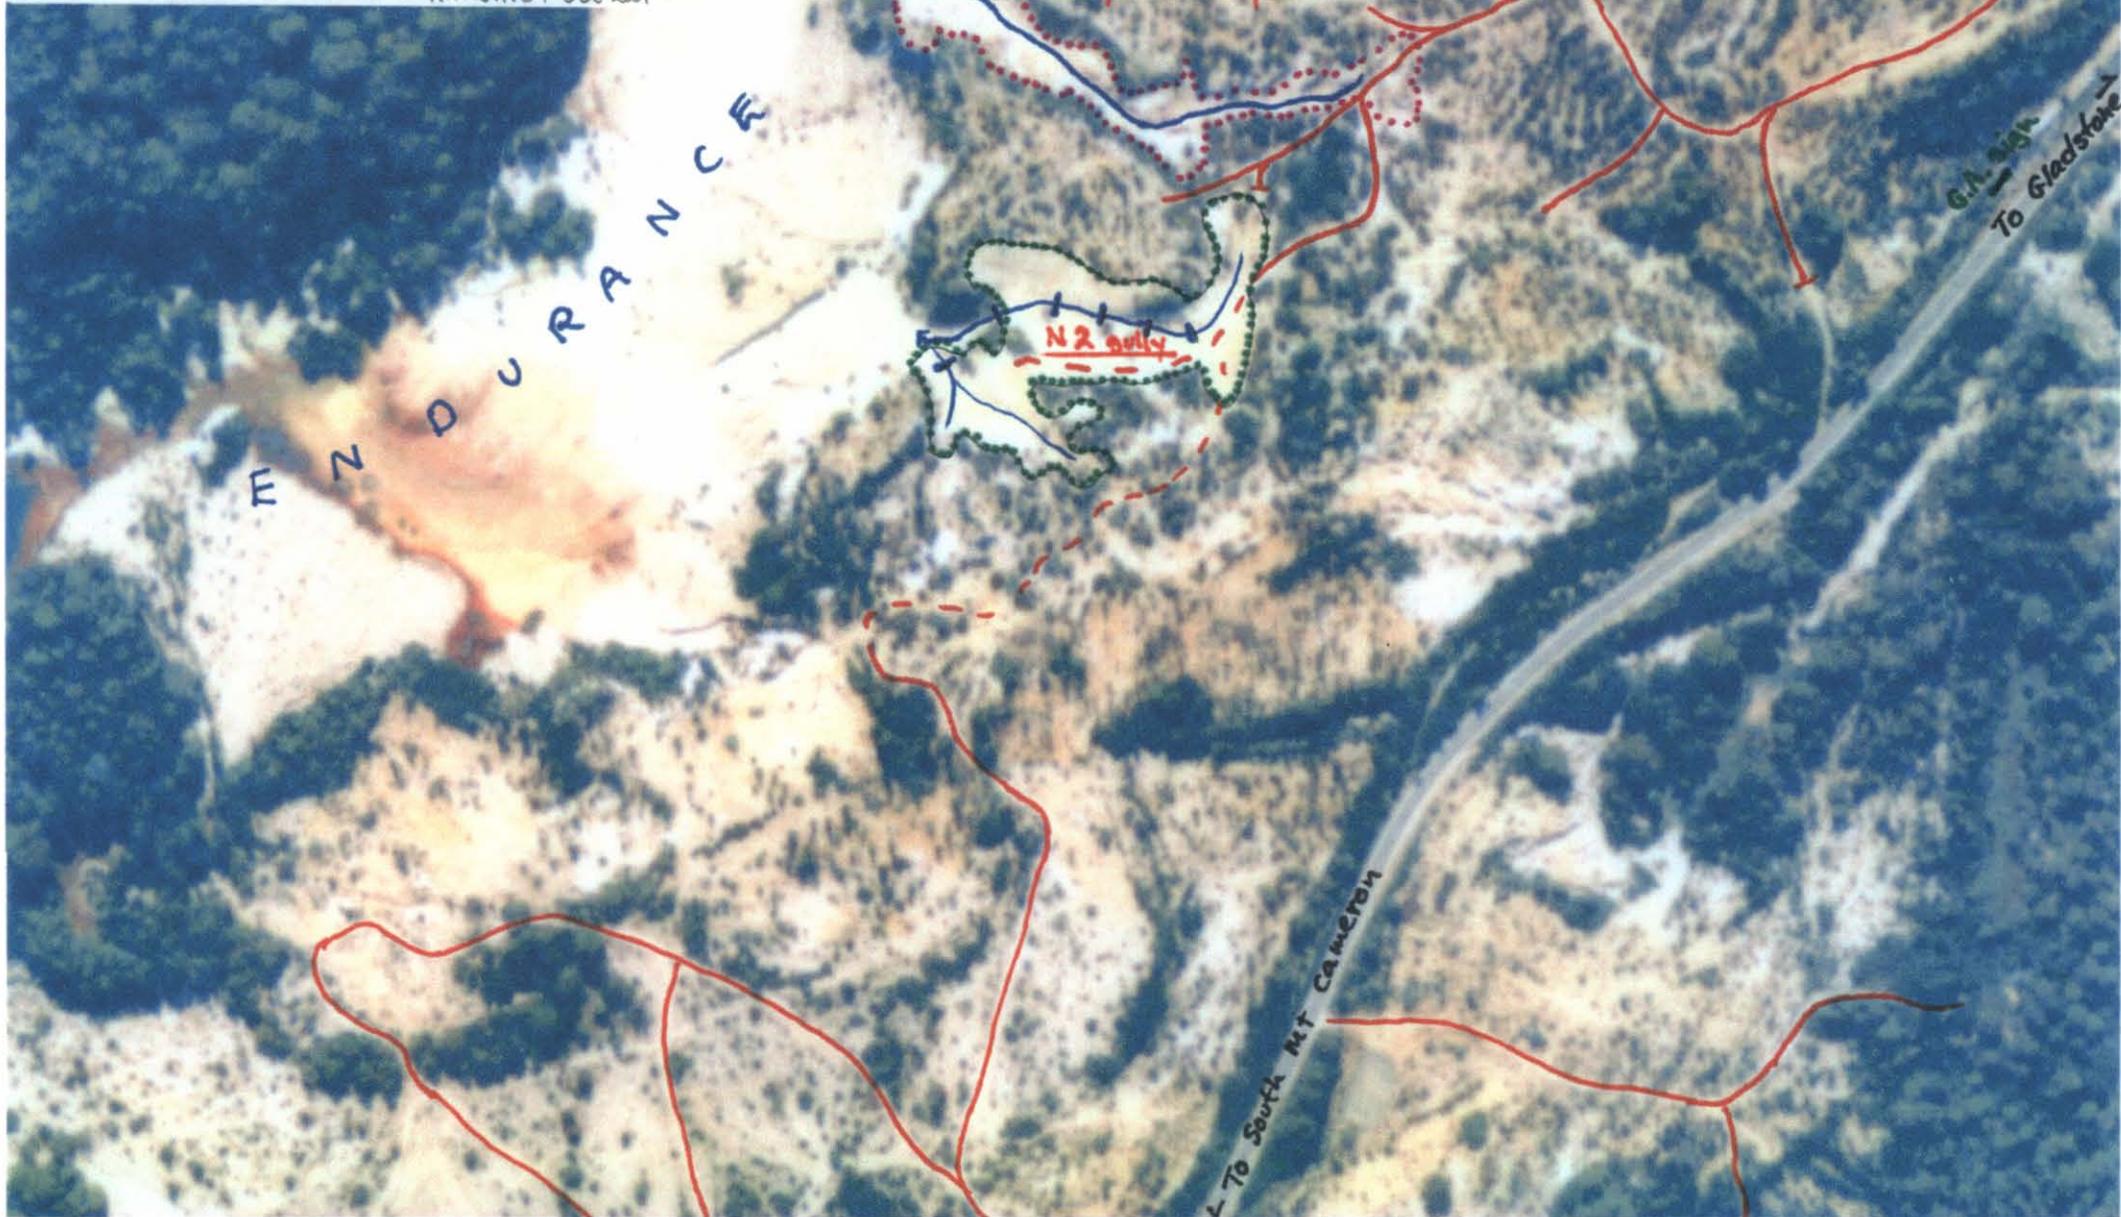
Figure 9.

Rehabilitated Gully showing  
gabion locations  
Area Seeded & Fertilised

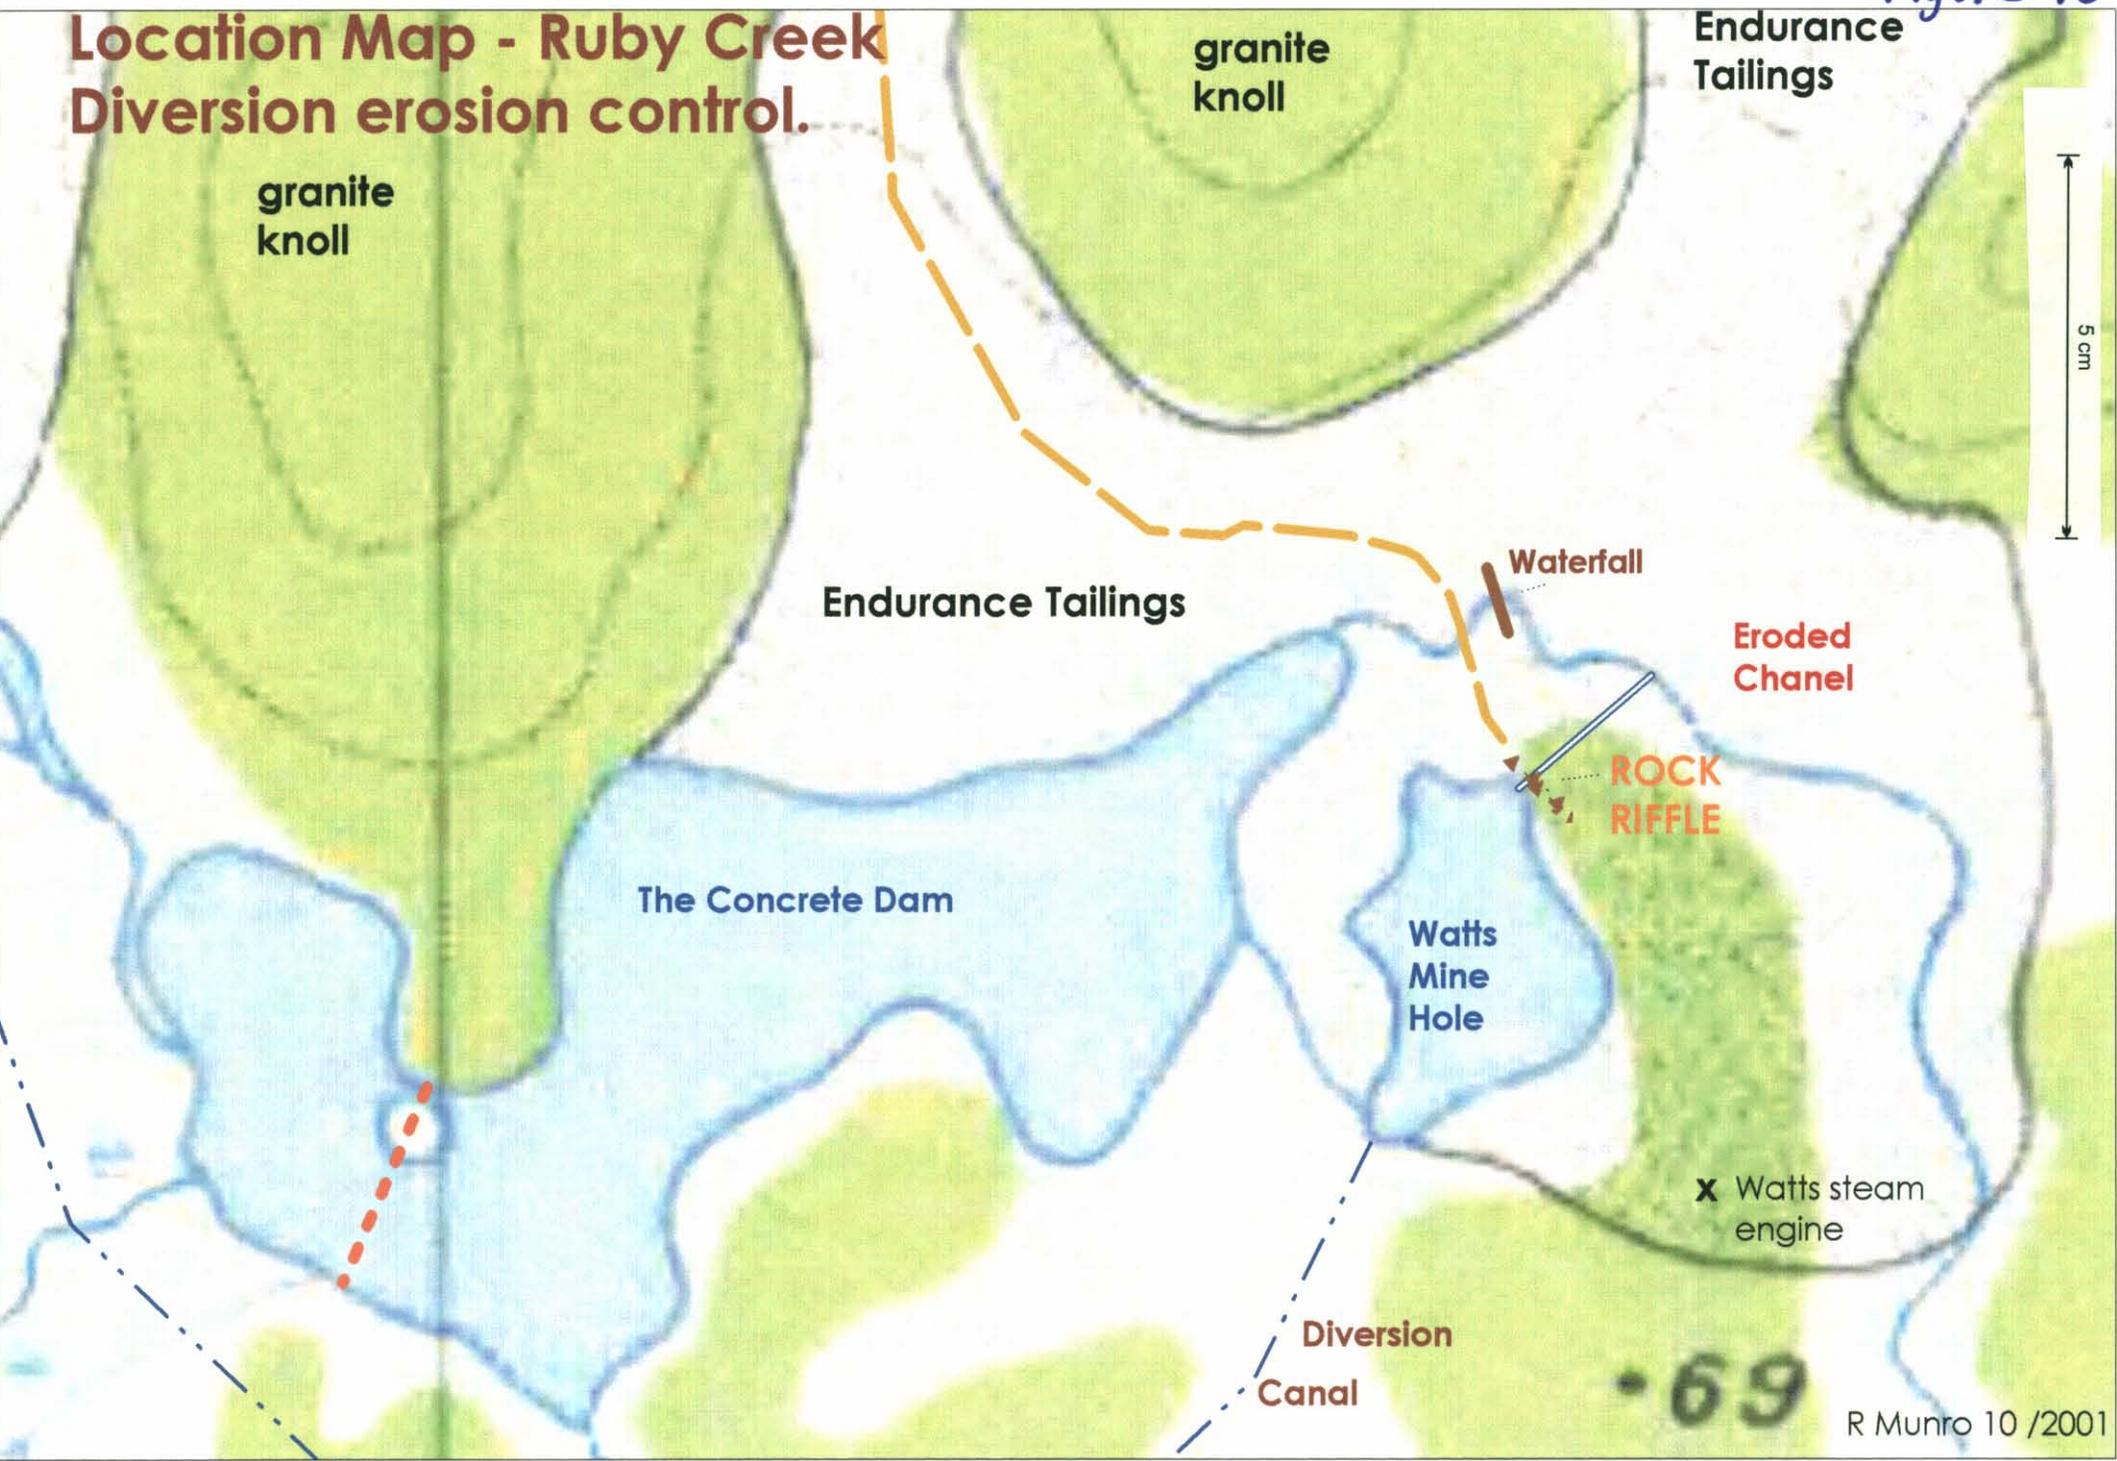
Figure 10

In the late winter of 1999 it was necessary to hastily construct a riffle from imported basalt rock to stem very active back cutting channel that was close to draining a mine wetland. The location of this riffle and the associated diversion channel are shown in Figure 10. The riffle, before a follow-up maintenance and addition of more rock is pictured below. The logs in the foreground were displaced by water action.

Works this year has been limited to continued inspection. Both the riffle and the channel are stable. Ongoing inspection is recommended as it is apparent that the drain carries large amounts of runoff at times.
