FLY-BY-NIGHT MINE - WATER QUALITY INVESTIGATION

REPORT FOR MINERAL RESOURCES TASMANIA

18 June 2013 - Final - Project No: 2821.004

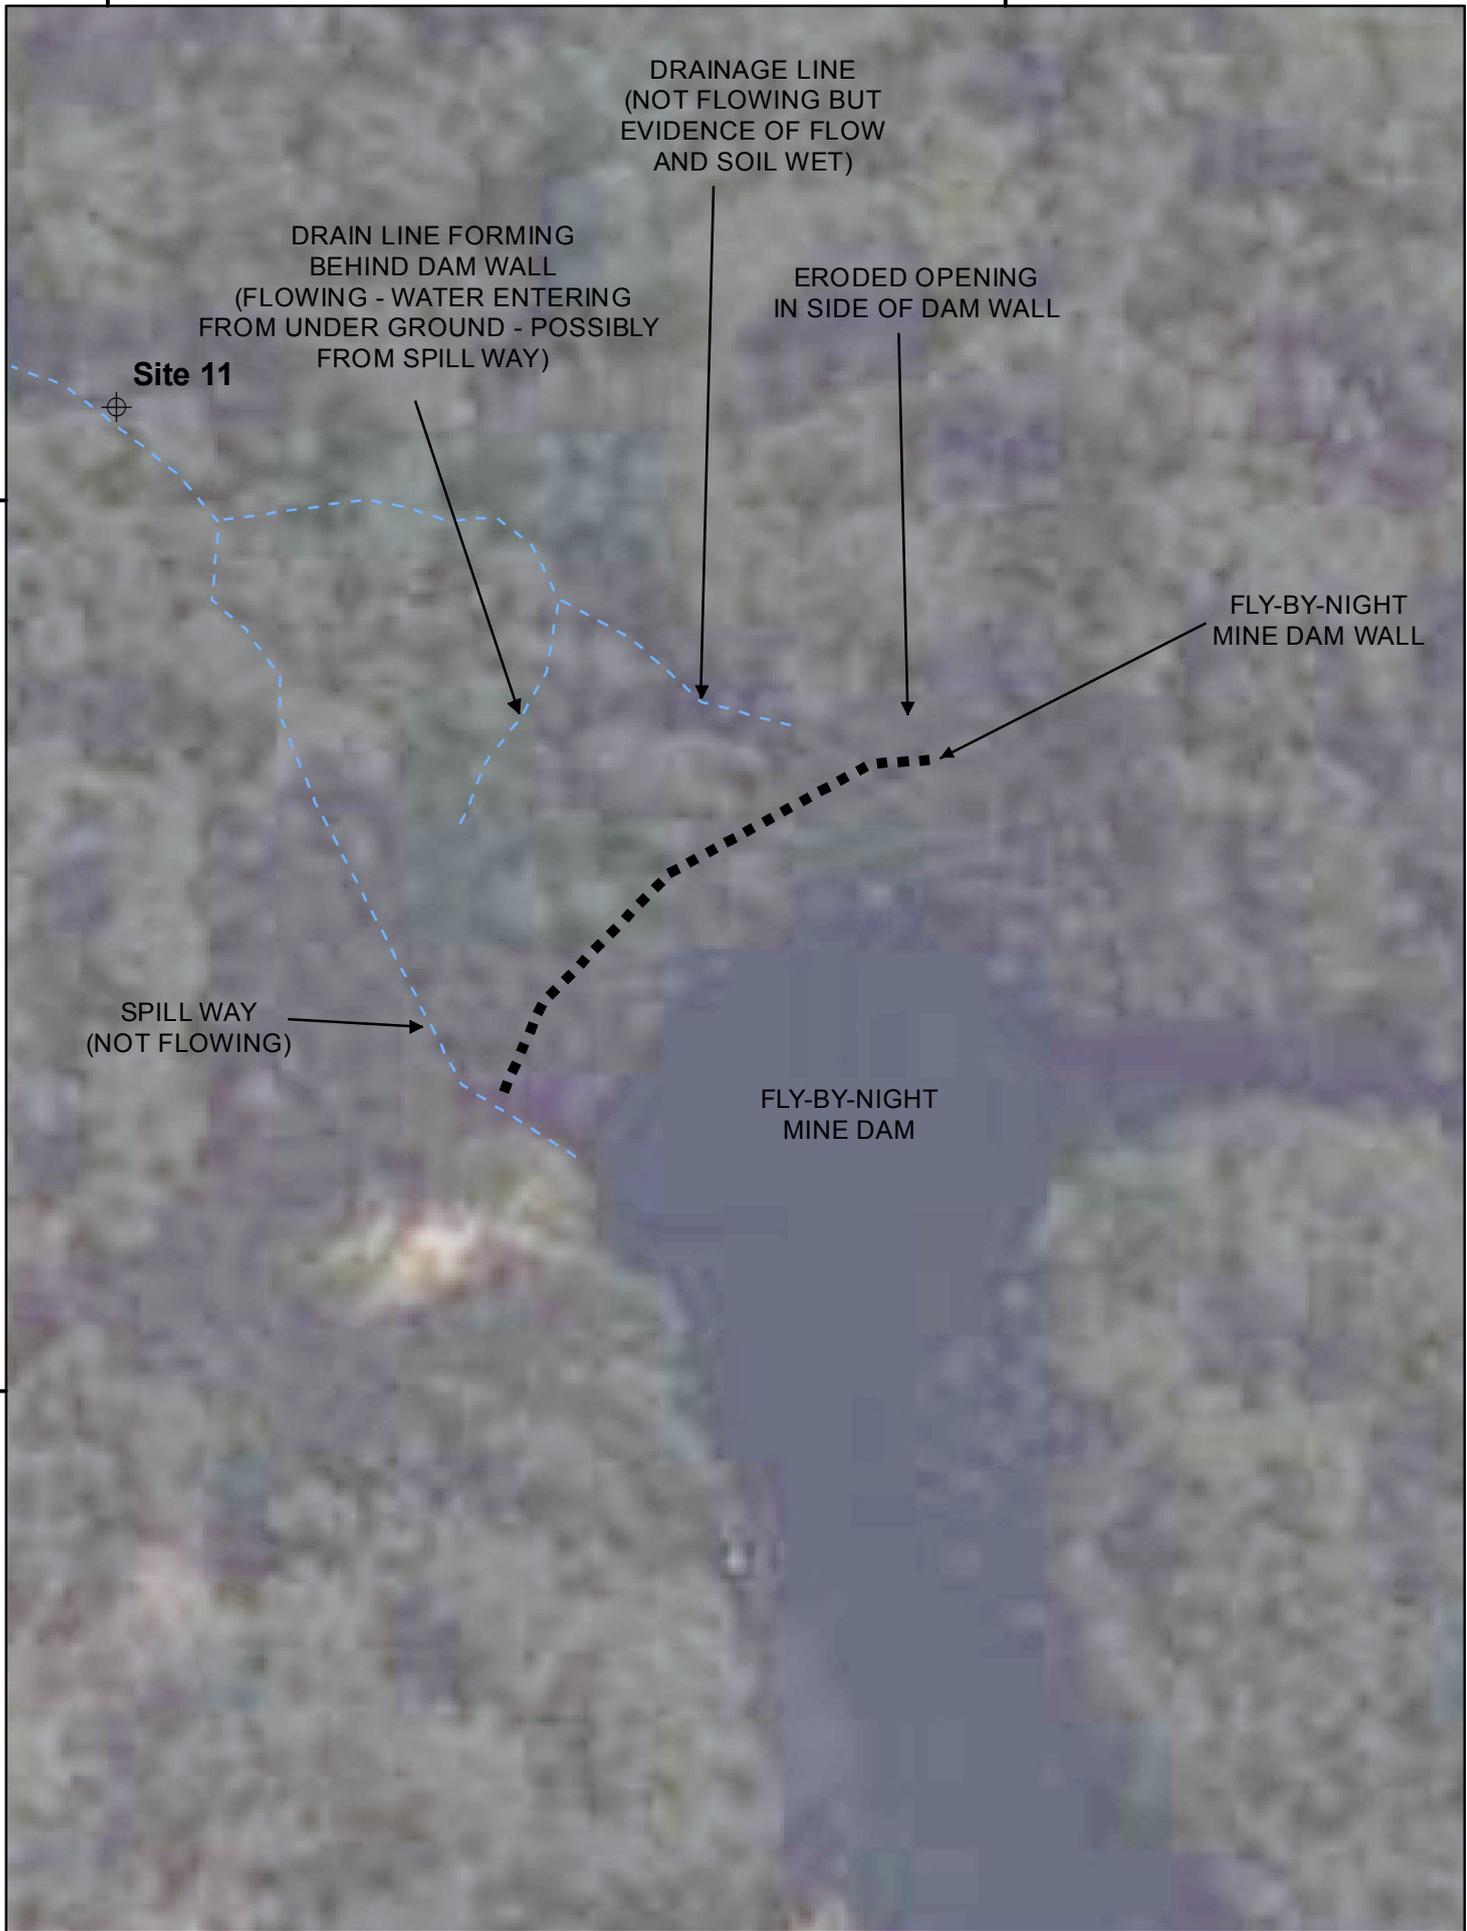
Figure 5: Fly-By-Night Mine Dam

A visual inspection of the surface water dam, located below historic mine workings on FBNC was completed during the site assessment. The location of various erosion features were noted and photographed, with results integrated into Section 3.5 of the report.
