August 2025

# Annual Report

## Rehabilitation of Mines 2024-25

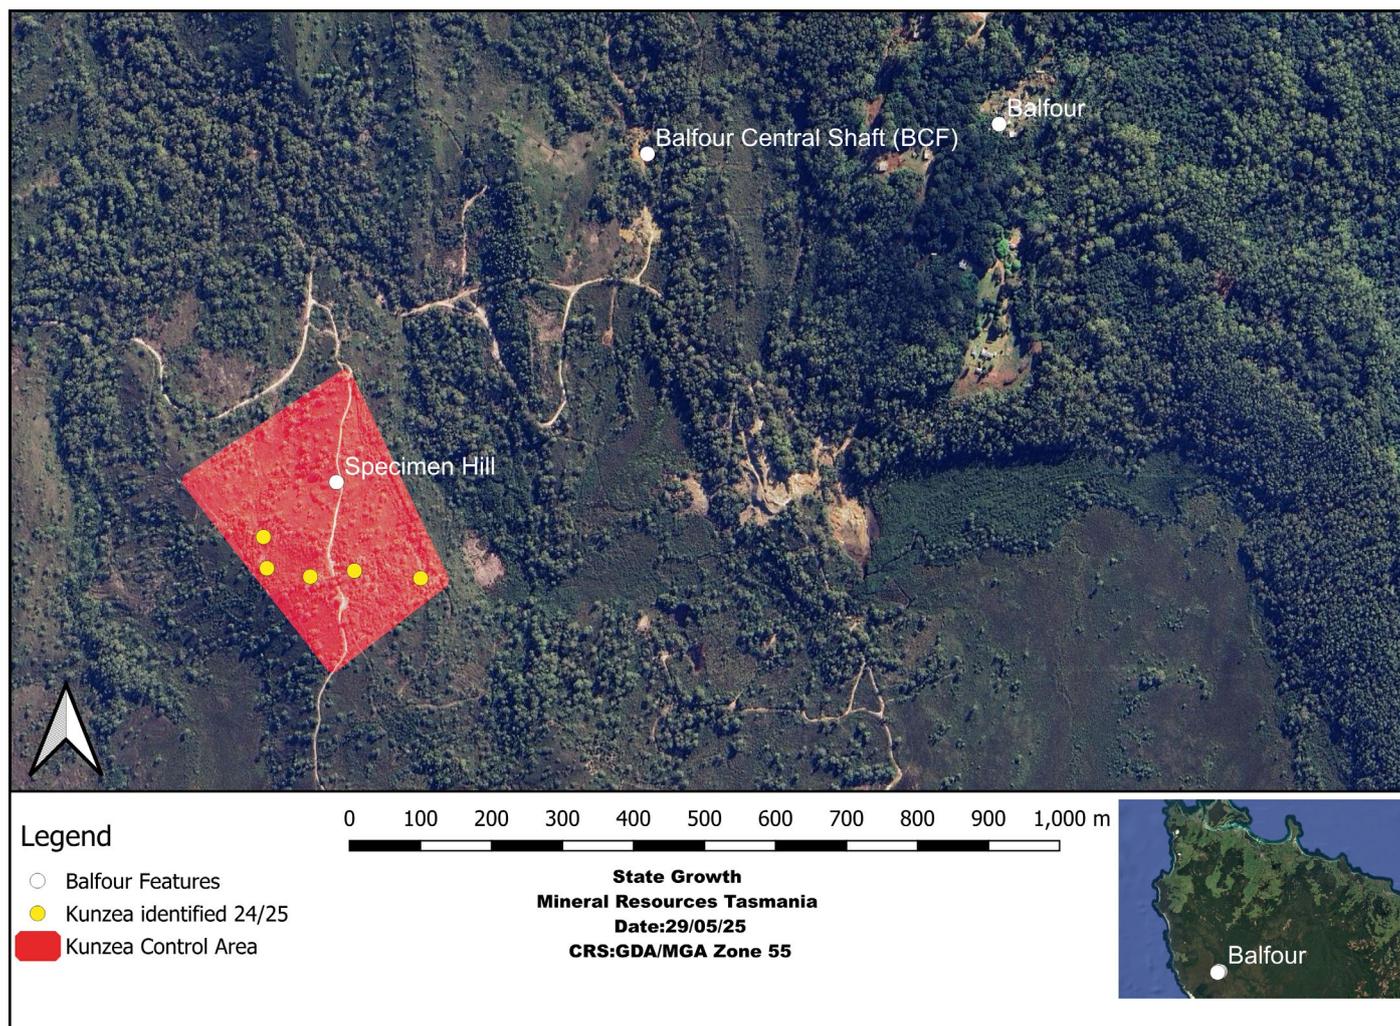
In December 2024, the removal of *Kunzea ambigua* from historical revegetation sites continued on Specimen Hill in the proximity to Balfour. *Kunzea ambigua* is locally endemic to northeastern Tasmania. Removal of this species has been ongoing since 2019, with observations significantly reduced during the 2024 effort (Figure 3). Follow-up weed monitoring is scheduled for November 2025, coinciding with the onset of flowering.

Figure 3. Specimen Hill *Kunzea sp.* control area, December 2024.

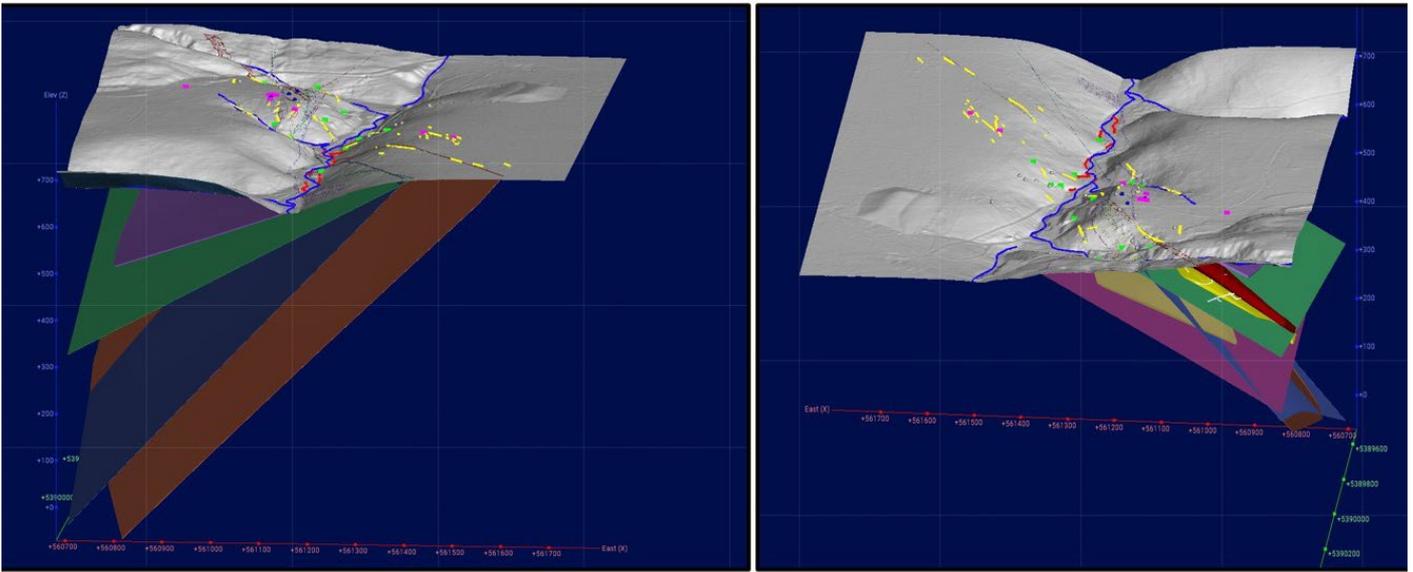
Since the early 2000s, the RTF has been funding ongoing remediation works at the Storys Creek Mine, including the relocation of precipitate and jig tailings, construction of an anoxic limestone drain (ALD), limestone spreading, and adit capping. Implementation of these activities has seen demonstrable improvements in water quality and its suitability for downstream agriculture and livestock use, however MRT are still working to improve water quality in the immediate vicinity of the milling precinct, particularly addressing the discharge from adits flowing into Side Creek just above its confluence with Storys Creek. In July 2024, the RTF received a report summarising the results of extensive on-site activities commissioned in 2022, which included bore design and installation, a hydrological assessment, and a detailed feature survey of the area. In addition, this report provided a 3D model demonstrating how historical workings have created high permeability zones for groundwater infiltration into the mineralised veins and local groundwater system (Figure 6).

Figure 6. Conceptual hydrogeological groundwater model (not to scale) (Hydro Earth, 2024).

The report recommended priority features for remedial action, recommending drainage diversion and surface capping to reduce surface water penetration. MRT will look to progress this program in FY 25/26. Key focus points for progression involve:

- Scope for functional repair of ALD;
- Analysis of surface microtopography for the optimisation of drainage placement and design;
- Identification of source material proximal to historical mine site to overcome load limit constraining transportation via main access road;
- Approvals for sourcing capping material and quotation for processing and supply;
- Development scope for the capping and revegetation of priority surface features.

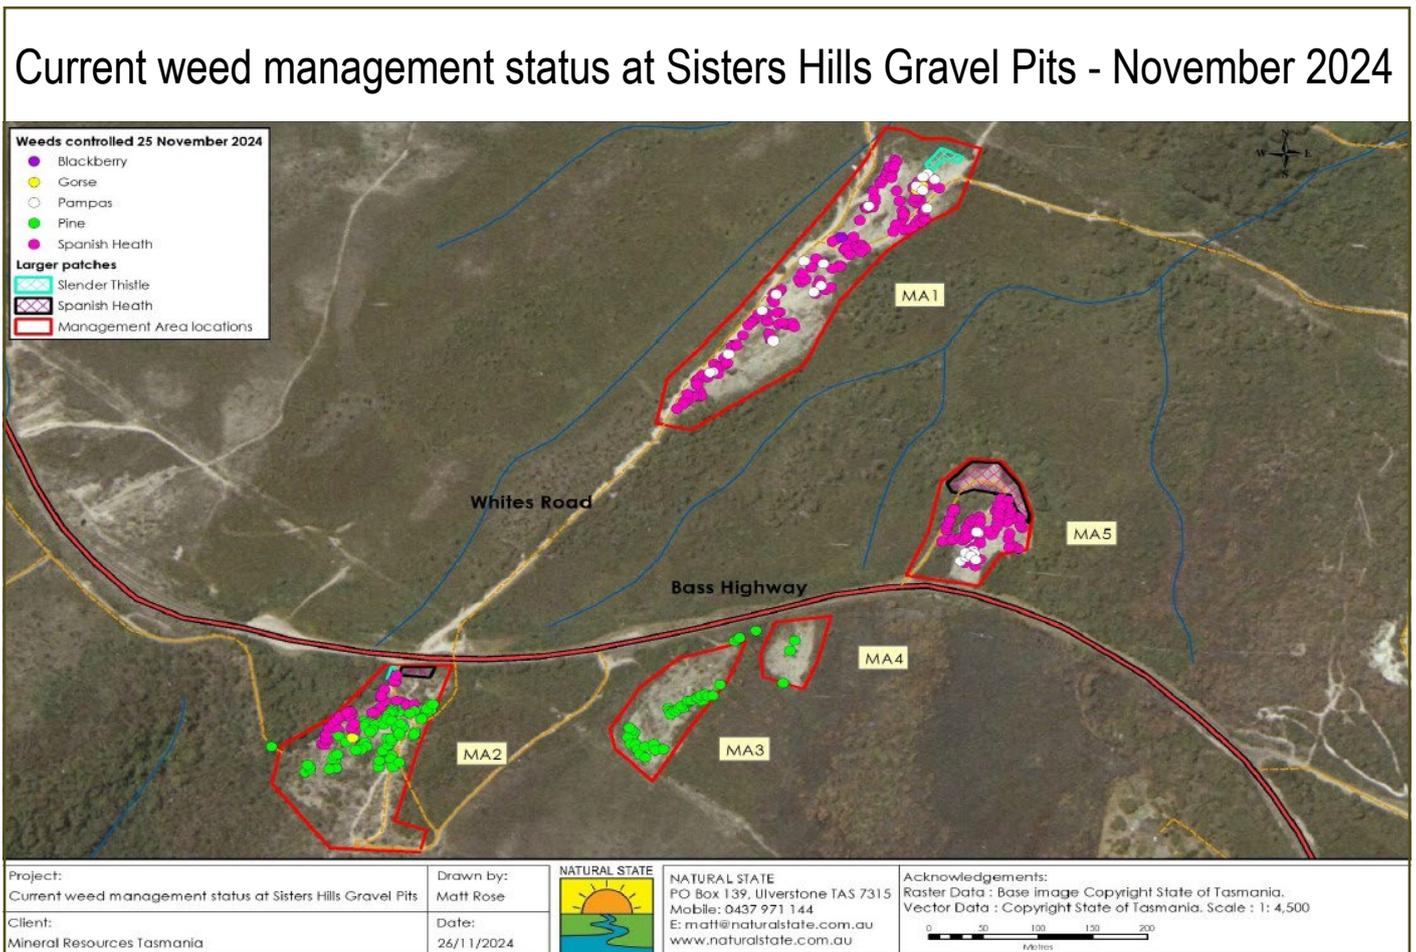
Remediation of the Sisters Hills quarry has been ongoing since 2010. Natural State has been responsible for the implementation of the Sisters Hills Weed Management Plan, commissioned by the RTF in 2018 (Figure 8). In November 2024, Natural State continued with the program undertaking progress mapping and weed control. The 2024 survey indicated successful eradication of Blackberry (*Rubus fruticosus*), Blue Butterfly Bush (*Buddleia* sp.), Spear Thistle (*Cirsium Vulgare*) and Montibetia (*Crocasmia* sp.) across the sites. A continuation of the programs in 2025/26 is recommended to manage recruiting Pine (*Pinus radiata*), Pampus grass (*Cortaderia selloana*) and Spanish Heath (*Erica lusitanica*).

Figure 8. Future target species and focus areas for ongoing management, Sisters Hills, November 2024.
