14. Examination of land at East Devonport

The Devonport Council requested an inspection of a proposed subdivision of c.8 ha (20 acres) of land and a report on any possible unstable areas. The land, owned by M.F. Savage, is on the outskirts of East Devonport and is bounded by Port Sorell Main Road on the north, Bovill Street on the west and Drew Street on the south.

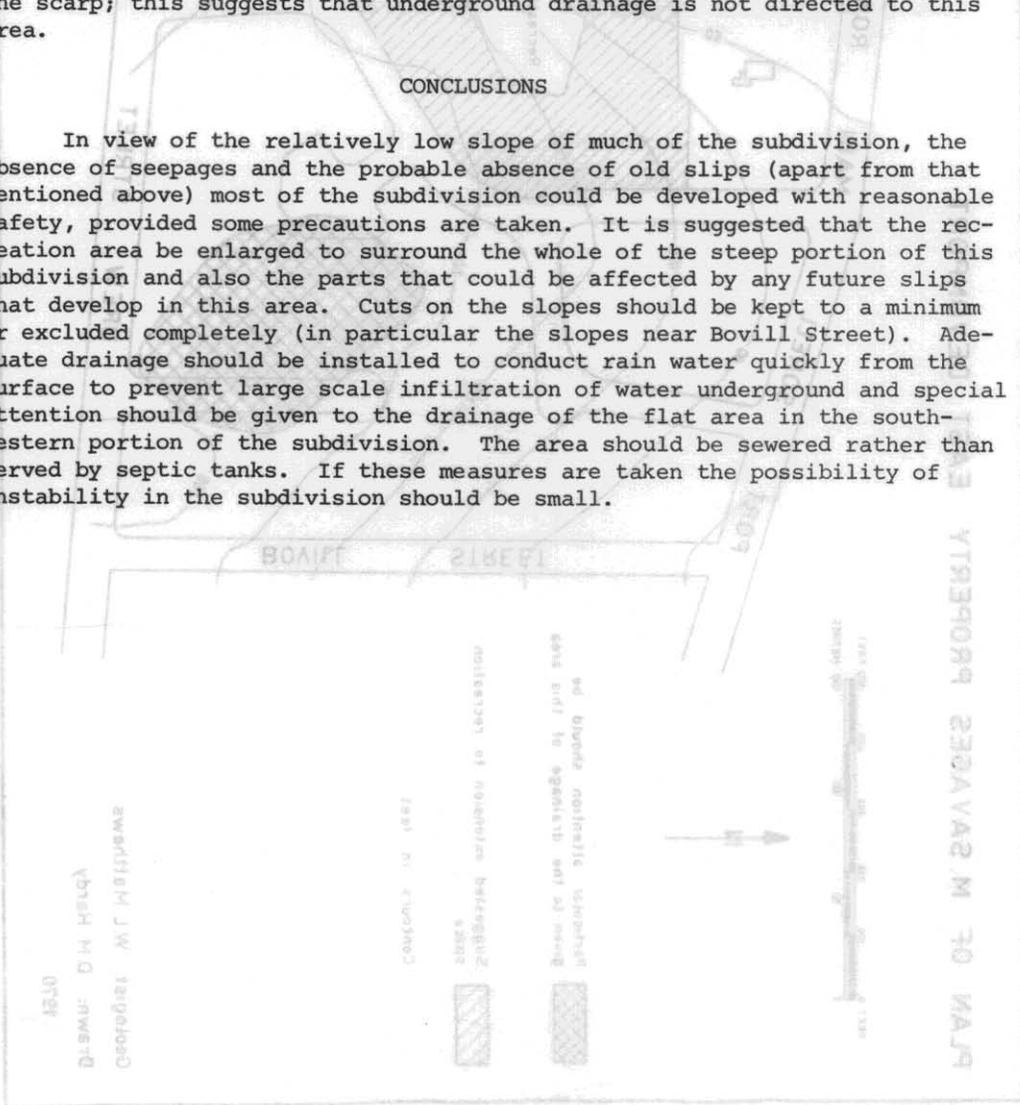
Figure 14.

PLAN OF M. SAVAGES PROPERTY EAST DEVONPORT

Particular attention should be given to the drainage of this area

Suggested extension to recreation space

In view of the relatively low slope of much of the subdivision, the absence of seepages and the probable absence of old slips (apart from that mentioned above) most of the subdivision could be developed with reasonable safety, provided some precautions are taken. It is suggested that the recreation area be enlarged to surround the whole of the steep portion of this subdivision and also the parts that could be affected by any future slips that develop in this area. Cuts on the slopes should be kept to a minimum or excluded completely (in particular the slopes near Bovill Street). Adequate drainage should be installed to conduct rain water quickly from the surface to prevent large scale infiltration of water underground and special attention should be given to the drainage of the flat area in the south-western portion of the subdivision. The area should be sewered rather than served by septic tanks. If these measures are taken the possibility of instability in the subdivision should be small.
