UR1975-73

Seismic survey at a golf course at Penguin.

W.L. Matthews

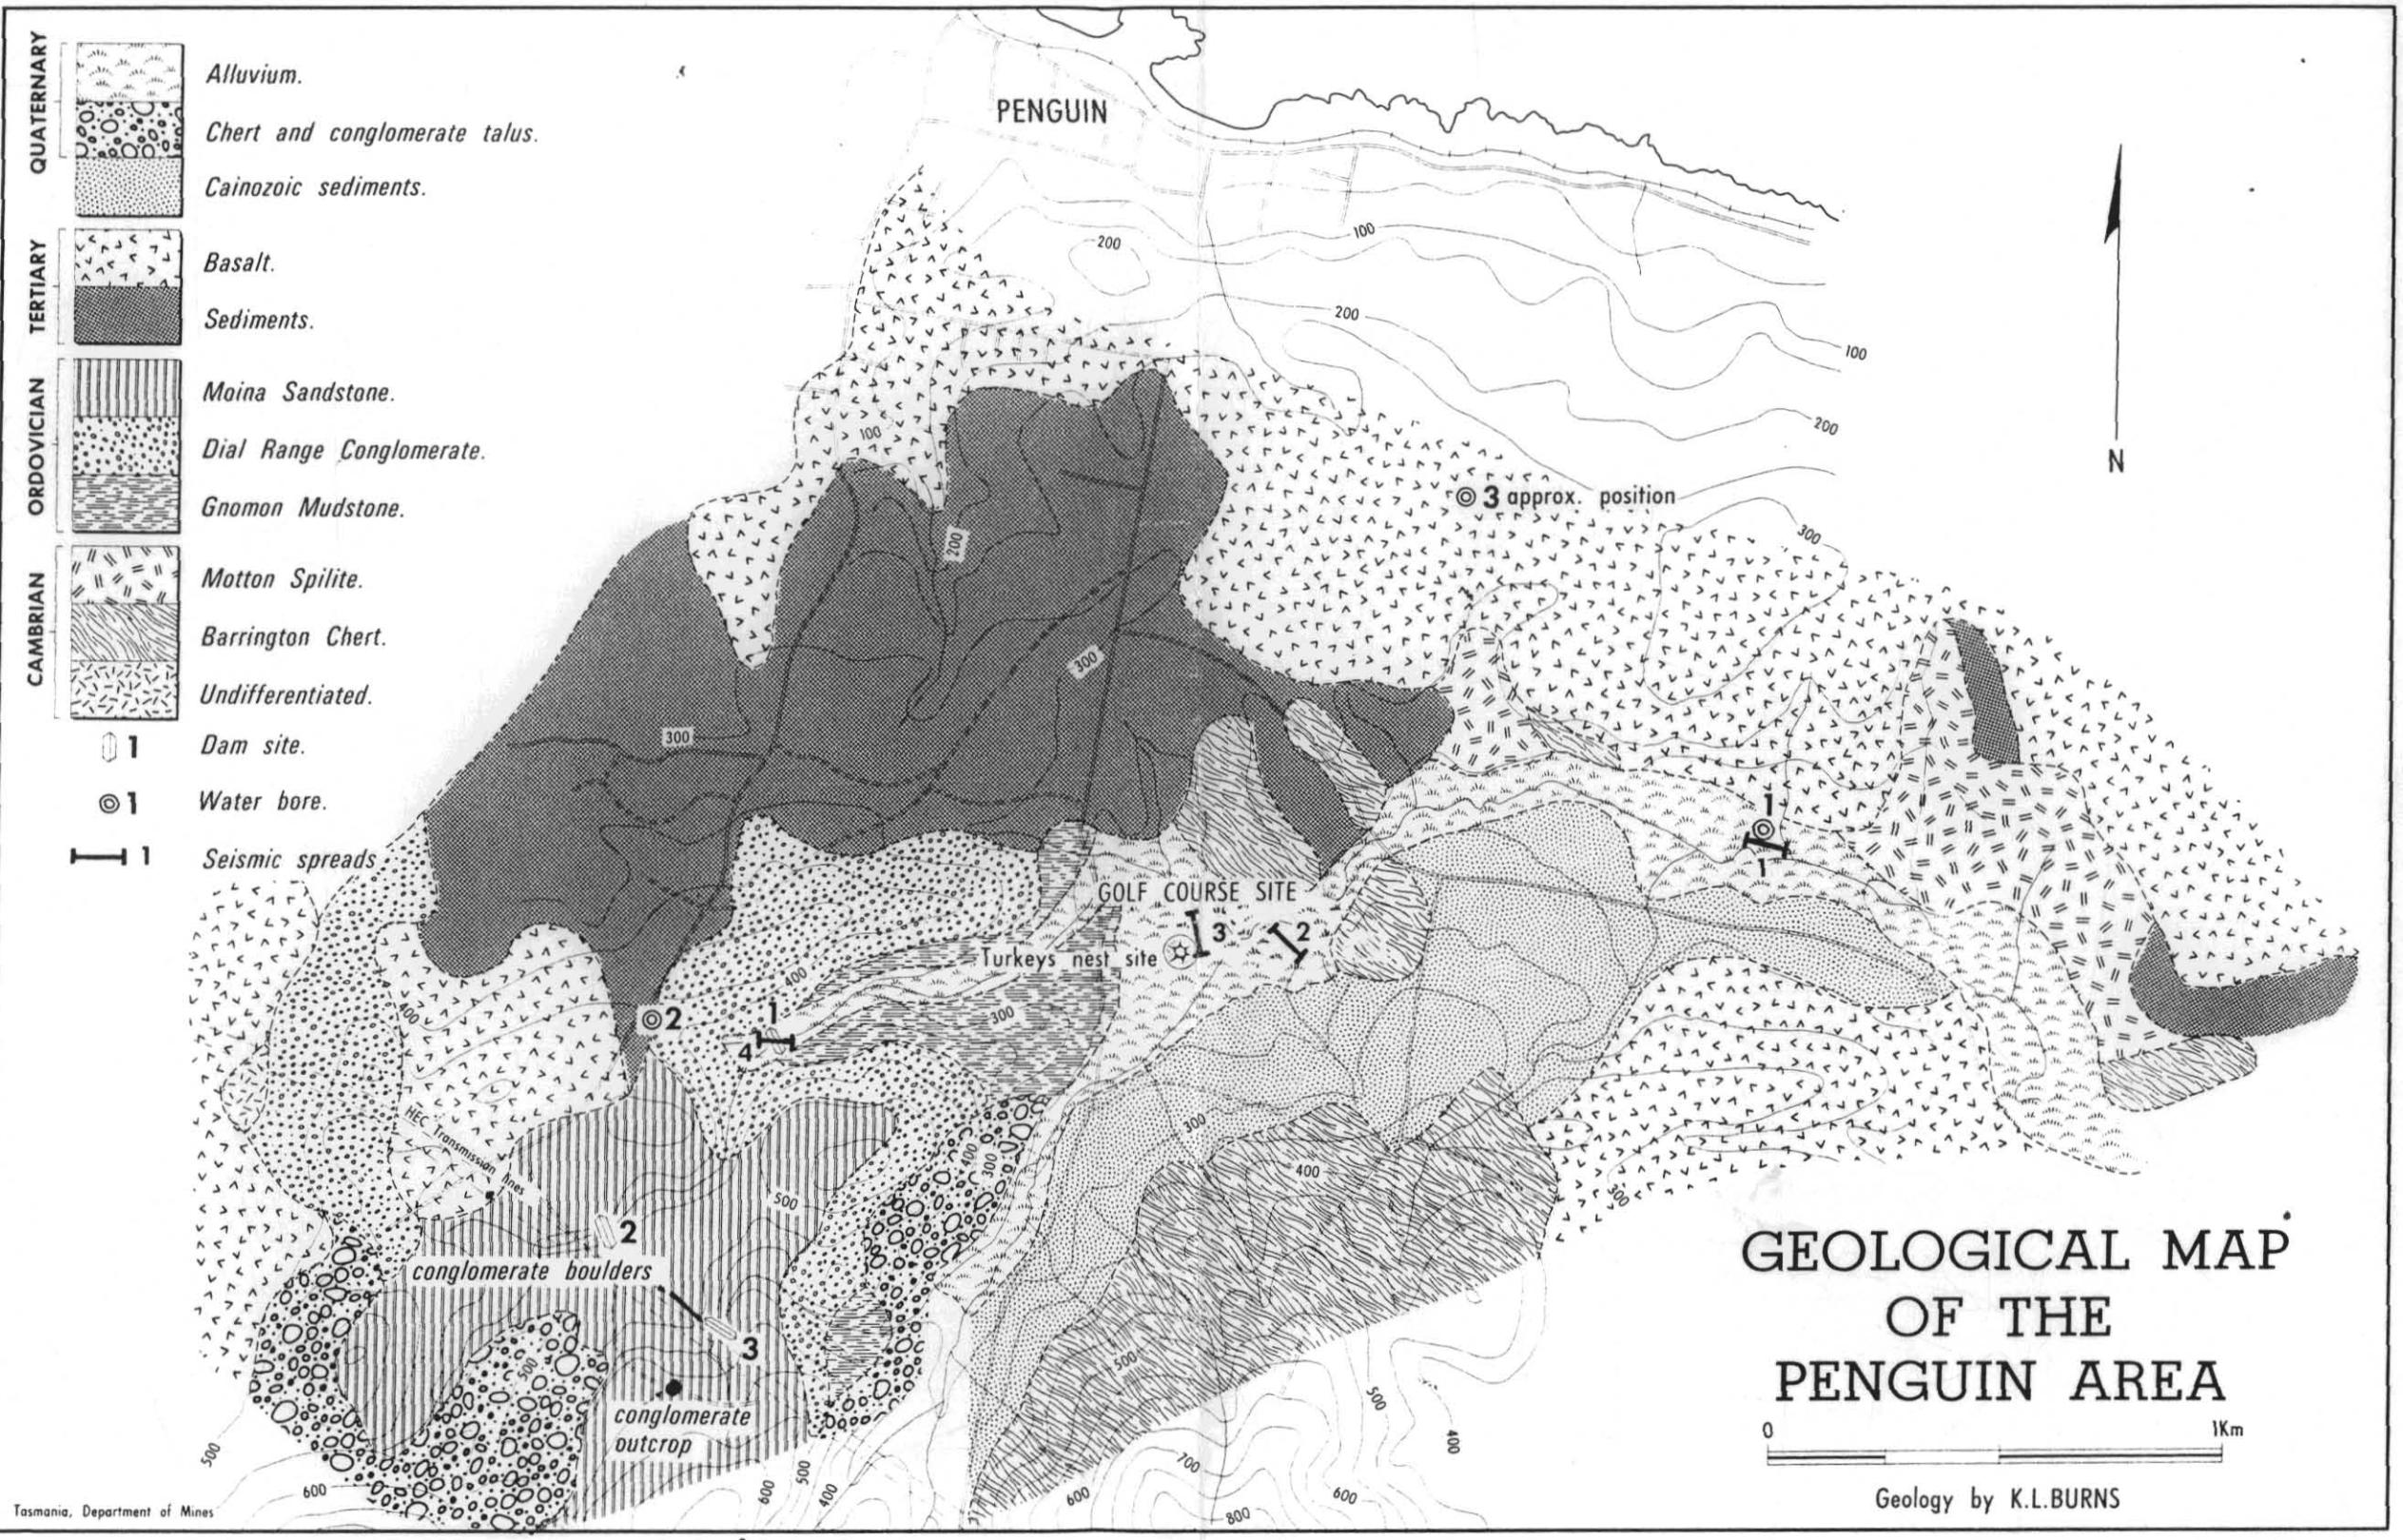
The results of these spreads are summarised in Table 1. The approximate positions of the spreads are shown in Figure 1 and interpreted cross sections are given in Figure 2.
