UR1976-06

1976/6. Inspection of a landslip on D.J. Squibbs' property, Spreyton.

W.L. Matthews

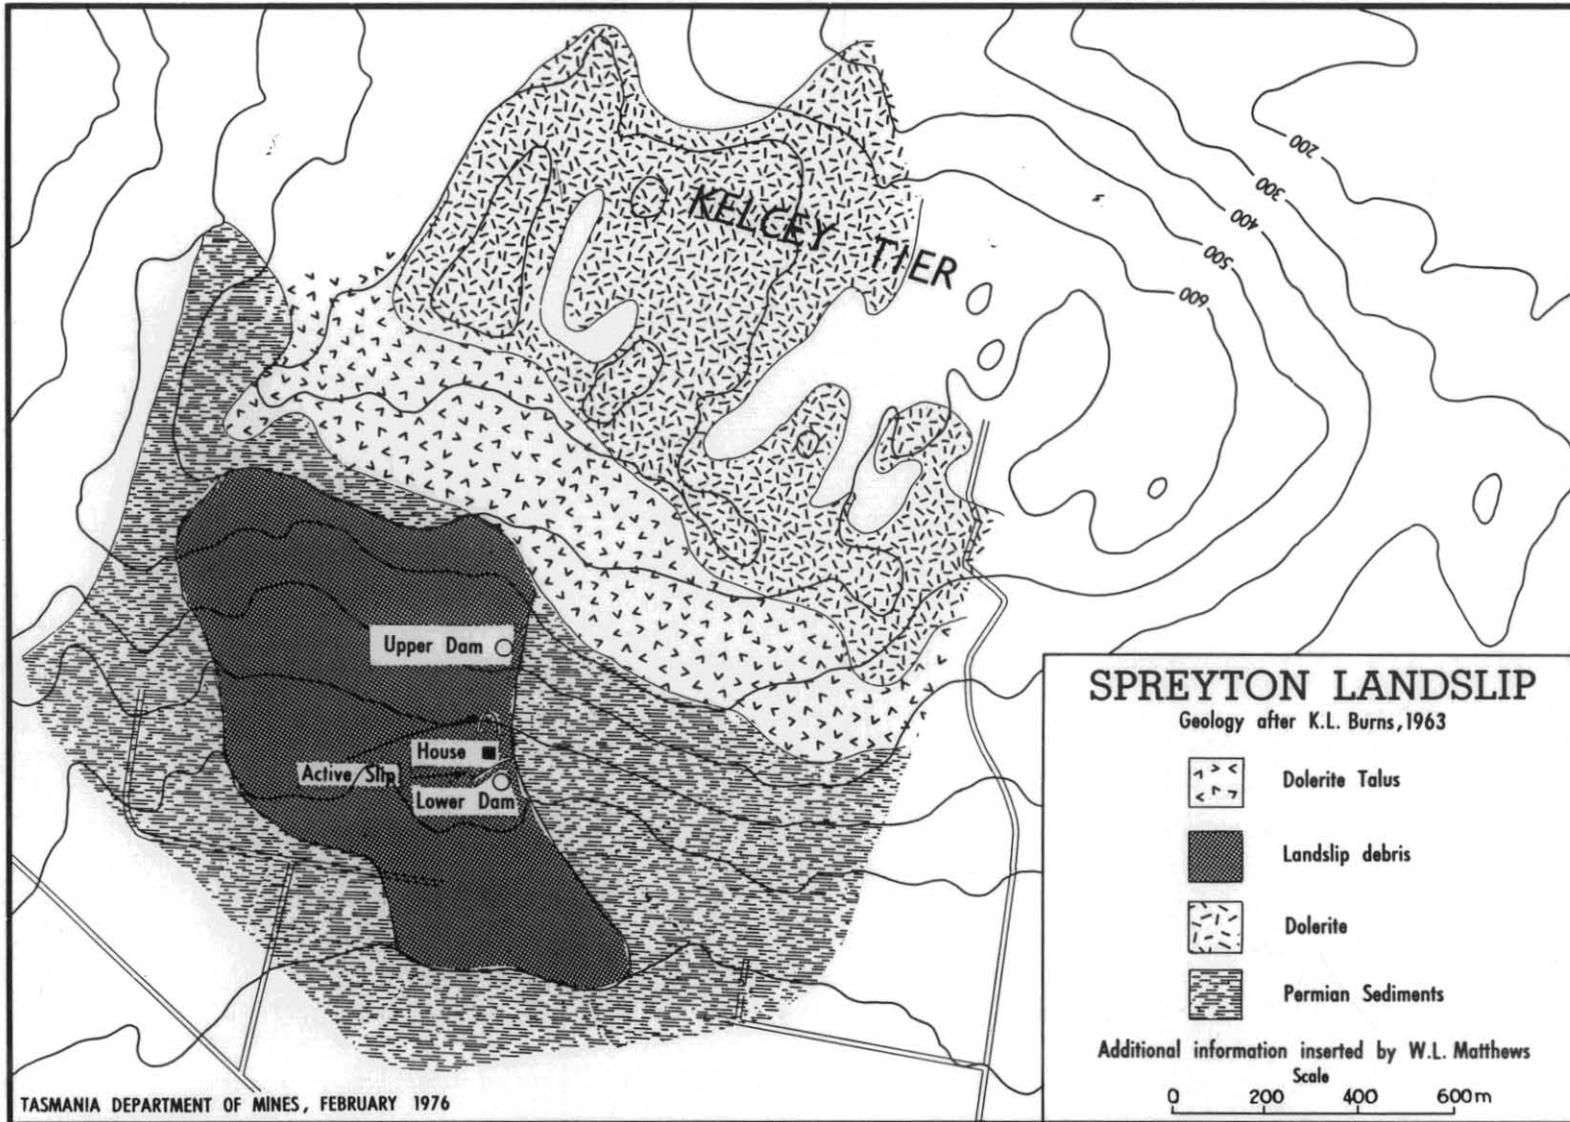
Figure 1.

The house is situated on the eastern bank of the Kelcey Tier towards the base of the main slope (fig. 1). The land surface rises slightly from orchard land to the house site situated on a narrow flat and then rises steeply behind the house. There are a series of benches around the slope before the summit is reached, about 170 m above the house.
