1976/31. Engineering geology and slope stability analyses of the Round Hill quarries, Burnie.

W.R. Moore

The Senior Mining Engineer, Department of Mines, Burnie requested that the Engineering Geology Section 'establish guide lines that were to be the basis of the final design for the working and rehabilitation of the Round Hill area'.

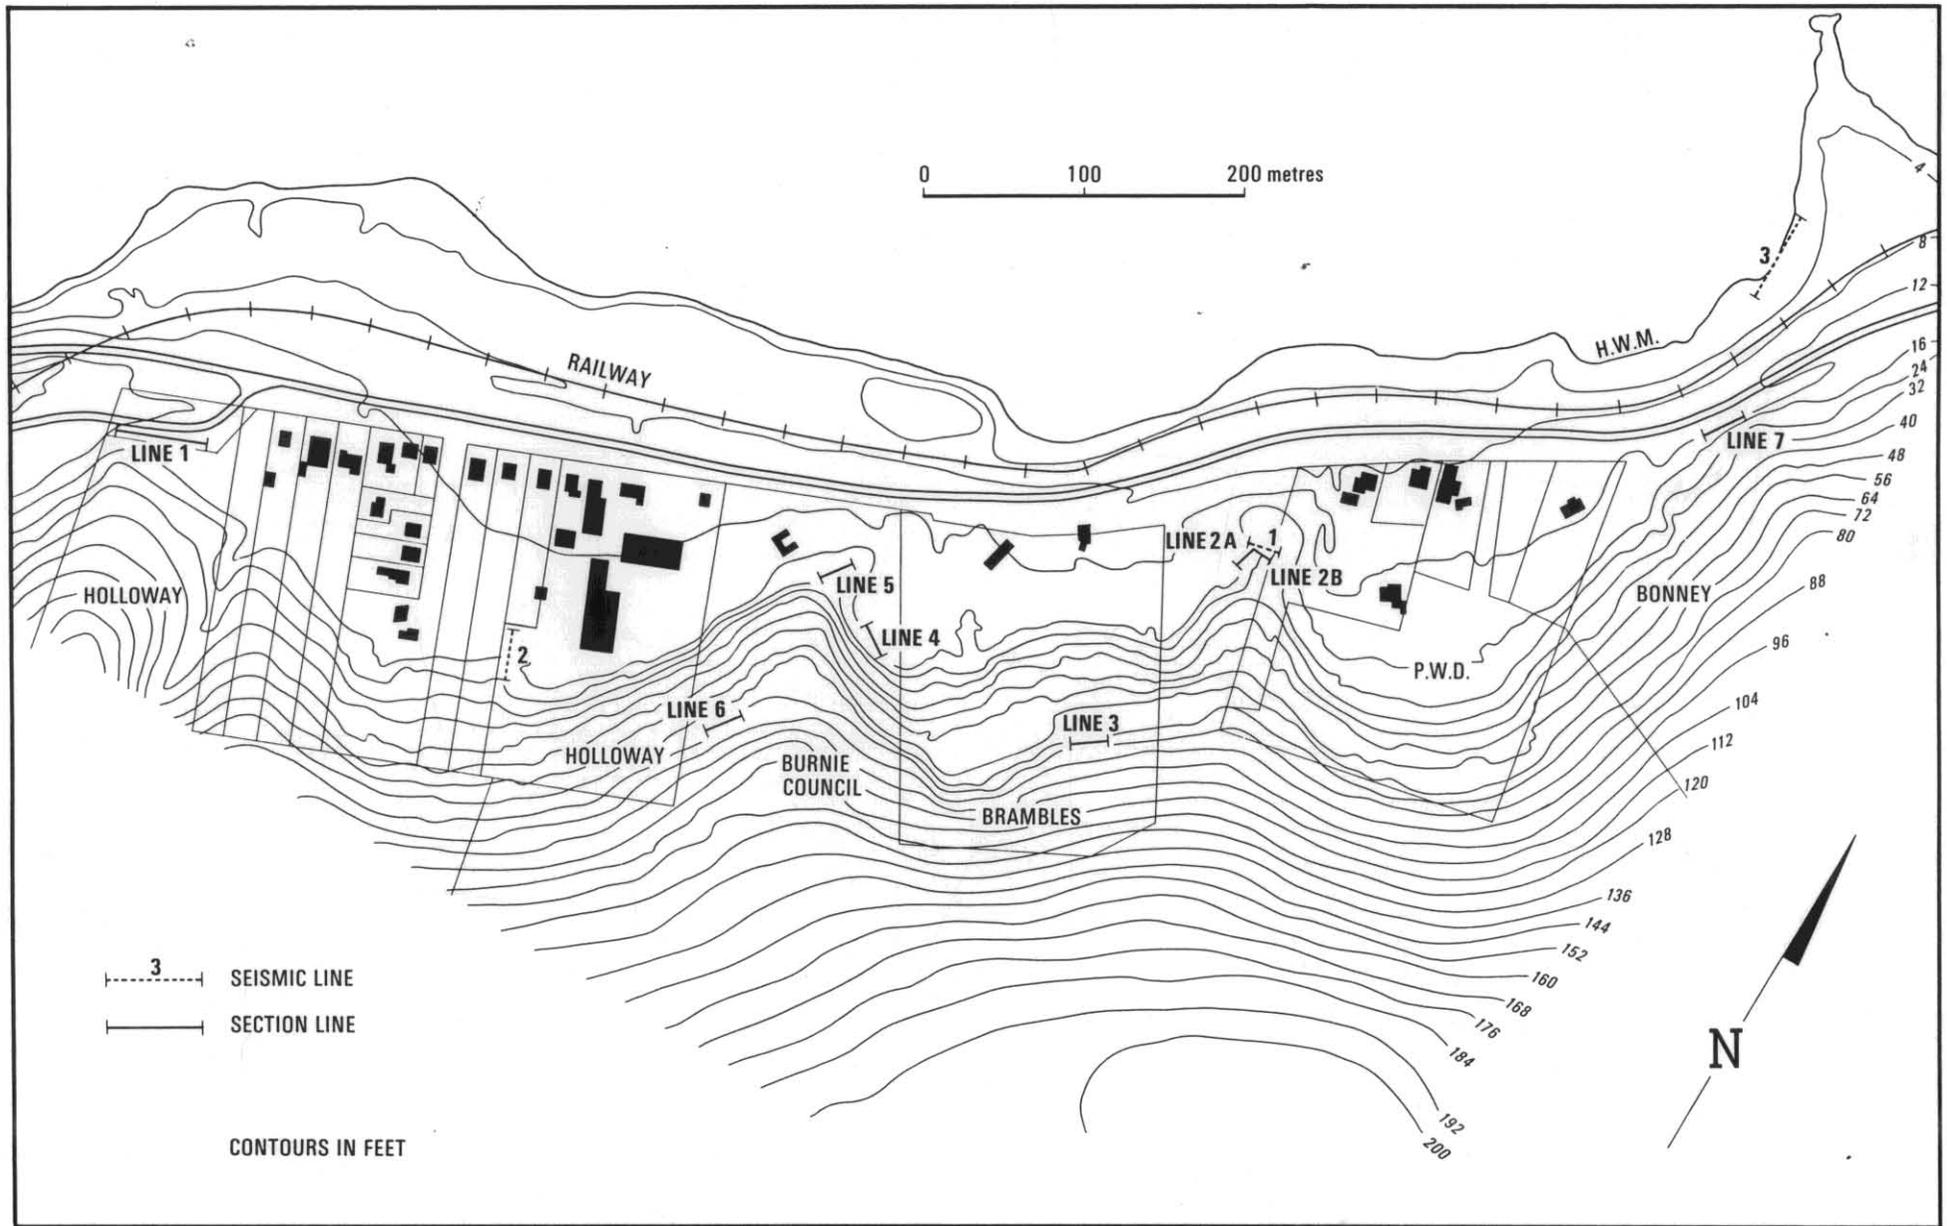
Figure 1. Location of quarries, seismic lines, and structural analysis lines

This report is based on one day of general site inspection of the various quarries and outcrops on Round Hill, four days of structural measurements and photography and one day of refraction seismic firing. The location of the slope stability structural analyses lines, and seismic lines are shown on Figure 1.
