1977/35. House damage in the Taroom area.

C.J. Knights

Expansive clay, combined with change of moisture content and inadequate foundations is the major cause of house damage in the area studied. Less commonly, damage may be caused by dispersion and settlement of the clays, by consolidation of peaty layers, or through landslip.

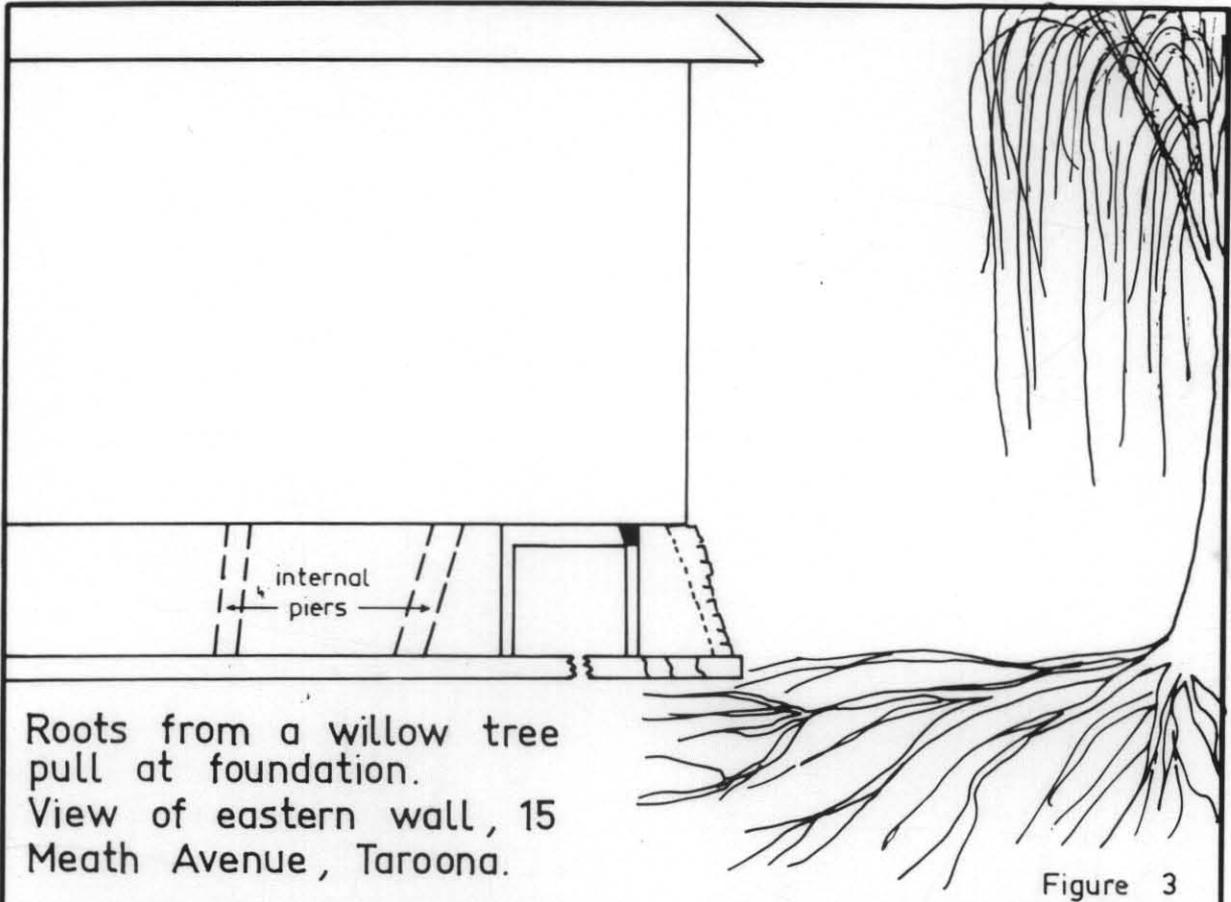
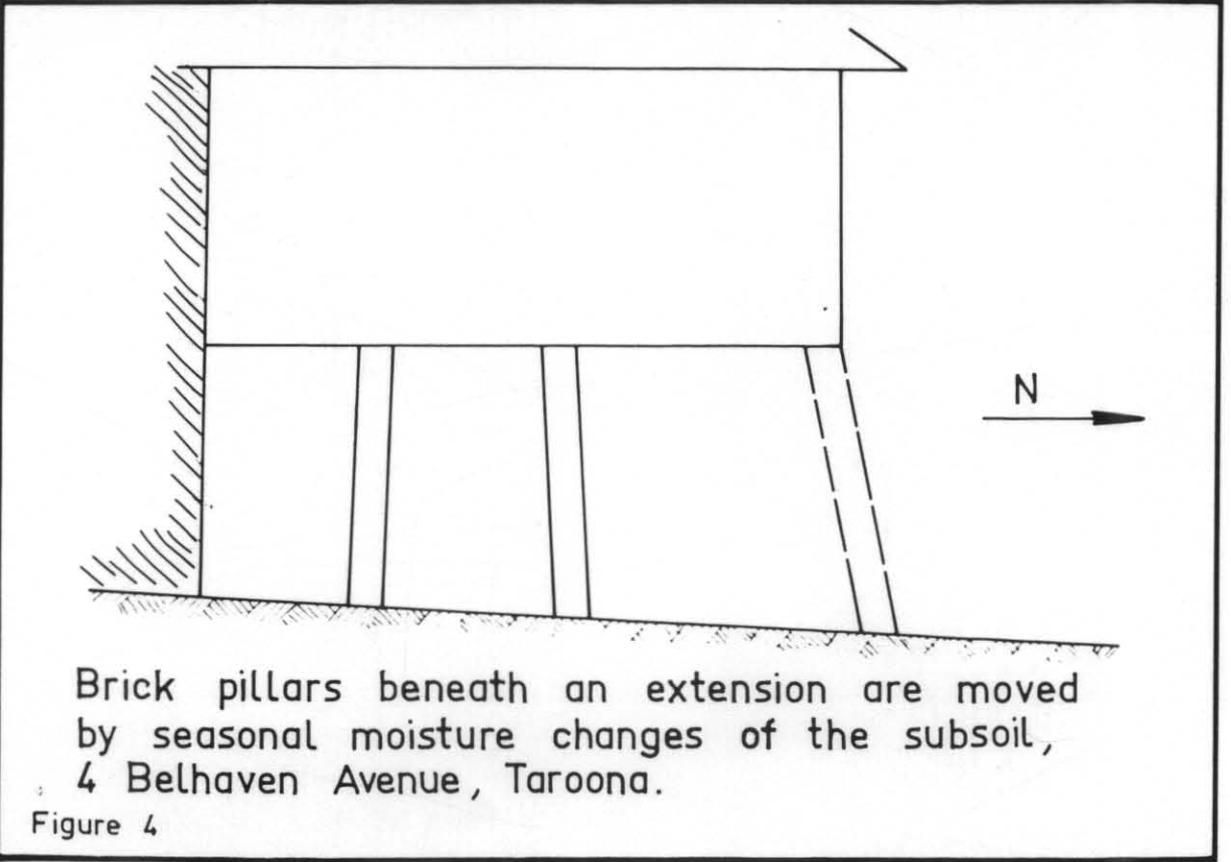
This weatherboard house has single brick foundation walls one metre high, founded on moist, black peaty clay ( $m = 38-44\%$ ). Serious damage commenced in 1973 and is restricted to the northern half of the house. It appears that the footings beneath the northern wall have been pulled outwards, away from the house, so that the foundation wall leans in towards the weatherboard above it (plate 1). On the east side of the north-east corner there is a hatchway leading under the house. Here the footings have an open crack several centimetres wide, and the top of the hatch is pulled apart by about 30 mm (plate 2), again suggesting that the northern foundations are being pulled away (fig. 3). Excavation of the corner footings show them to be 46 cm deep and 46 cm wide at the top, narrowing downwards. The internal piers tilt towards the damaged wall.

Plate 2. 15 Meath Avenue. View of hatchway in eastern wall. Note tension crack in footing and separation of hatchway frame from brickwork.

the foundation has been laterally moved outwards. In the front garden there is a large willow tree with roots extending to the house footings. Roots from this tree form a mat which interacts with the clay so that in summer suction by the roots causes dessication, but also the interwoven roots allow the whole front wall to be moved.

Apart from the action of the tree, the footings are insufficiently deep for an expansive clay area.
