Slope stability in the Mt Punter area, eastern Tasmania.

D.J. Sloane

Abstract

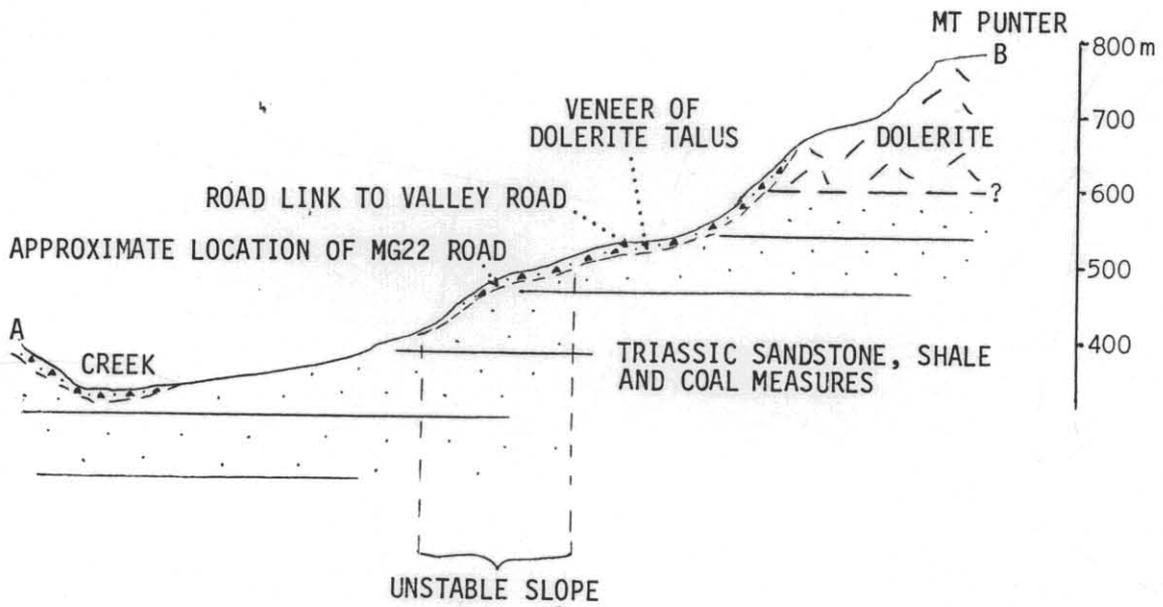
Figure 2. *Diagrammatic cross-section A-B*
(D.J. Sloane and R. Castleden)

The cross-section of the area (fig. 2) indicates the geological relationships. The main features consist of the Jurassic dolerite capped Mt Puzzler, considered to be a remnant of a dolerite sheet, overlying a shallowly dipping sequence of Triassic sandstone, shale and coal measures (R.H. Castleden, pers. comm.). The Triassic rocks are exposed in creek beds and in the culverts along the MG22 road. These sediments range from weathered conglomerate with well rounded quartzite and occasional granite pebbles to coarse to medium-grained feldspathic sandstone and mudstone sequences containing small coal seams.
