1980/18. The stability of a building allotment at Kayena, West Tamar.

D.J. Sloane

LOCATION KAYENA ROAD

TAMAR VALLEY LANDSLIP ZONE MAP CLASSIFICATION : ZONE IV AND ZONE I

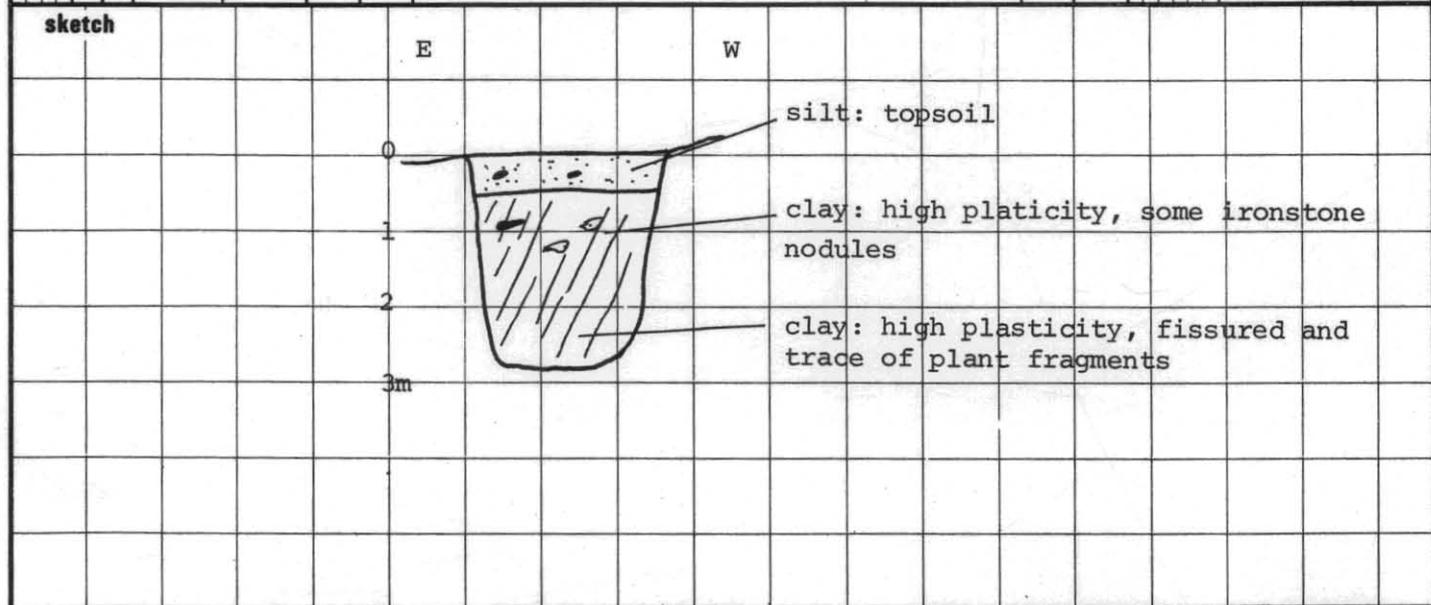
project G. LAUDER	location KAYENA ROAD
co-ordinates DQ920387	exposure type Backhoe Pit
R.L. ≈15m	equipment
excavation dimensions 1m x 2.5m x 2.75m	operator
	pit commenced 1.4.1980
	pit completed 1.4.1980
	logged by D.J.Sloane
	checked by

penetration	support	water	notes samples, tests	metres R.L. depth	graphic log	classification symbol	material soil type: plasticity or particle characteristics, colour secondary and minor components	moisture condition	consistency density index	hand penetrometer kPa	structure, geology
1	2	3								25 50 100 200 400	
			Vane shear (kPa)			ML	SILT: Low plasticity. Some quartz gravel and medium sand. Dark brown. Some ironstone boulders	D	L		Al soil horizon. Topsoil Columnar structure Desiccation cracks. Surface desiccation cracks to 1m. Hackly fracture, some fissures. Some fissures
			19r	1		CH	CLAY: High plasticity. Yellowish brown - yellowish olive brown. Trace of silt and fine quartz sand. Some ironstone concretions.				
			36r	2		CH	CLAY: High plasticity. Dull yellowish brown. Some greyish yellow cutans along fissures. Trace of plant leaf and stem fragments.	D-M	Vst		
			35r	3				D-M	Vst		
			r=residual
