1984/59. Subsurface movement in expansive clay: An alternative explanation for house cracking at Sandown Road, Launceston

W.R. Moore

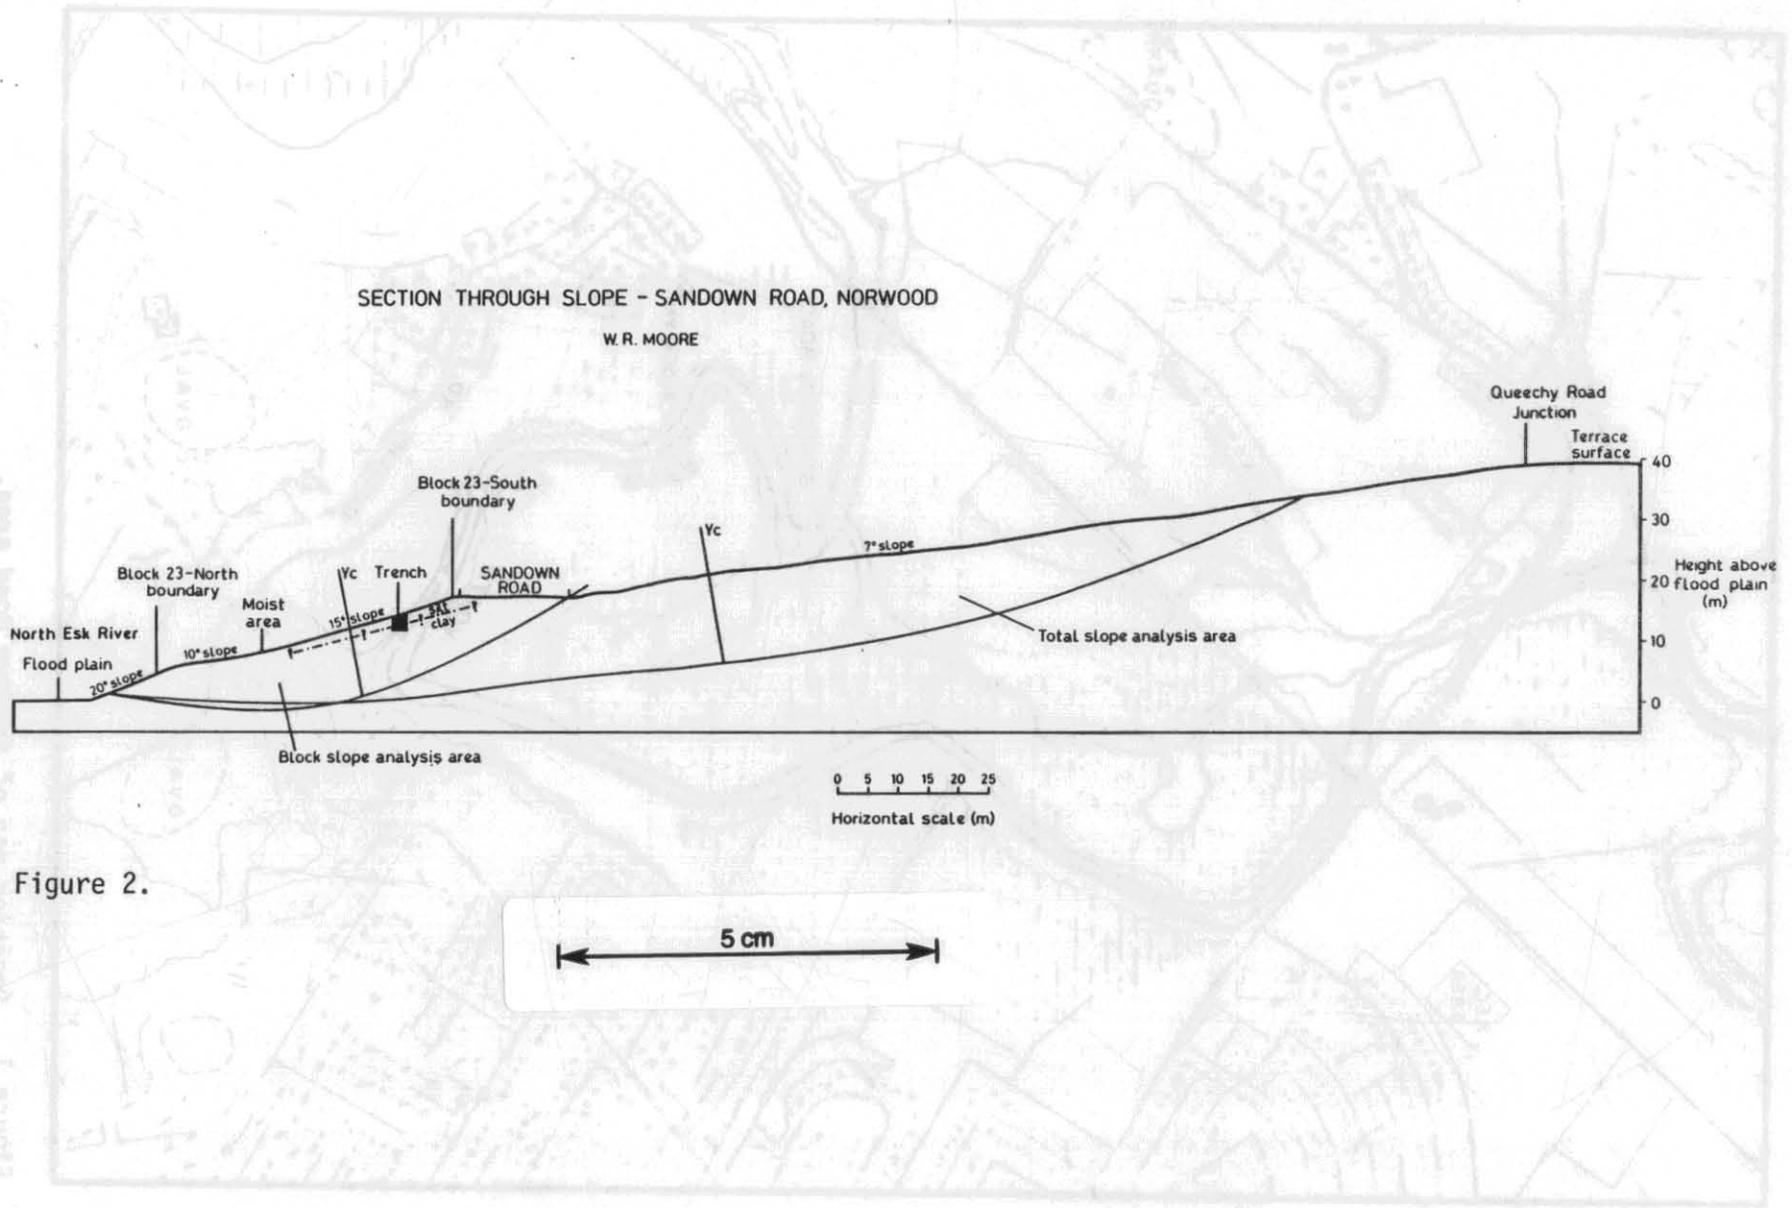
Figure 2.

Block 23 is situated on the lowest part of Sandown Road and is situated on the toe of the slope [EQ146115]. The northern boundary of the block is approximately 5-7 m above the North Esk River flood plain. The block slopes away from the road with a uniform 15° slope 21 m long and then flattens to 10° with a sharp change in slope. At the change in slope is a wet area. The 10° slope is 18 m long to the northern boundary of the block, from where the land falls steeply (22°) for 16 m to the river flood plain. The overall slope of Sandown Road above the block is 7°, with a slope length of 225 m to the junction with Queechy Road. The steep section of 15° on Block 23 is small when compared with the overall length of the Sandown Road slope (fig. 2).

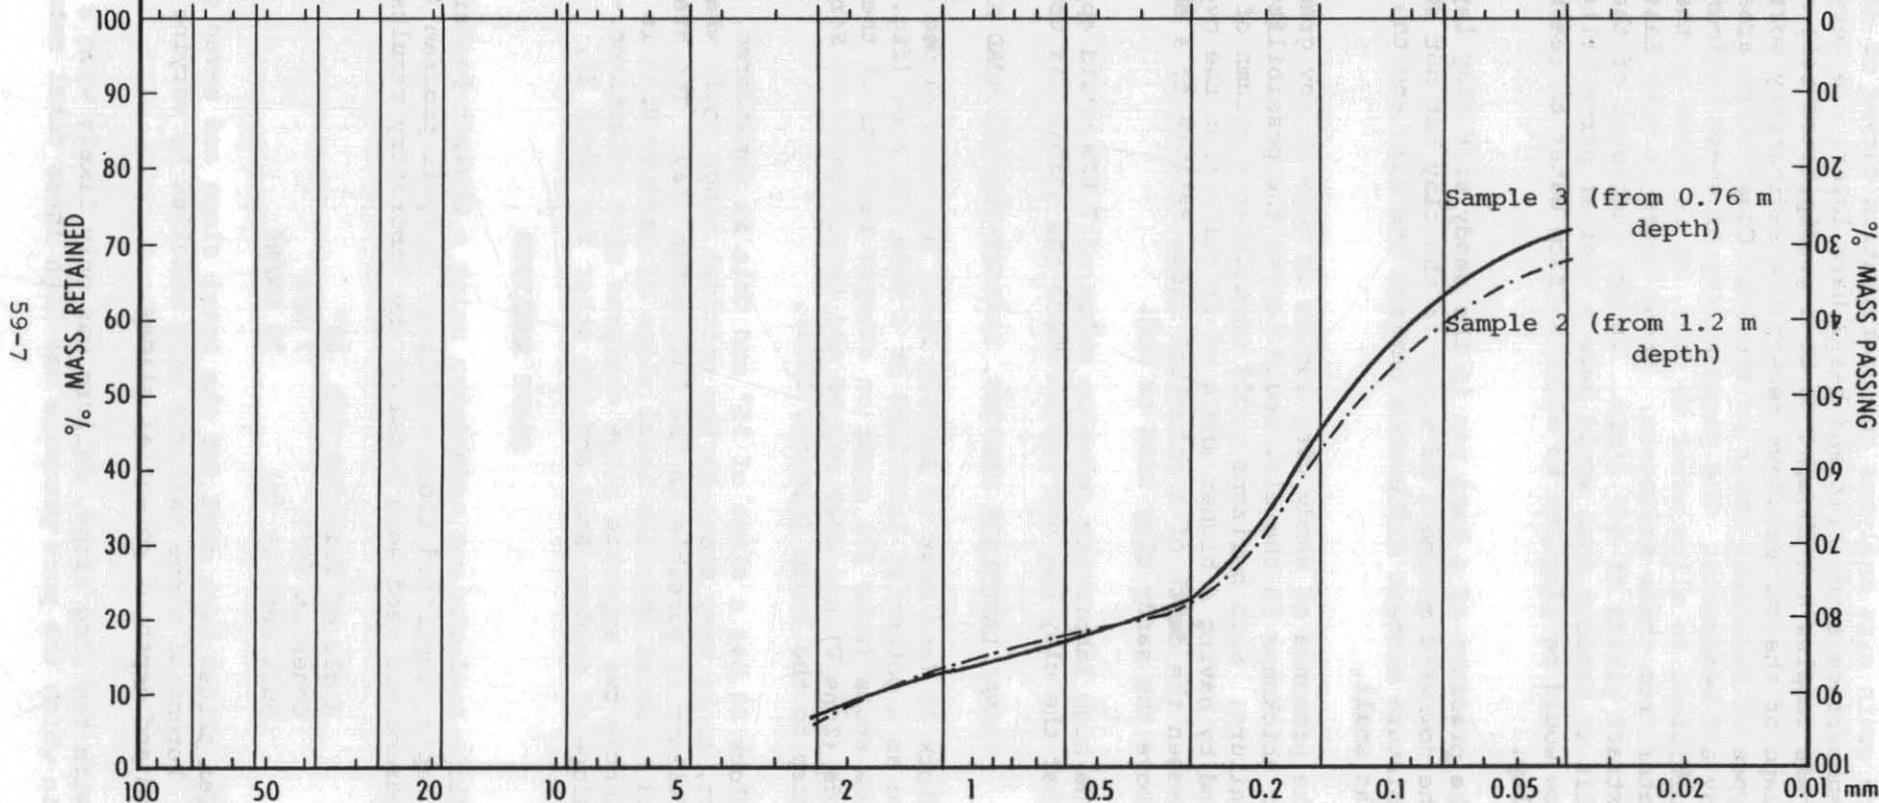
Figure 3. Grading curves of Samples 2 and 3.

The laboratory results (Table 1) confirm that the surface soil (Sample 1) is a low plastic clay with a plastic index of 12 and linear shrinkage of only 5%. The clay component (kaolinite) was only minor. The grain size analyses show Samples 2 and 3 to be identical in composition with 60% fine silt, 20% fine sand and 20% medium to coarse sand. The difference in hardness is thought to be due to a groundwater precipitate and cementing horizon (hard pan) above the low permeable clay layer. The silt horizon was dry except for a moist, soft layer immediately below the surface soil. Small gravel lenses and boulders were present throughout these beds. The surface soil and underlying subsoil layer of sandy silt would be sufficiently friable and permeable to allow surface water to reach the underlying clay. The Tertiary age clay and sandy clay lens were both moist, with moisture contents of 32% and 28% respectively. The clay, in contrast to the sandy clay, was highly plastic with a plastic index of 91 and linear shrinkage of 24%. Kaolinite was present in moderate amounts and the expansive montmorillonite was present. The sandy clay had a low plasticity with a liquid limit of only 34, compared with 118 for the overlying clay.
