**TASMANIA DEPARTMENT OF MINES
UNPUBLISHED REPORT 1987/77**

Inspection of house sites near Danbury Park, Legana

by W. R. Moore and W. L. Matthews

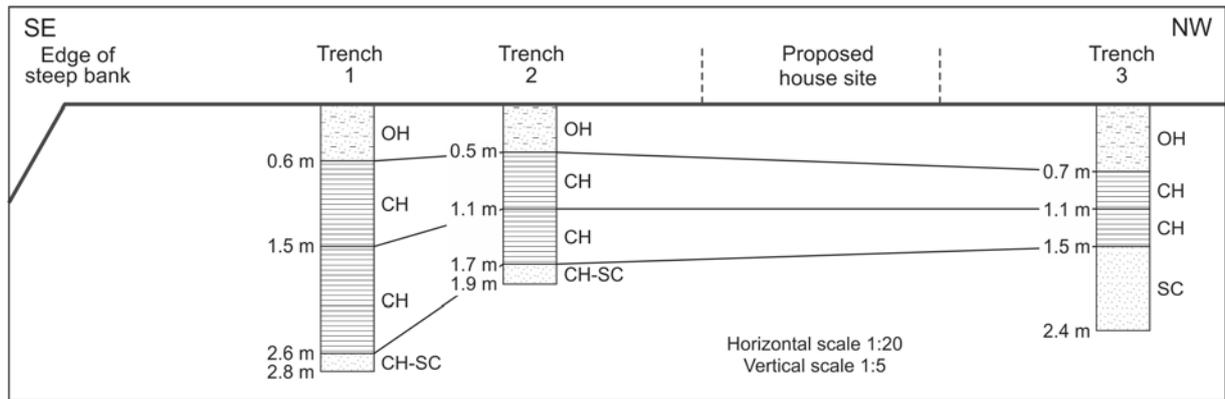
Figure 3

Three trenches were dug on the proposed house site on 7 September (fig. 2, 3). Lithological logs of these trenches are attached (Appendix 2). The soil laboratory testing results from clay samples collected from trenches 1 and 2 are shown in Appendix I.
