Slope stability and engineering geology of the Blackstone Heights area

by W. R. Moore

Abstract

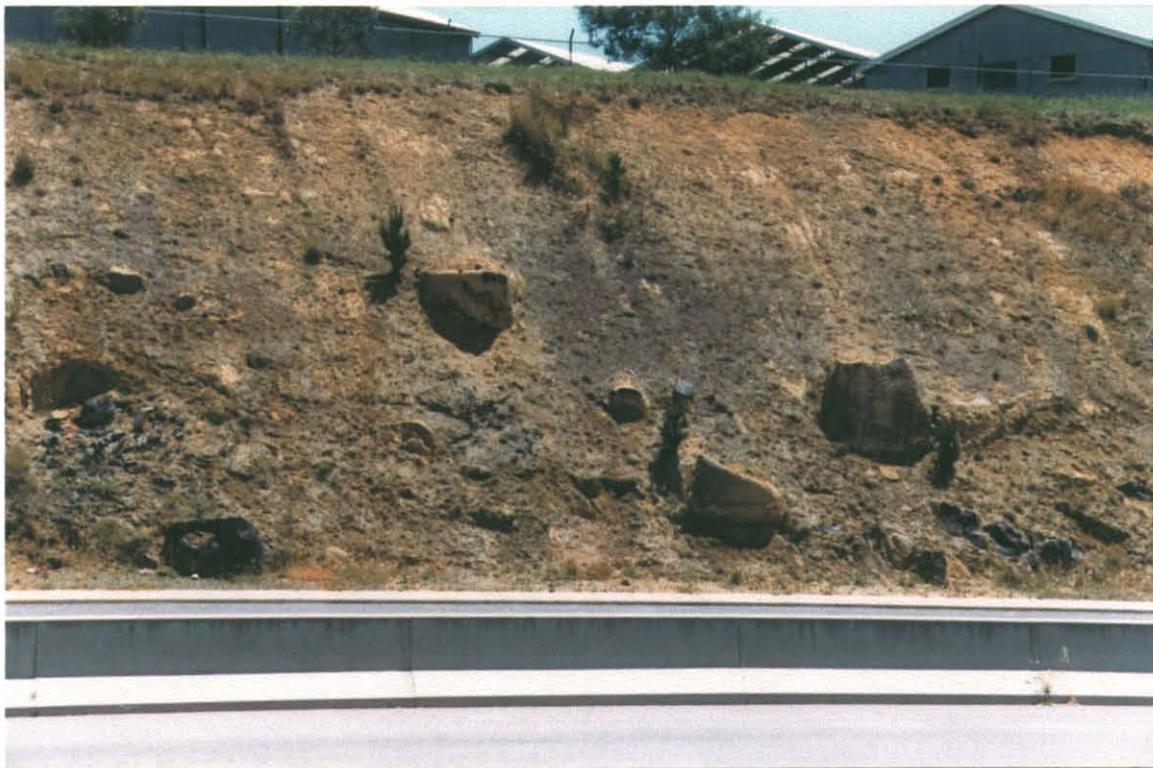
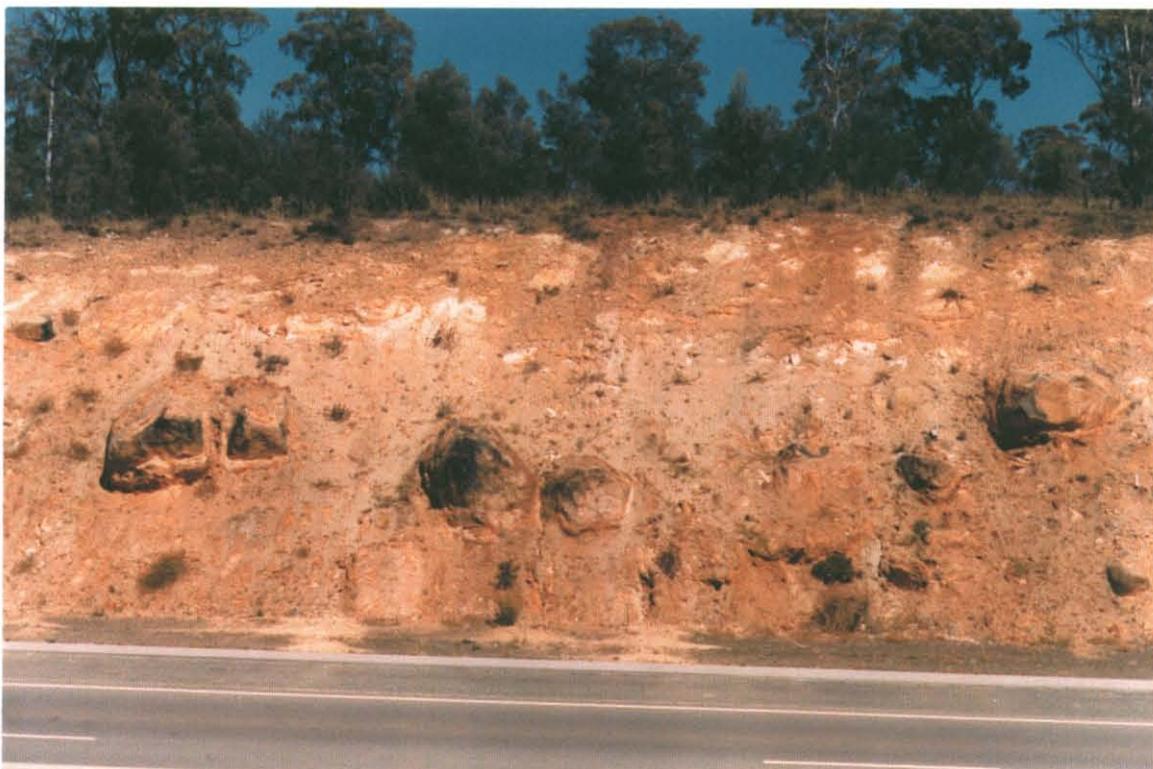
Plate 1. *In situ* clay derived from the weathering of dolerite:- the Blackstone Heights clay.

Locations: Southern Outlet Road, Launceston.

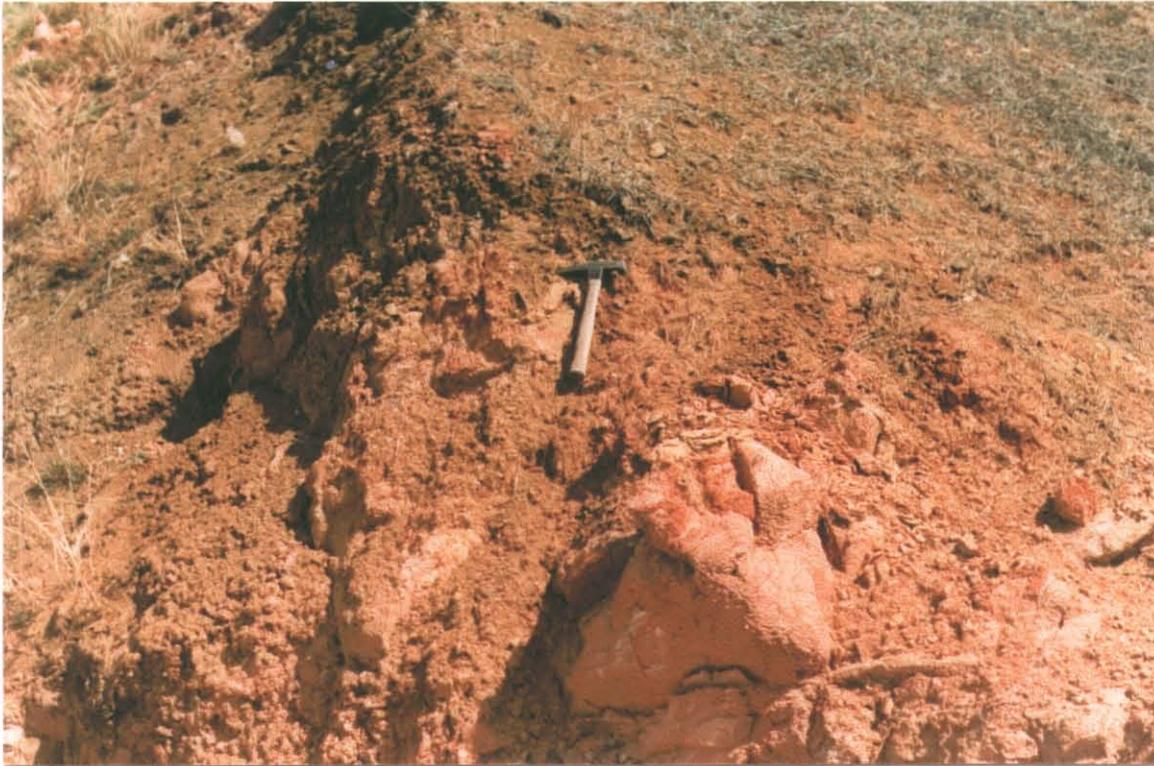
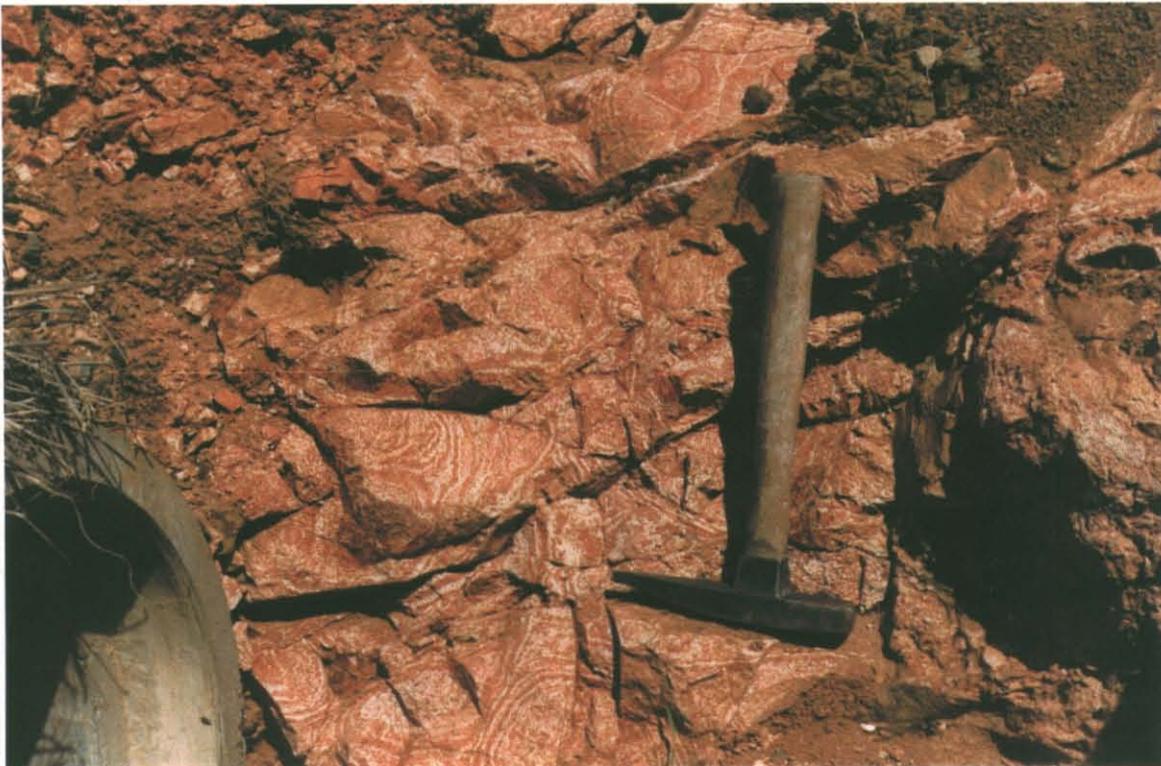
Good exposures of this chemically-altered dolerite occur at the junction of the Trulls Saddle and Blackstone roads (Plate 2), and this clay was drilled at 7 m depth in a nearby bore hole (Excavation 1 and Bore 1 logs; Appendix 1).

Plate 2. *Brown clay underlain by extremely to medium weathered metasomatised dolerite.*

Location: Junction of Trulls Saddle and Blackstone Roads.

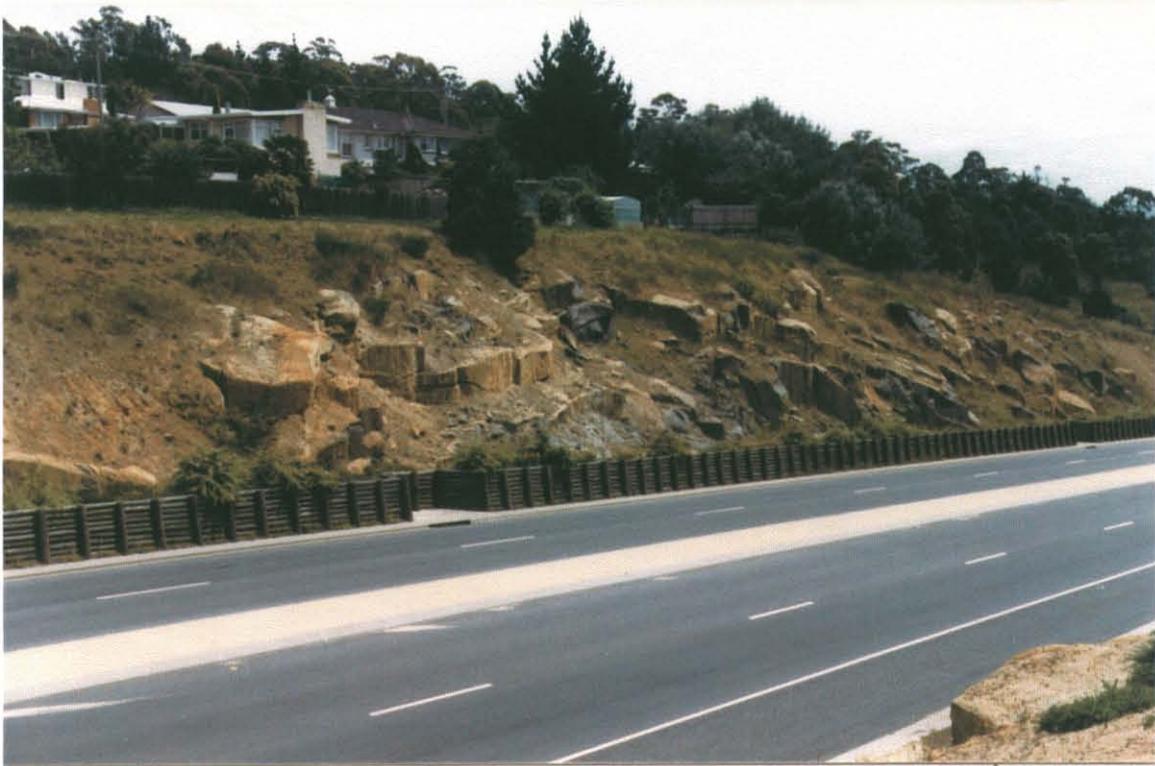
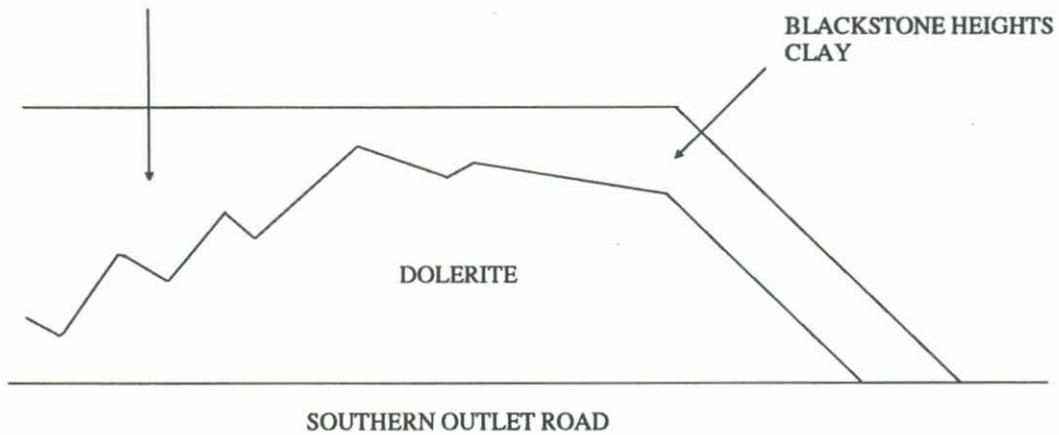
Deposition of the Launceston Beds is thought to have occurred at this time in the Tertiary period. Clay of the Launceston Beds and *in situ* Blackstone Heights clays are exposed on the Southern Outlet Road south of Launceston (Plate 5). At Blackstone Heights some of the brown clays may belong to the Launceston Beds, probably being deposited as isolated pockets. Further deposition, since removed by erosion, probably occurred along this western margin of the Tamar Trough.

Plate 5. *Clay-dolerite profile, Southern Outlet Road, Launceston.*

Launceston Beds upslope, Blackstone Heights clay downslope

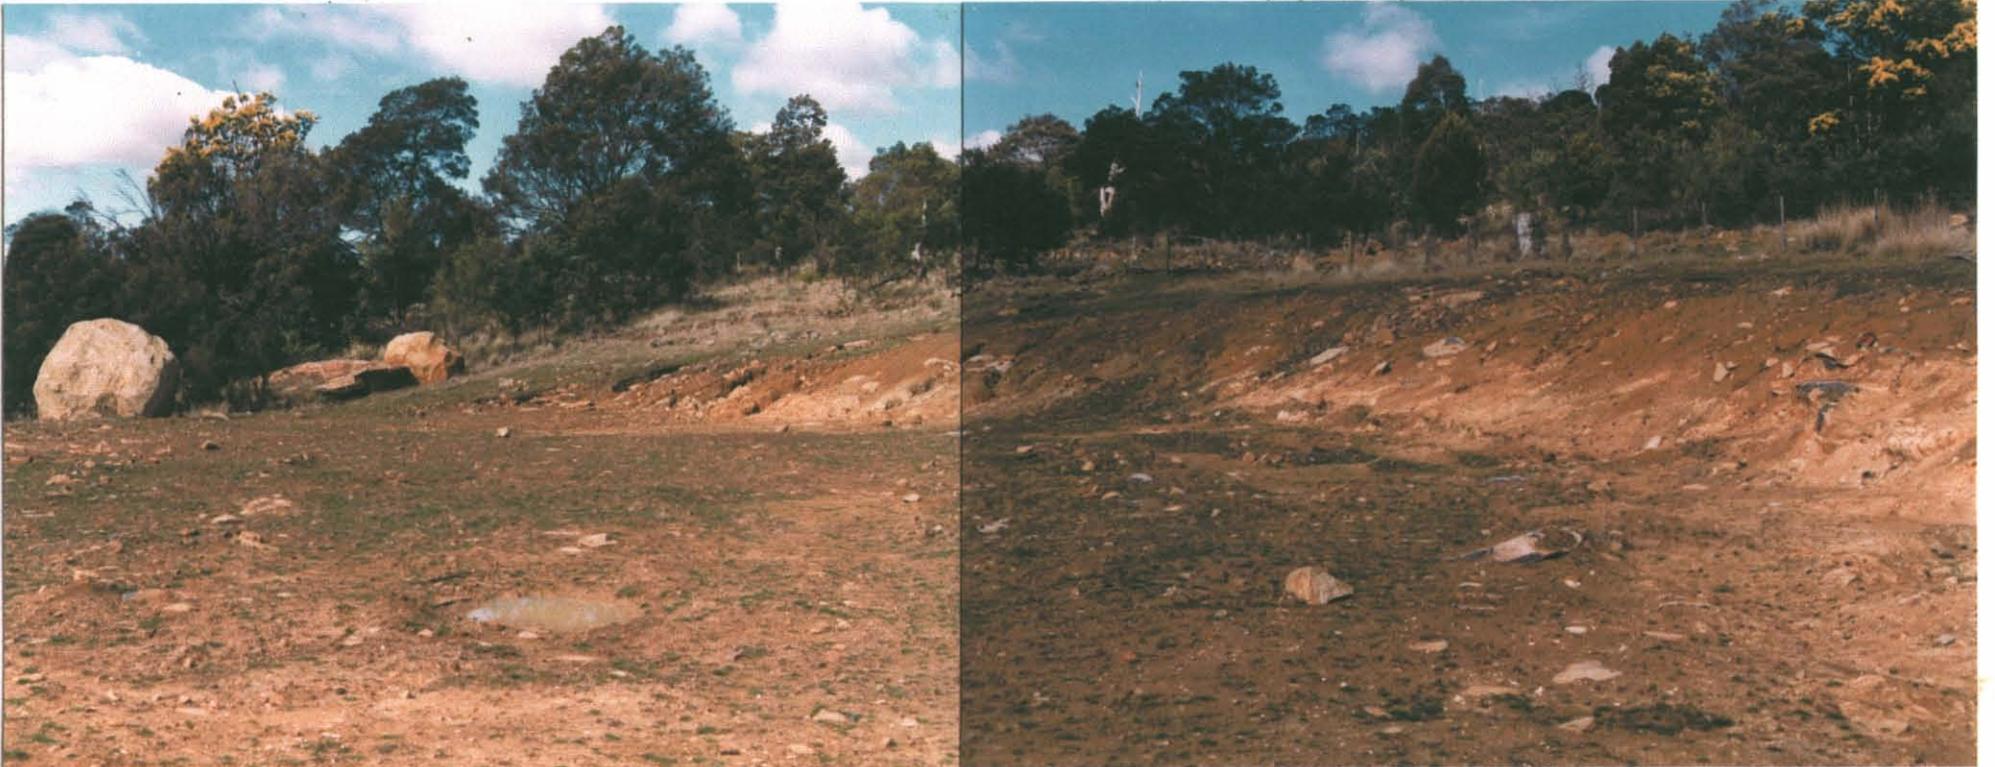
From the lithological variety seen in the road, quarry and reservoir exposures of the early subdivisions, it was apparent that surface mapping alone would not be adequate for slope stability assessment, and would be unreliable for any engineering geology mapping. At surface exposure level it was frequently impossible to distinguish isolated dolerite outcrops from large dolerite boulders produced by concentric weathering, or large boulders within talus deposits (Plate 6).

Plate 6. Large boulders, produced by concentric weathering of dolerite, removed from a prepared house site. House site shows upper brown clay merging with lower, yellow-white clay.

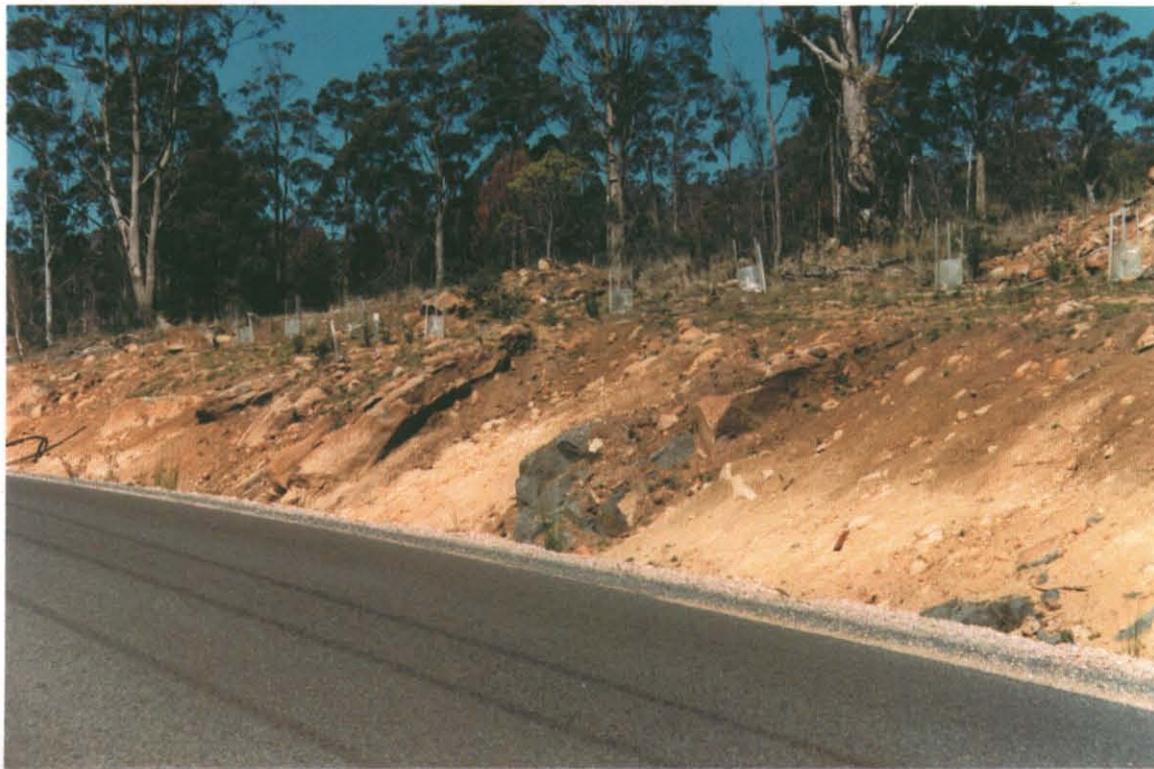
Plate 10. Clay and dolerite with small outcrops and boulders, Blackstone Road.

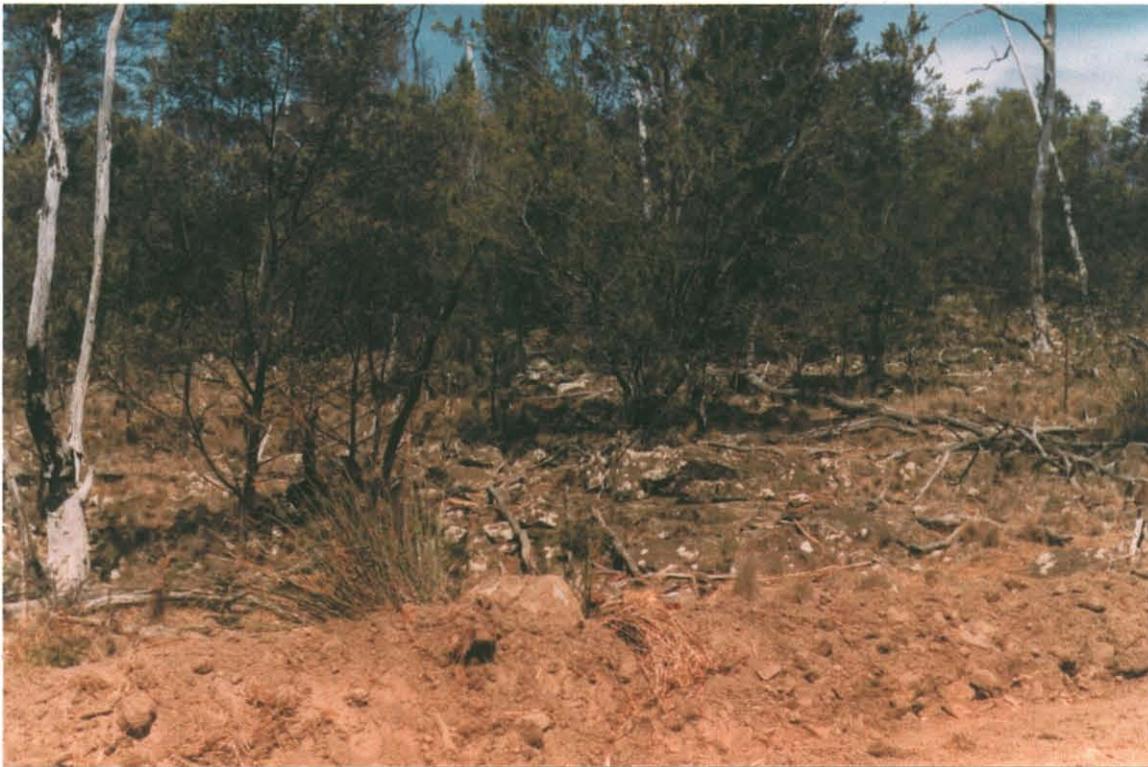
Plate 11. *Talus deposits, Badger Plains Track.*

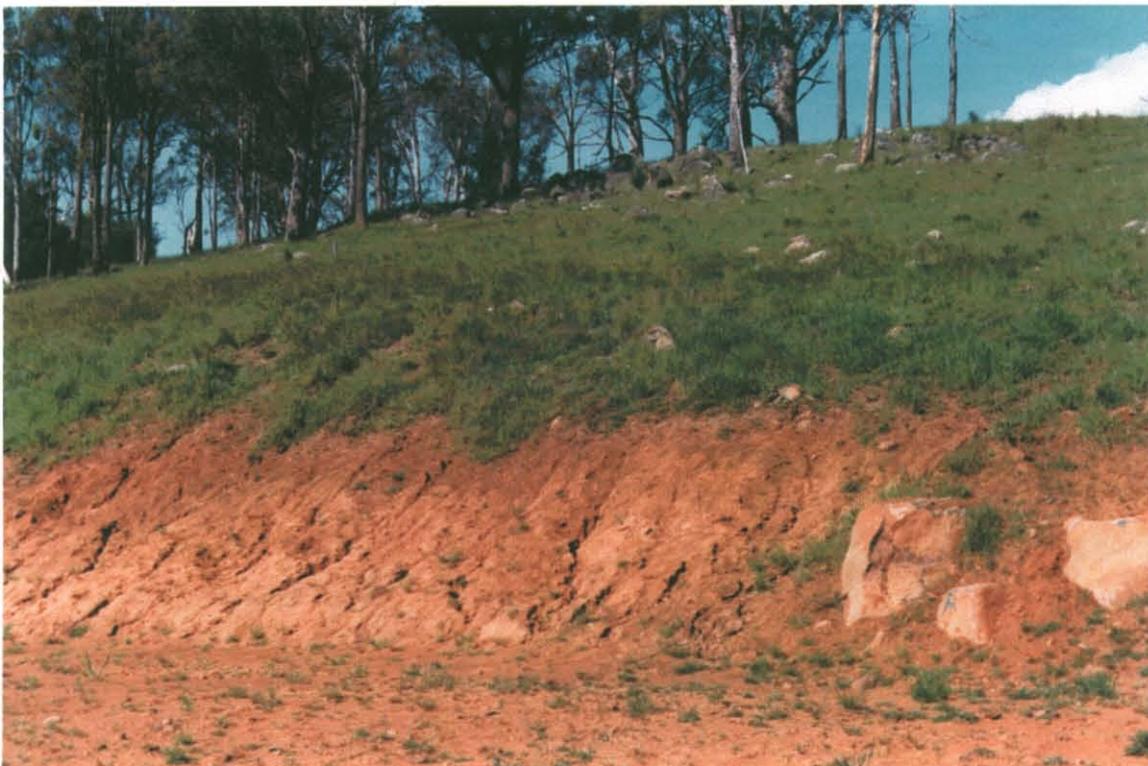
Plate 12. *Talus boulders underlain by clay and weathered dolerite.*

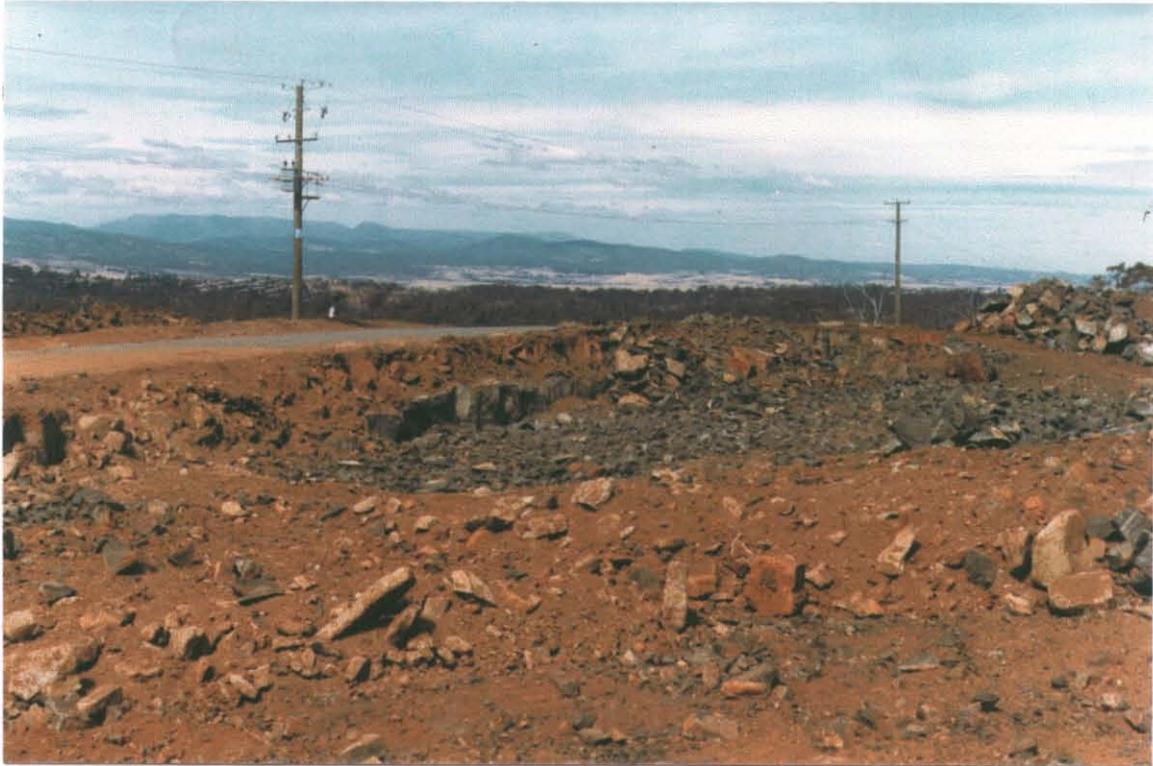
Plate 13. *Hard, high velocity dolerite capping Mt Leslie ridge at reservoir site. Dolerite velocities: $V_0=500-1000$ m/sec; $V_1=2500-3700$ m/sec.*

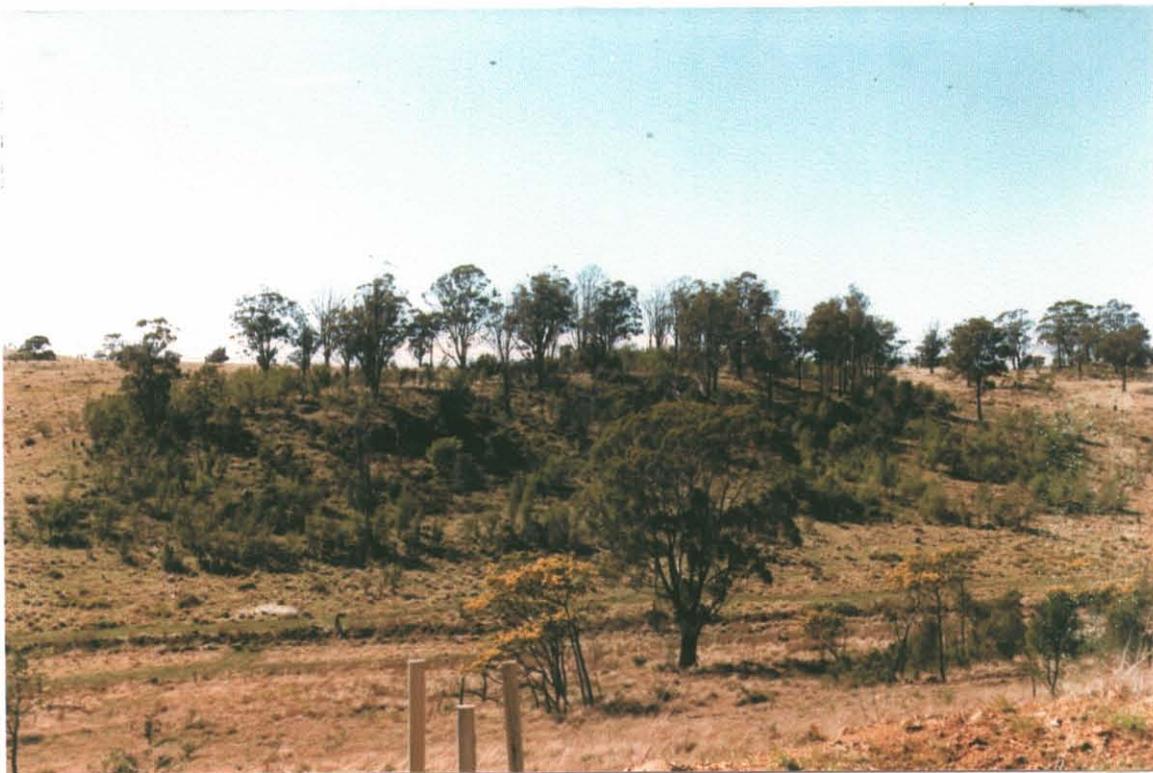
Plate 14. *Scarp slope, eastern valley slope of Blackstone Creek. Cap rock is dolerite, with talus front slope and clay below on lower slopes of valley.*
