Tasmanian Geological Survey
Record 2007/04

Lawrence Vale Landslide Investigations: implications for landslide hazard assessment in Launceston

by A. R. Ezzy and C. Mazengarb

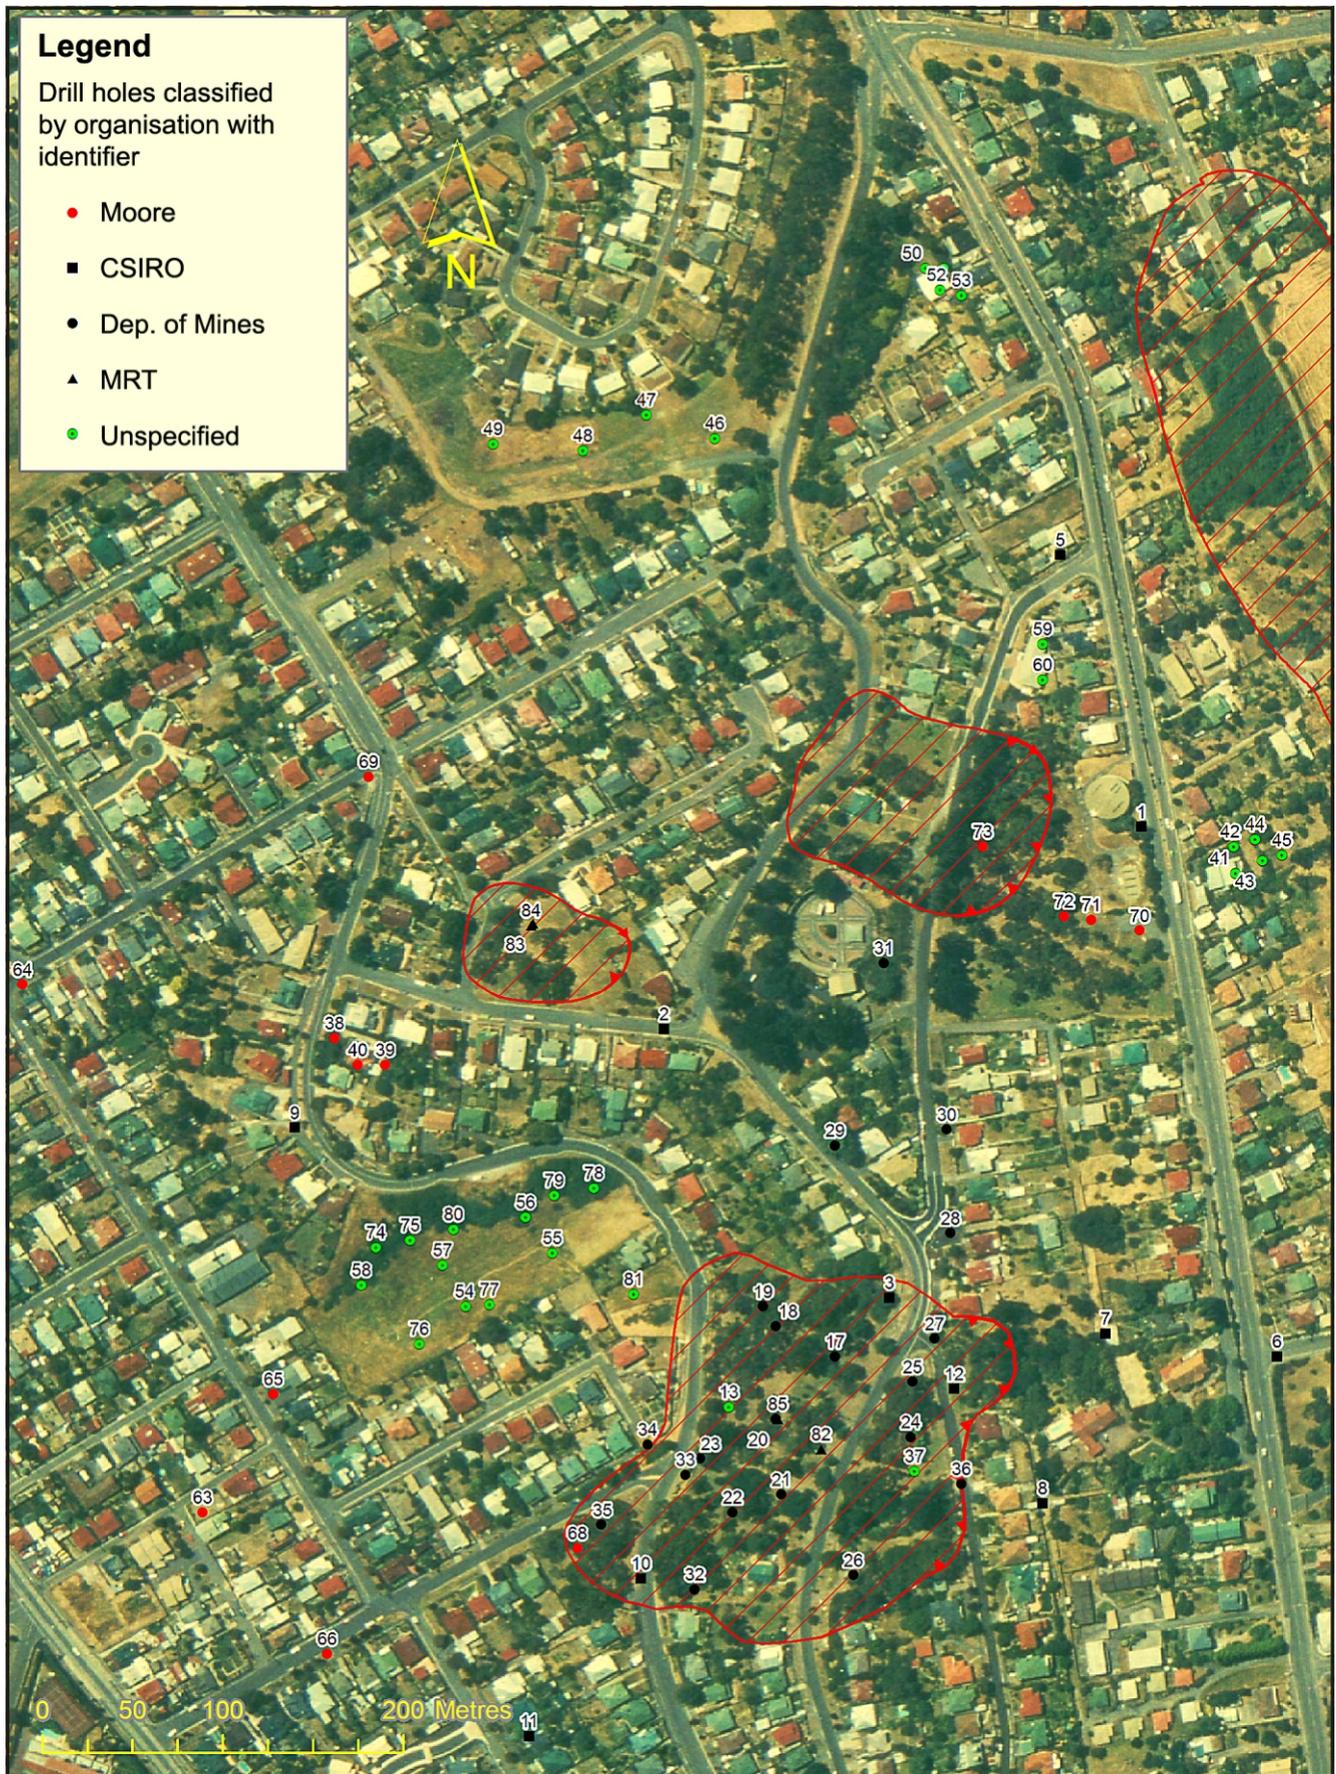
Figure 5

Location of boreholes and test pits referred to in text. Details of these features are summarised in Tables 1 and 2.

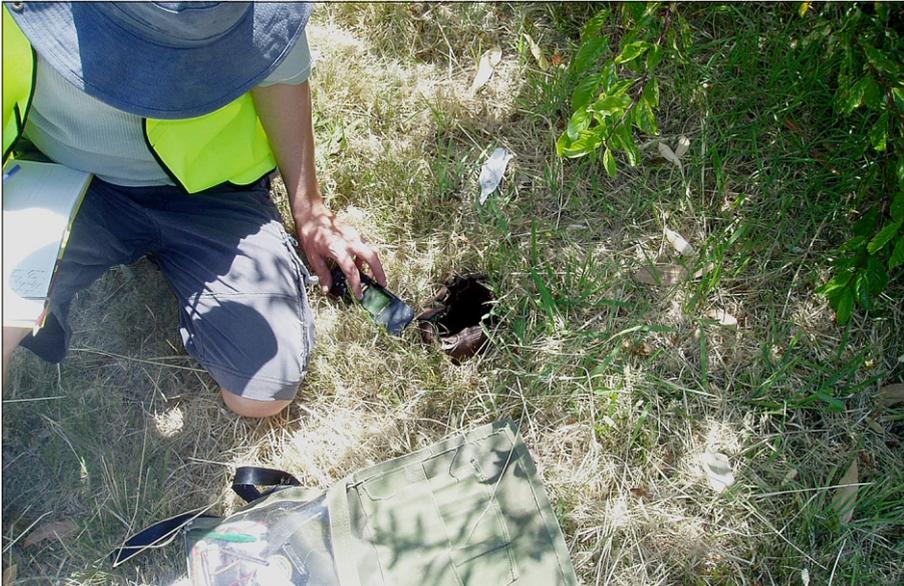
Plate 1

Bore hole collar of DHH19 from 1959 CSIRO drilling program.

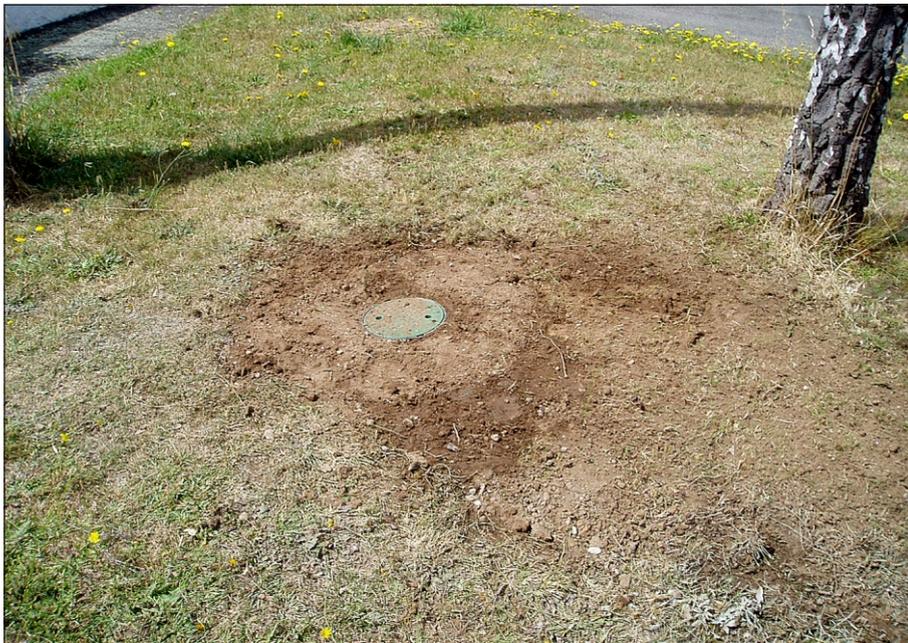
Plate 4
*Upgraded bore hole 14
(Knights, 1977), end of
January 2005.*

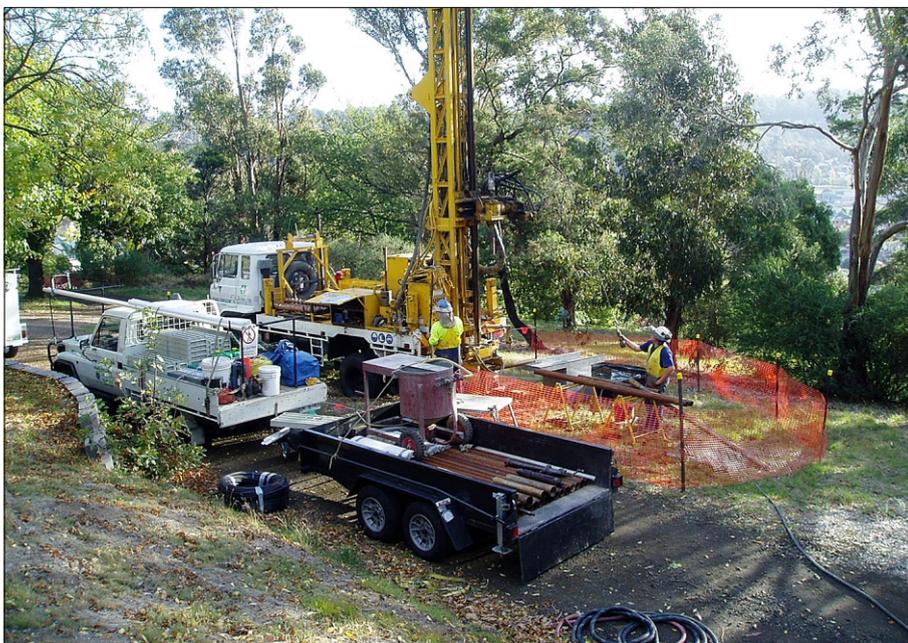
Plate 5
*Drilling set up at drill hole
LV_IBH1_2005, April 2005.*

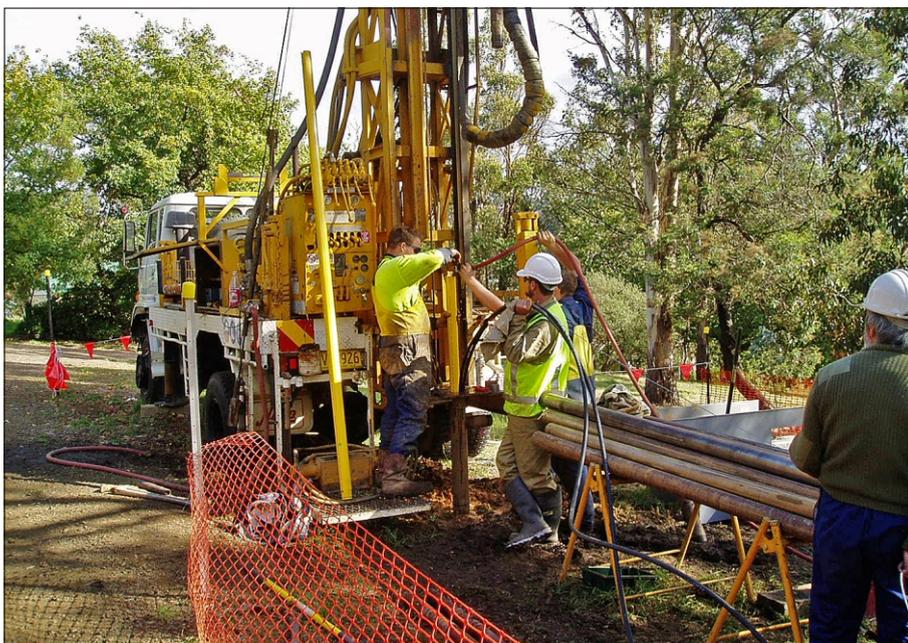
Plate 6
*Inclinometer being installed in drill
hole LV_IBH1_2005, April 2005.*

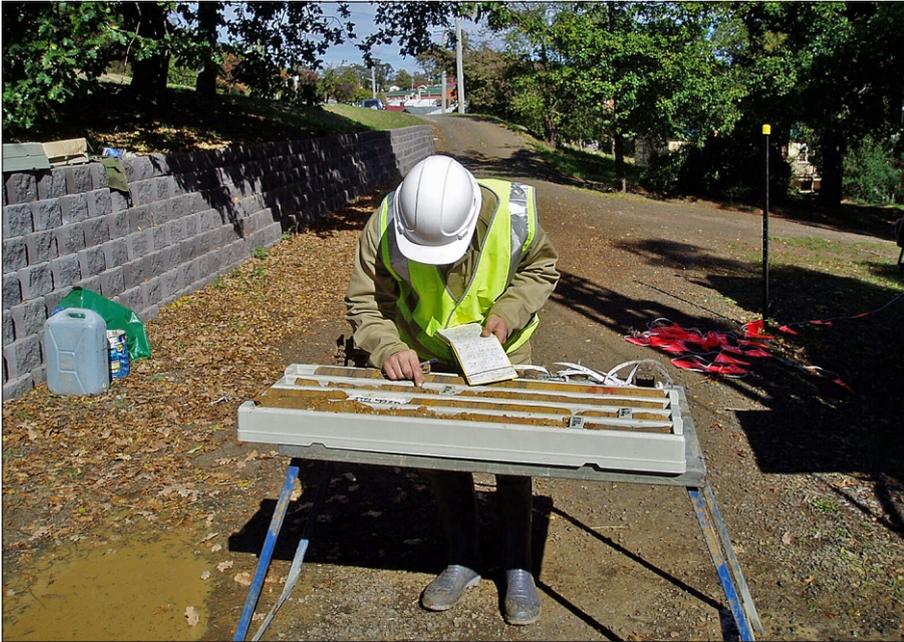
Plate 7
*Field logging of diamond core
from drill hole LV_IBH1_2005,
April 2005.*

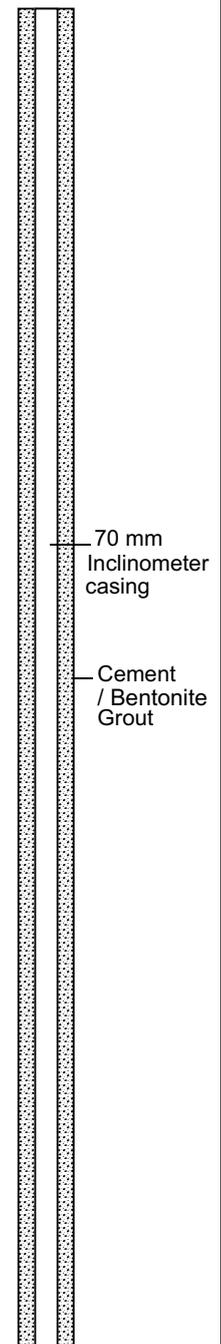
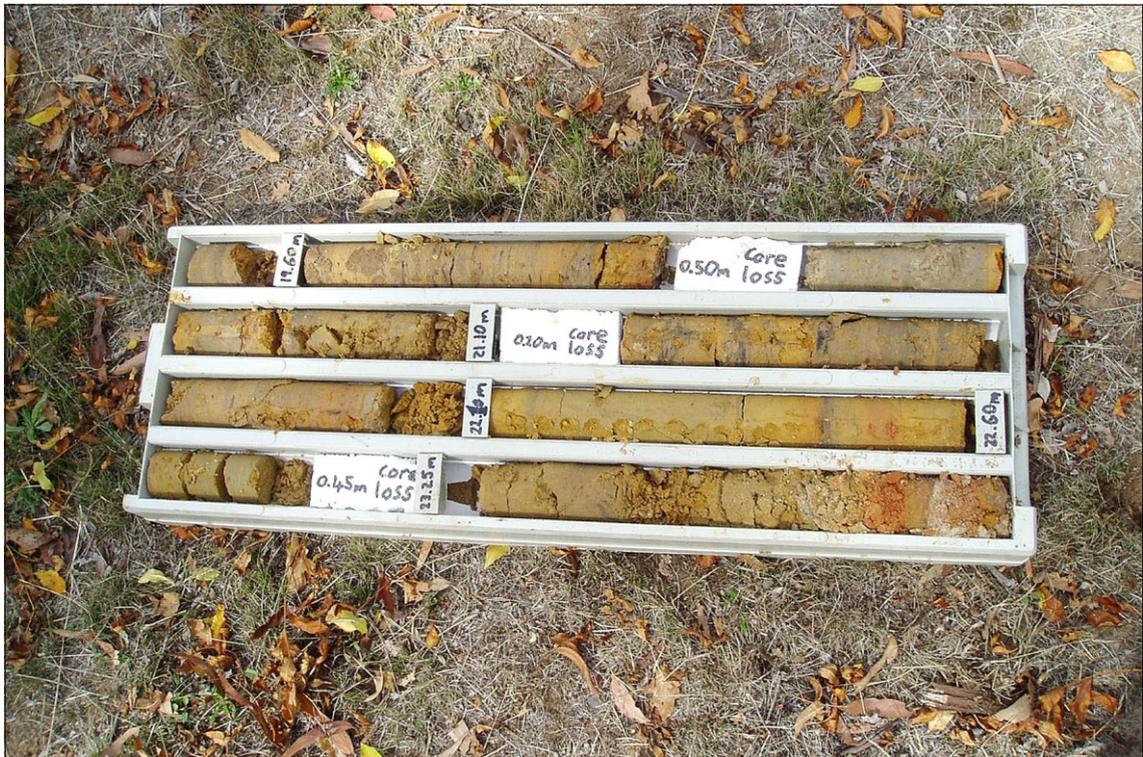
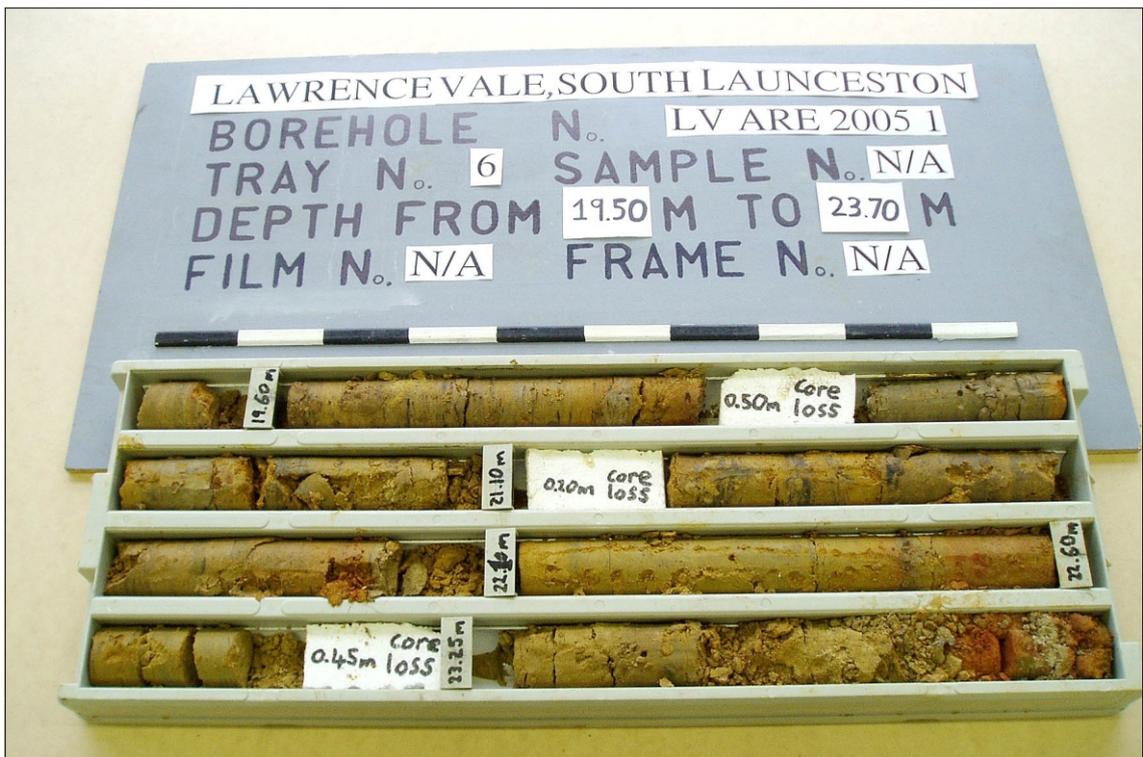
Depth in Meters	Sample	GRAPHIC	USCS	Sample Condition	Sampler Type	Moisture condition	Consistency Density index	Average hand penetrometer (kg)	Weathering	REMARKS, and defect descriptions
				Disturbed Undisturbed	SA Solid stem SS Split Spoon DC Diamond Core					
DESCRIPTION										
20				NO CORE						
			CH	CLAY - high plasticity, light olive brown.		M	St	5.2		
			SC	SILTY SAND - fine to medium, yellowish brown, flecked quartz, feldspar.			MD			
21				NO CORE						
			SC	CLAYEY SAND - fine to medium, banded yellowish brown, light yellowish brown, dark red, flecked quartz, intergranular organics, black.		M	D	2.2		
22	DC			NO CORE						
			SC	CLAYEY SAND - fine, brownish yellow.		M	MD	0.8		
			SC	SAND - fine, light grey, red, yellowish brown.		D				
			SC	IRONSTONE - dark red.		D				
			SC	SAND - fine, light grey, red, yellowish red.		D				
			SC	IRONSTONE - dark red.		D				
24				SAND - fine to medium, yellowish brown, yellowish brown, quartz, organics, black.		D	D			Major loss of all drilling fluid, rapid drop of drill head, 22.60 to 23.25 m. Possible failure plane.

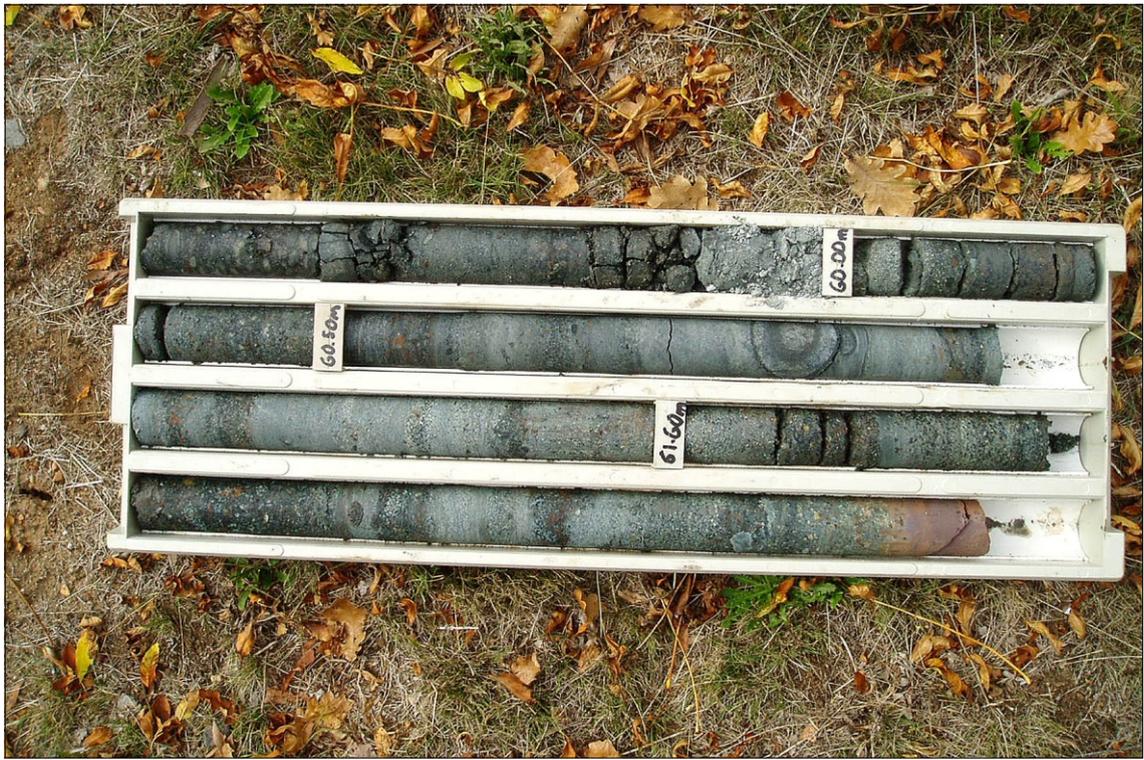
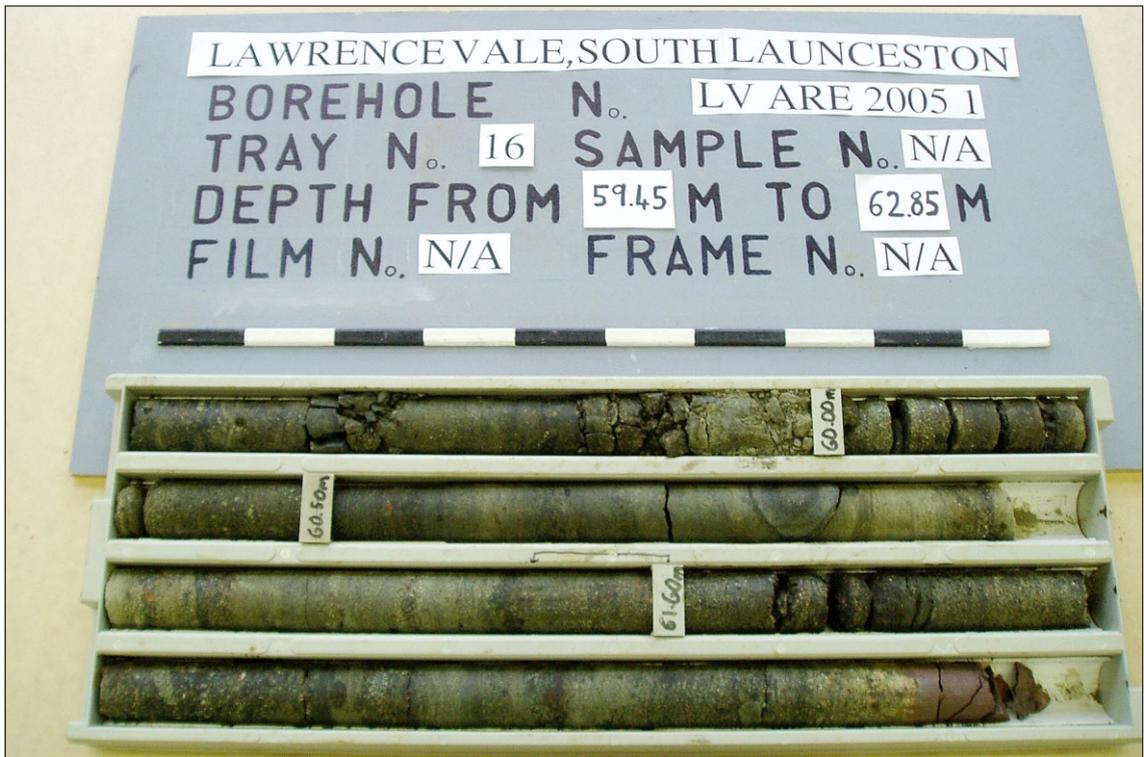
ENGINEERING LOG - LV_IBH1_2005 (LV_ARE_2005_1)

Plate 9
*Polished slickenside defect in
claystone at 62.80 metres in
drill hole LV_IBH1_2005.*

Depth in Meters	Sample	GRAPHIC	USCS	Sample Condition	Sampler Type	Moisture condition	Consistency Density index	Average hand penetrometer (kg)	Weathering	REMARKS, and defect descriptions
				<input type="checkbox"/> Disturbed <input type="checkbox"/> Undisturbed	SA Solid stem SS Split Spoon DC Diamond Core					
60										
										60.05 to 60.25 m banded clay spacing 50 mm thickness 4 to 12 mm
61										
62										
										62.01 m irregular 3mm
63										
										62.80 to 63.20 m smooth irregular polished slickensides
64

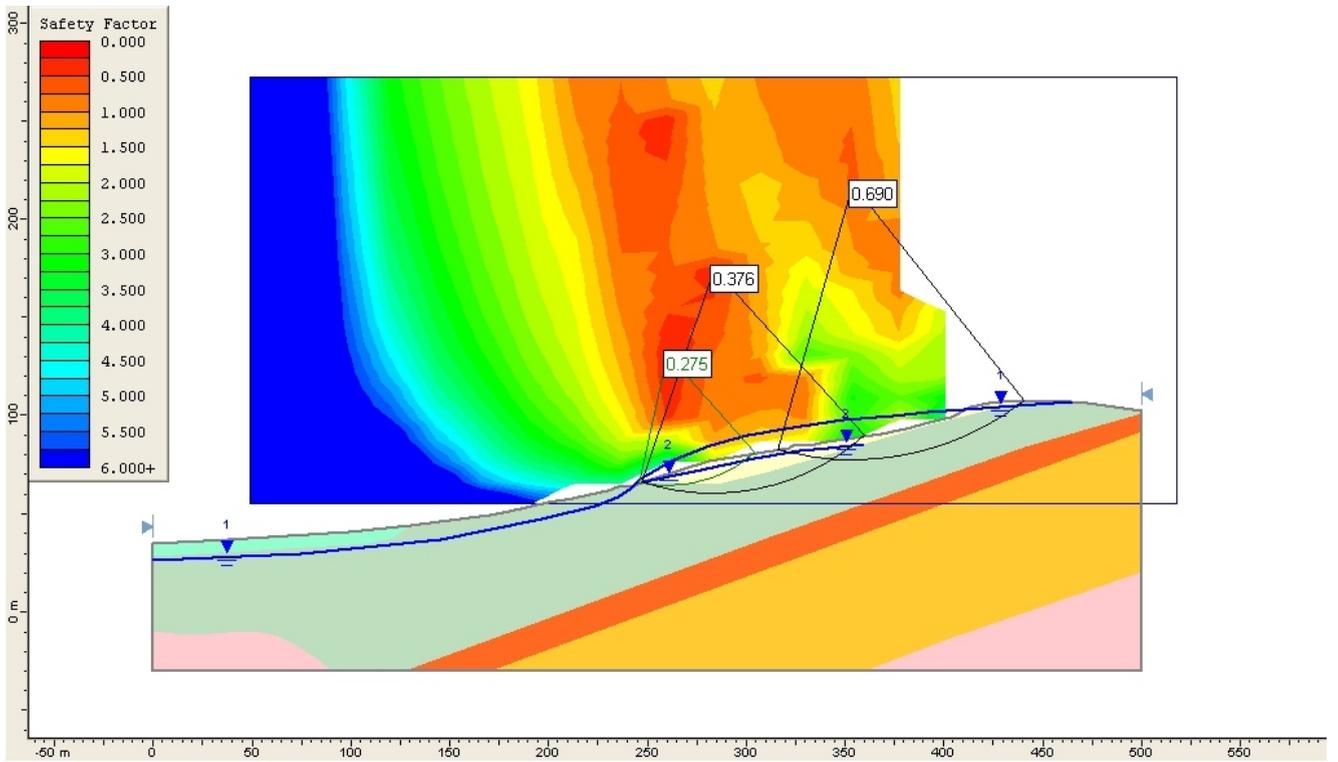
Model A

- Model A** starts with maximum groundwater conditions as inferred by MRT comprising artesian pore pressures in the LF2 aquifer and near surface water levels in LF1. The results indicate deep failure through LF2 at a greater depth than the known landslide.

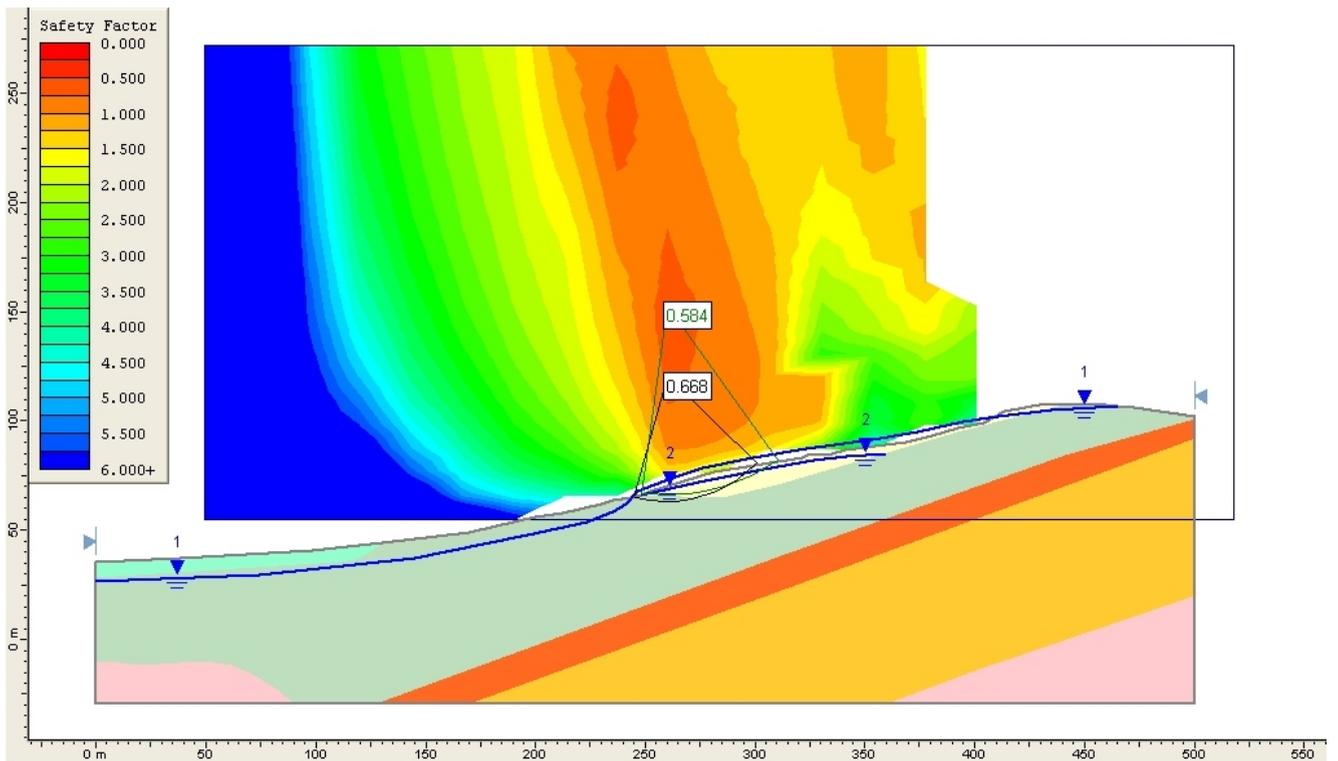
Model B

- Model B** has a lower pore pressure in the LF2 aquifer, which results in very low FOS in LF1 materials on the nose of the slide mass, but FOS >1 for larger scale failures through LF2. This scenario is closer to the observed landslide behaviour.

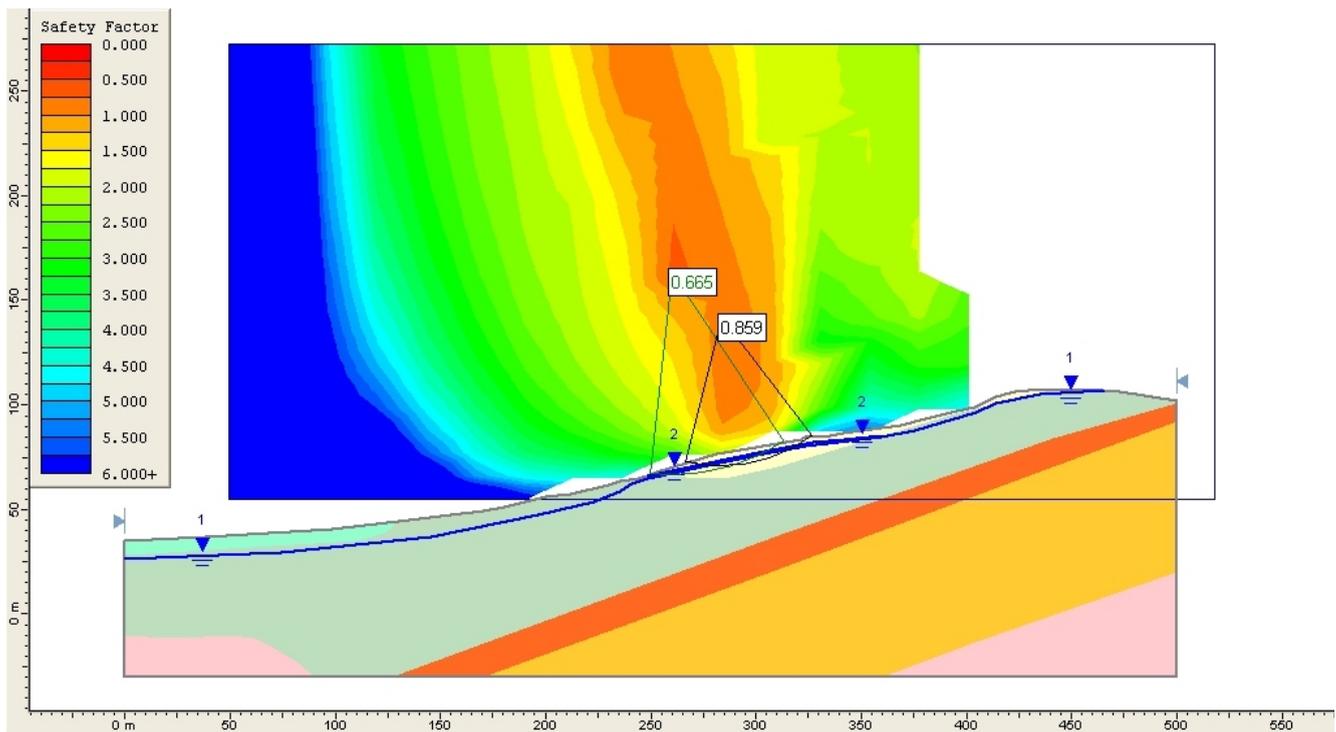
Model C

- Model C** further lowers the LF2 aquifer pressure to below the ground surface. Circular failures within the LF1 unit are still FOS <1.
- Model D** drops the LF2 aquifer down to the base of the LF1 unit and illustrates that this change has little effect on the potential failures in the upper unit. The implication is that subartesian movement of LF2 aquifer is not as critical to slope stability as movement of the LF2 aquifer from sub-artesian to artesian levels.

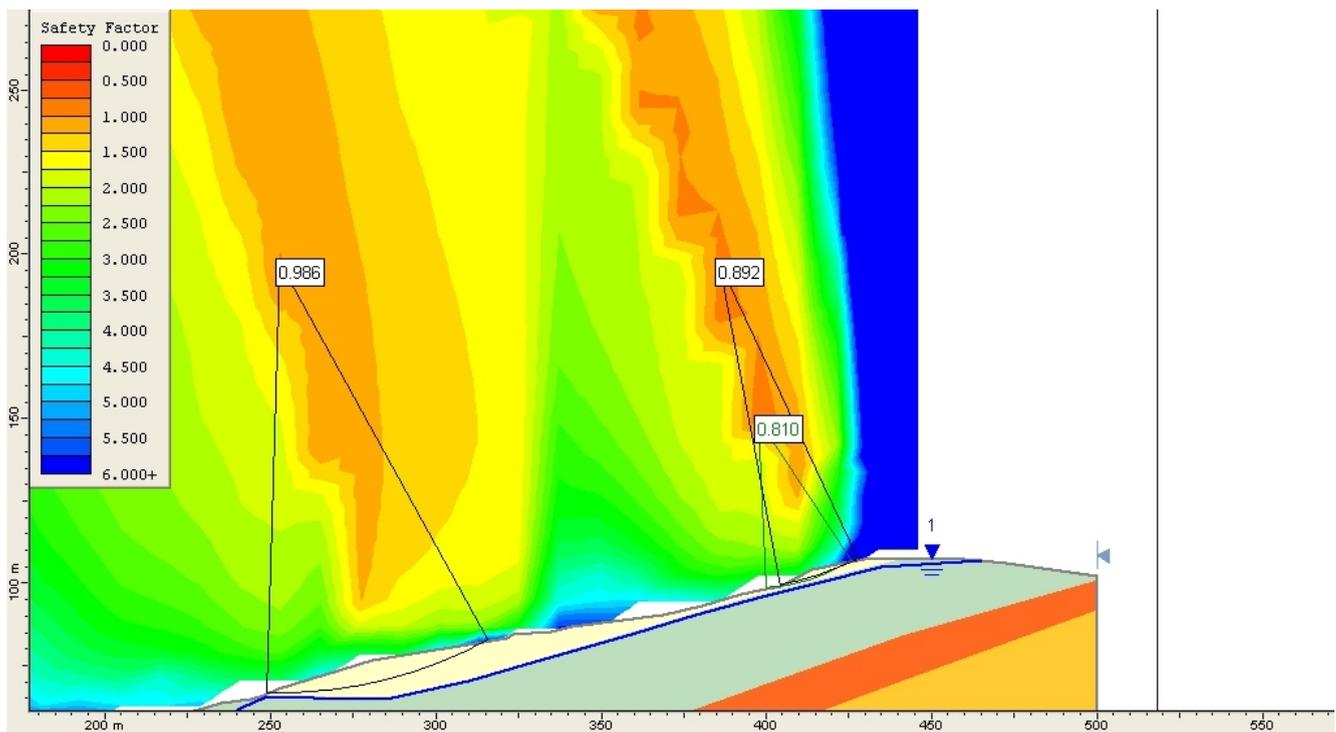
- Model E and F** illustrate that critical circular failure is possible on the existing geometry with the LF1 aquifer drained or part full. The aquifer scenarios shown on Model e and F are approximate to the measured levels in 2005 and 2006, therefore using a homogeneous shear strength of 2 kPa and 11° for the LF1 materials with circular failure planes may not be a reasonable approximation of the actual conditions. Model F also shows how a small rise in water levels at the toe of the LF1 material is sufficient to reduce FOS from approx 1 (equilibrium) to 0.89 (failure).

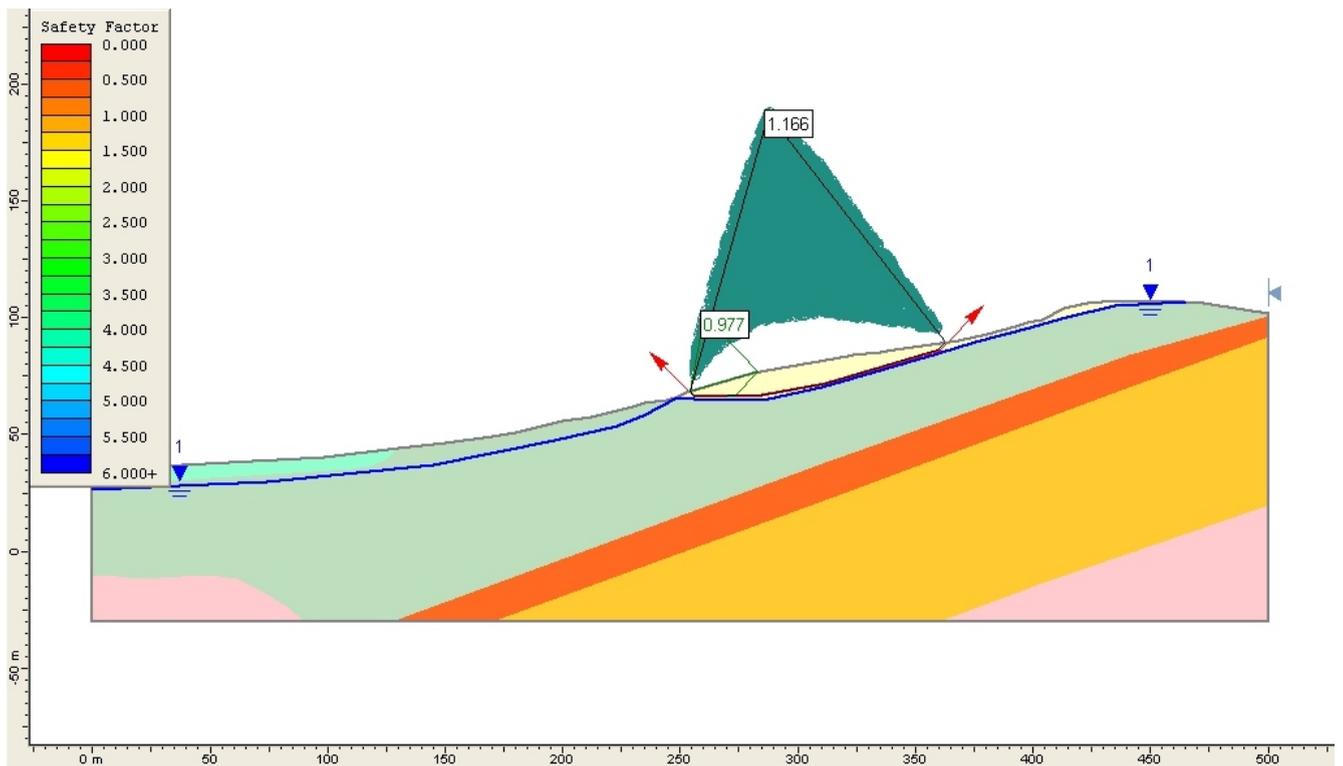
Plane Failure

- Plane failure considers a scenario based on the following observations –
 - Movement has occurred from full head to toe of the slide mass with the current slope geometry. This is not shown by circular failure analysis.

- Circular failures in homogeneous material indicate movement should be occurring under current conditions where there is no observed movement.
 - Plane failure approximates sliding along residual strength planes at the base of the LF1 unit with break out at the head and toe.

- Plane failure and plane failure 2 and 3 show basal failure with FOS approx 1 for drained LF1 and LF2 aquifer at the base of LF1. This appears to be reasonable approximation of the existing 'in equilibrium' state of the landslide.

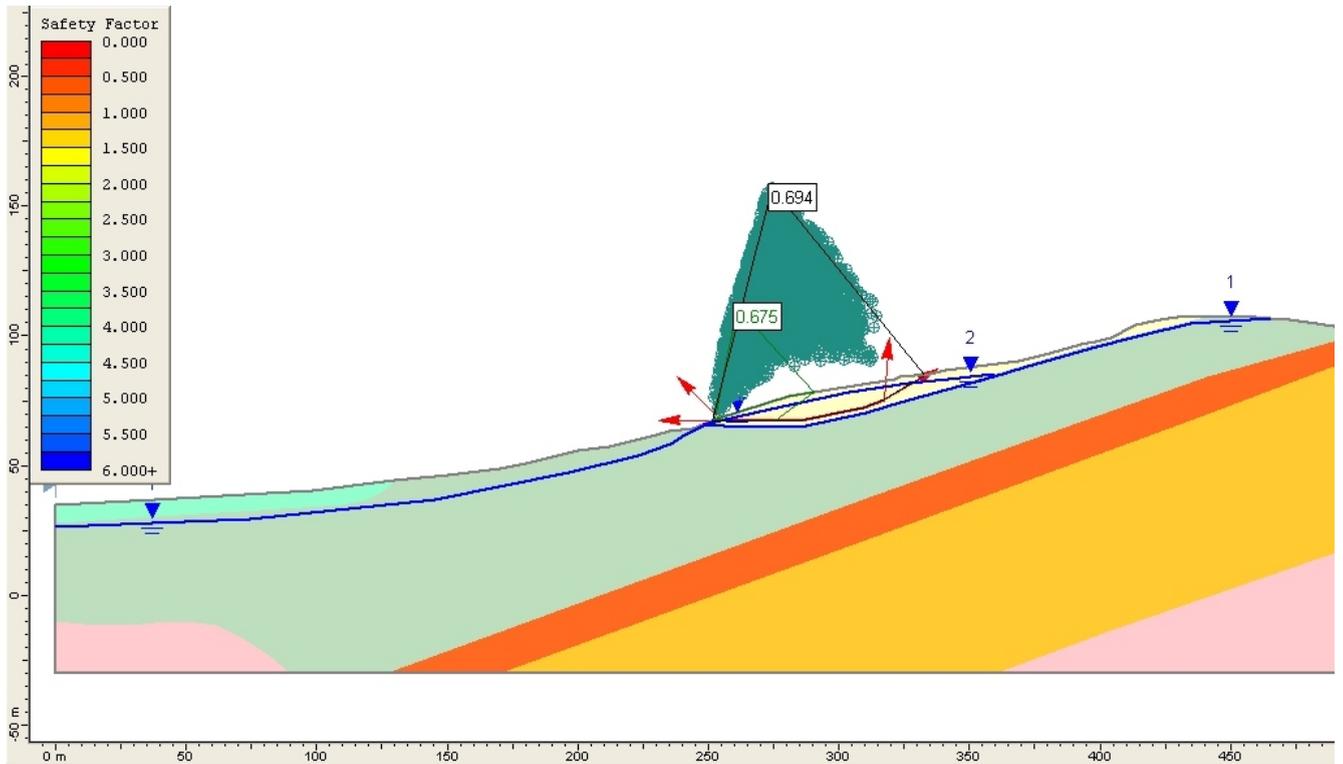
- Plane failure 4 and 5 show similar sensitivity of planar failures to circular failures with regard to increasing water levels in the LF1 aquifer.
