GEOTECHNICAL ASSESSMENT OF
TIN MINING OPERATIONS AT
PIONEER, TASMANIA.

CLIENT:
Amdex Mining Limited,
119 York Street,
SYDNEY. N.S.W. 2000.

OUR REFERENCE:
Report No. 7878/1
Job No. E-078
28th July, 1978.

GEOTECHNICAL ASSESSMENT.

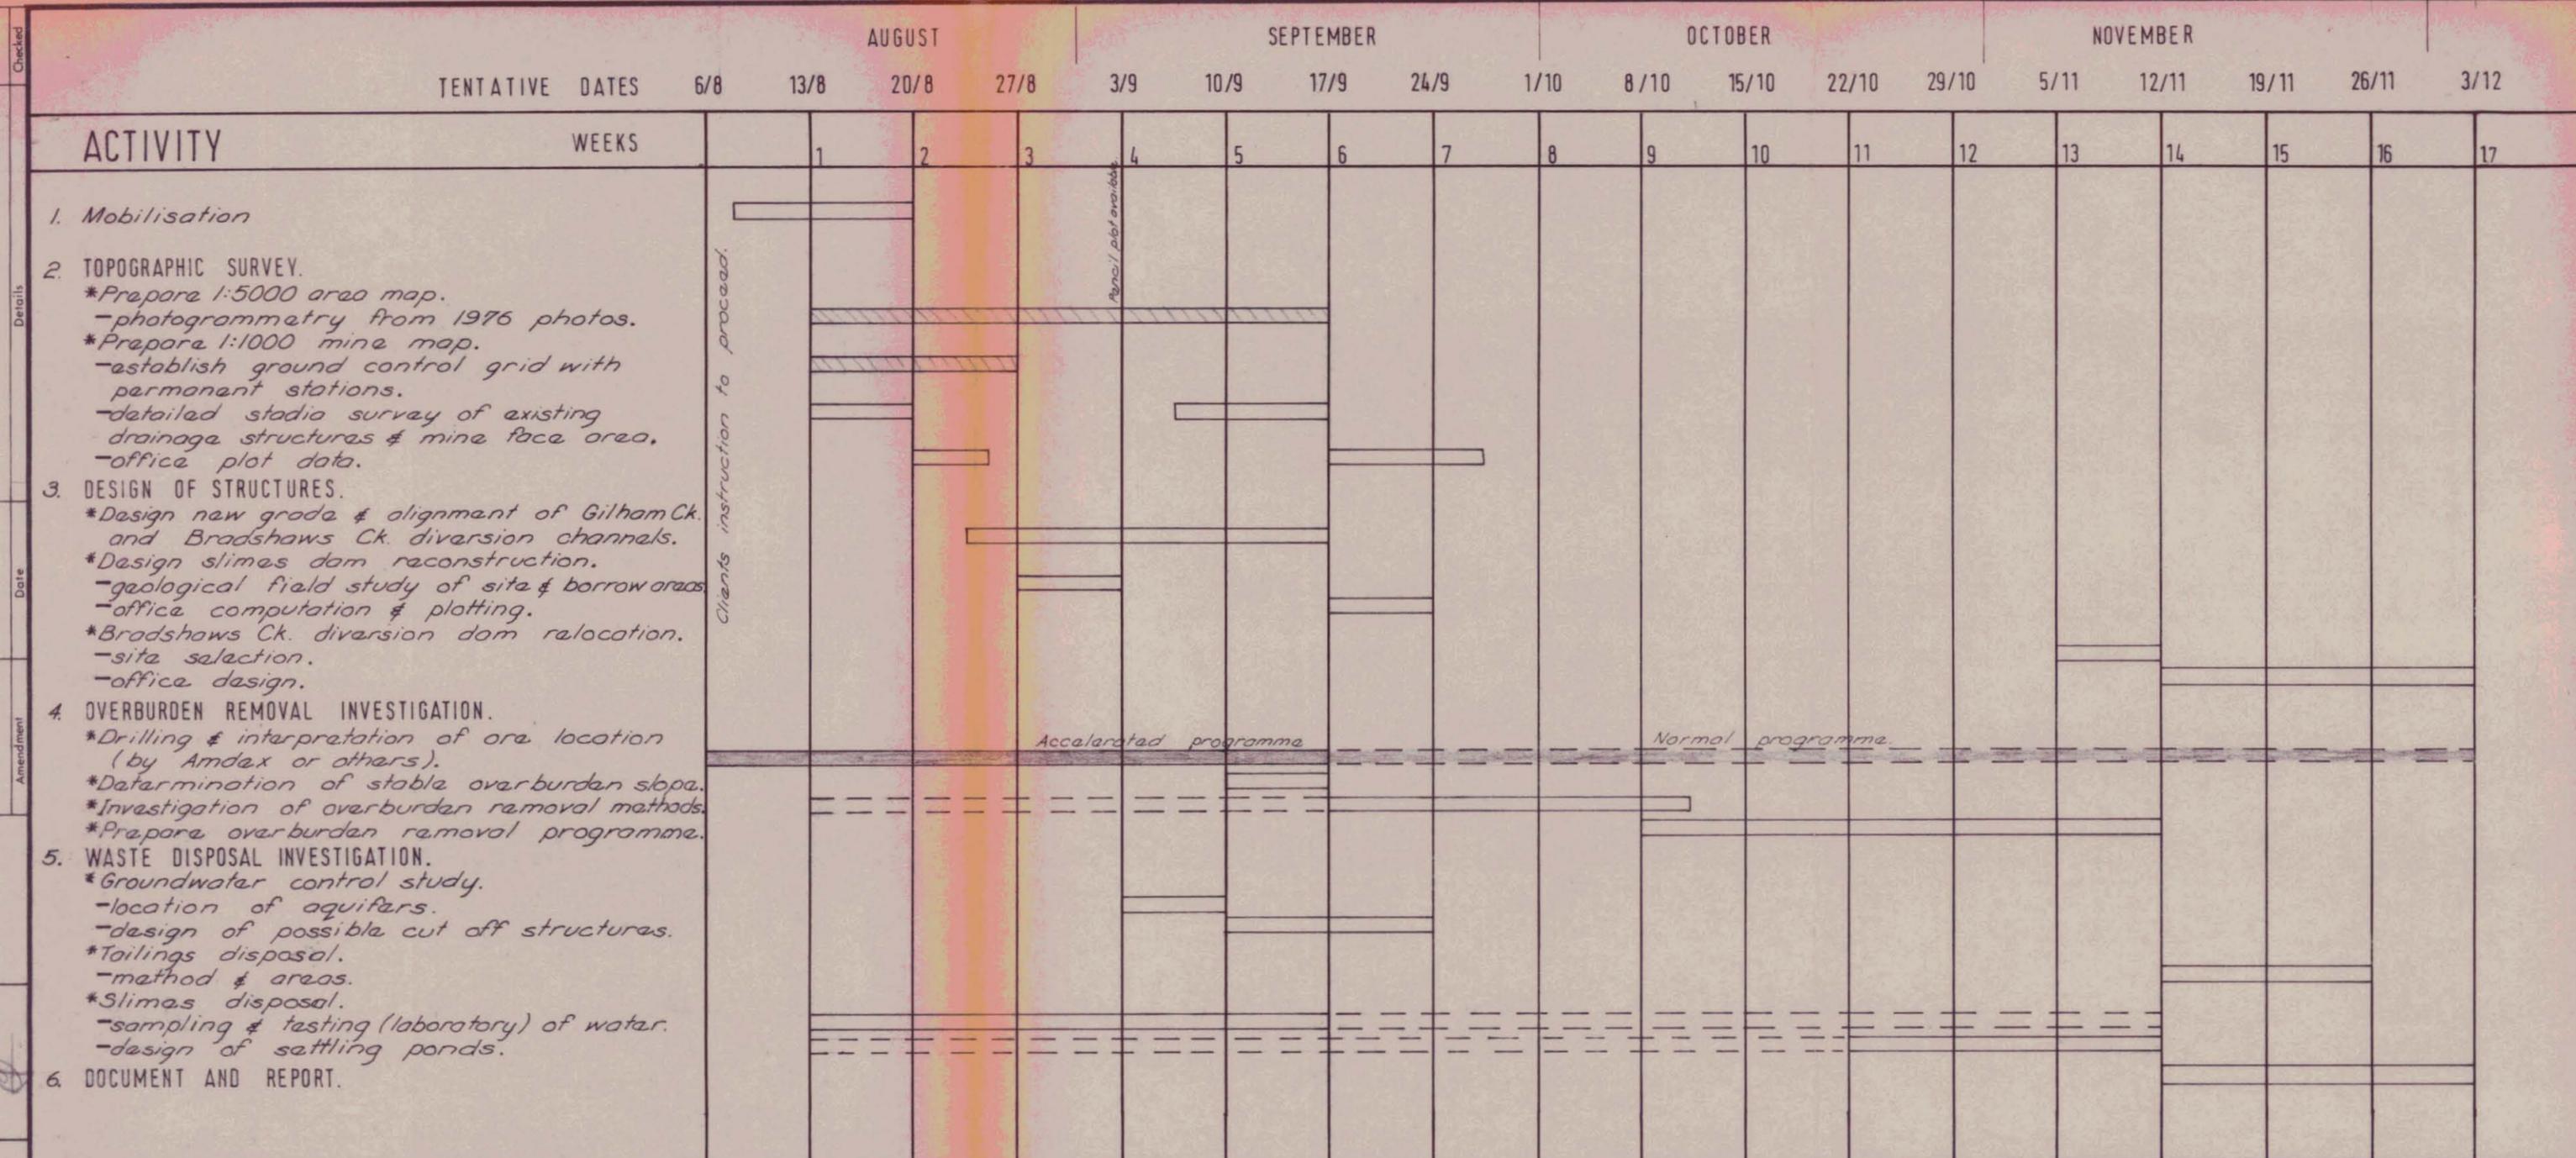
- * Construction of a new diversion dam at Bradshaw's Creek.
- * Reconstruction of the Old Water Race for Gilham Creek.
- * General Pit Stripping and Overburden removal planning.
- * Design of new slimes disposal areas (e.g. on the old tailings dumps).
- * Development of improved methods of tailings disposal.

To assist in the implementation of the above, Drawing No. E-078/G2, has been prepared, and is included to facilitate discussion of the site problems.
