KING ISLAND SCHEELITE

No. KG2-01-019

DOLPHIN MINE
 GEOLOGICAL CROSS-SECTION
 220 360 E

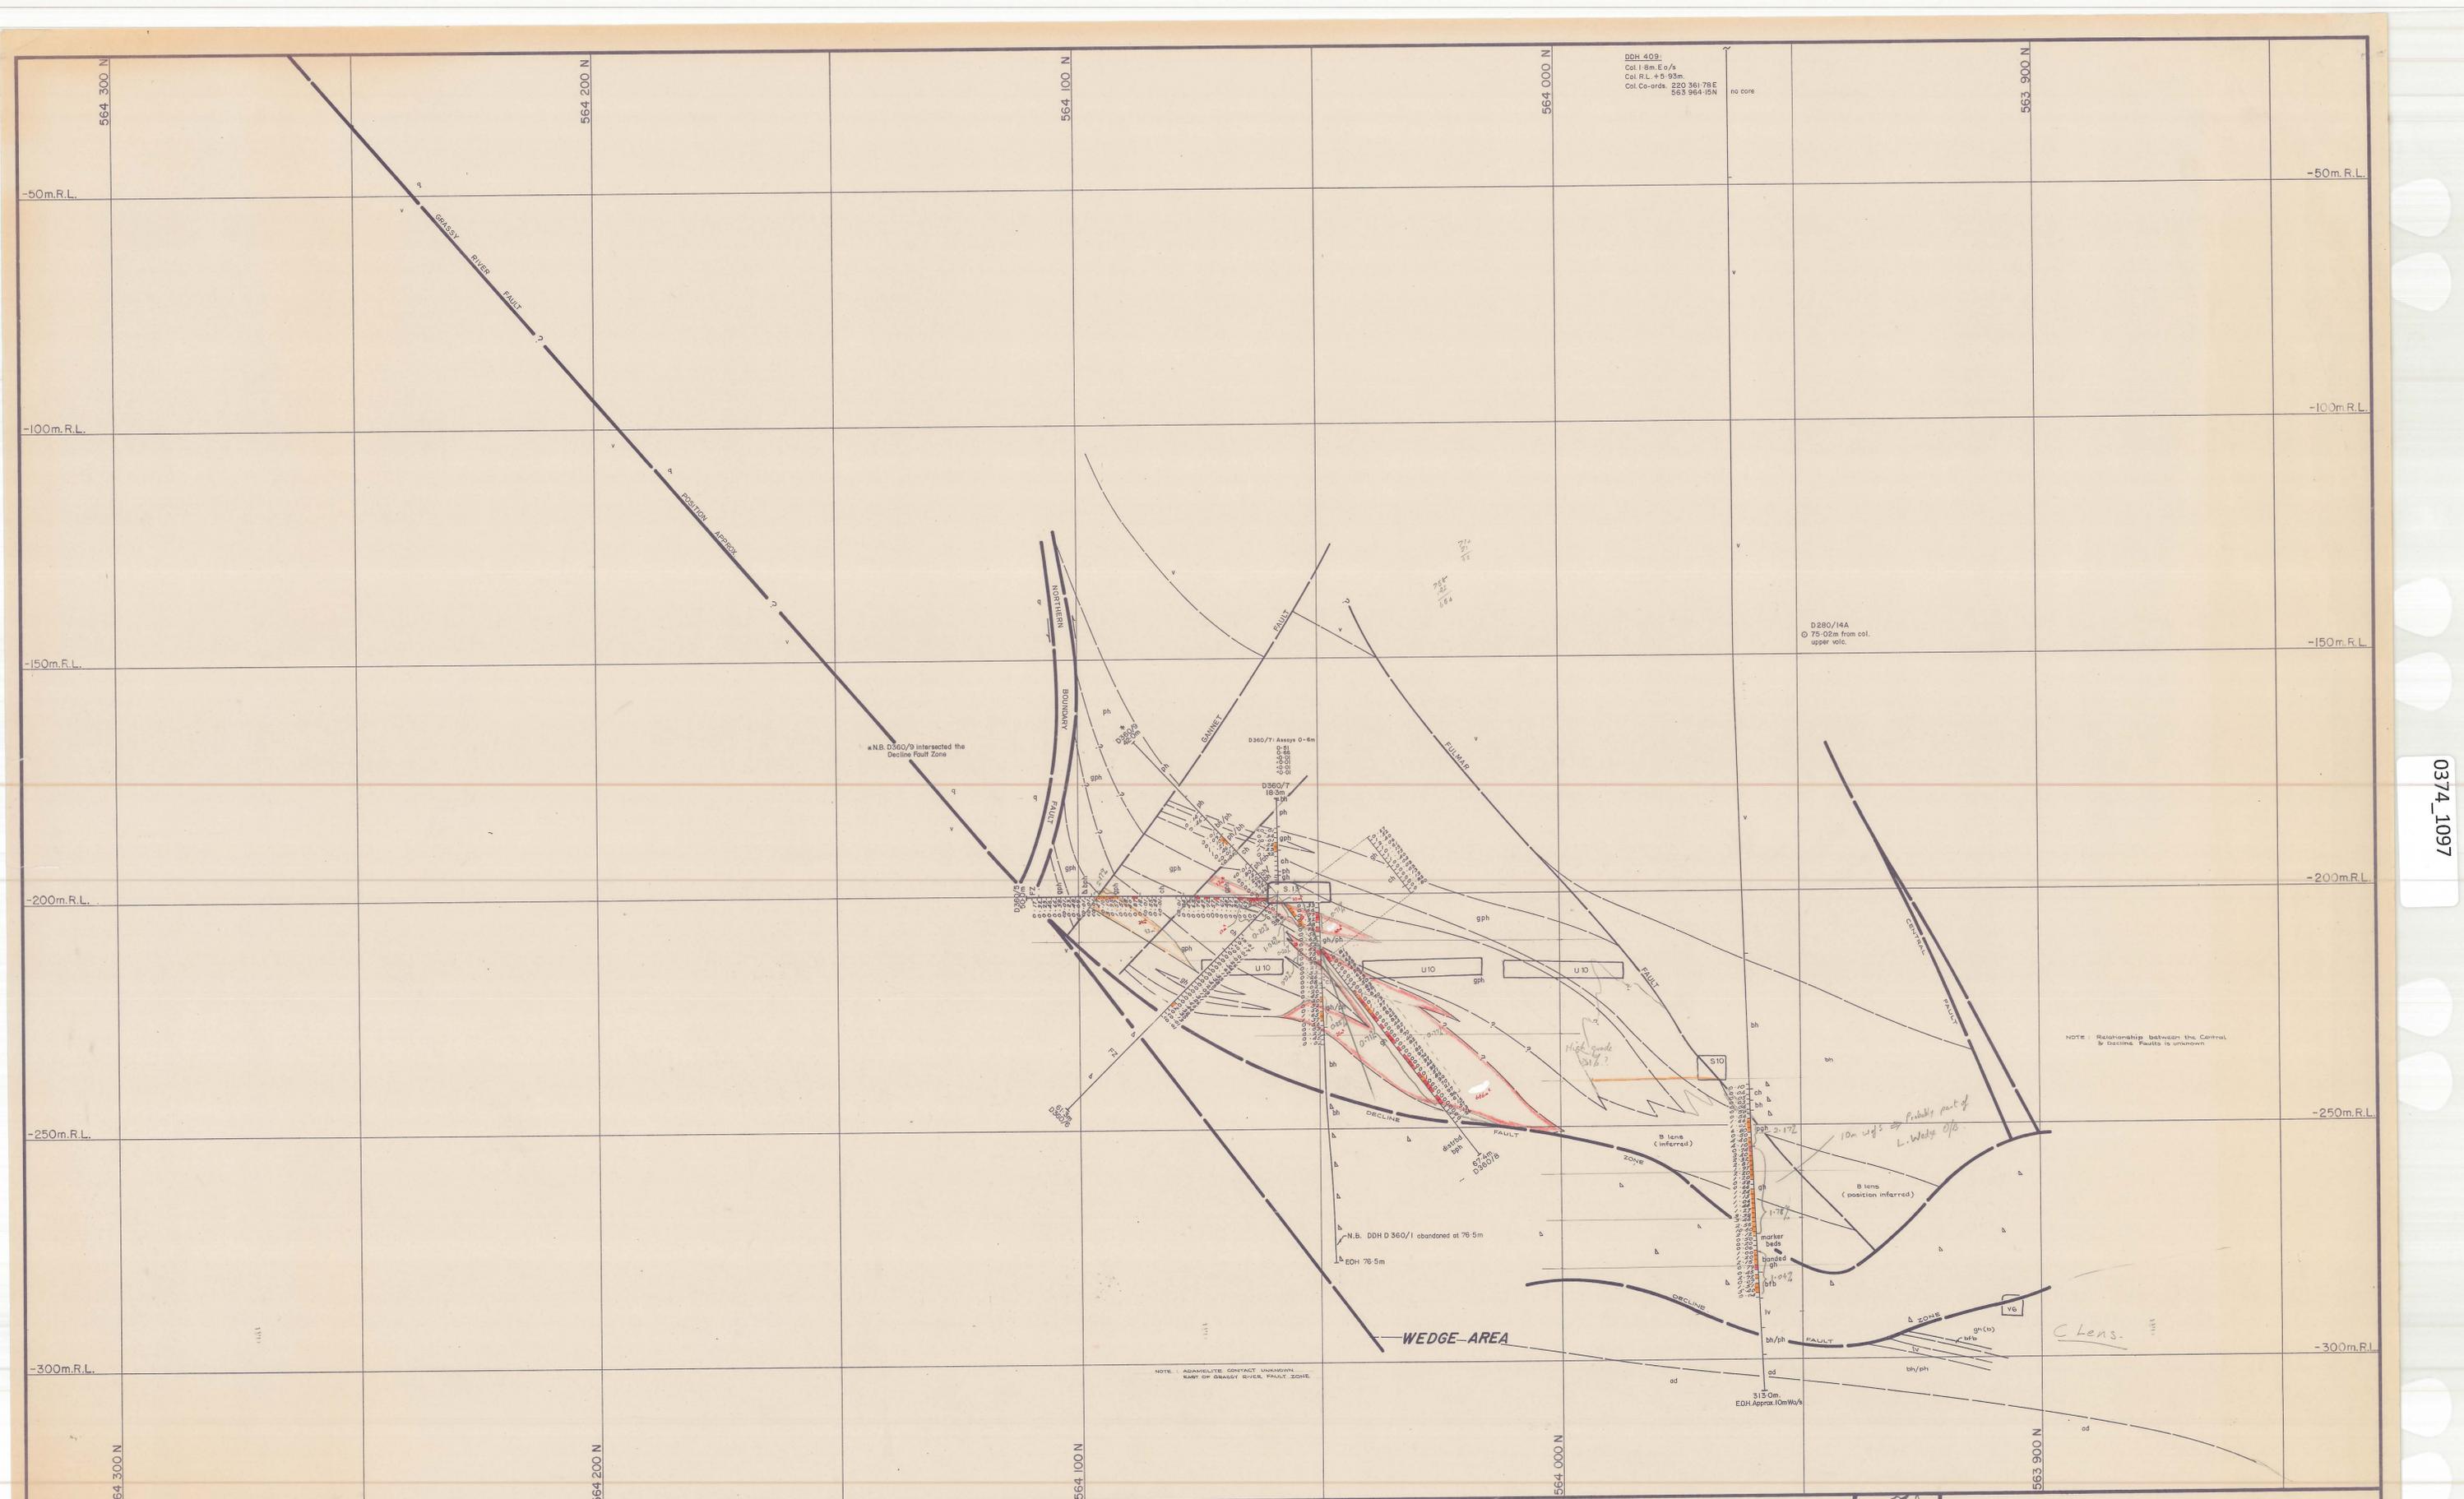
BDH 409:
 Col. 1.6m, E. 0.75
 Col. R.L. + 2.93m
 Col. Co-ords. 220 361 78 E
 563 964 15N

D280/14A
 @ 75.02m from col.
 upper volc.

NOTE: Relationship between the Central
 & Decline Faults is unknown

NOTE: ADAMSELITE CONTACT UNKNOWN
 PART OF GRASSY RIVER FAULT ZONE

RQD %
 >90 Minimum or no support
 60-90 Intermediate support; rockbolts and one shotcrete application
 <60 Maximum support
 (after E. Miller, March, 1972)
