GEOPEKO LIMITED  
KING ISLAND GROUP  
No. K63-264-009  
SCALE 1:250  
BOLD HEAD MINE  
GEOLOGICAL FLOOR PLAN  
B LENS FAULT BLOCK  
Q 54 DRIVE

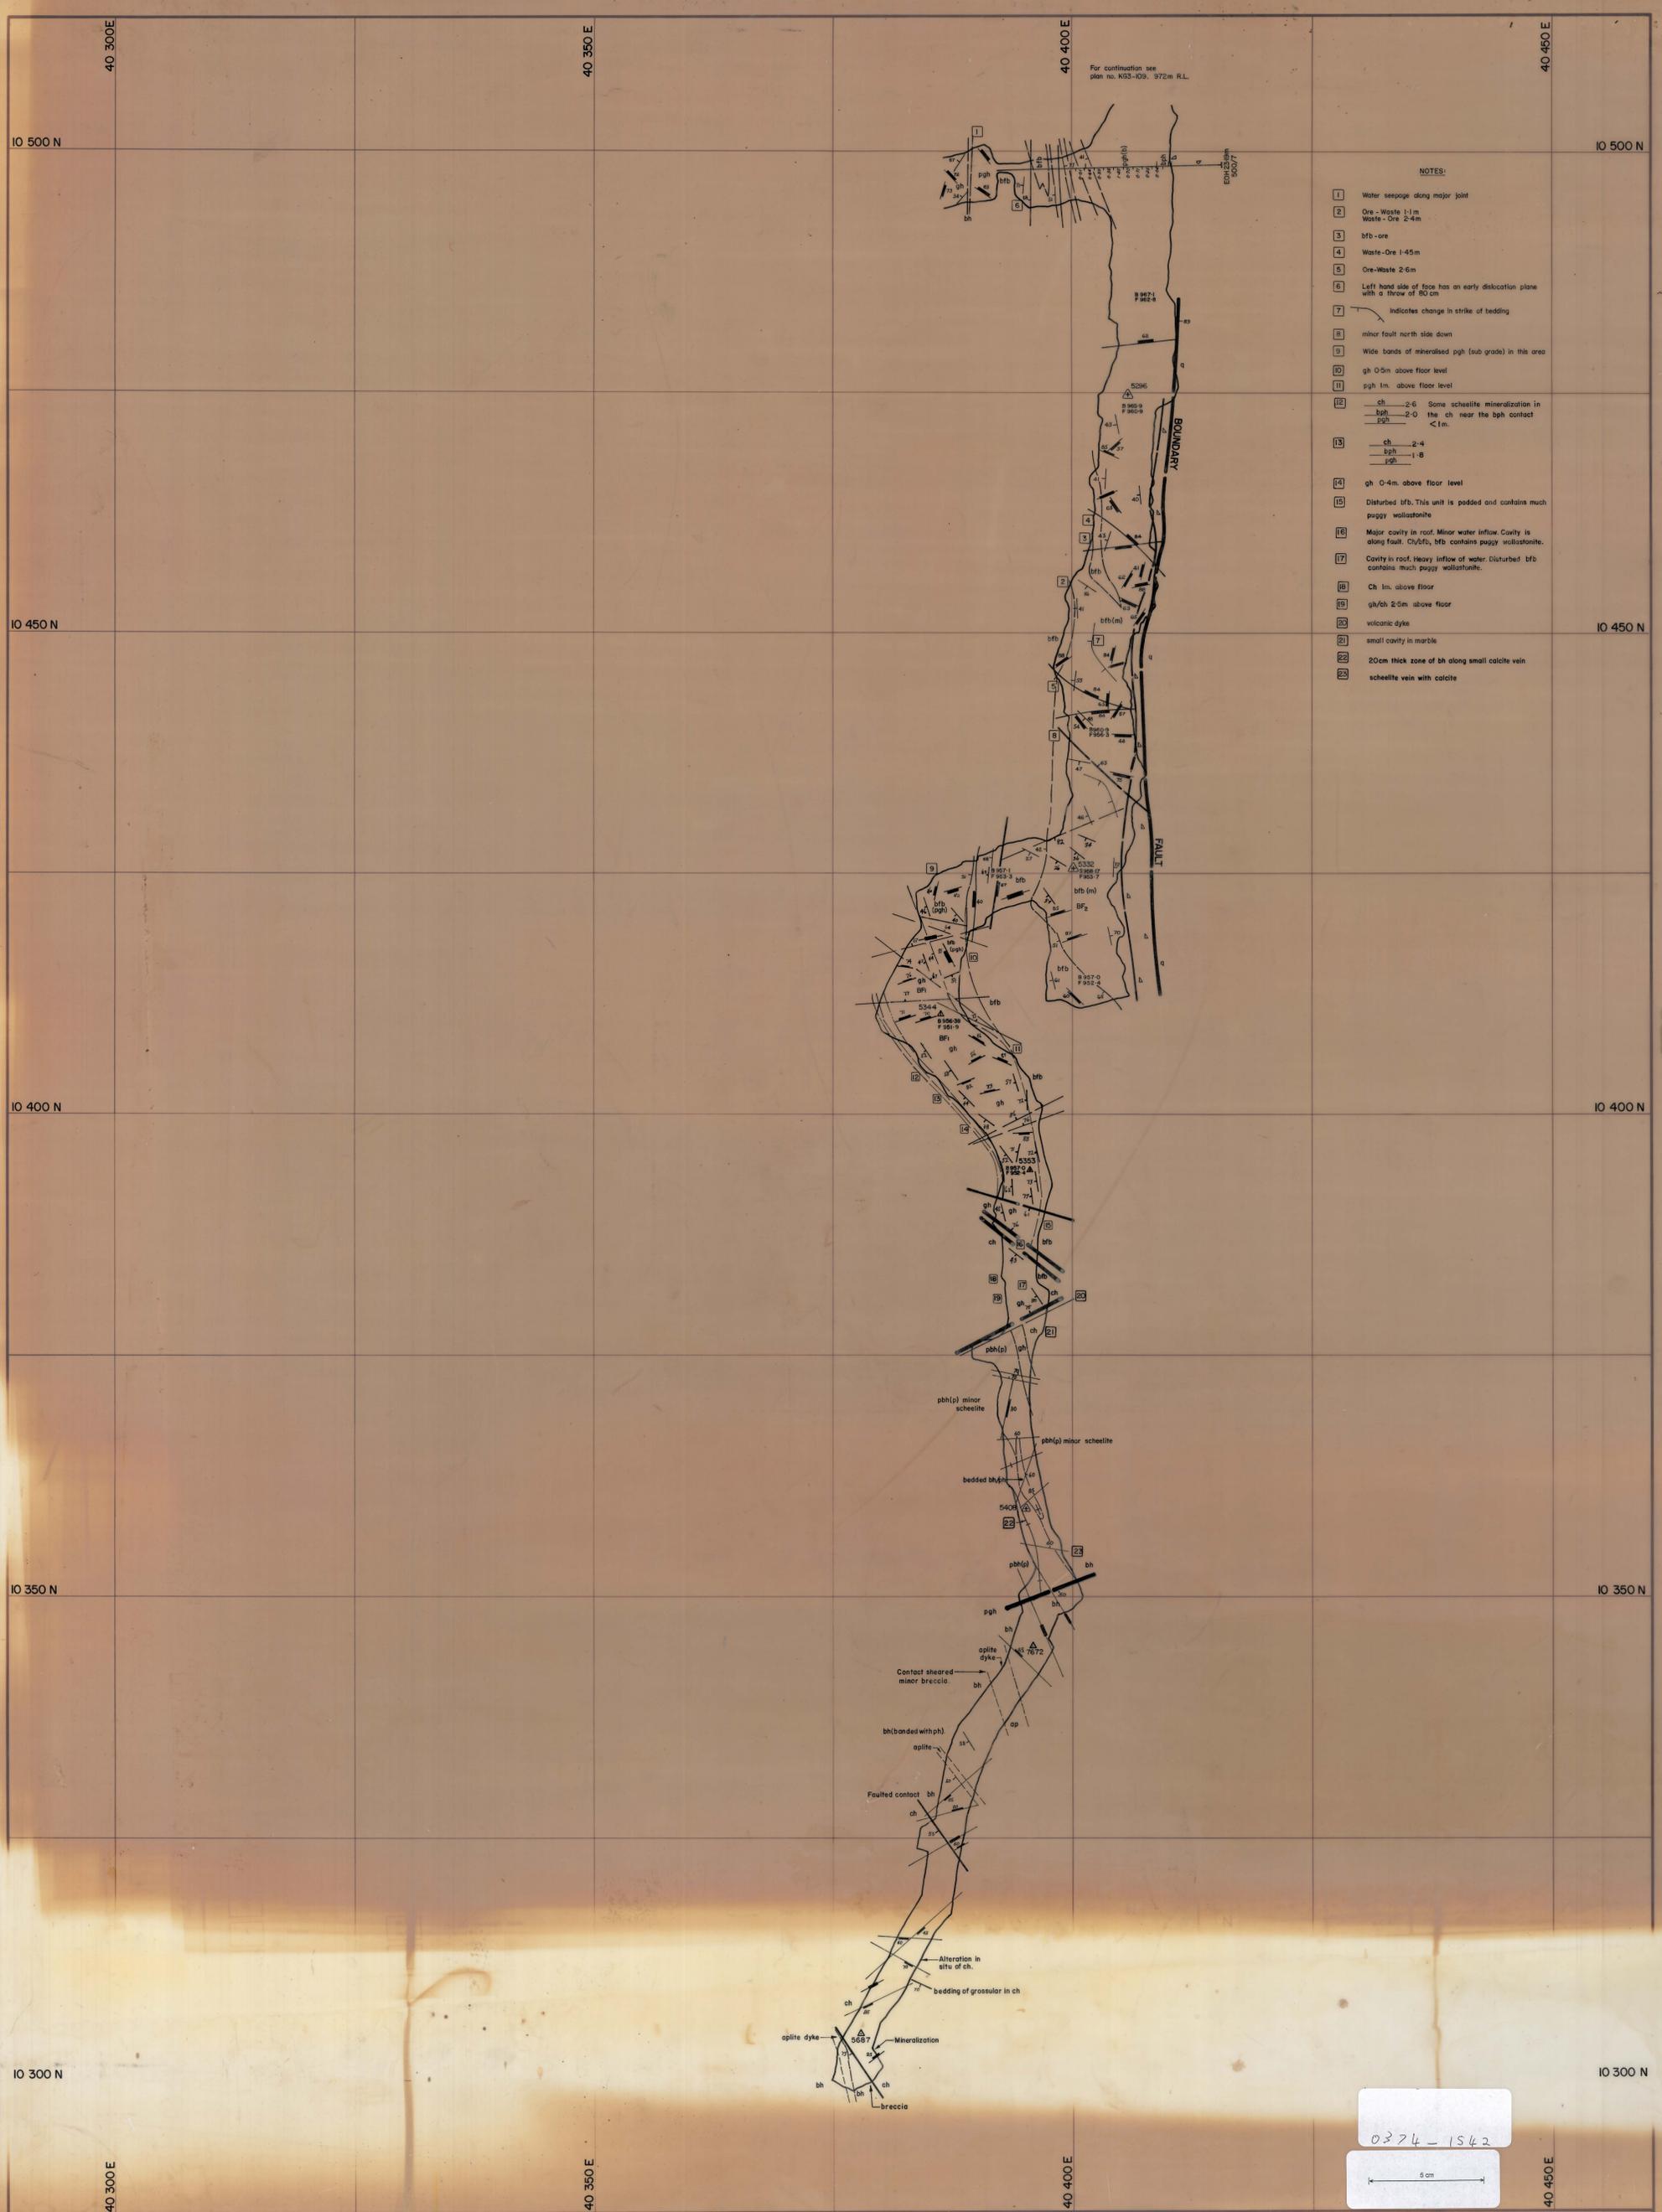
- NOTES:
- 1 Water seepage along major joint
  - 2 Ore-Waste 1-1m  
Waste-Ore 2-4m
  - 3 bfb-ore
  - 4 Waste-Ore 1-45m
  - 5 Ore-Waste 2-6m
  - 6 Left hand side of face has an early dislocation plane with a throw of 80 cm

- 7 Indicates change in strike of bedding
  - 8 minor fault north side down
  - 9 Wide bands of mineralised pgh (sub grade) in this area
  - 10 gh 0-5m above floor level

- 11 pgh 1m. above floor level
  - 12 ch 2-6 Some scheelite mineralization in  
bth 2-0 the ch near the bth contact  
pgh <1m.
  - 13 ch 2-4  
pgh 1-8
  - 14 gh 0-4m. above floor level

- 15 Disturbed bfb. This unit is podded and contains much puggy wollastonite
  - 16 Major cavity in roof. Minor water inflow. Cavity is along fault. Ch/bfb, bfb contains puggy wollastonite.

- 17 Cavity in roof. Heavy inflow of water. Disturbed bfb contains much puggy wollastonite.
  - 18 Ch 1m. above floor
  - 19 gh/ch 2-5m above floor
  - 20 volcanic dyke

- 21 small cavity in marble
  - 22 20cm thick zone of bh along small calcite vein
  - 23 scheelite vein with calcite
