GEOEKO LIMITED  
KING ISLAND GROUP

SCALE: 1:500 No. KG2-02-012

DOLPHIN MINE  
ENGINEERING GEOLOGY SECTION  
220 220 E

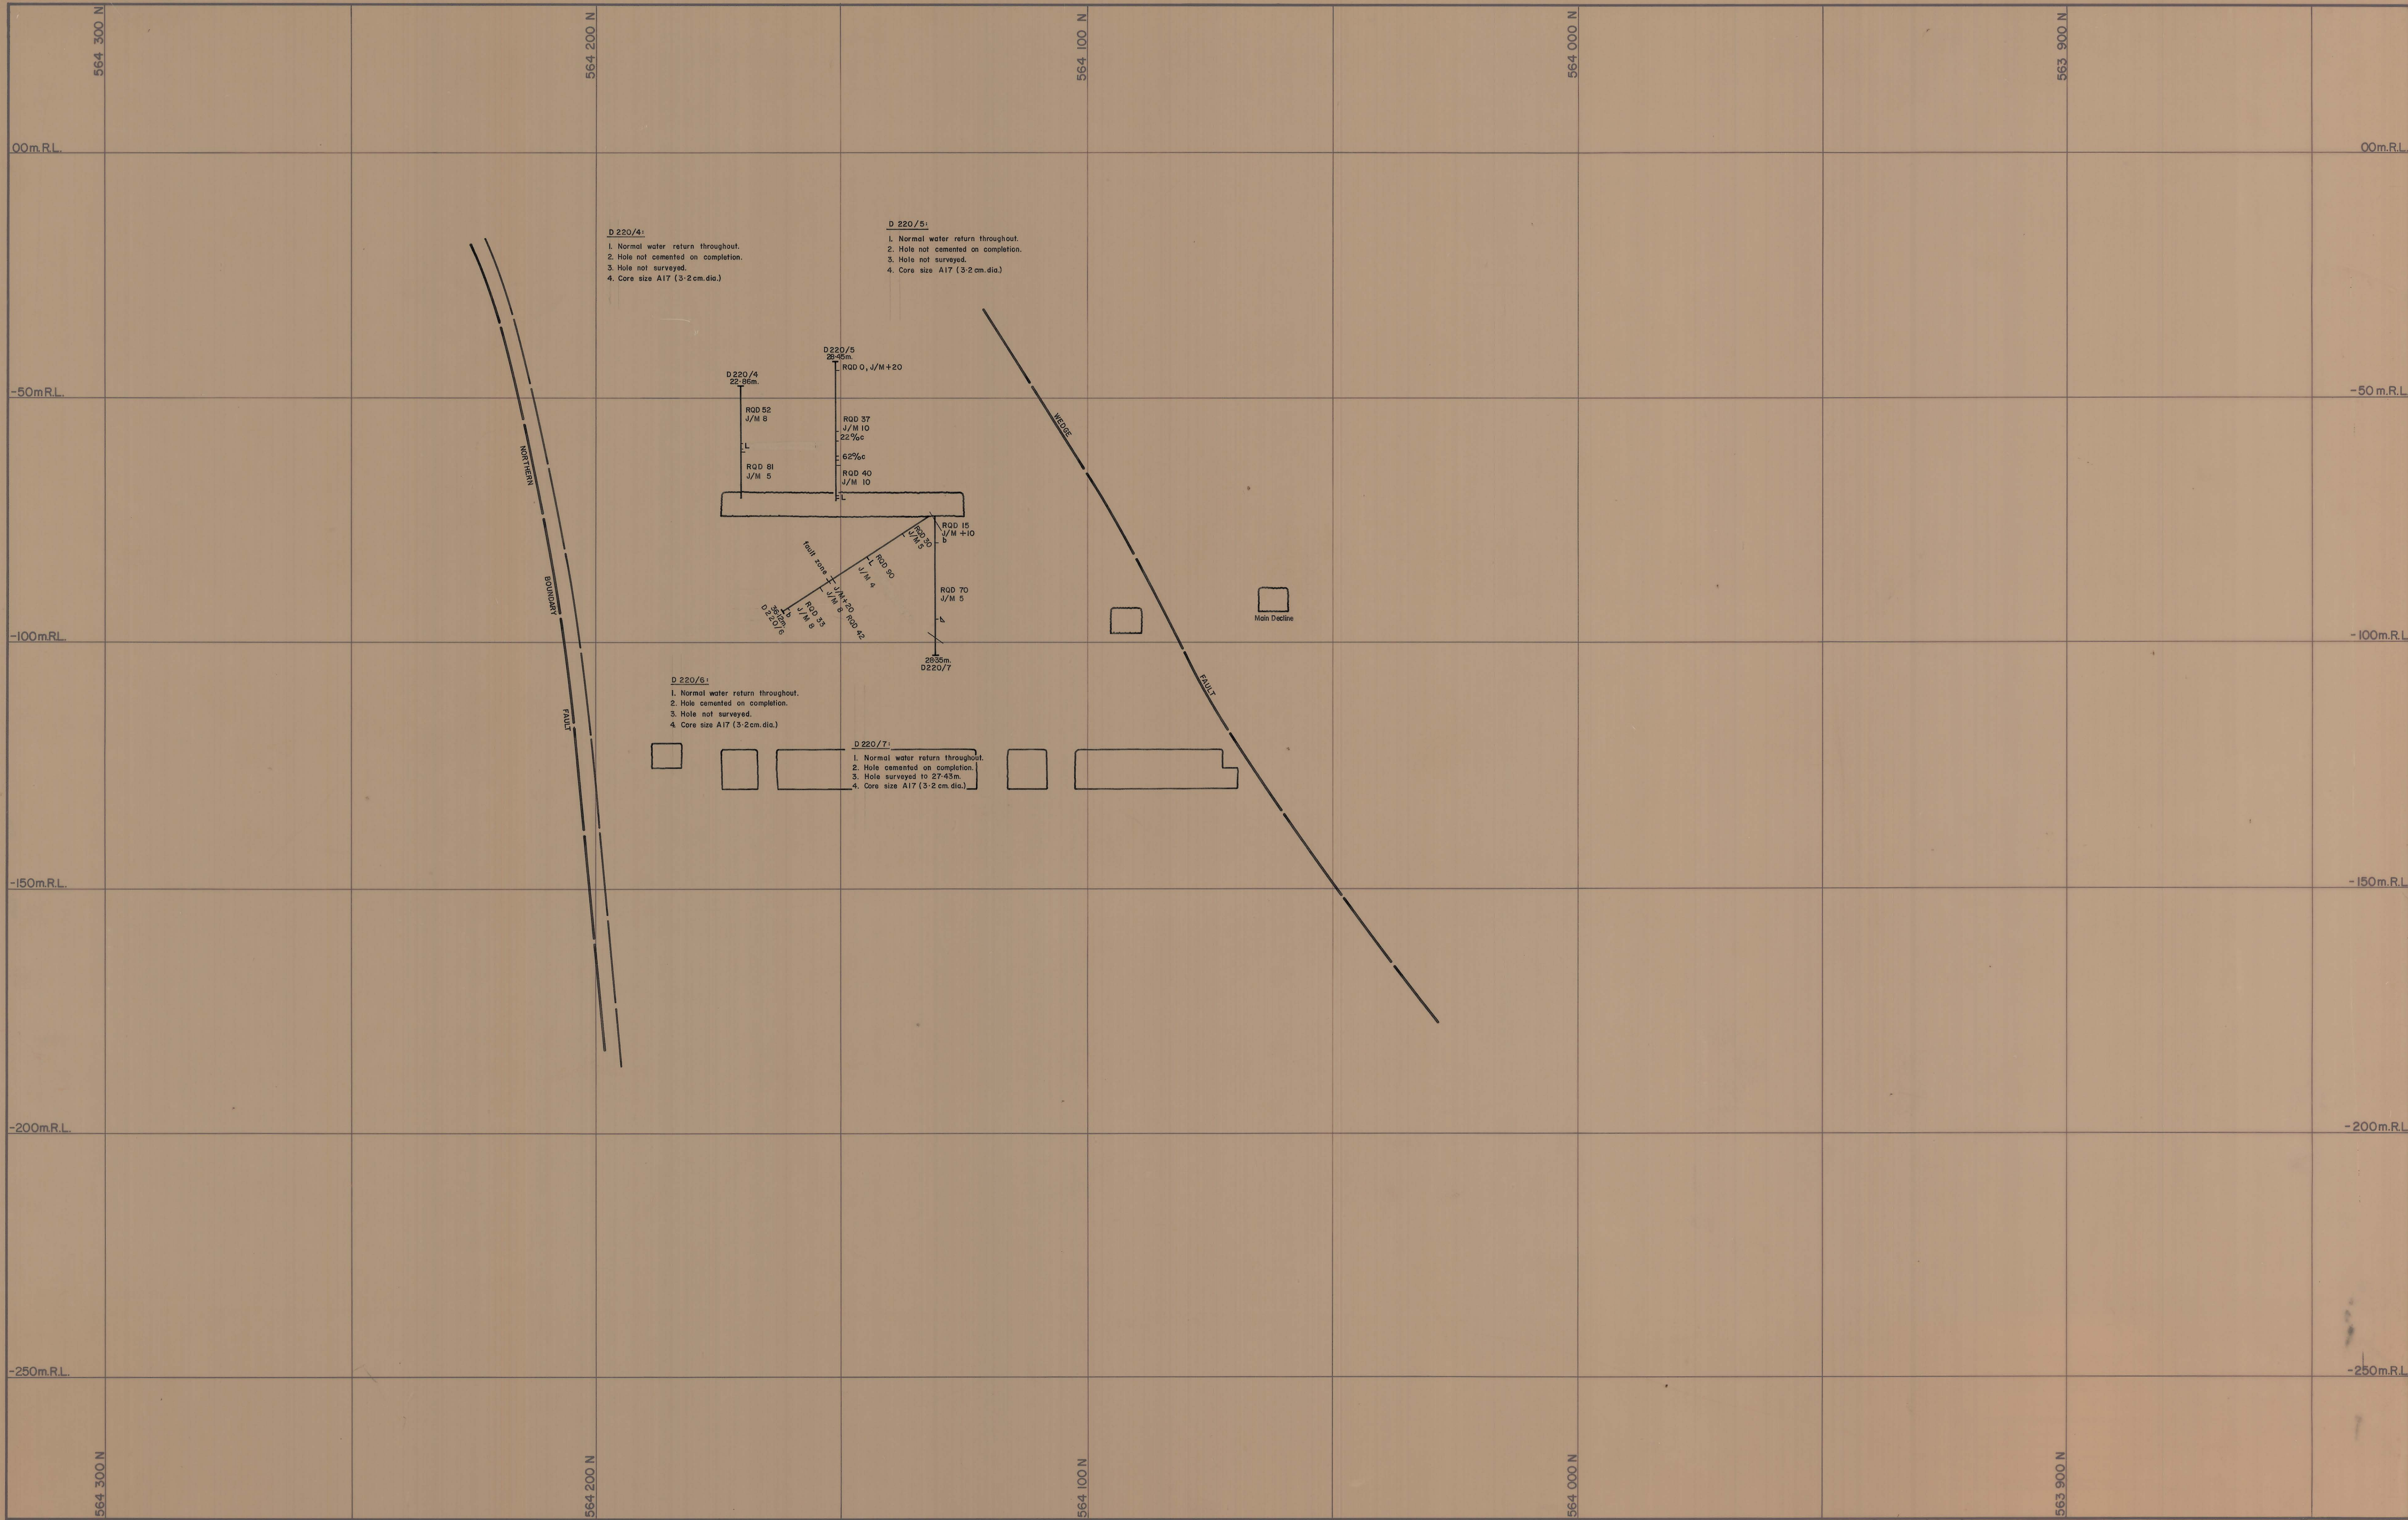
RQD %:  
>90 Minimum or no support  
80-90 Intermediate support; rockbolts and one shotcrete application  
<80 Maximum support  
(after E. Miller; March, 1972)
