**TASMANIAN DEVELOPMENT  
AND RESOURCES**

**ROSSARDEN / STORY'S CREEK MINE SITES**

**REHABILITATION PLAN**

Thompson & Brett Pty. Ltd.  
7 Bayfield Street, Rosny Park 7018

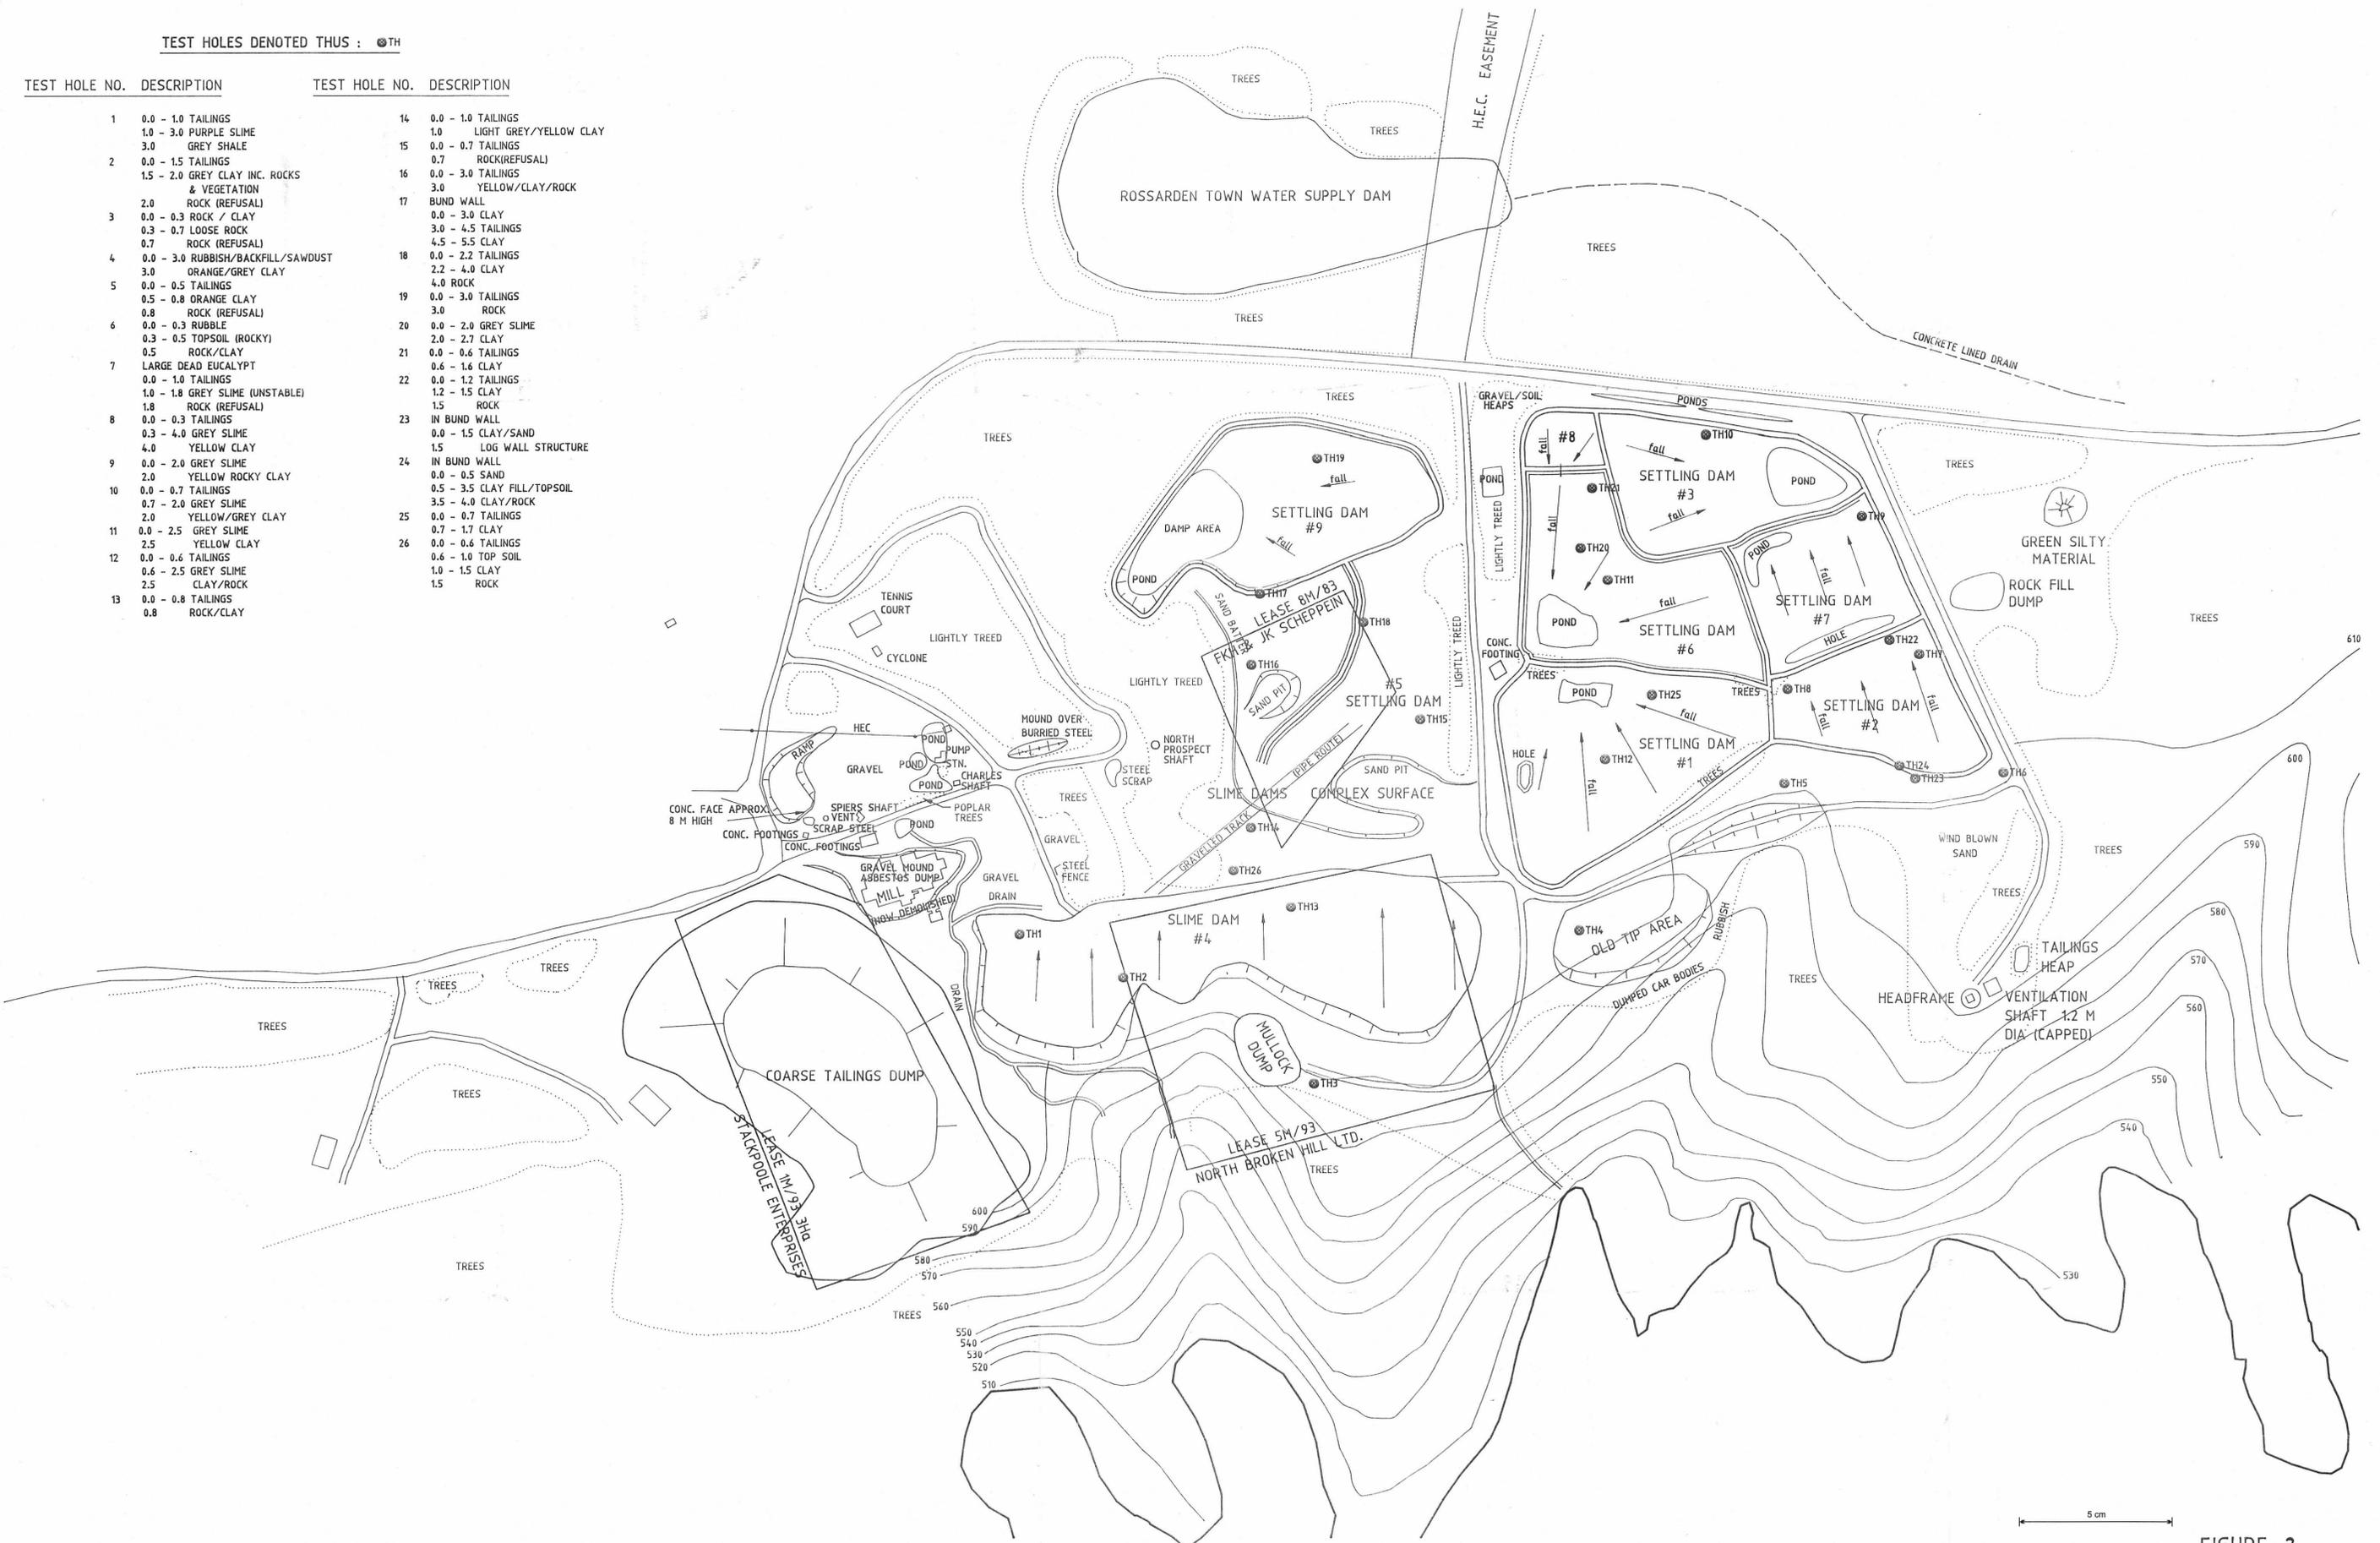
FIGURE 2

TEST HOLES DENOTED THUS : ●TH

2.5 YELLOW CLAY	26	0.0 - 0.6 TAILINGS
12	0.0 - 0.6 TAILINGS		0.6 - 1.0 TOP SOIL
	0.6 - 2.5 GREY SLIME		1.0 - 1.5 CLAY
	2.5 CLAY/ROCK		1.5 ROCK
13	0.0 - 0.8 TAILINGS

0.8 ROCK/CLAY

Drawing Title	CURRENT ROSSARDEN SITE CONDITIONS & TEST HOLE DATA
Drawing No.	94 - 1096 - 01

The existing surface works at Rossarden are shown in Figure 2 (Drawing No. 94-1096-01) together with the details of various test holes dug to investigate the depth of tailings materials. The areas of interest for rehabilitation works include the old Mill site, and tailings dams areas. Areas leased by Stackpoole Enterprises, North Broken Hill Pty., Ltd. and F.K.H and V. K. Sheppein are active mine areas and cannot be rehabilitated under the current proposals.
