PRECIPITATE DAM RELOCATION DESIGN REPORT

Mineral Resources Tasmania : Storys Creek
precipitate dam relocation design report / John
Miedecke and Partners Pty Ltd 2000

Mineral Resources Tasmania

MARCH 1999

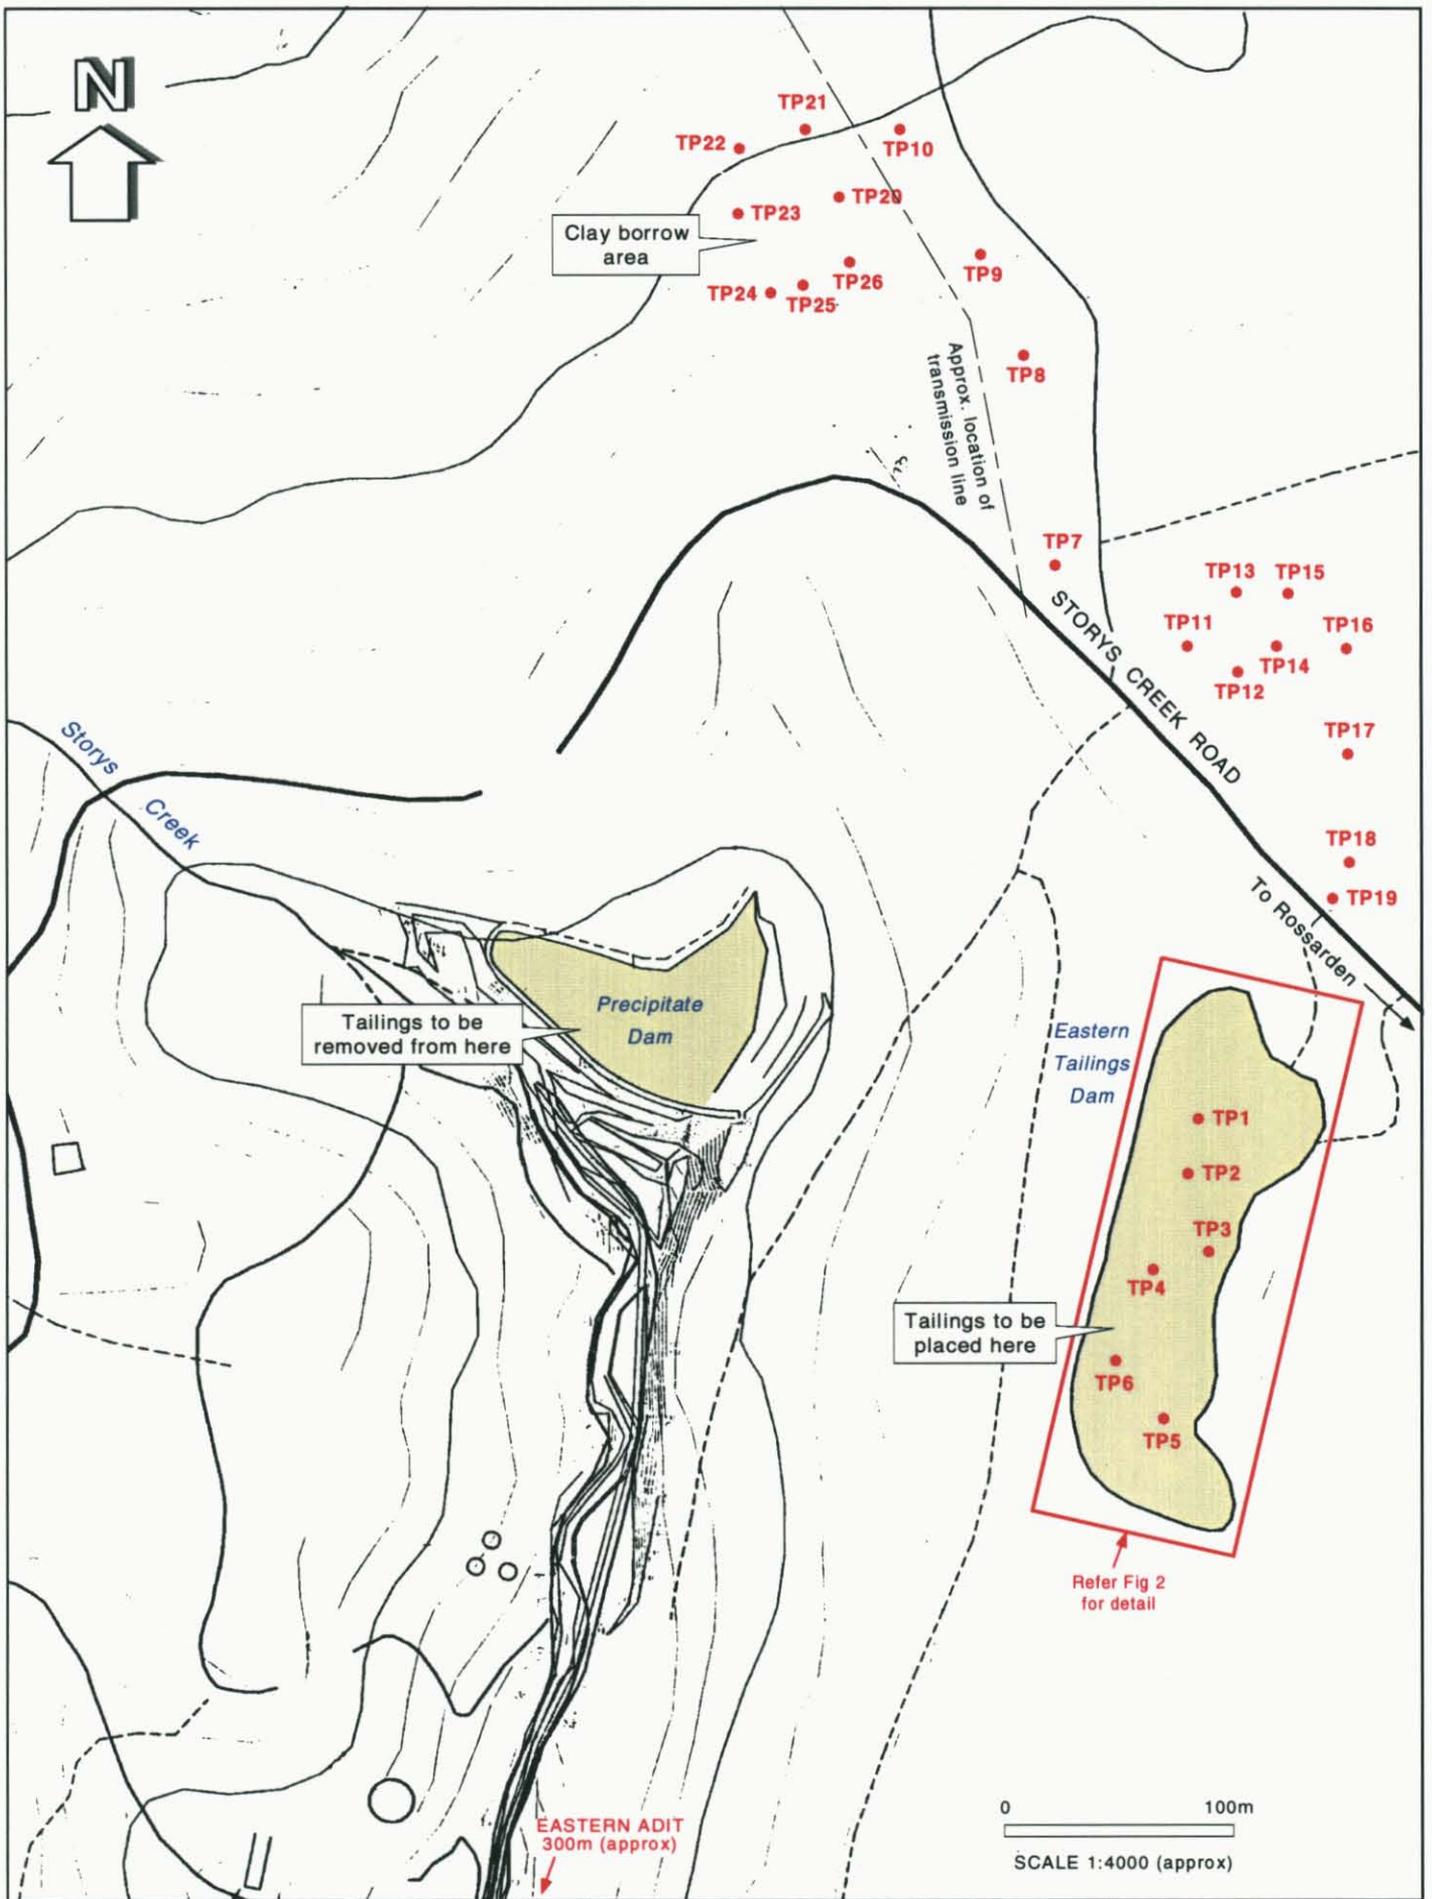
MINERAL RESOURCES TASMANIA	
Storys Creek & Rossarden AD Remediation Projects Precipitate Dam Area - Location	
John Miedecke & Partners P/L	FIG 1

● TP1 Approximate location of test pit

The area selected for the relocated tailings, is an existing disturbed area adjoining the Storys Creek road and known as the Eastern tailings dam (Figure 1) . This was the site of the proposed new tailings dam for the mine in the 1970's before the decision was made to cart ore to the Rossarden Plant and cease on-site processing.

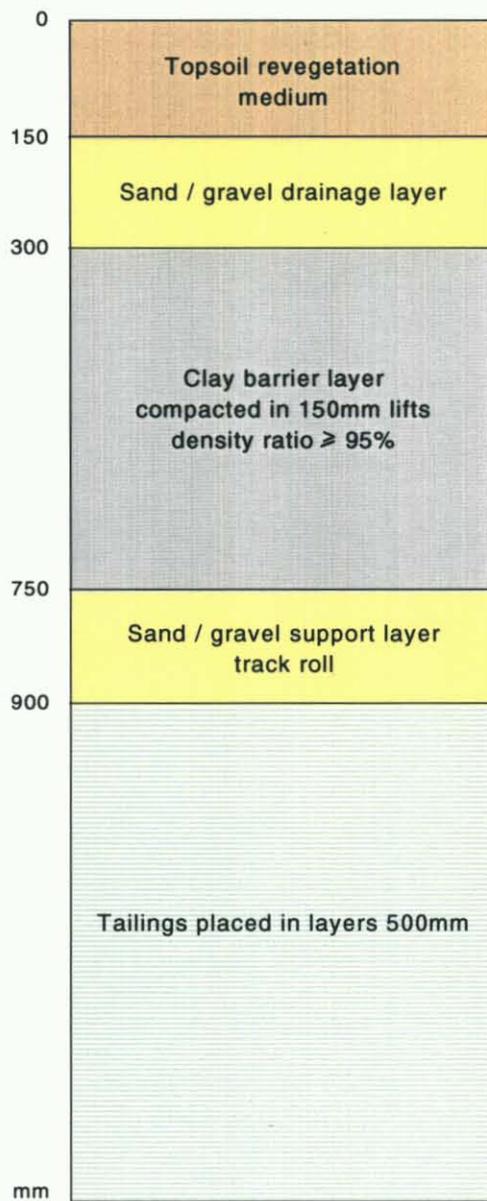
FIG 4

Storys Creek & Rossarden AD Remediation Projects
Precipitate Dam Relocation - Cover Design

MPA Williams have prepared a cover design for the capping and located a suitable clay source (Figure 4).

The cover design has been completed and infiltration modelled using the HELP program. The cover consists of 150mm of topsoil/ growth medium, 150mm of sands/gravel drainage layer and 450mm of compacted clay over 200mm of gravel/sands (from the precipitate dam) track rolled as a cover of the tailings which will be placed in layers. The cover will be keyed into bedrock on all sides.

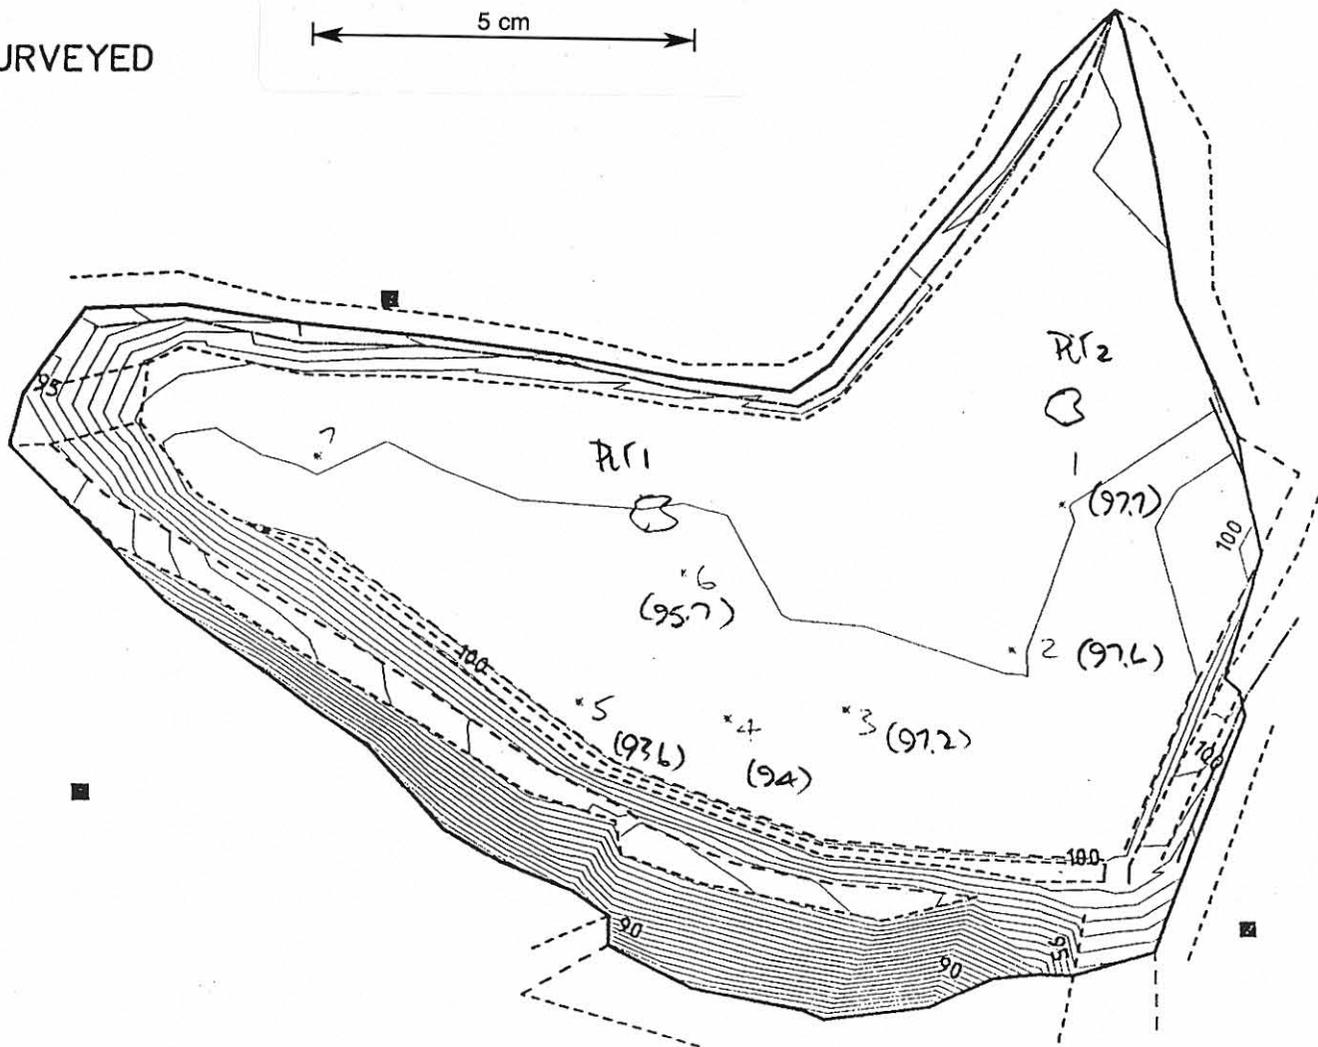
hole No
1 (water level)

The location of the seven holes are illustrated on Figure 1 and the reduced level (to an arbitrary datum) surveyed. Each hole was logged and the results are shown in Table 1. The bottom of each hole was noted for quantity survey purposes. Composite samples were taken of representative materials throughout the profile for geochemical testwork.

The water table within the storage was monitored by measuring the standing level in the boreholes (water levels are noted in Figure 1). This indicates that the tailings dam phreatic level is quite deep near the embankment, but rises sharply away from it. This is consistent with a dam constructed by spigotting tailings from the embankment. Water movements are expected to be through the storage, and expressed as the leakage at the base of the dam wall.

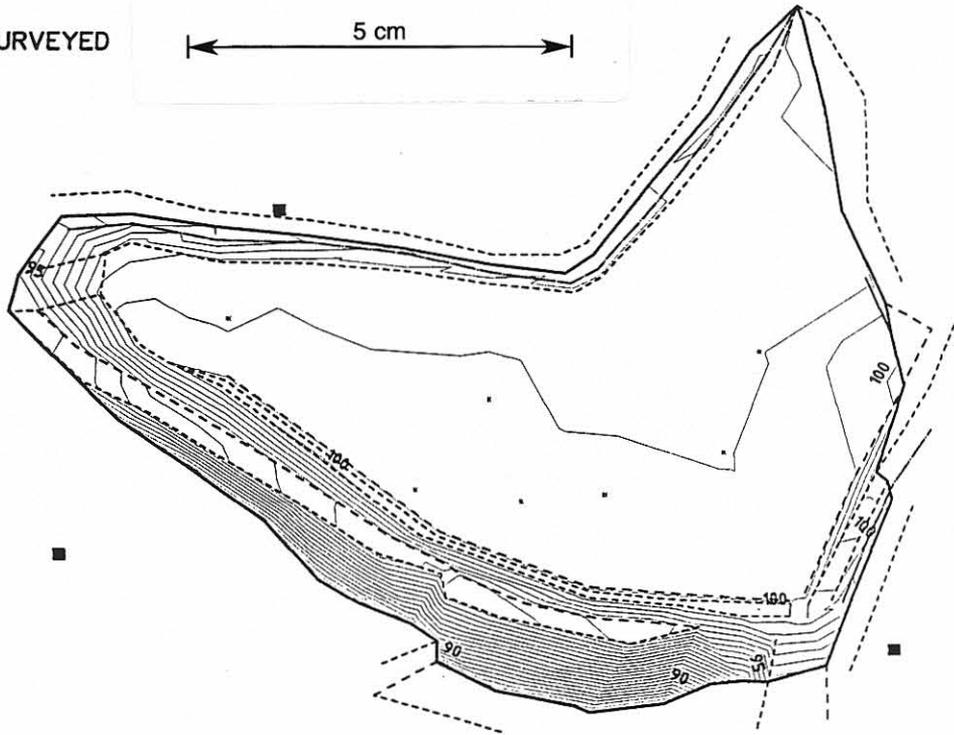
SHAPE AS SURVEYED

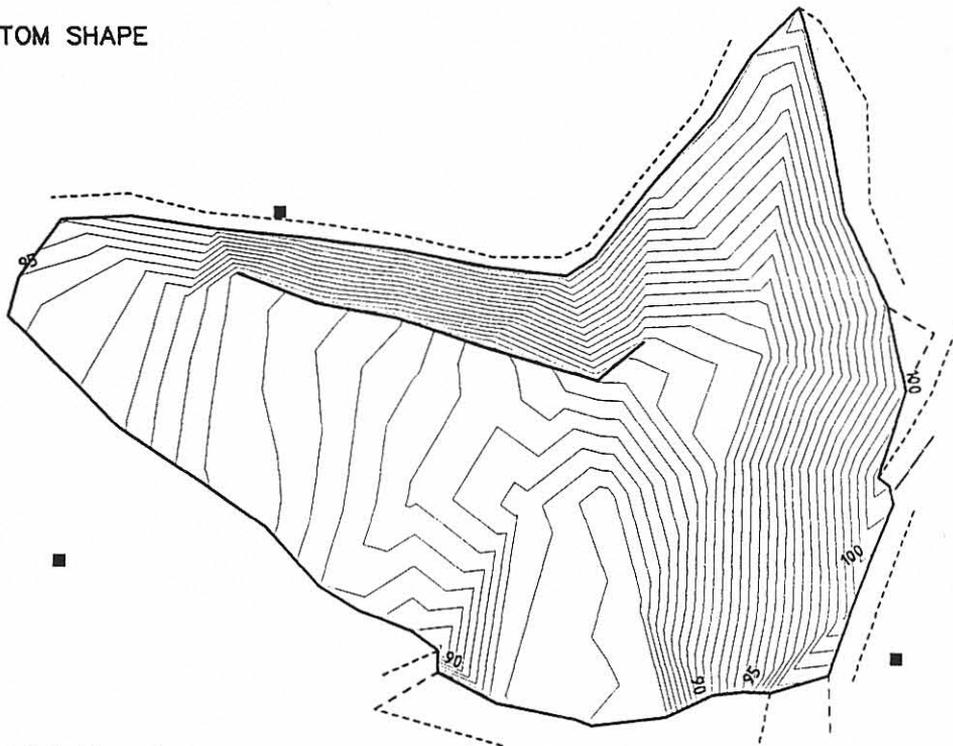
ASSUMED BOTTOM SHAPE

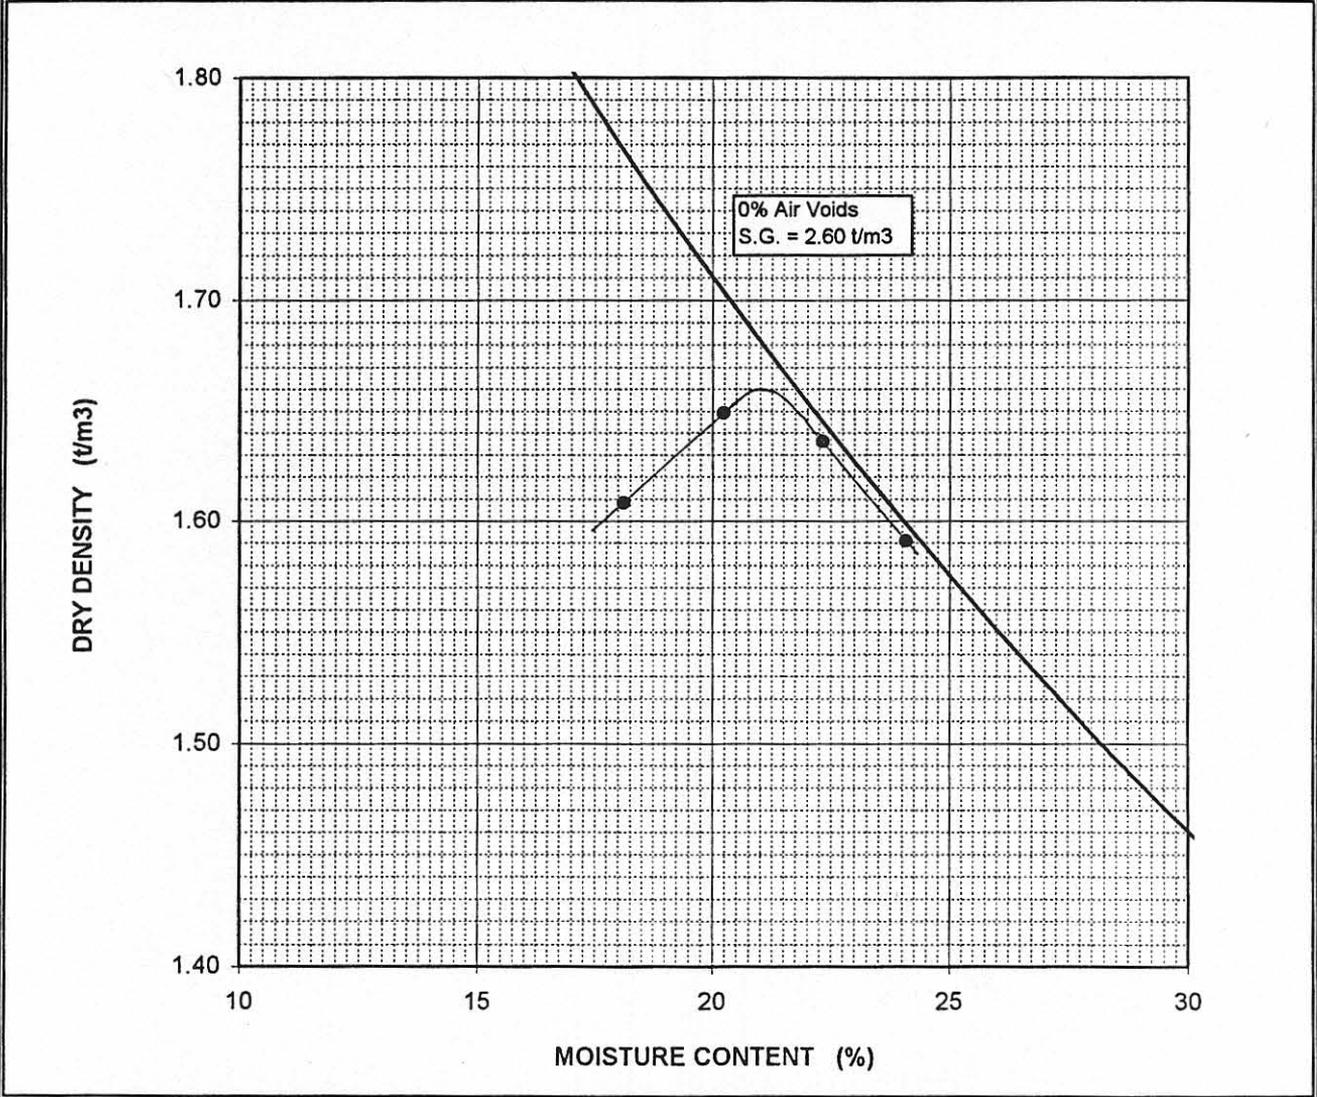
COMPACTION TEST RESULTS		NATA	
COMPACTION CURVE		REPORT No. :	R12798
AS 1289.5.1.1 (STANDARD) <input checked="" type="checkbox"/>			
AS 1289.5.2.1 (MODIFIED) <input type="checkbox"/>		JOB No. :	98037
CLIENT:	John Miedecke & Partners	REGISTER No. :	37198
PROJECT:	Minesite Rehabilitation	LOCATION:	Storys Creek, Tasmania
SAMPLE DESCRIPTION :	Sandy CLAY (CH)	BOREHOLE <input type="checkbox"/>	TEST PIT <input checked="" type="checkbox"/>
		No. : 20	DEPTH: 0.5 - 1.0 m
MAXIMUM DRY DENSITY	<input type="text" value="1.66"/> (t/m3)	OPTIMUM MOISTURE CONTENT	<input type="text" value="21.0"/> (%)

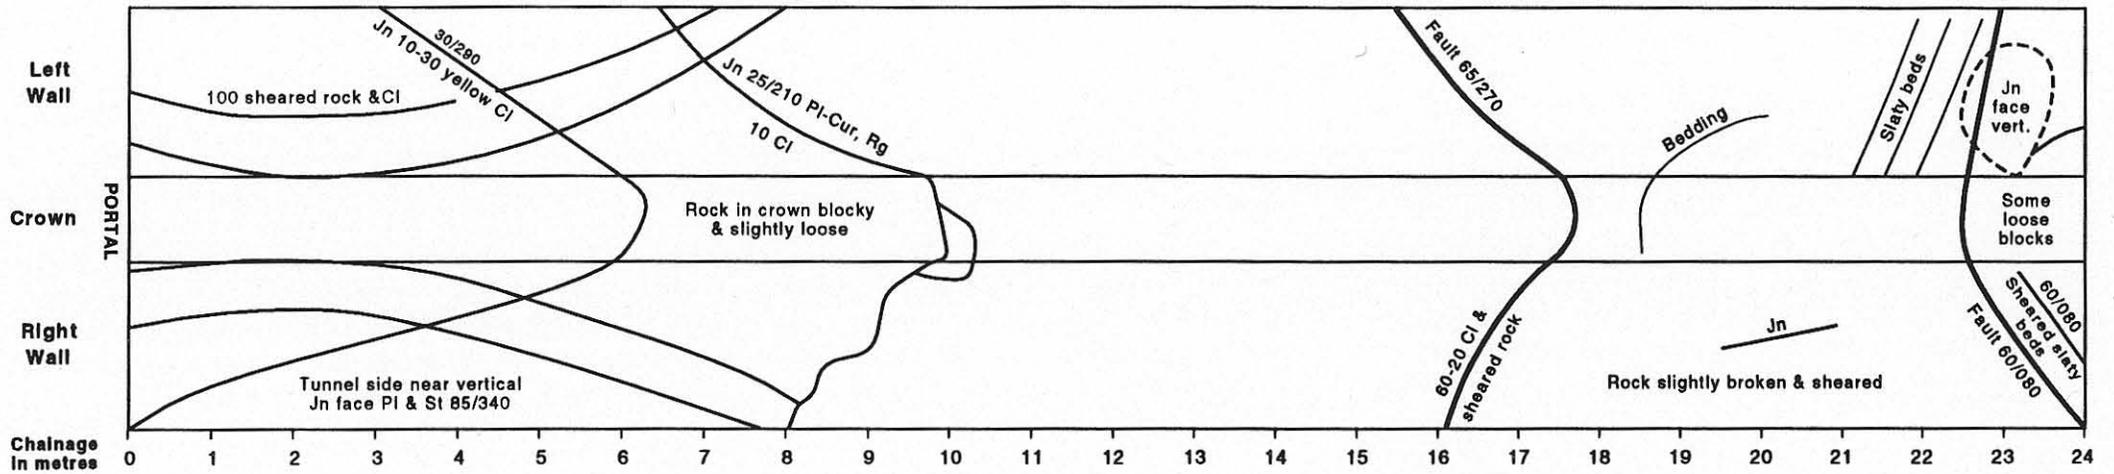
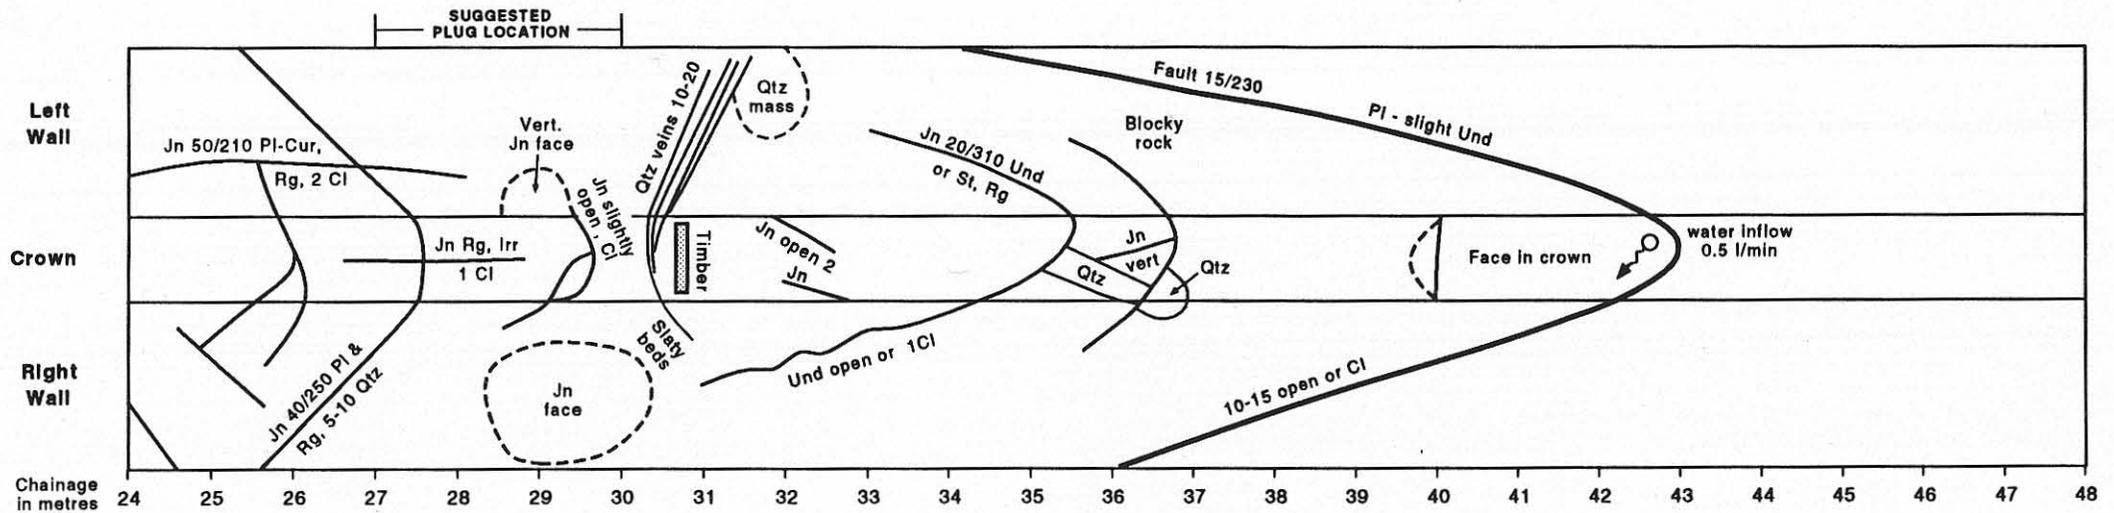
Jn	Joint (measurements in mm)		
50/210	Dip & direction of discontinuity		
Pl	Planar	CI	Low plasticity clay
Und	Undulating	Qtz	Quartz
Cur	Curved		
St	Stepped		
Irr	Irregular		
Rg	Rough		
			Water inflow
