**Merrywood Coal Mine**

**Rehabilitation Project Stage 1**

**2001-2002**

**Version 2**  
**Dated 9/1/2002**  
**Nigel Bedford CPEng**  
**Civil Engineering Consultancy**

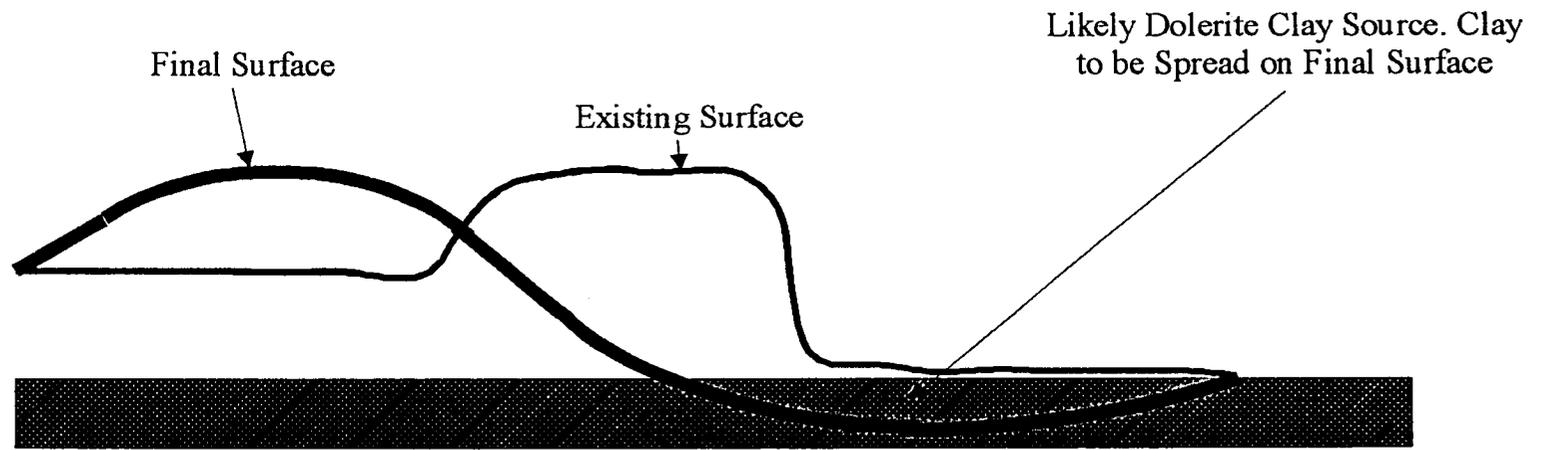
Typical Treatment Area 6 (Fine Coal Washery Waste)

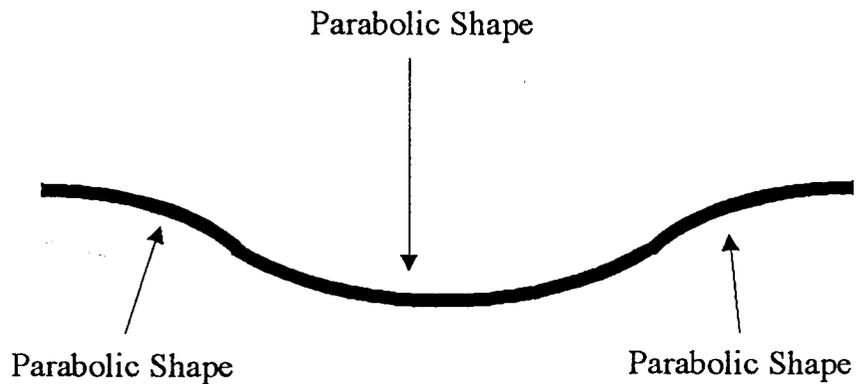
Drg.MCM 1 (NTS)

Typical Drain Cross-Section

Drain & Area 6 Cross-Sections

The major cause of poor regeneration on previously untreated areas, apart from the poor nutrient values, is rainfall run off management. To this end, this plan will detail typical drainage structures, drain cross-section, maximum open drain slope, energy dissipaters and other earthworks to retard the velocity of runoff so that revegetation is given the best chance to succeed. The secondary cause is the direction of the ripping. Previously the operator rehabilitated by ripping across the contours rather than with the contour. The main areas for treatment will be ripped on the contour to slow runoff, decompact soils, allow trapping of nutrients in areas they are required (applied), and present the optimal texture growth medium for seed germination.

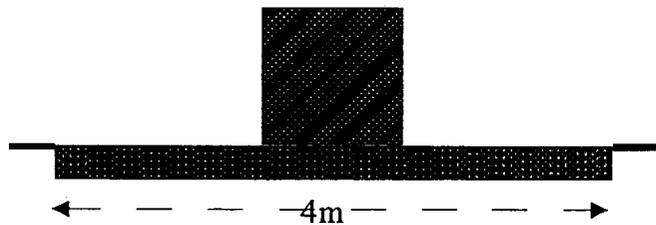
Merrywood Coal Mine Rehabilitation  
Project 2001-2002  
Energy Dissipator Structure Drg. MCM 2  
 (NTS)

Side Elevation

Plan

1. Standard Gabions and mattress dimensions are 2x1x1 and 4x2x0.25 respectively.
2. Gabion fill to either paddock rock to the manufacturers req'ts or erodable fill wrapped in geofabric bags (Bidim A34 or equiv) sewn closed.
3. Mattress to be shaped to suit drain profile and finished flush with invert. Gabion to be attached to mattress with tie wire.
4. All installation to as per manufacturers' requirements.

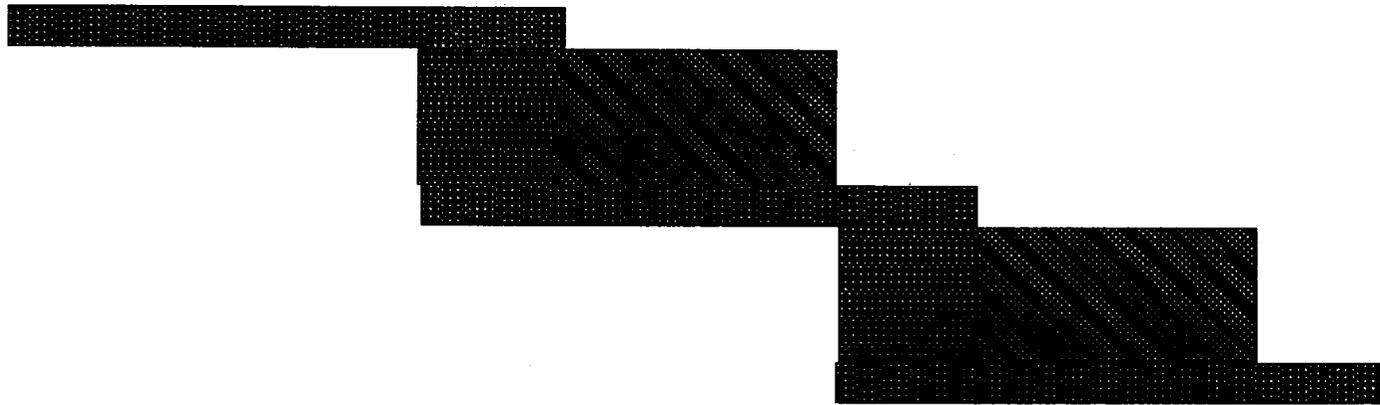
Elevation From Side

Elevation From Downstream

1. Standard Gabions and mattress dimensions are 2x1x1 and 4x2x0.25 respectively.
2. Gabion fill to be either paddock rock to the manufacturers req'ts or erodable fill wrapped in geofabric bags (Bidim A34 or equiv) sewn closed.
3. Drop structure surrounds to be shaped to suit.
4. All installation as per manufacturers' requirements.

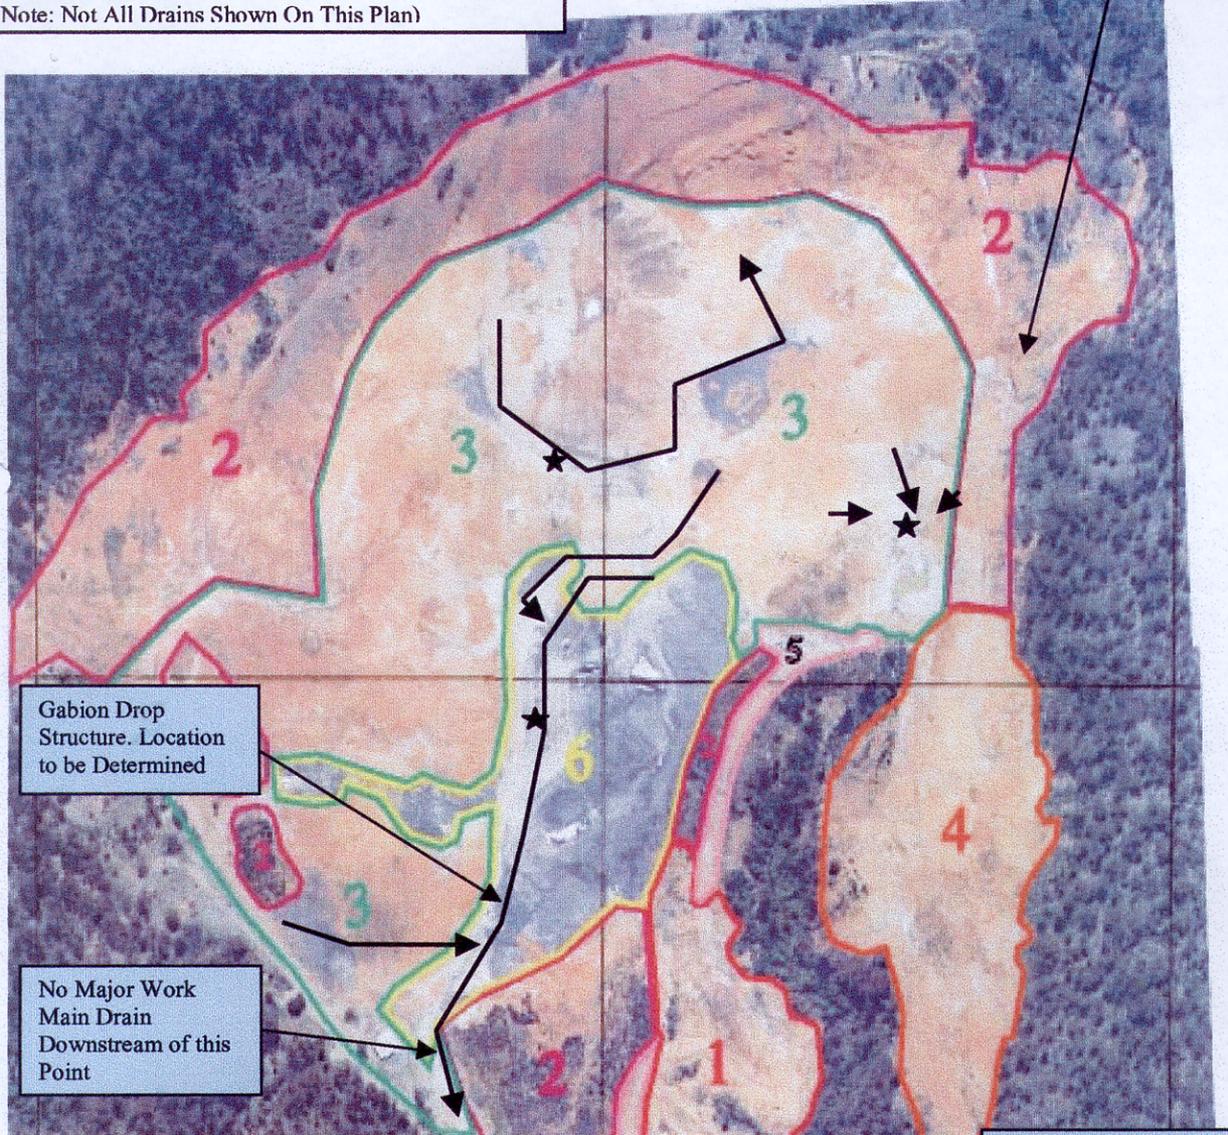
Drainage improvement at Sup't Direction . Allow 16 hrs Exc. Hire In This Area

- 1 Landslip
- 2 Revegetated Areas
- 3 Main Central Section
- 4 Eastern Section Across Creek
- 5 Compacted Roads
- 6 Coal Wash Fines
- 7 Wash Down Facility

Maintain Existing Sub Surface and Open Drainage Thru Plant Area
