TR16-138-147

26. A reconnaissance geological survey of the route of the Bell Bay railway.

PART 1. LADY NELSON CREEK TO NEAR BELL BAY

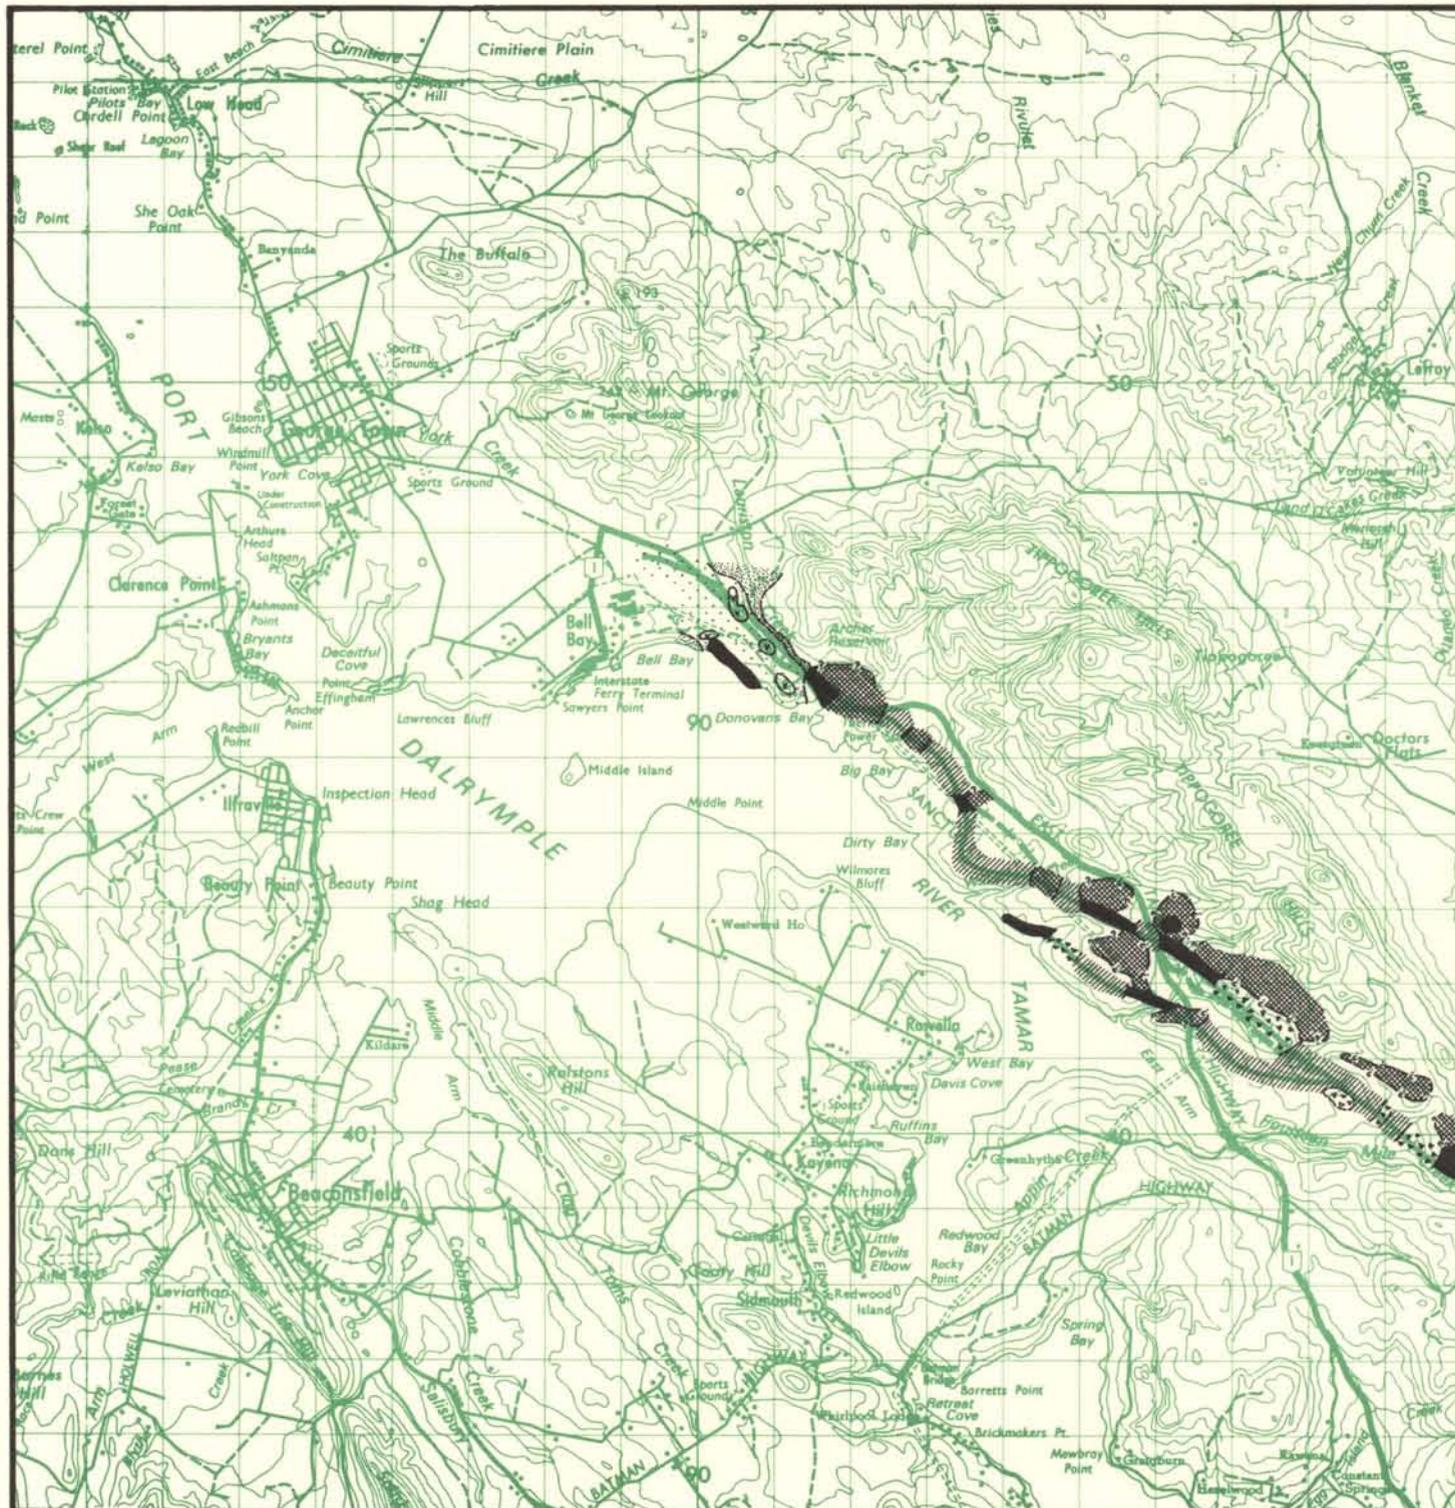
GEOLOGY ALONG BELL BAY RAIL ROUTE NORTH SHEET

At the request of the General Manager of the Tasmanian Government Railways, a reconnaissance geological survey was made of the route of the Bell Bay railway from its junction with the North East Line at Lady Nelson Creek to the point where the route crosses the East Tamar Highway 4 km south of George Town (figs. 43, 44).

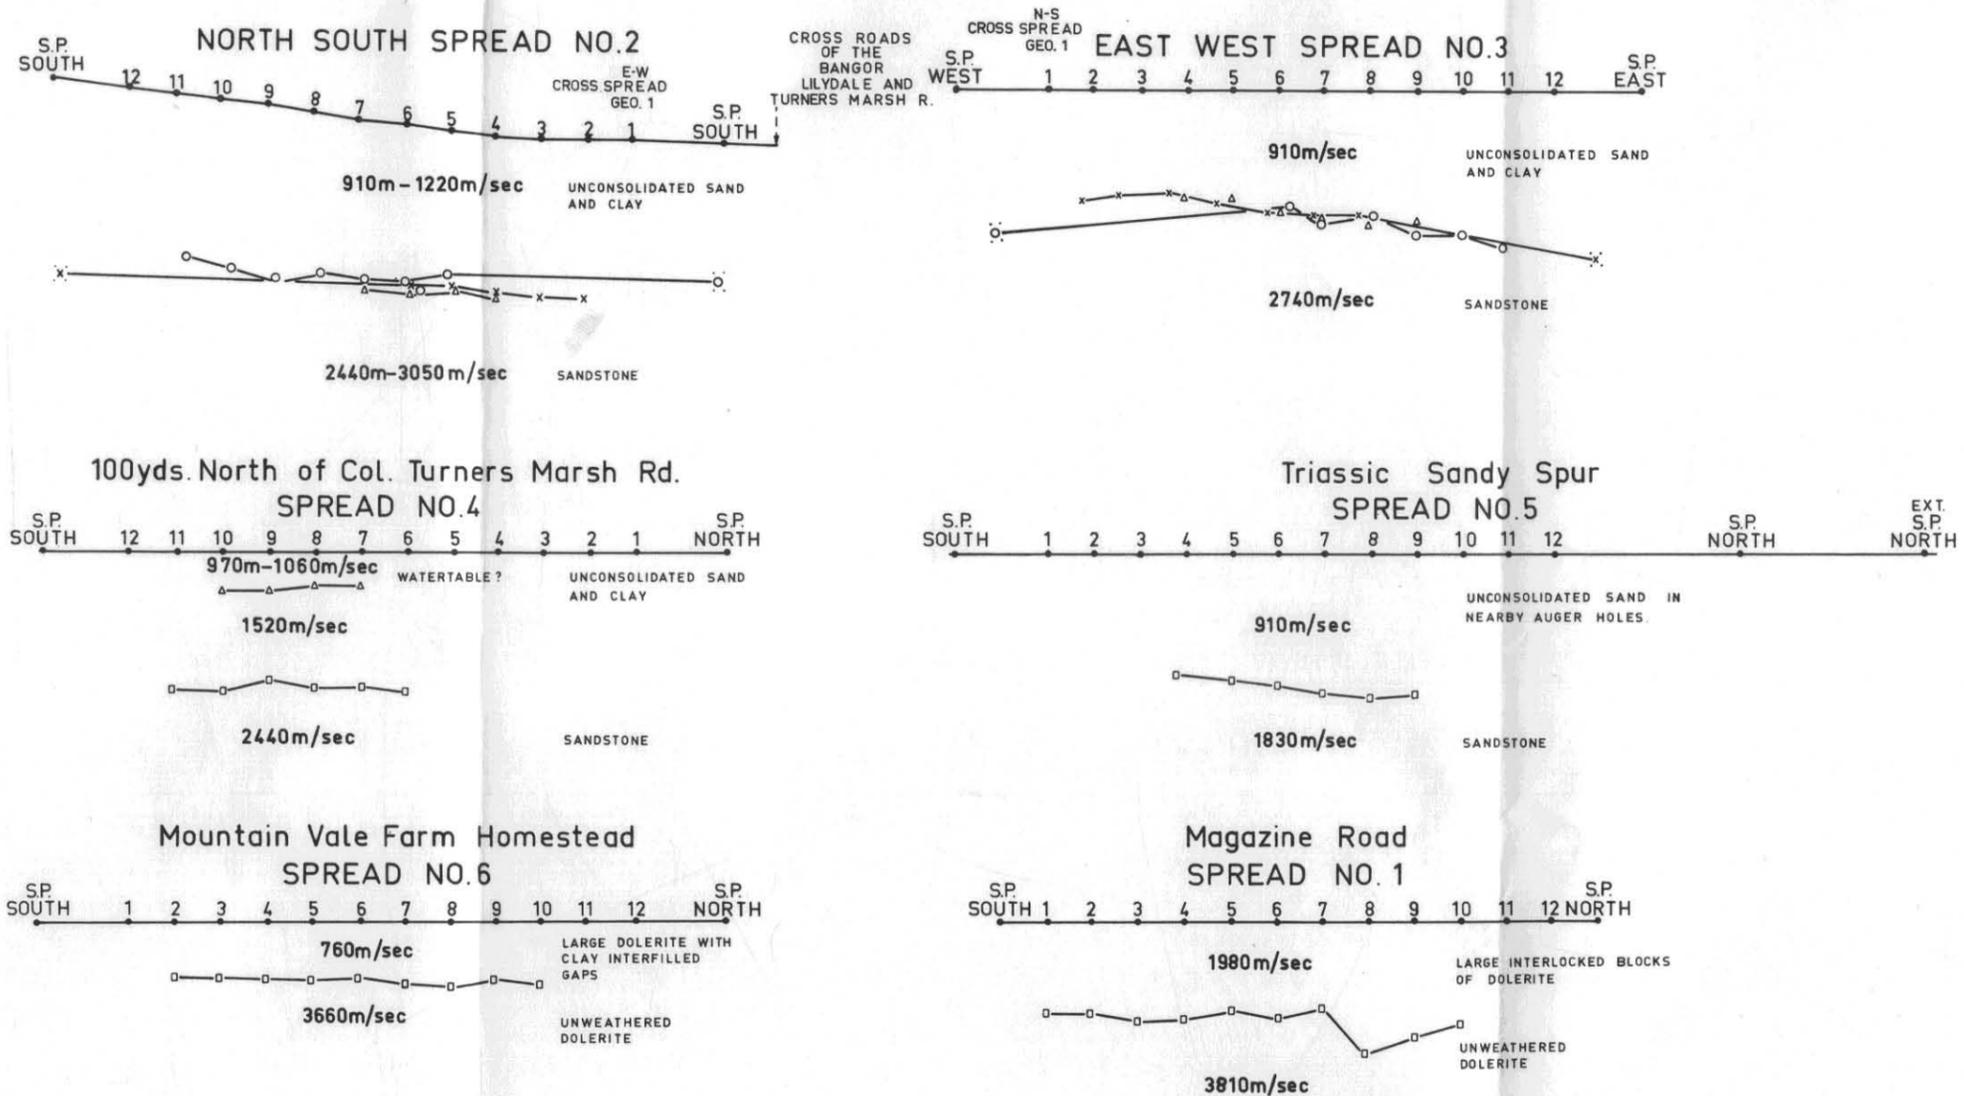
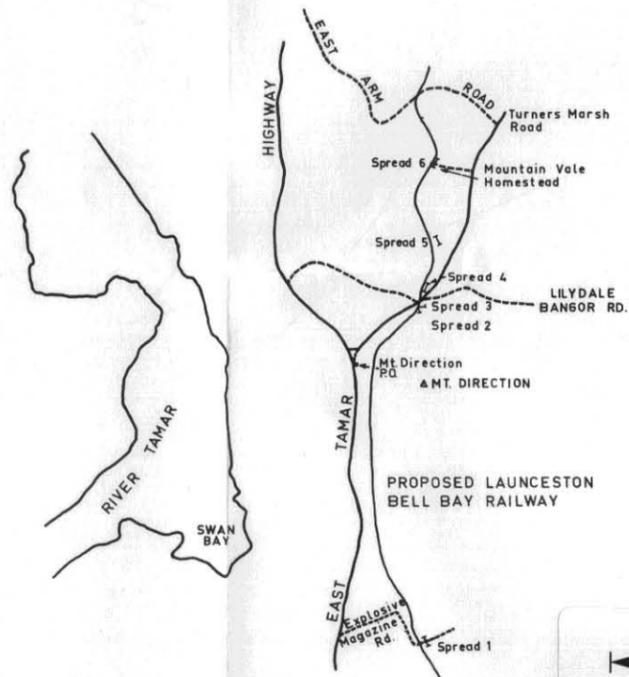
TURNERS MARSH - MOUNT DIRECTION COL.

- 1 2 GEOPHONE POSITION & NUMBER
- S.P. SHOT POINT POSITION
- INTERFACE CALCULATED
- x—x BY TIME DELAY METHOD
- ⊗ ⊗ CALCULATED DEPTH OF SHOT POINT
- INTERFACE CALCULATED BY
- △—△ TIME DEPTH METHOD

RECONNAISSANCE SEISMIC SURVEY
 SOUTHERN SECTION
 BELL-BAY RAILWAY LINE

The depth of the auger holes near Spread 5 is unknown but no consolidated rock appears to have been encountered. The spoil heaps from the eight holes found at this locality were composed of unconsolidated, fine sand with a small but variable percentage of clay and would represent the upper seismic velocity layer. The fine iron-stained yellow sand is derived from the weathering of Triassic sandstone. Much of the sand appears to be windblown but the calculated thickness of 20-24 m for this material appears far too great for this type of sand to have weathered *in situ* from sandstone bedrock. More likely this windblown accumulation is underlain by very deeply weathered and decomposed clay and sand of probable Tertiary age overlying sandstone of Triassic age. This sandstone is thought to represent the second (1,830 m/s) seismic velocity layer.

Elsewhere the seismic velocity of both the Tertiary and Triassic sediments was found to be very variable especially where the Tertiary sediments are derived from Triassic sediments. Tertiary sands are known to have seismic velocities varying from 610-1,525 m/s and it is known that the seismic velocity of unconsolidated sands can increase from 760-915 m/s to 1,370-1,525 m/s below the water table. Seismic velocities in Triassic sandstone are known to vary from 2,440-3,660 m/s. It appears likely that the unconsolidated sands from the auger holes occur below the surface at the Mount Direction col. They form the thick 915-1,220 m/s surface layer in Spreads 2 and 3 and the two upper seismic layers in Spread 4 on the northern side of the col. The 2,440-3,050 m/s layer occurring below the surface layer is thought to be Triassic sandstone.
