29. Drainage problems at Prospect, Launceston.

P.C. Stevenson

The Westbury Council sought advice on problems of drainage and ground-water seepage in an area adjacent to the Westville Estate, Prospect, which was subject of previous reports by Messrs Scott & Furphy, Consulting Engineers.

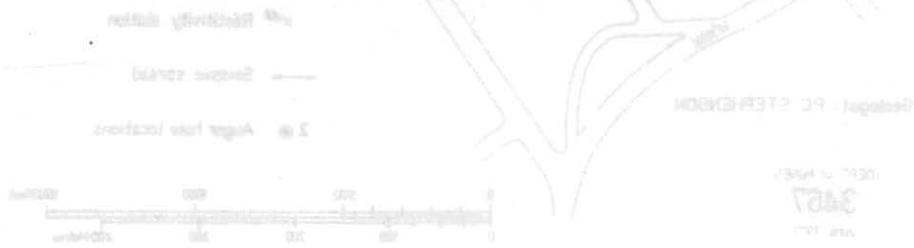
Figure 48. Location of geological work and watering, Westville Estate, Prospect Vale.

Backhoe trial pits were recommended as a quick and cheap means of showing subsurface conditions, three of these were put down under the supervision of the engineers, and samples and photographs of the pits forwarded to the Department.
