1976/50. The effect of a water bore on a nearby dam at Hagley.

W.L. Matthews

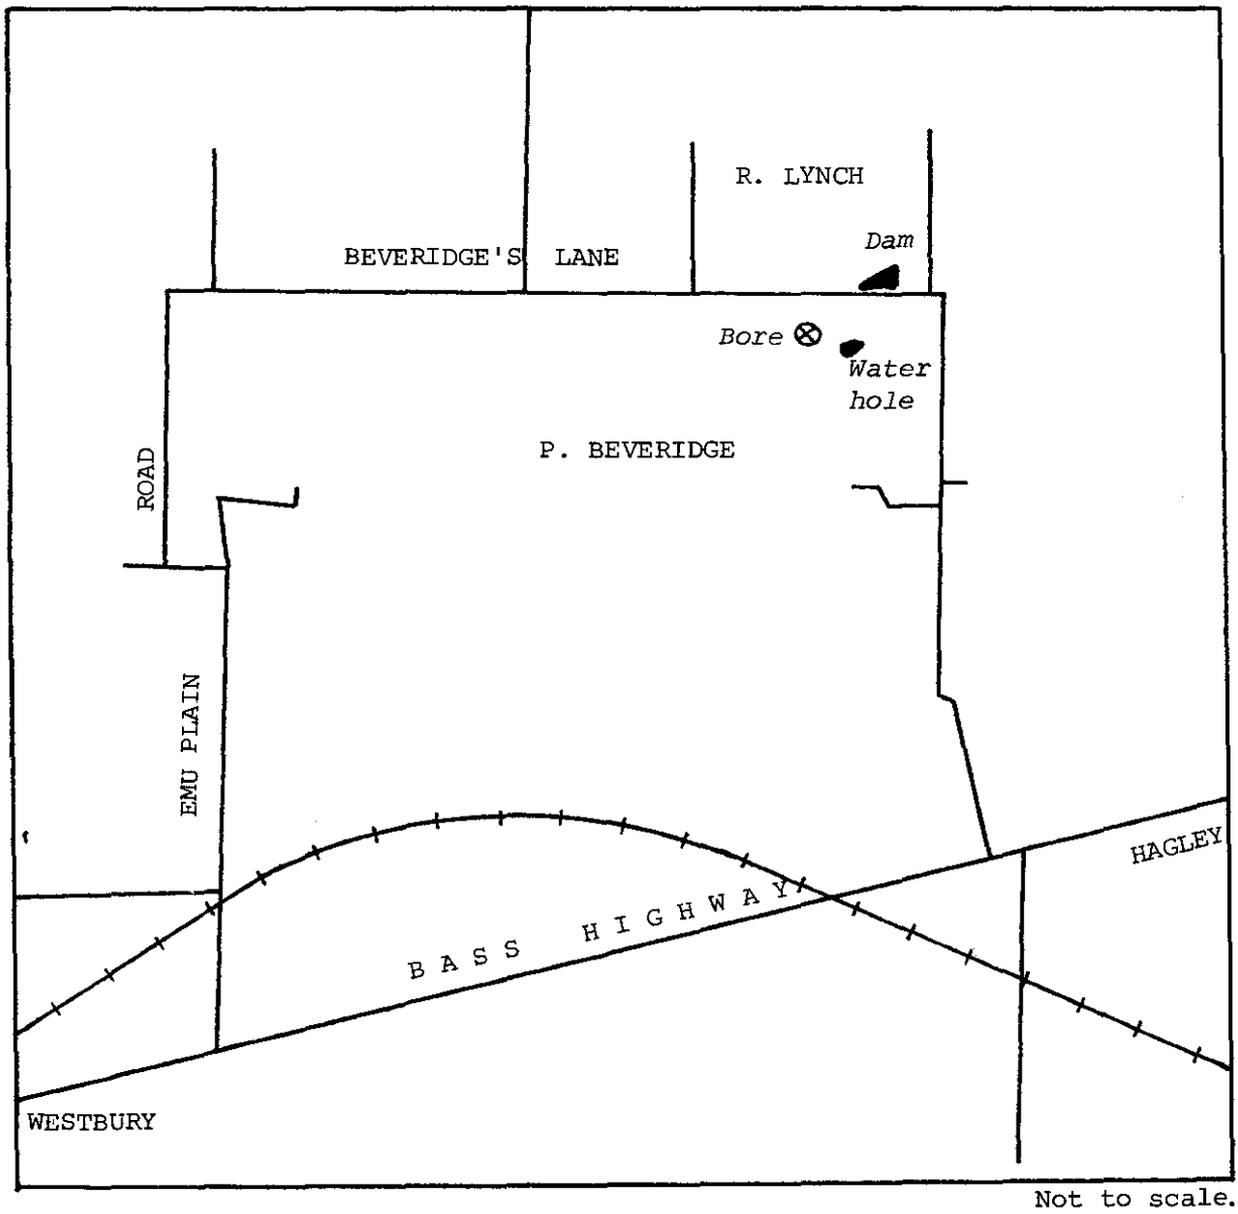
Figure 1. Location of dams and bore hole, Hagley area.

The Rivers and Water Supply Commission requested advice on whether a bore, used for irrigation, was affecting the water level of a dam on a neighbouring property. The bore is situated on the property of P. Beveridge, located approximately 2 km north-west of Hagley (fig. 1). The dam, on the property of R. Lynch, is approximately 100 m north-east of the bore.

The property where the bore is situated has a small water hole about 50 m east of the bore. During pumping, the water level in this hole is drawn down and it seems quite likely that a dam 100 m away could also be affected. There is, however, some difference in the times when water levels are lowered. The small water hole on Beveridge's property is reportedly affected almost immediately after pumping starts, whereas the water level in Lynch's dam is reported to have gone very low some 6 weeks after irrigation from the bore ceased.
