1977/44. Notes on groundwater and dam sites, south-eastern coastal streams area.

D.J. Sloane

The following notes have been compiled at the request of the Rivers and Water Supply Commission.

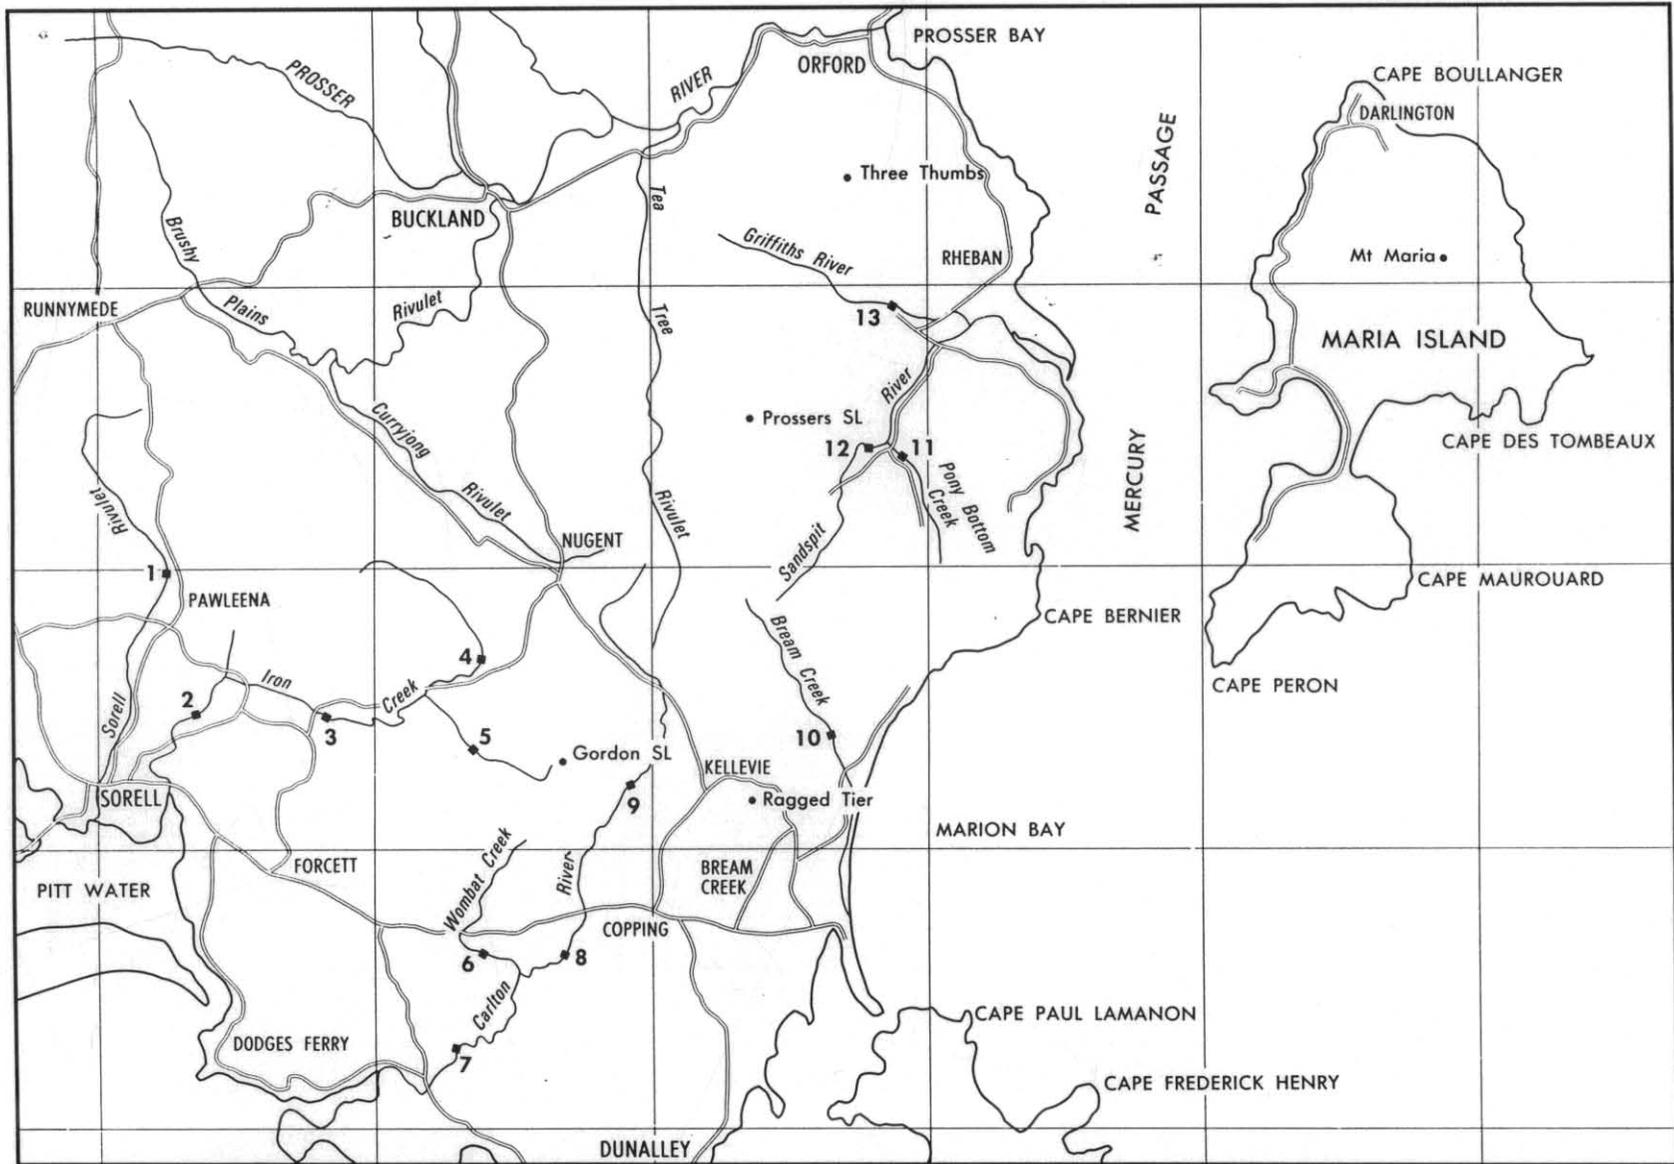
Figure 1. Location of proposed dam sites.

These comments are based on a brief geological field examination of the proposed dam sites (fig. 1).
