# Foundation investigation at the proposed Civic Square site, Hobart

by R. C. Donaldson

A foundation investigation at the site of a proposed Civic Square, in the area bounded by Argyle, Davey, Elizabeth and Morrison streets in Hobart (527000 mE, 5251900 mN), was undertaken between 1 and 8 December 1986. The investigation involved the drilling of four holes into bedrock in order to ascertain the nature of the subsurface materials beneath the site.

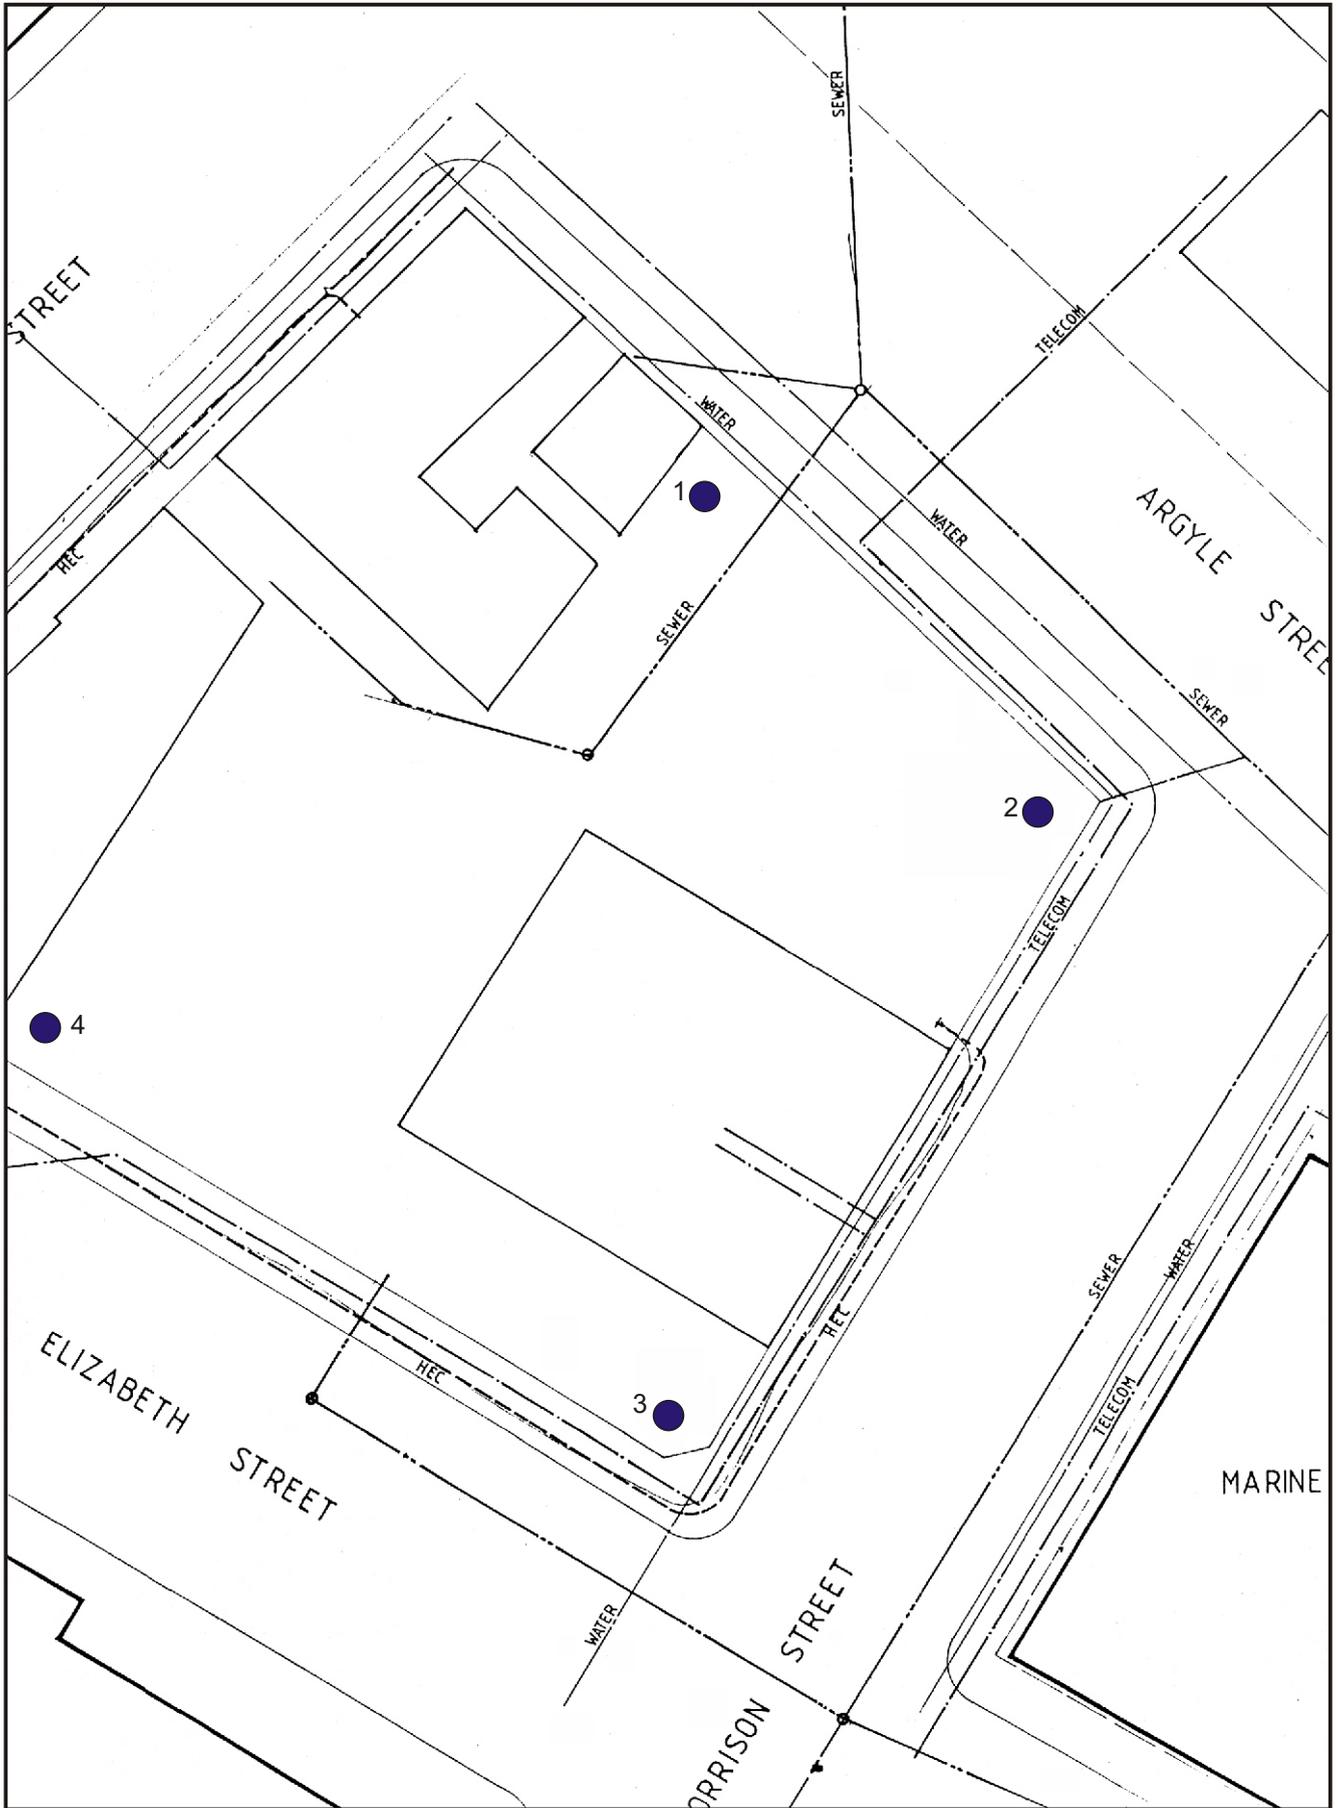
**Figure 1**  
*Location of boreholes*

The work was carried out using a combination of auger and diamond drilling. Detailed descriptions of materials and conditions encountered are given on the appended engineering log forms.
