## MIDDLE ARM PROJECT TASMANIA

### EL6/2012: MIDDLE ARM

SECOND ANNUAL TECHNICAL REPORT

OF EXPLORATION ACTIVITIES

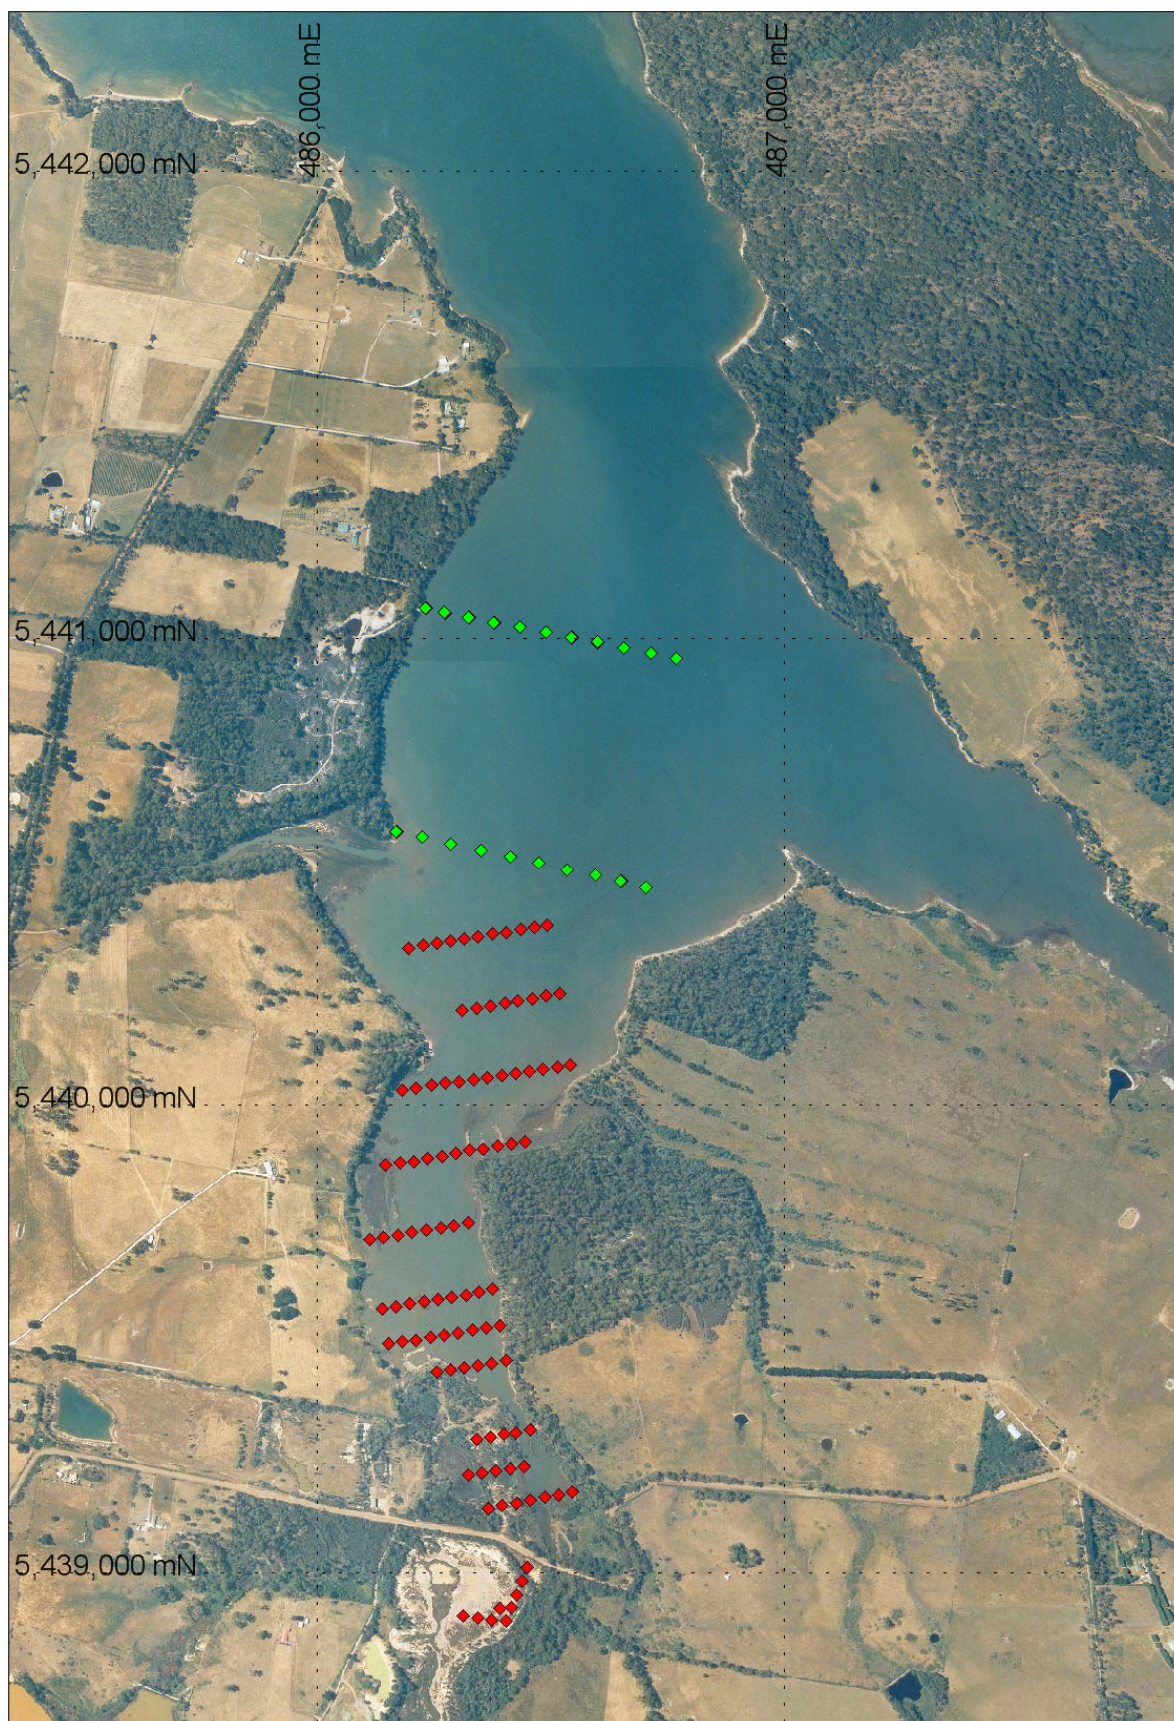
Figure 4 Sludge pump sampling locations. BMI samples in red, K A White samples in green.

The earlier work had indicated that the tailings deposit was generally quite thin (usually less than 2m, often much less) but dispersed over an extensive area (the most northerly gold bearing samples taken by White were more than 2km downstream of the historic battery). Both the BMI sampling and the sampling done by White was done with sludge pumping (hand operated in the case of BMI). The 1975 BMI reserve calculated by Smith suggested an in-situ grade of 3.6g/t Au, but the head grade from Golconda (who operated in effectively the same area that the 1975 reserve related to) was substantially lower (circa 2.0-2.2g/t average). This suggests problems with the sampling method used by BMI (and by extension, White) and the early sampling is therefore considered unreliable in terms of grade. An alternative explanation for the grade discrepancy would be very substantial mining dilution incurred by Golconda, but the degree of dilution required to account for the grade difference is considered unrealistically high. The historic sampling locations are shown in Figure 4. Note that the background to Figure 4 is an aerial photograph taken at or close to high tide. Most of the time, at least part of the area of Middle Arm is exposed subaerially.

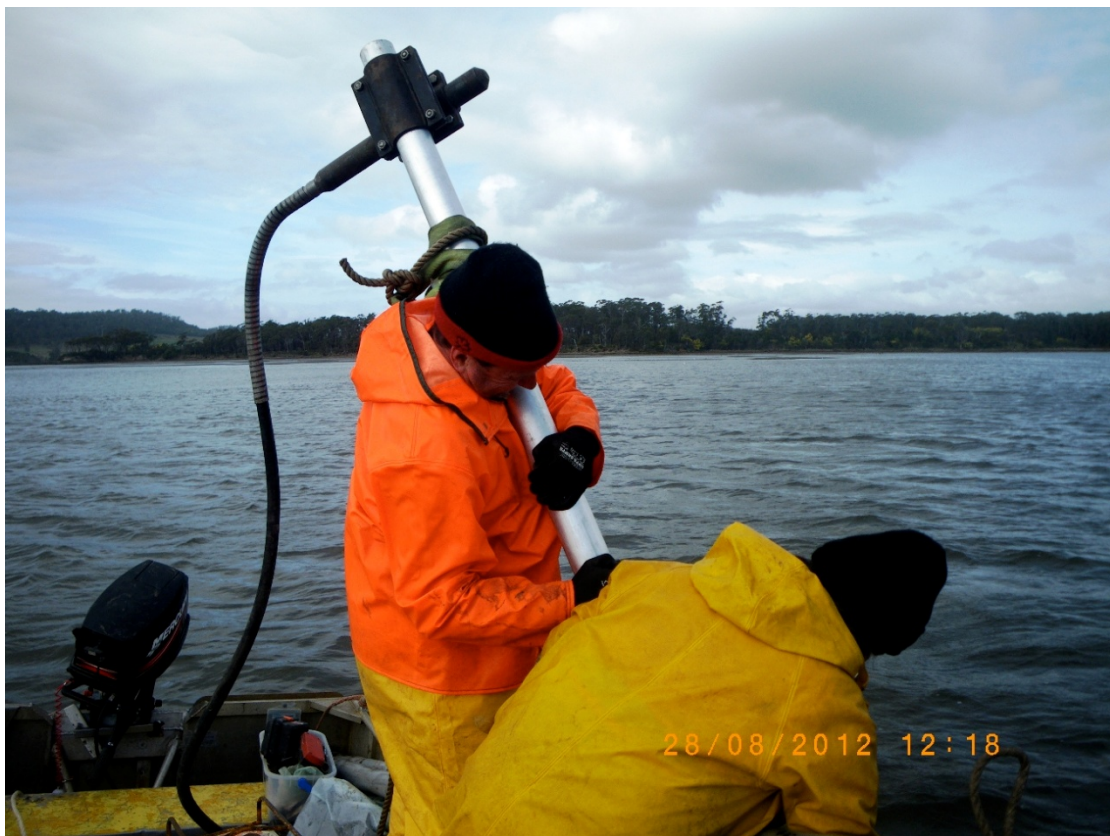
Figure 5 Manually deploying prepared Vibracorer

Planned coring locations were navigated to by handheld GPS (nominal accuracy +/-5m), and then the boat was secured by two anchors and a spud. Once the coring was commenced, the position was reacquired to account for movement during the anchoring process. Minor sediment disturbance occurred during coring and anchor deployment/retrieval. Figures 5 to 8 show aspects of the system in use.

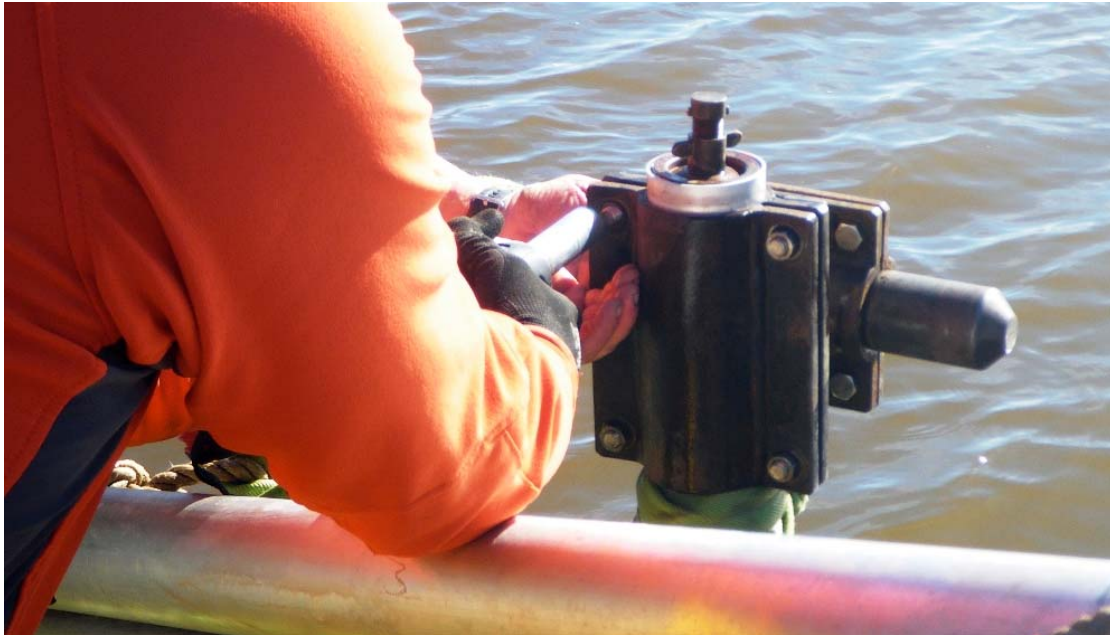
**Figure 6 Detail of clamping system**

The vibrating head (seen in figure 6) was firmly clamped to the barrel using a bracket. The bracket was attached and removed as necessary with a battery operated impact wrench. The vibrating unit is based on a 'Wacker' concrete vibrator.

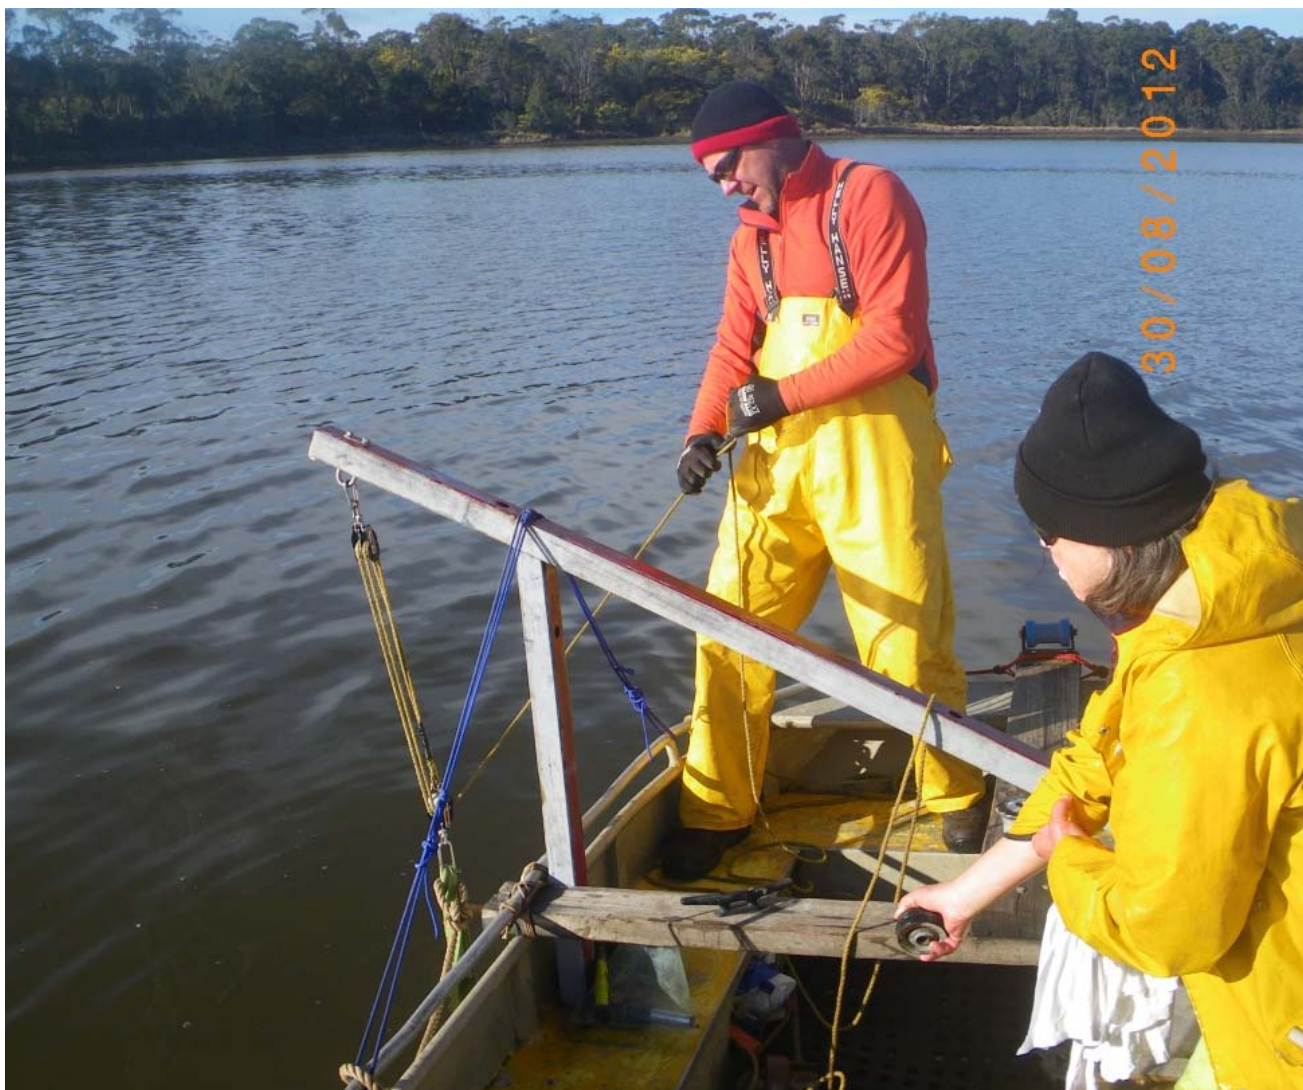
Figure 7 Retrieval of barrel with pulley system

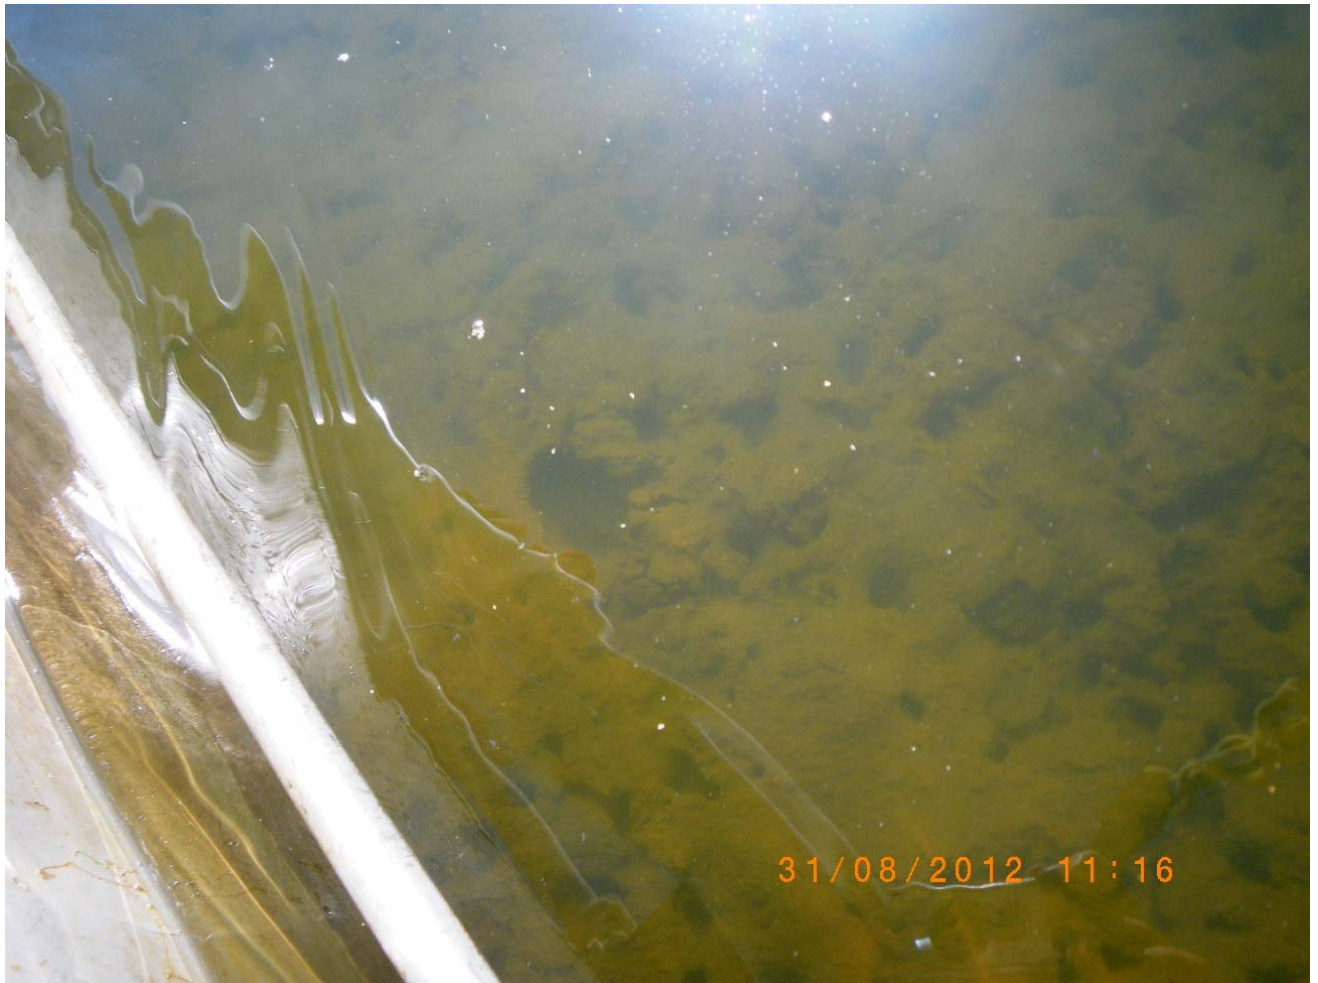
**Figure 8 Hole in sediment after core retrieval ( just left of centre of frame)**

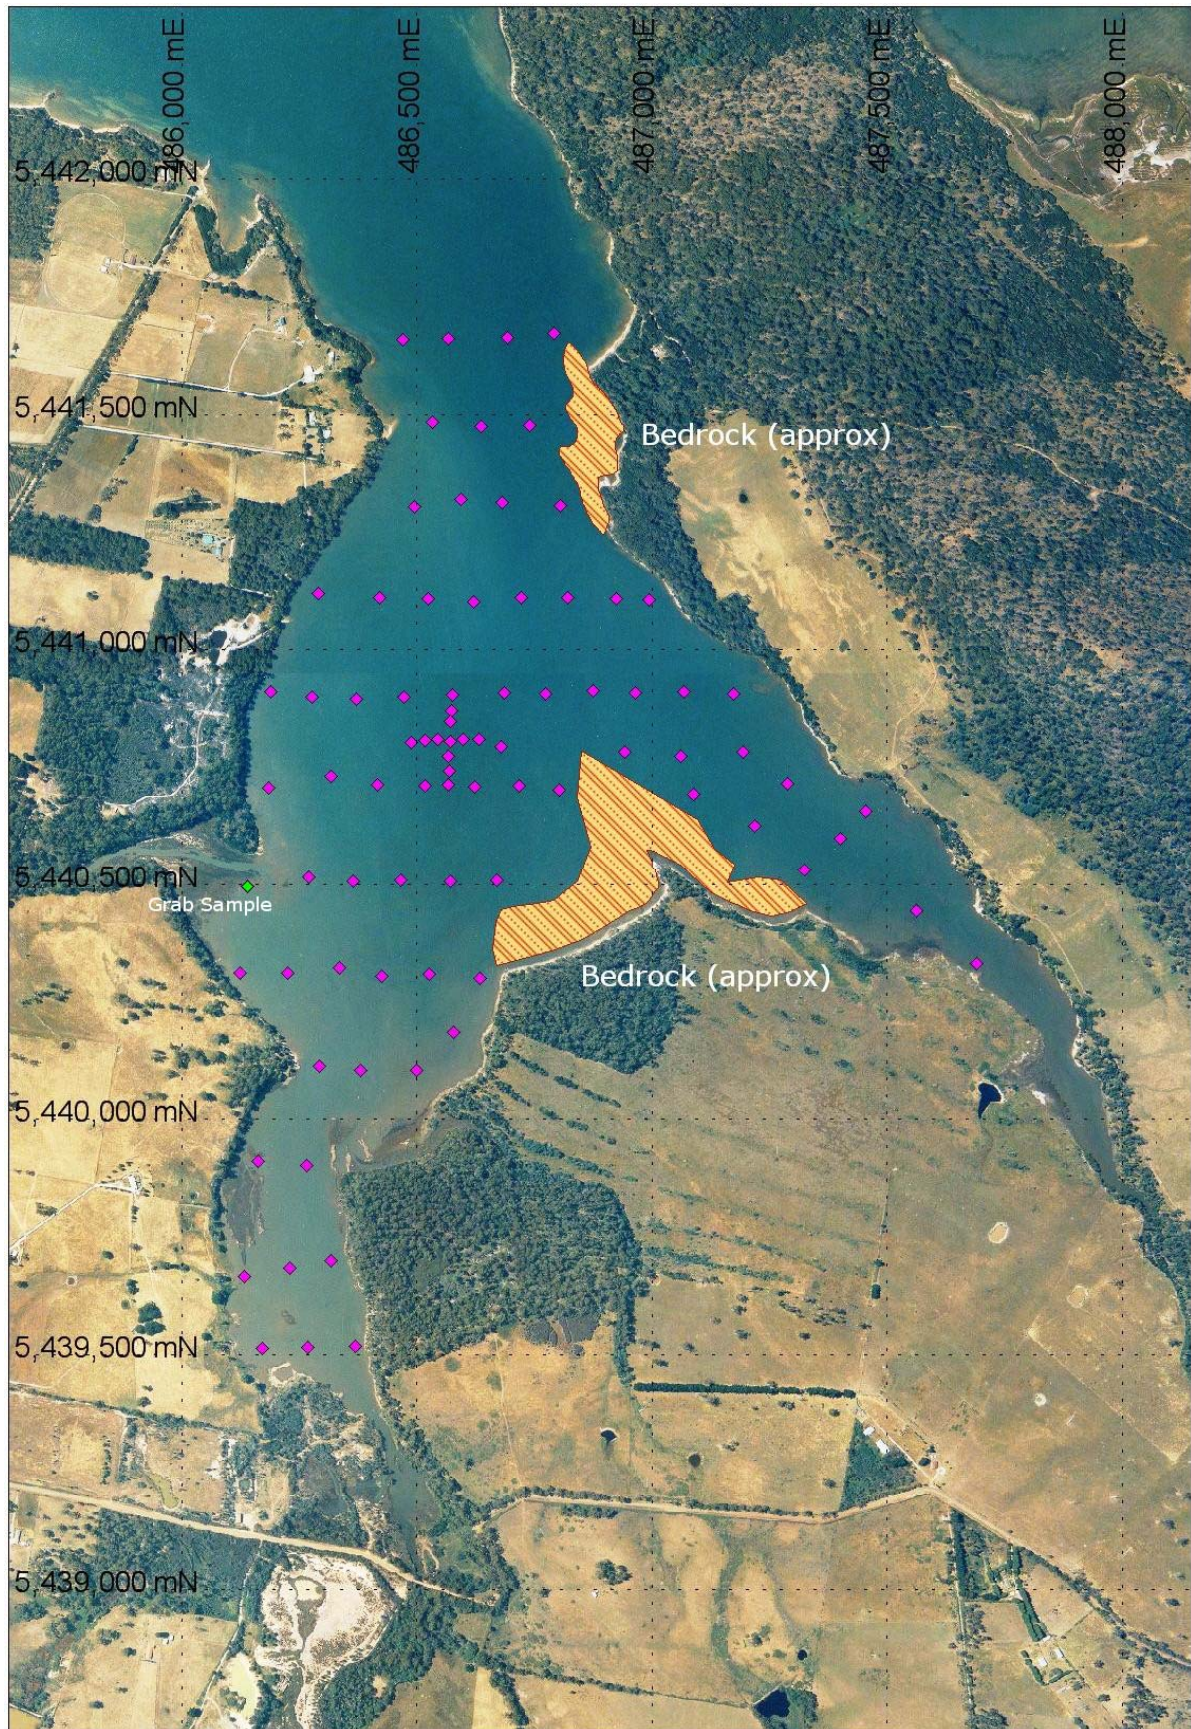
Figure 9 Collar locations for Vibracoring (pink diamonds)

Significant intersections are presented in Appendix 1. Sampling locations are shown in Figure 9.
