MIDDLE ARM PROJECT TASMANIA

EL6/2012: MIDDLE ARM

SECOND ANNUAL TECHNICAL REPORT

8TH AUGUST 2014 TO 7TH AUGUST 2015

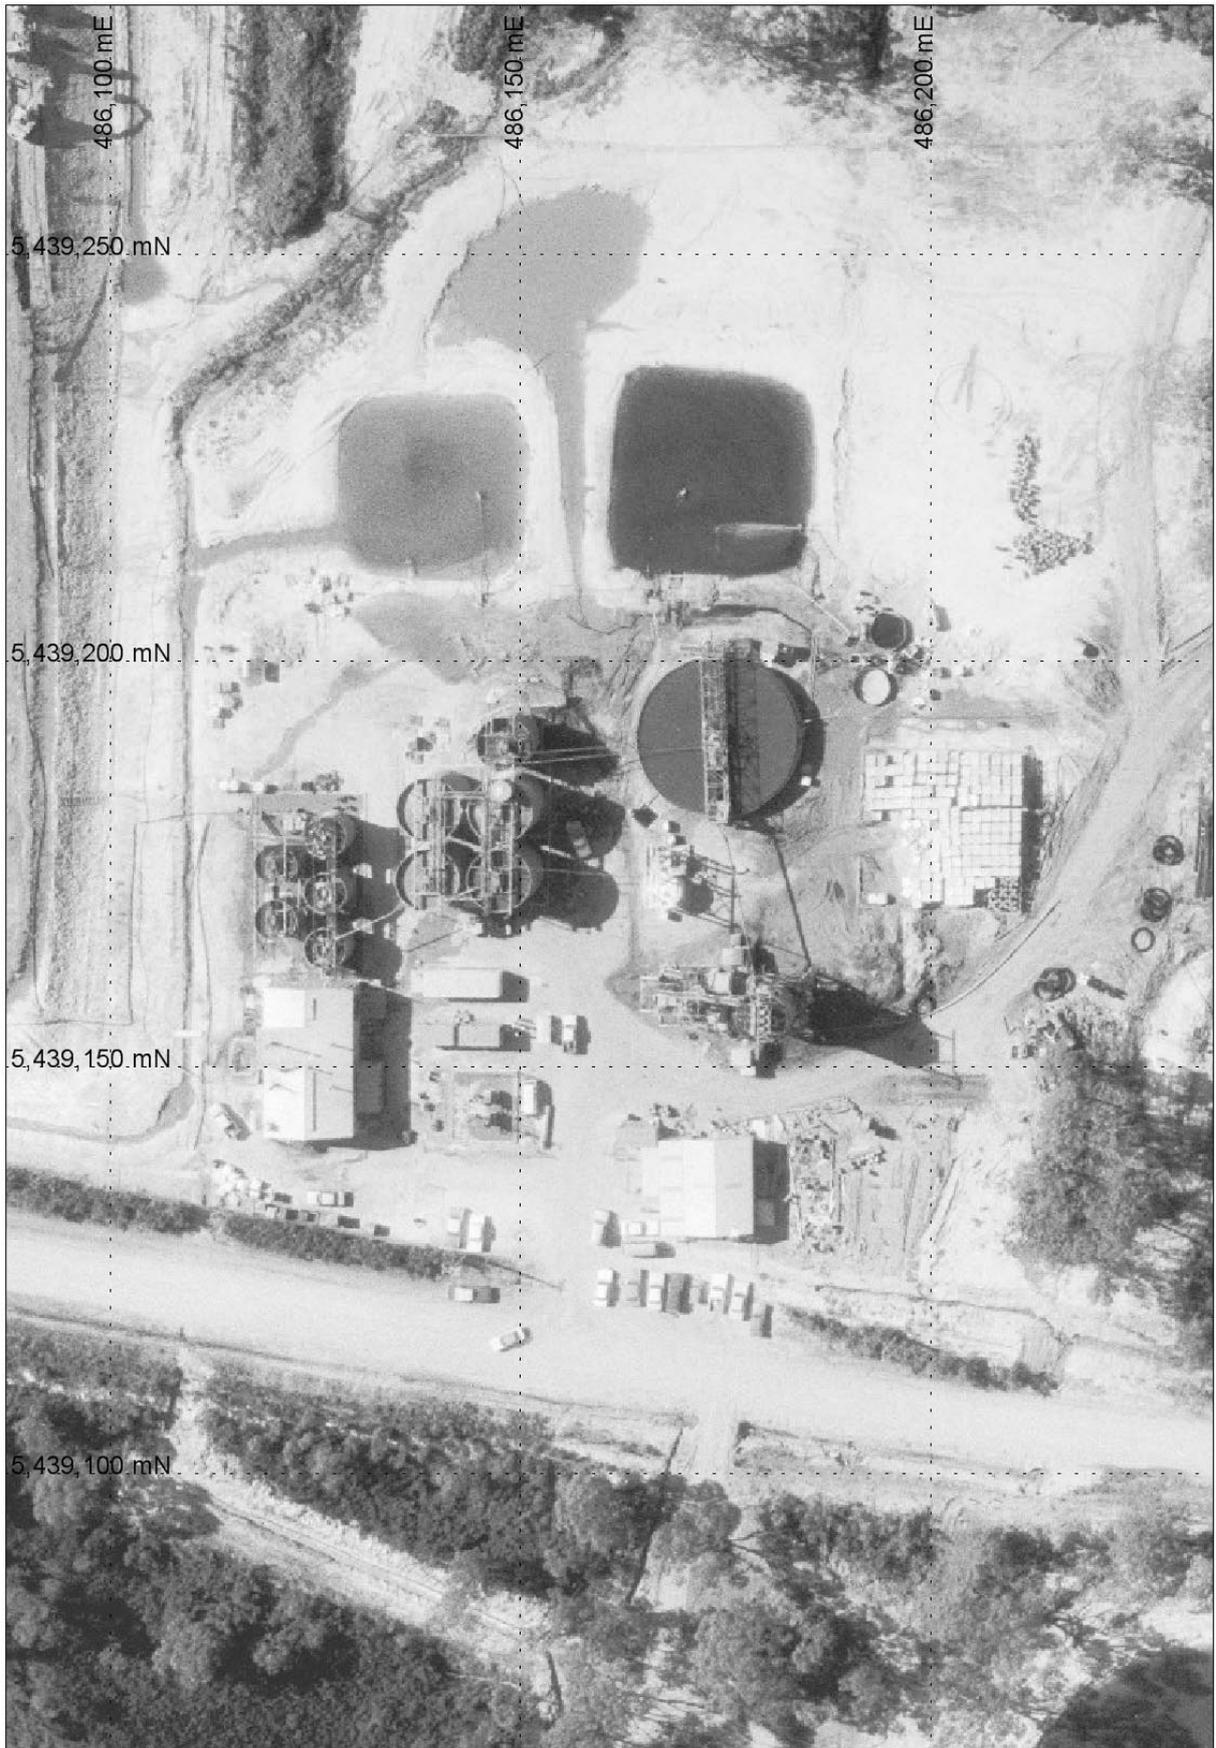
Figure 2 Golconda plant site October 1986.

Figure 2 shows the detail of the Golconda plant site during operations in October 1986. Auburn Road runs across the bottom of the image, and the edge of the eastern wall of tailings dam #1 can be seen at the left hand side. This is part of a much larger image showing much of the area of operations.

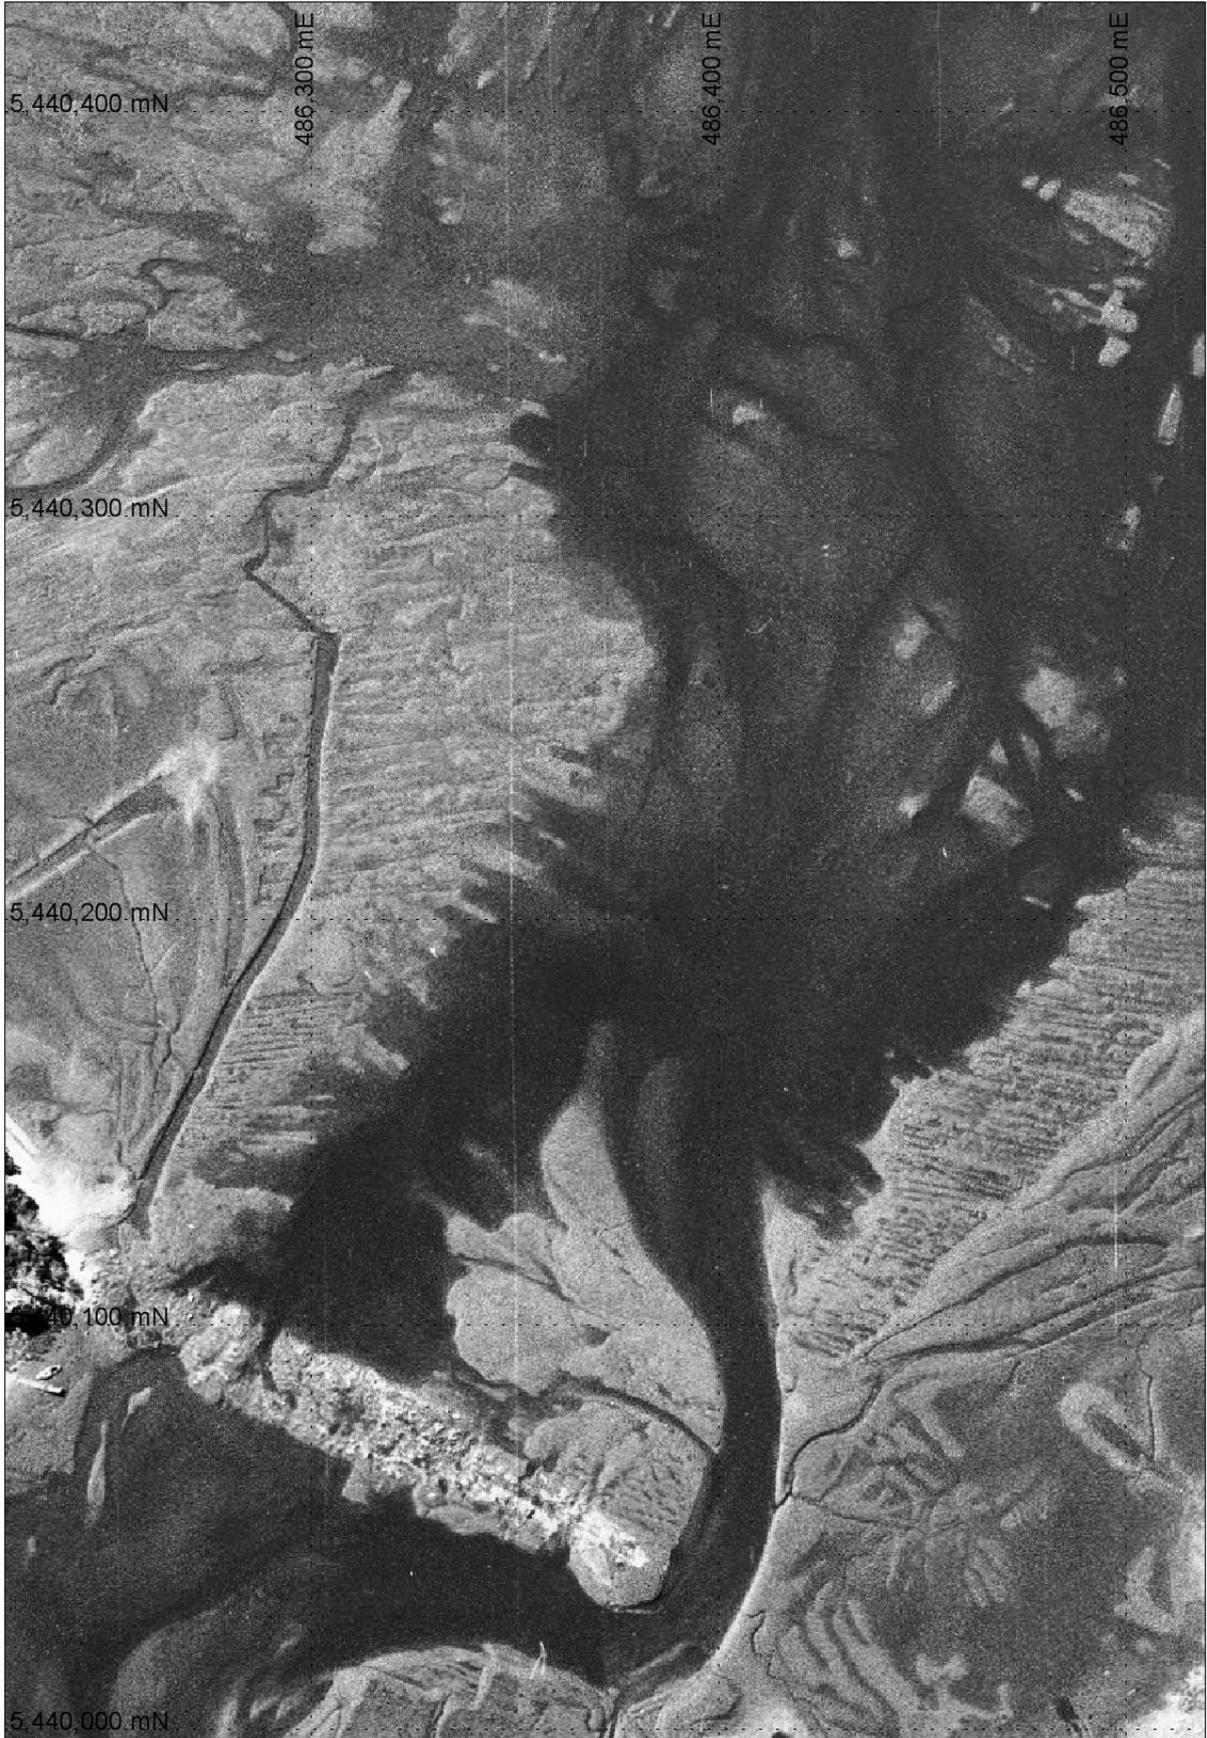
Figure 3 Area around Scotchman's Point, 1989 (post-Golconda)

Figure 3 shows a part of the area worked by Golconda. This photo was taken in 1989, after operations had ceased. This part of the image shows the area immediately north of Scotchman's Point, and the machinery marks in the sediments can clearly be seen.

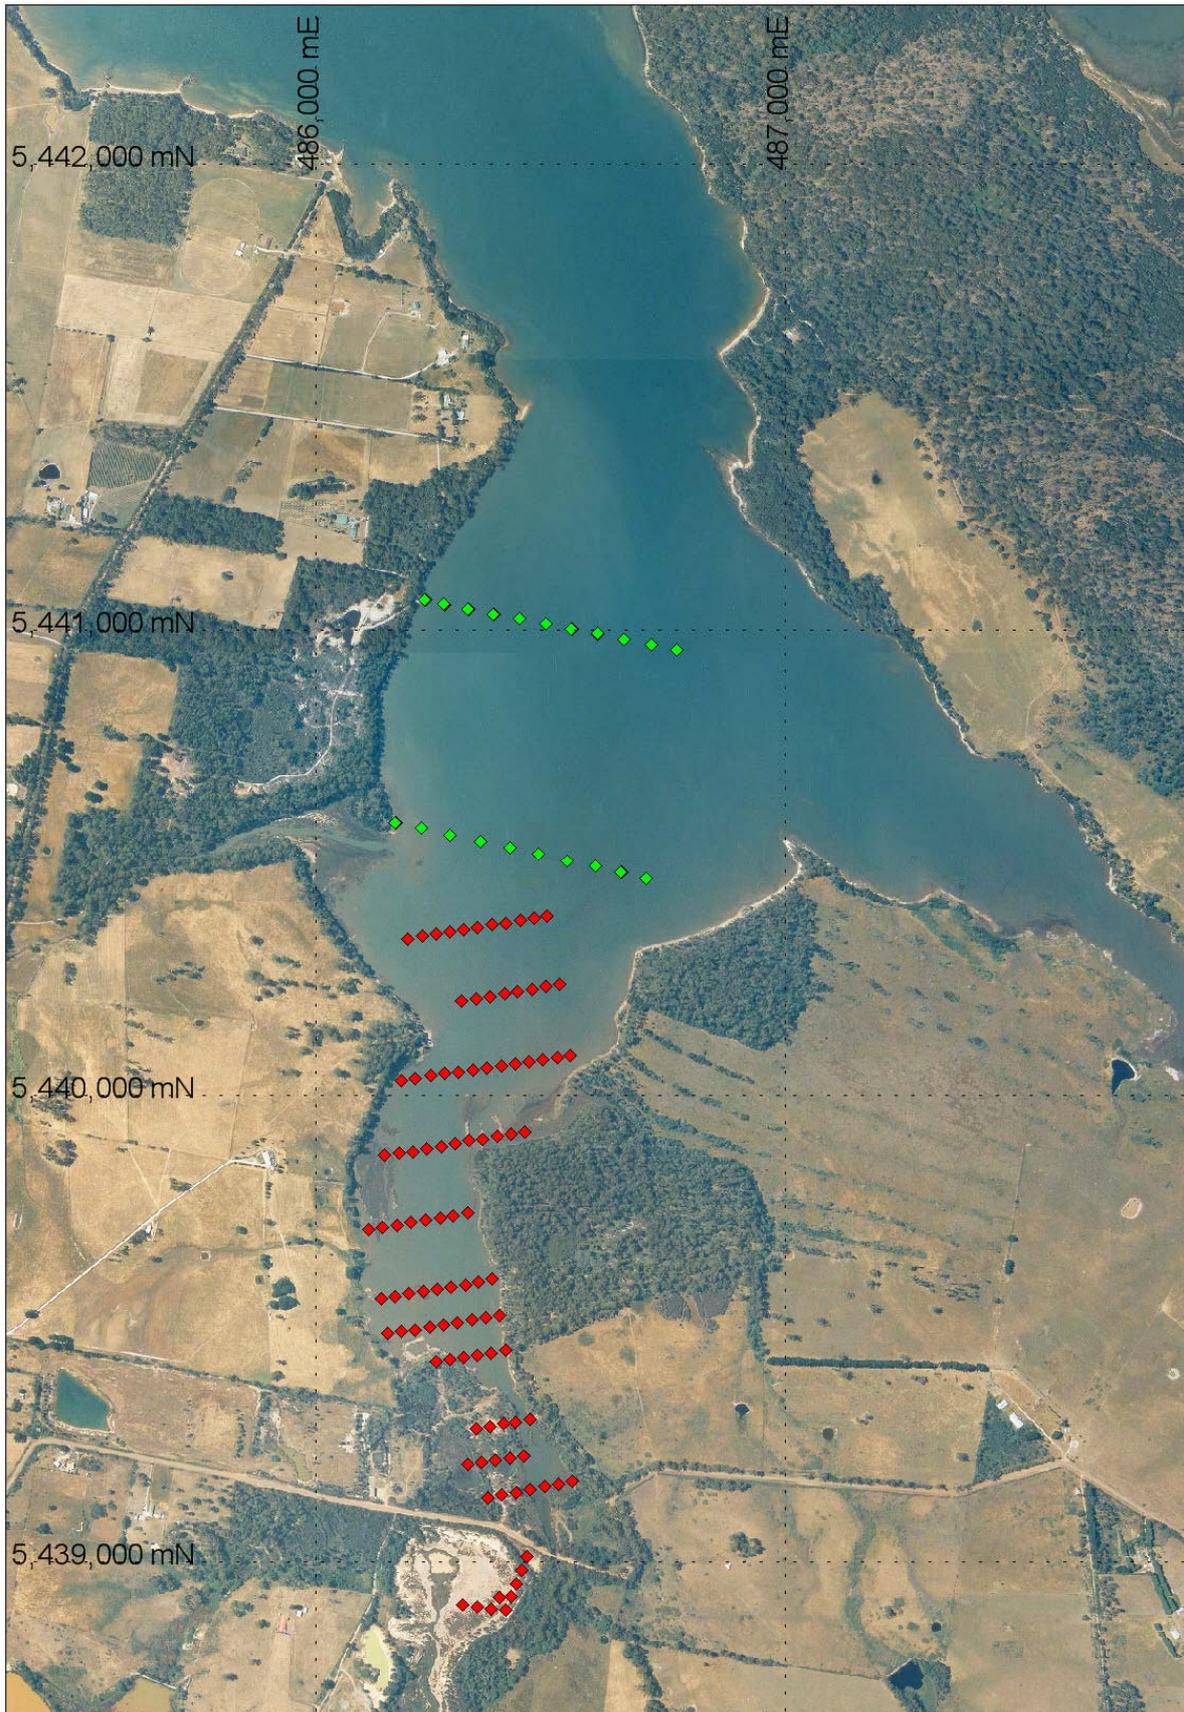
Figure 4 Sludge pump sampling locations. BMI samples in red, K A White samples in green.

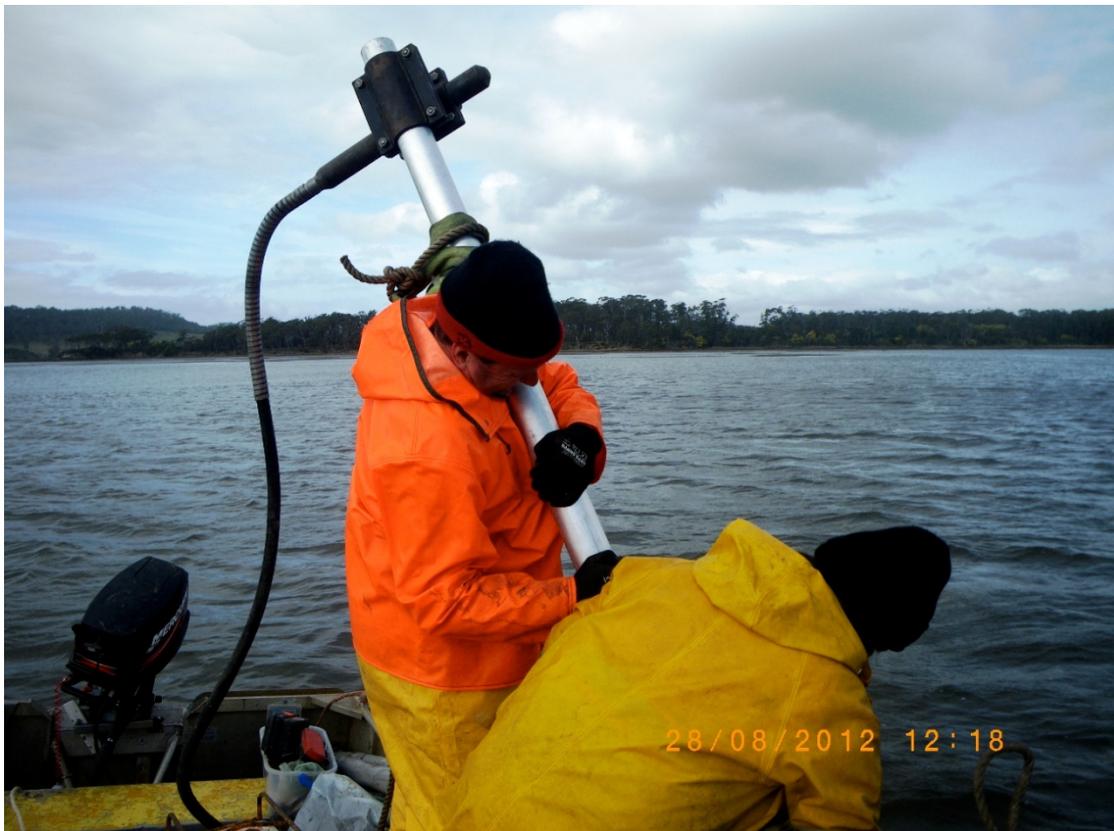
Figure 5 Manually deploying prepared Vibracorer

Planned coring locations were navigated to by handheld GPS (nominal accuracy +/-5m), and then the boat was secured by two anchors and a spud. Once the coring was commenced, the position was reacquired to account for movement during the anchoring process. Minor sediment disturbance occurred during coring and anchor deployment/retrieval. Figures 5 to 8 show aspects of the system in use.

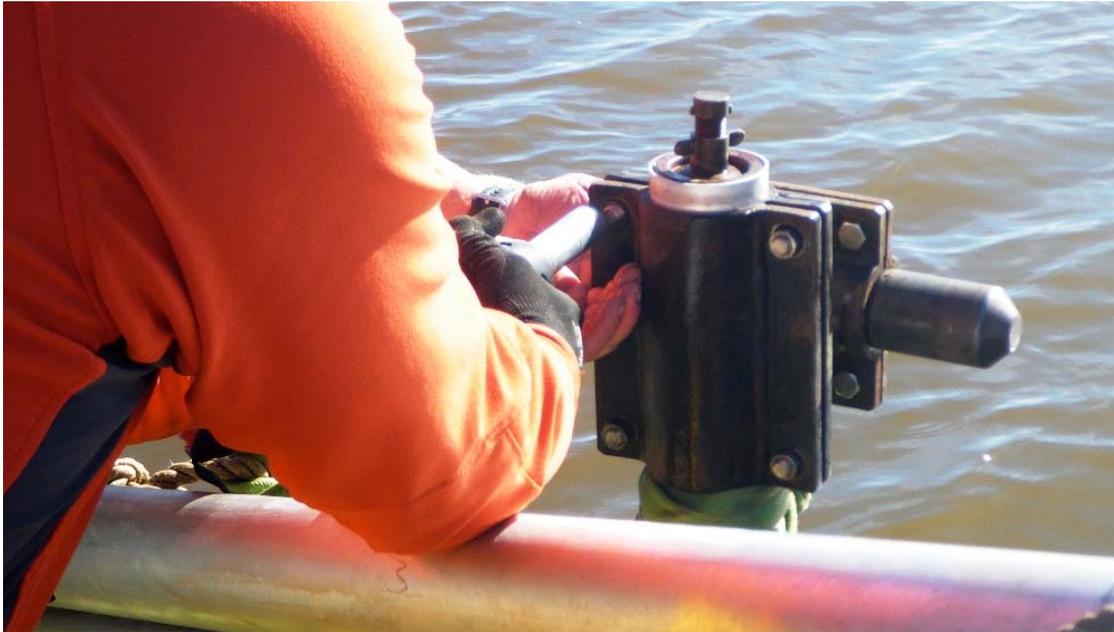
Figure 6 Detail of clamping system

The vibrating head (seen in figure 6) was firmly clamped to the barrel using a bracket. The bracket was attached and removed as necessary with a battery operated impact wrench. The vibrating unit is based on a 'Wacker' concrete vibrator.

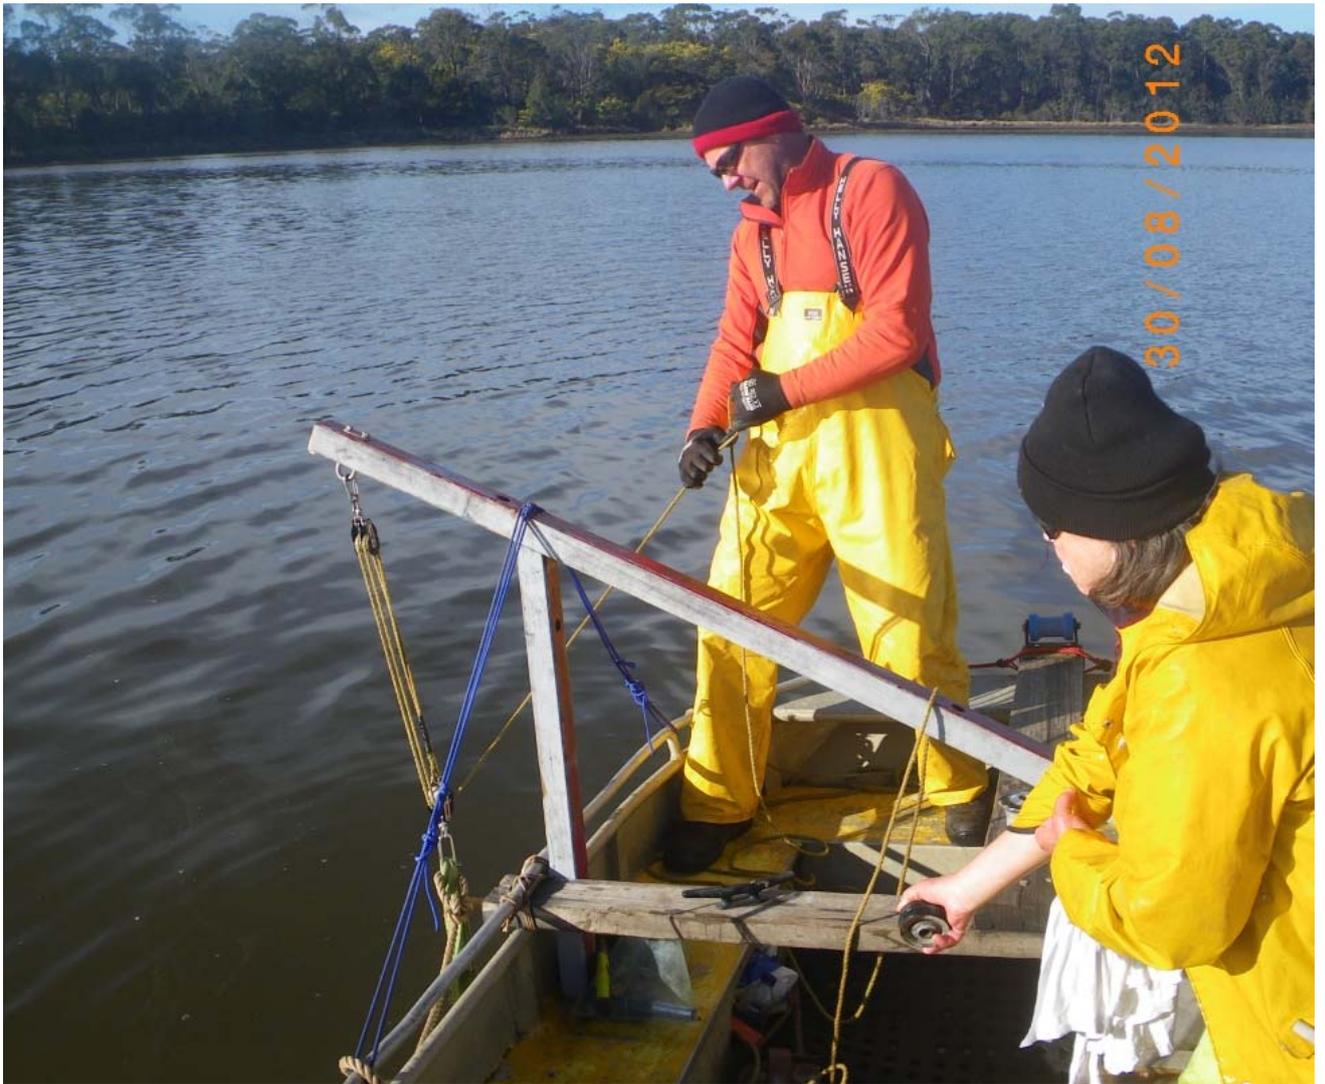
Figure 7 Retrieval of barrel with pulley system

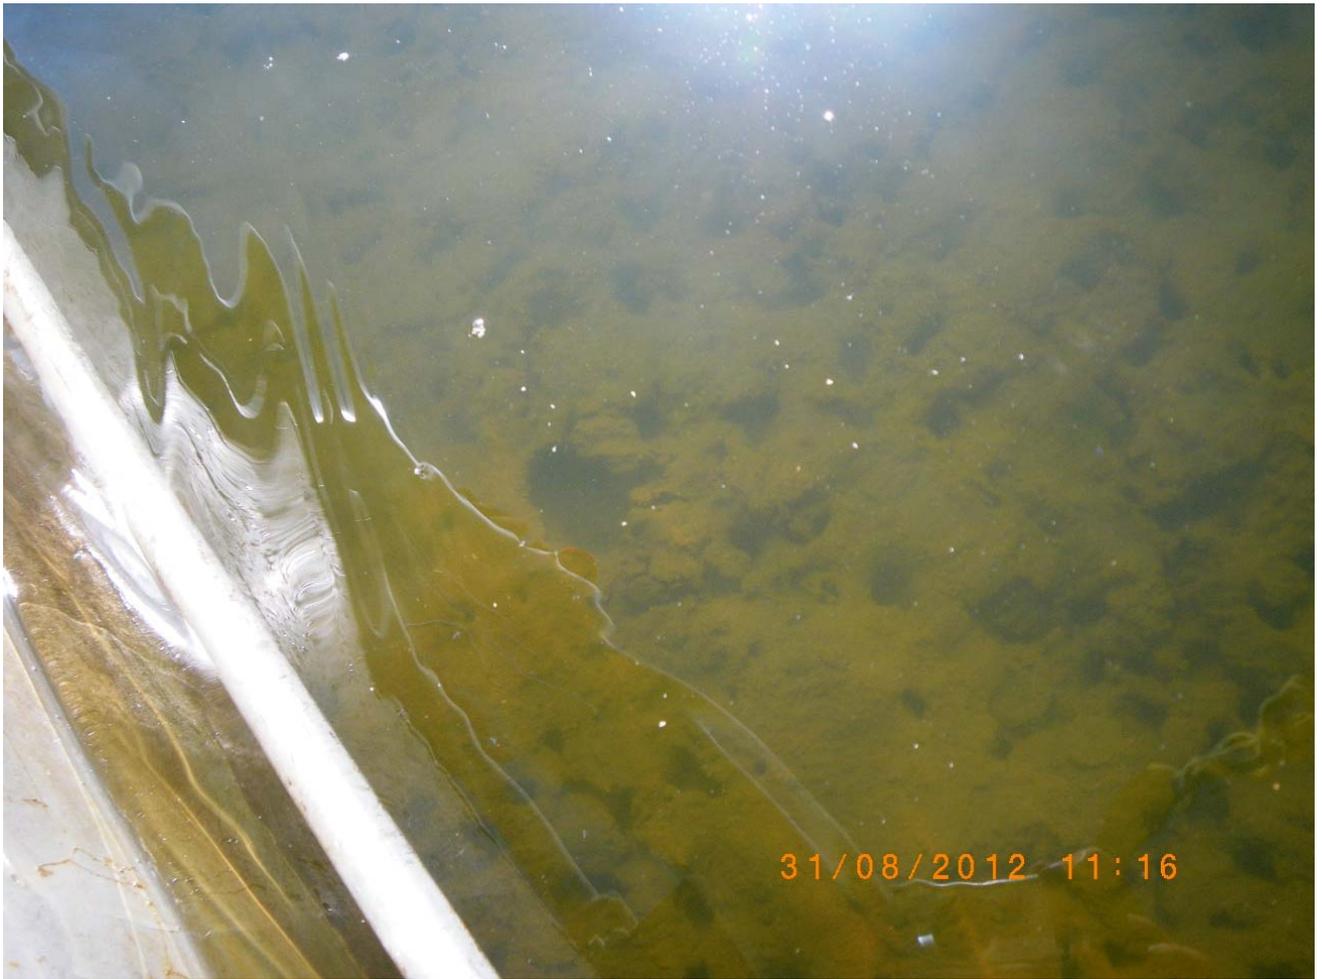
Figure 8 Hole in sediment after core retrieval (just left of centre of frame)
