# THE CORNWALL COAL COMPANY NO LIABILITY

**ANNUAL REPORT:**  
Exploration Licence 50/82 and R/L's 8812-8816

### DUNCAN COLLIERY 1988-89

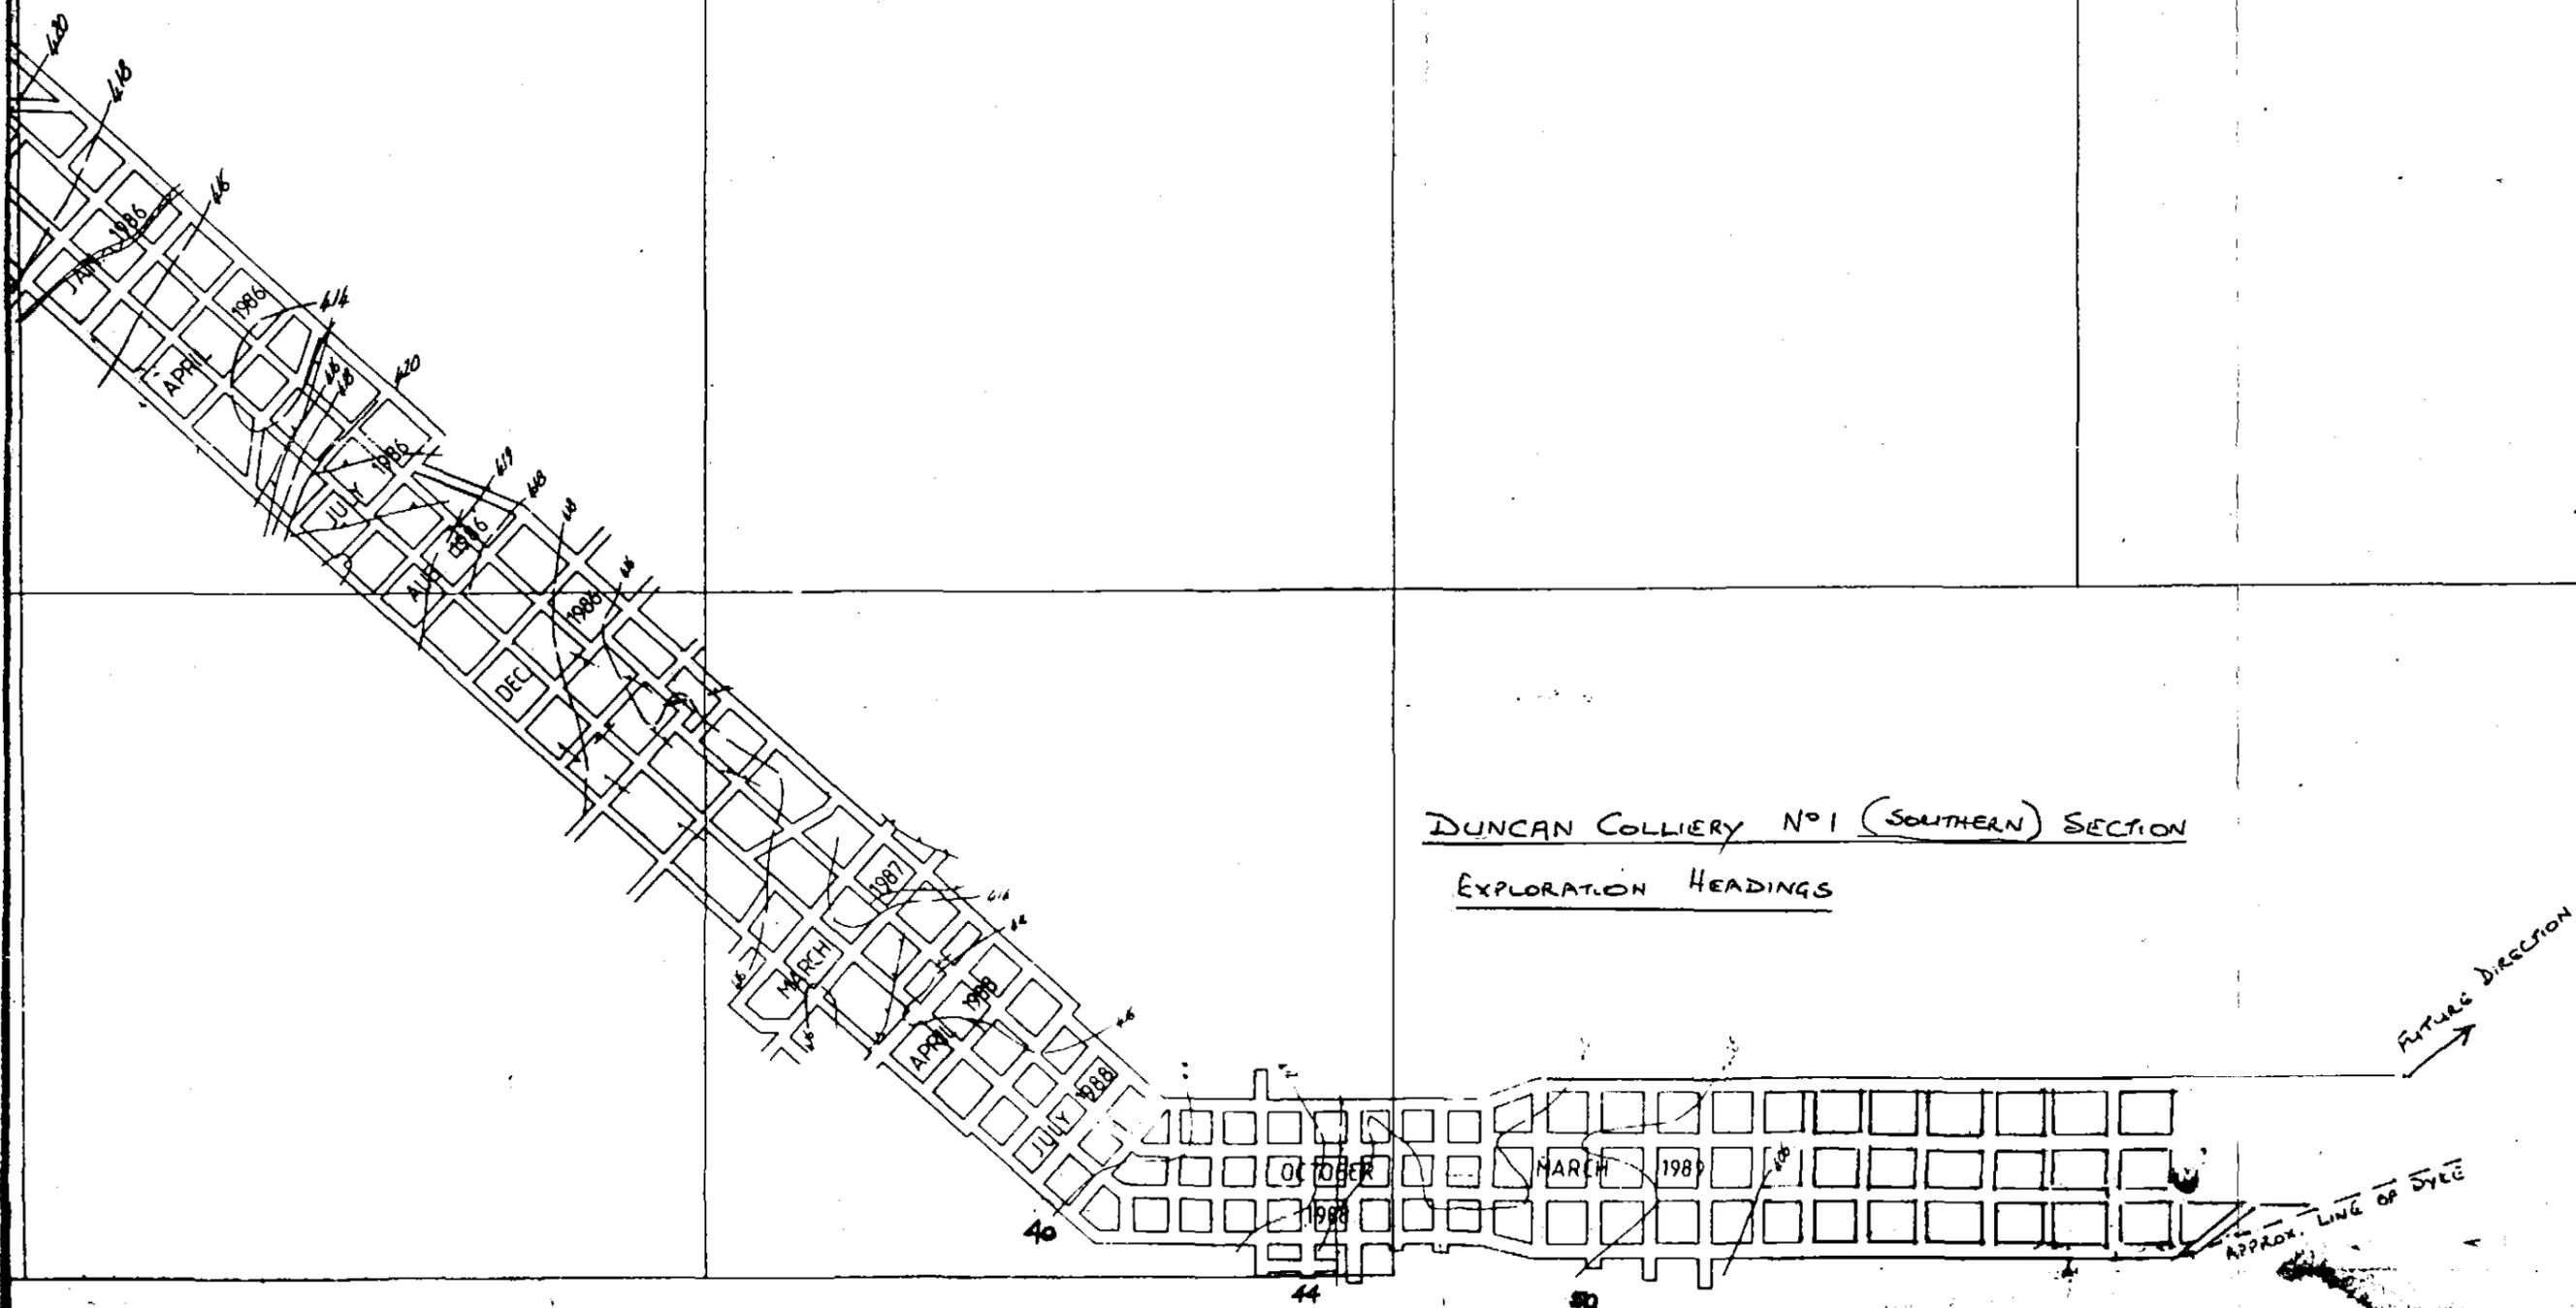
DUNCAN COLLIERY NO 1 (SOUTHERN) SECTION  
EXPLORATION HEADINGS

FUTURE DIRECTION  
→

Development was carried out for the full year 1988-89 in the southern area of the mine in the district known as No. 1 section. At the start of the period the face was being developed in a south easterly direction and had reached No. 38 cut-through. Conditions at the face have been wet with floor and roof water following the section to the dip. The seam contained a band of hard silt stone in the lower half of the seam from 35 cut-through to 47 cut-through. Seam thickness ranged from 1.5m to 1.8m from 38m cut-through to 47 cut-through. These three factors have slowed the rate of advance of the development. Coal quality improved progressively from 47 cut-through to 52 cut-through, coal quality from this point has been comparable with the better coal in the northern area of the mine.
